# Profile/Photo Observation Report

Date:	<b>11/07/2021</b>	Weather:		Coding:	<b>PACP 7.0</b>
Pipe Length (ft):	<b>260.2</b>	Owner:	<b>City of Hobart</b>	Pre Clean:	<b>Heavy Cleaning</b>
P.O.#:	<b>YES502259</b>	Surveyor:	<b>Steven Bucklin</b>	PSR:	<b>P-505-068-069</b>
Customer:	<b>City of Hobart, IN (Red</b>	Clean Date:	<b>11/07/2021</b>	Shape:	<b>C</b>

Street:	<b>West 1st Place</b>	Flow Control:	<b>Not Controlled</b>
City:	<b>City of Hobart</b>	Year Renewed:	
Location:	<b>Alley</b>	Tape/Media #:	
Purpose:	<b>Routine Assessment</b>	Dia/Height:	<b>10"</b>
Use:	<b>Sanitary Sewage Pipe</b>	Material:	<b>VCP</b>
Drain Area:		Lining:	<b>None</b>
Category:	<b>NA</b>		
Comment:			
Location Details:		Direction of Survey:	<b>Downstream</b>
US MH:	<b>M-505-069</b>	DS MH:	<b>M-505-068</b>
		Total Length Surveyed (ft):	<b>260.2</b>

O&M Index:	<b>1.81</b>	O&M Quick:	<b>4132</b>	O&M Rating:	<b>47.00</b>
Structural Index:	<b>2.39</b>	Structural Quick:	<b>5444</b>	Structural Rating:	<b>129.00</b>
Overall Index:	<b>2.20</b>	Overall Quick:	<b>5445</b>	Overall Rating:	<b>176.00</b>

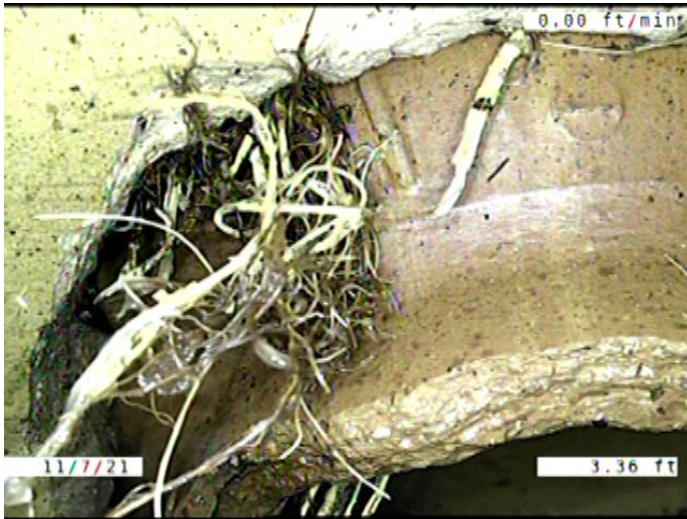
Code:	<b>RFC</b>
Description:	<b>Roots Fine Connection</b>
Distance (ft):	<b>3.4</b>
Structural Grade:	<b>0</b>
O&M Grade:	<b>1</b>
Clock Start/From:	<b>10</b>
Clock To:	<b>12</b>
1st Value:	
2nd Value:	
Value Percent:	
Continuous Index:	
Within 8" of Joint:	<b>NO</b>
Remarks:

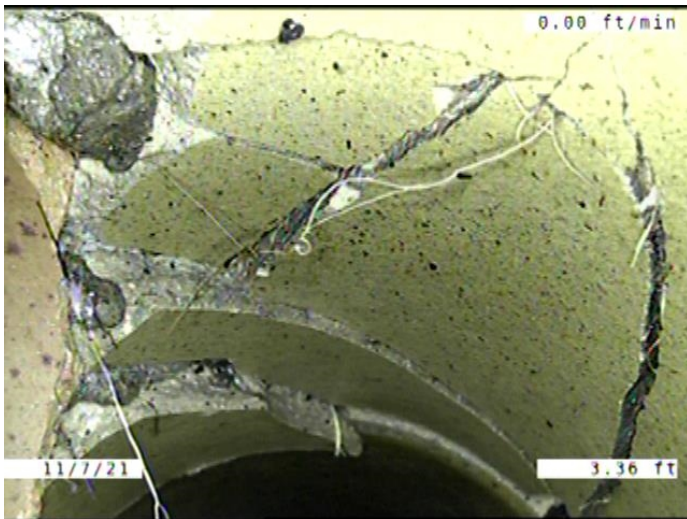
Code:	<b>B</b>
Description:	<b>Broken</b>
Distance (ft):	<b>3.4</b>
Structural Grade:	<b>4</b>
O&M Grade:	<b>0</b>
Clock Start/From:	<b>10</b>
Clock To:	<b>3</b>
1st Value:	
2nd Value:	
Value Percent:	
Continuous Index:	
Within 8" of Joint:	<b>YES</b>
Remarks:

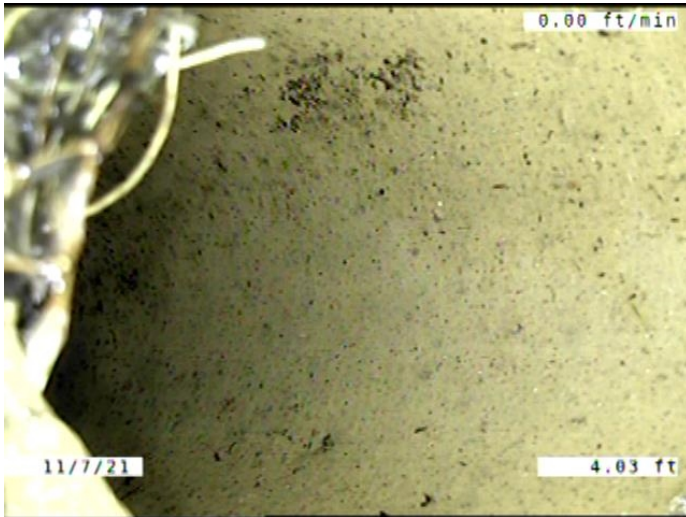
Code: **TBI**  
 Description: **Tap Break-in Intruding**

Distance (ft): **4.0**  
 Structural Grade: **0**  
 O&M Grade: **2**  
 Clock Start/From: **11**  
 Clock To:  
 1st Value: **4.000**  
 2nd Value: **2.000**  
 Value Percent:  
 Continuous Index:  
 Within 8" of Joint: **YES**  
 Remarks: **CONSTANTLY RUNNING WATER.**

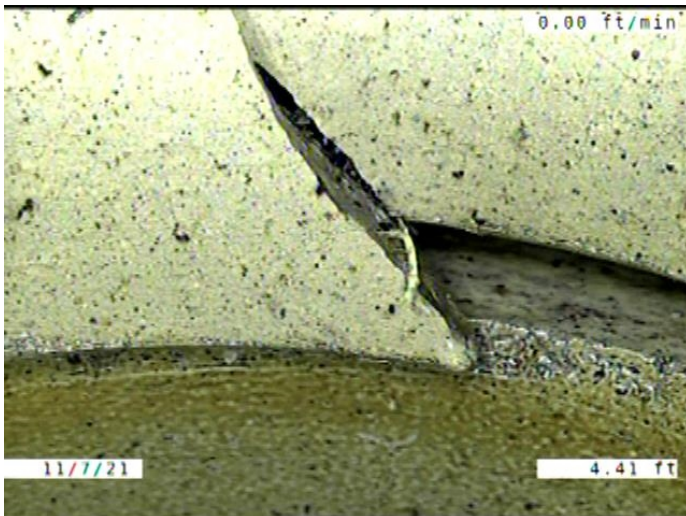
Code: **DR**  
 Description: **Deformed Rigid**

Distance (ft): **4.4**  
 Structural Grade: **4**  
 O&M Grade: **0**  
 Clock Start/From:  
 Clock To:  
 1st Value:  
 2nd Value:  
 Value Percent: **5.000**  
 Continuous Index:  
 Within 8" of Joint: **NO**  
 Remarks:

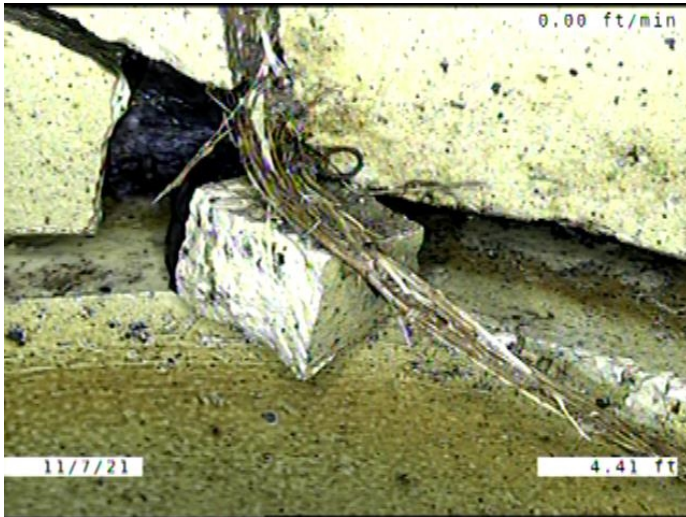
Code: **RFB**  
 Description: **Roots Fine Barrel**

Distance (ft): **4.4**  
 Structural Grade: **0**  
 O&M Grade: **2**  
 Clock Start/From: **1**  
 Clock To: **3**  
 1st Value:  
 2nd Value:  
 Value Percent:  
 Continuous Index:  
 Within 8" of Joint: **NO**  
 Remarks:

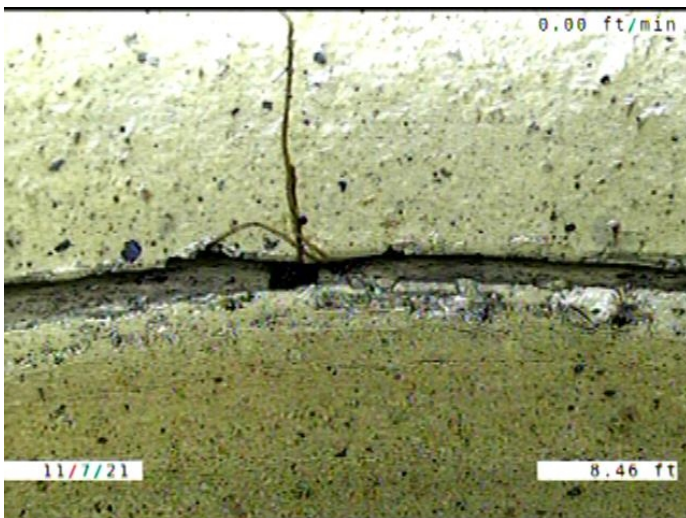
Code: **RFJ**  
 Description: **Roots Fine Joint**

Distance (ft): **8.5**  
 Structural Grade: **0**  
 O&M Grade: **1**  
 Clock Start/From: **10**  
 Clock To:  
 1st Value:  
 2nd Value:  
 Value Percent:  
 Continuous Index:  
 Within 8" of Joint: **YES**  
 Remarks:

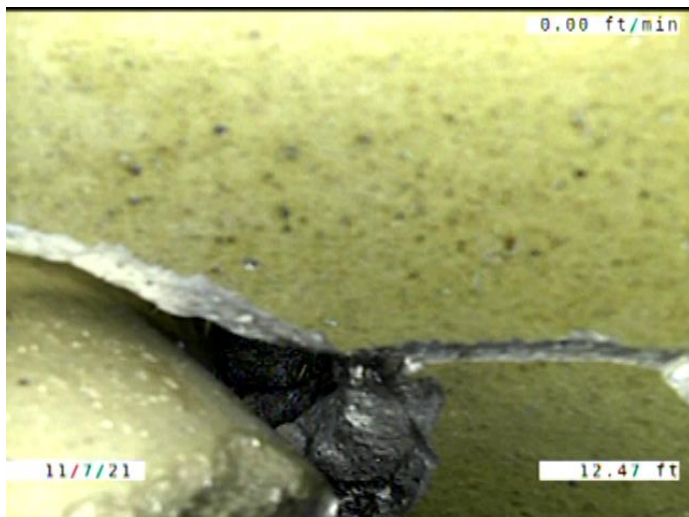
Code: **BSV**  
 Description: **Broken Soil Visible**

Distance (ft): **12.5**  
 Structural Grade: **5**  
 O&M Grade: **0**  
 Clock Start/From: **10**  
 Clock To: **6**  
 1st Value:  
 2nd Value:  
 Value Percent:  
 Continuous Index:  
 Within 8" of Joint: **YES**  
 Remarks:

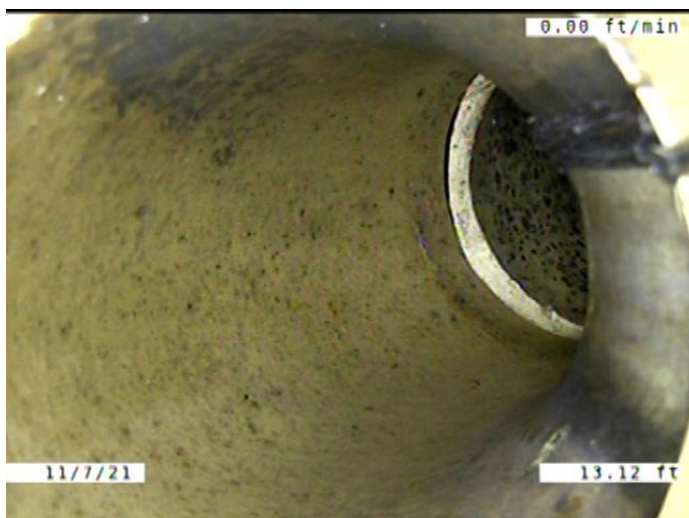
Code: **TBI**  
 Description: **Tap Break-in Intruding**

Distance (ft): **13.1**  
 Structural Grade: **0**  
 O&M Grade: **2**  
 Clock Start/From: **1**  
 Clock To:  
 1st Value: **4.000**  
 2nd Value: **3.000**  
 Value Percent:  
 Continuous Index:  
 Within 8" of Joint: **YES**  
 Remarks: **CONSTANTLY RUNNING WATER.  
 ROOTS GROWING INTO THE MAIN.**

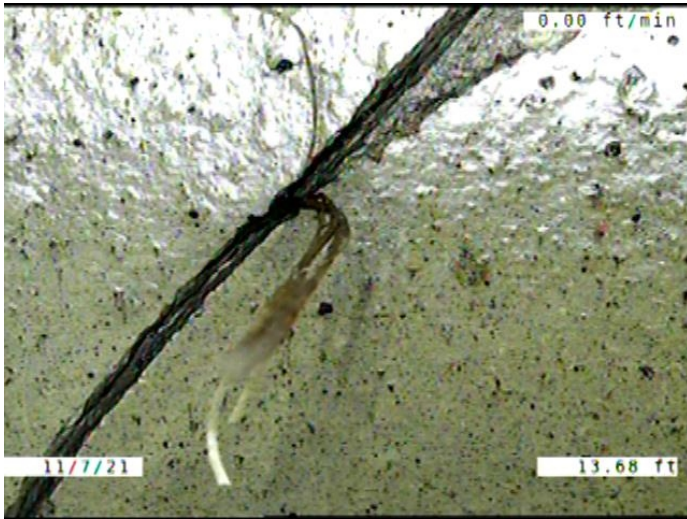
Code: **RFB**  
 Description: **Roots Fine Barrel**

Distance (ft): **13.7**  
 Structural Grade: **0**  
 O&M Grade: **2**  
 Clock Start/From: **10**  
 Clock To: **11**  
 1st Value:  
 2nd Value:  
 Value Percent:  
 Continuous Index:  
 Within 8" of Joint: **NO**  
 Remarks:

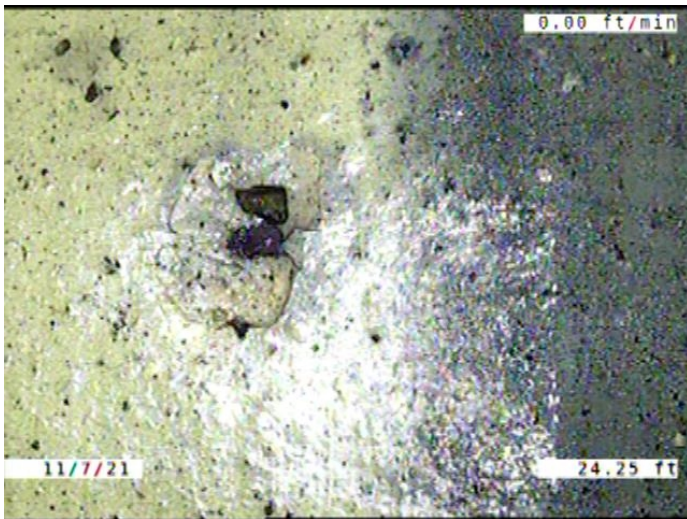
Code: **SSS**  
 Description: **Surface Damage Surface Spalling**

Distance (ft): **24.2**  
 Structural Grade: **2**  
 O&M Grade: **0**  
 Clock Start/From: **8**  
 Clock To:  
 1st Value:  
 2nd Value:  
 Value Percent:  
 Continuous Index:  
 Within 8" of Joint: **YES**  
 Remarks:

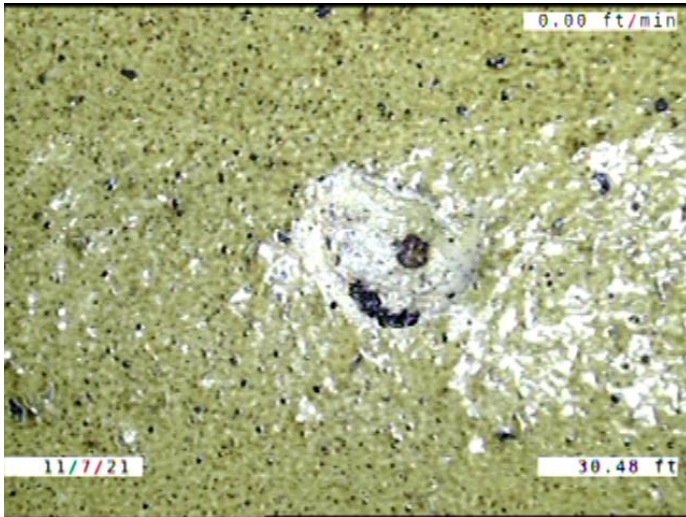
Code: **SSS**  
 Description: **Surface Damage Surface Spalling**

Distance (ft): **30.5**  
 Structural Grade: **2**  
 O&M Grade: **0**  
 Clock Start/From: **1**  
 Clock To: **3**  
 1st Value:  
 2nd Value:  
 Value Percent:  
 Continuous Index:  
 Within 8" of Joint: **NO**  
 Remarks:

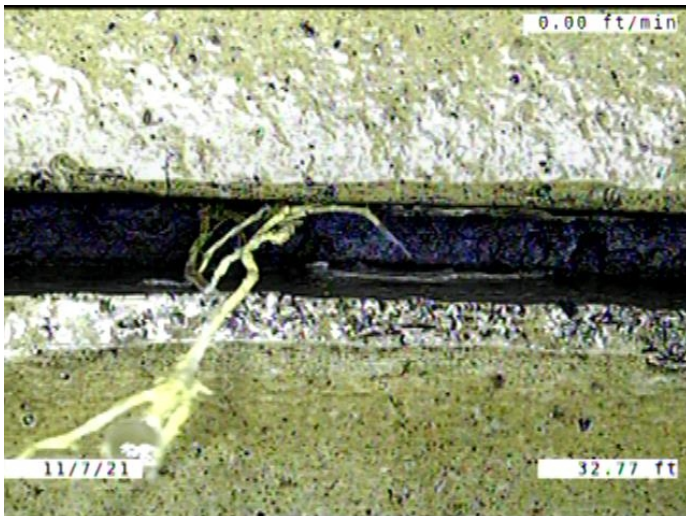
Code: **RFJ**  
 Description: **Roots Fine Joint**

Distance (ft): **32.8**  
 Structural Grade: **0**  
 O&M Grade: **1**  
 Clock Start/From: **11**  
 Clock To:  
 1st Value:  
 2nd Value:  
 Value Percent:  
 Continuous Index:  
 Within 8" of Joint: **YES**  
 Remarks:

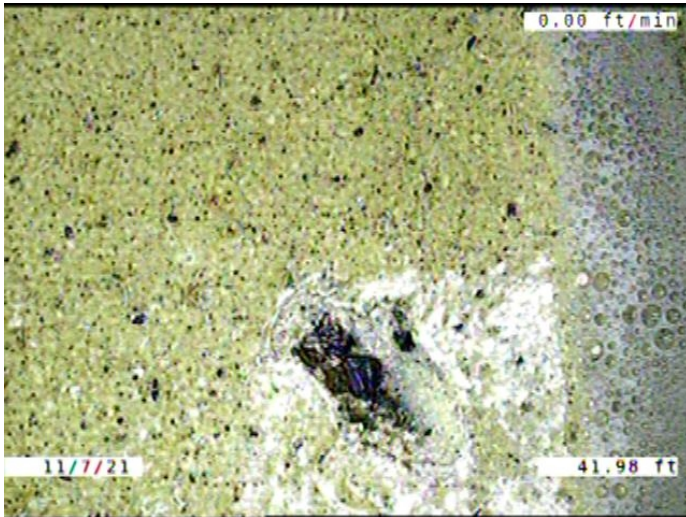
Code: **SSS**  
 Description: **Surface Damage Surface Spalling**

Distance (ft): **42.0**  
 Structural Grade: **2**  
 O&M Grade: **0**  
 Clock Start/From: **8**  
 Clock To:  
 1st Value:  
 2nd Value:  
 Value Percent:  
 Continuous Index:  
 Within 8" of Joint: **YES**  
 Remarks:

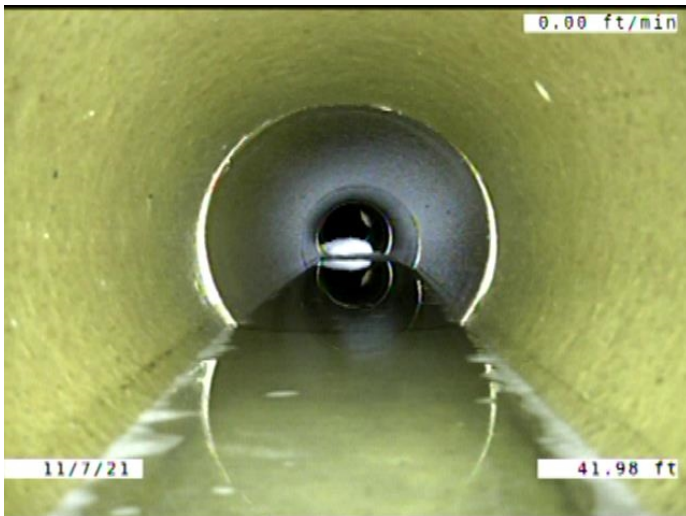
Code: **MWLS**  
 Description: **Miscellaneous Water Level Sag**

Distance (ft): **42.0**  
 Structural Grade: **2**  
 O&M Grade: **0**  
 Clock Start/From:  
 Clock To:  
 1st Value:  
 2nd Value:  
 Value Percent: **5.000**  
 Continuous Index: **S01**  
 Within 8" of Joint: **NO**  
 Remarks:

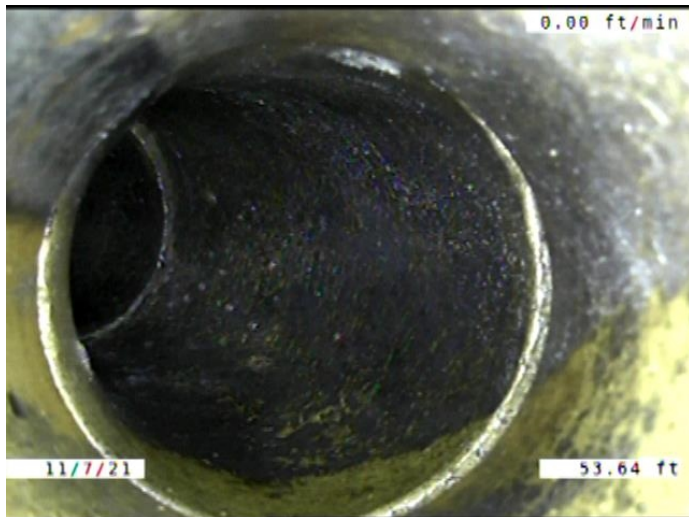
Code: **TF**  
Description: **Tap Factory**

Distance (ft): **53.6**  
Structural Grade: **0**  
O&M Grade: **0**  
Clock Start/From: **11**  
Clock To:  
1st Value: **4.000**  
2nd Value:  
Value Percent:  
Continuous Index:  
Within 8" of Joint: **YES**  
Remarks: **CONSTANTLY RUNNING WATER.**

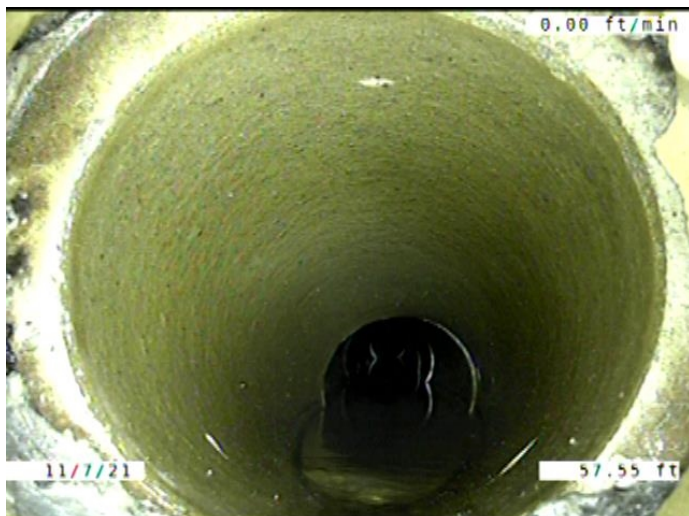
Code: **MWLS**  
Description: **Miscellaneous Water Level Sag**

Distance (ft): **57.5**  
Structural Grade: **2**  
O&M Grade: **0**  
Clock Start/From:  
Clock To:  
1st Value:  
2nd Value:  
Value Percent: **5.000**  
Continuous Index: **F01**  
Within 8" of Joint: **NO**  
Remarks:

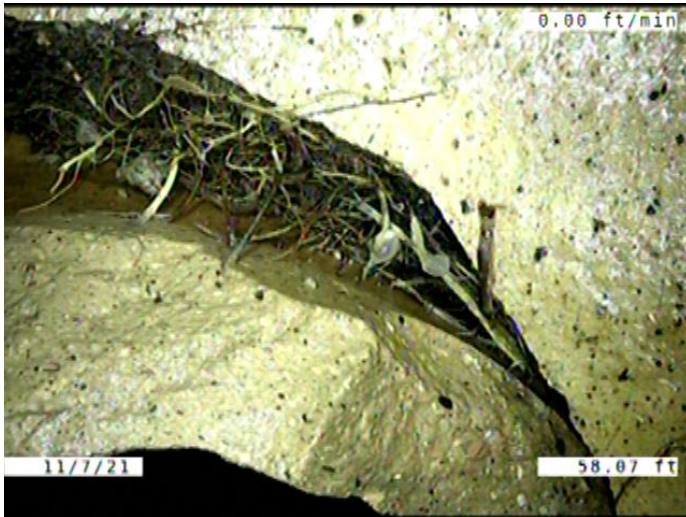
Code: **RFJ**  
Description: **Roots Fine Joint**

Distance (ft): **58.1**  
Structural Grade: **0**  
O&M Grade: **1**  
Clock Start/From: **1**  
Clock To: **3**  
1st Value:  
2nd Value:  
Value Percent:  
Continuous Index:  
Within 8" of Joint: **YES**  
Remarks:

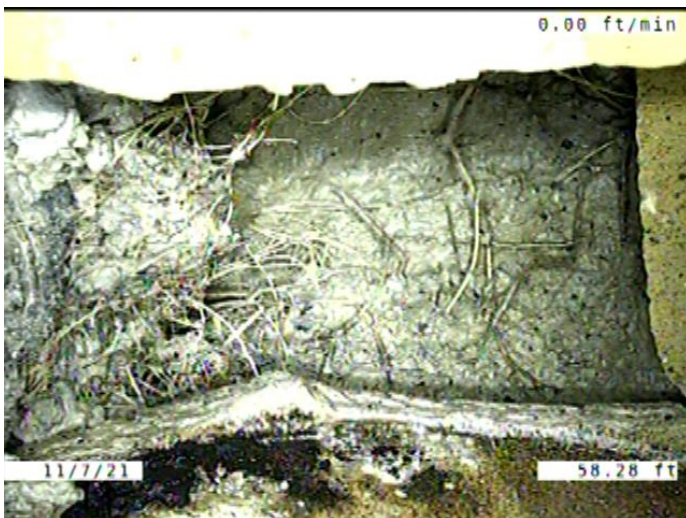
Code: **HVV**  
Description: **Hole Void Visible**

Distance (ft): **58.3**  
Structural Grade: **5**  
O&M Grade: **0**  
Clock Start/From: **3**  
Clock To: **9**  
1st Value:  
2nd Value:  
Value Percent:  
Continuous Index:  
Within 8" of Joint: **YES**  
Remarks: **SOIL VISIBLE TOO**

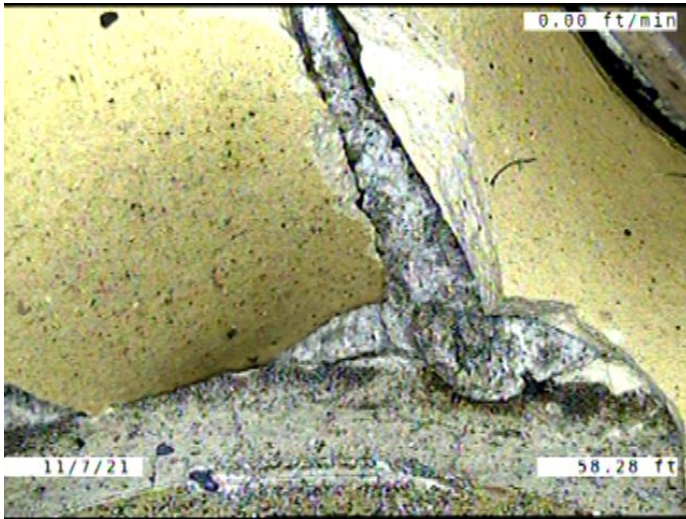
Code: **BSV**  
 Description: **Broken Soil Visible**

Distance (ft): **58.3**  
 Structural Grade: **5**  
 O&M Grade: **0**  
 Clock Start/From: **9**  
 Clock To: **3**  
 1st Value:  
 2nd Value:  
 Value Percent:  
 Continuous Index:  
 Within 8" of Joint: **YES**  
 Remarks:

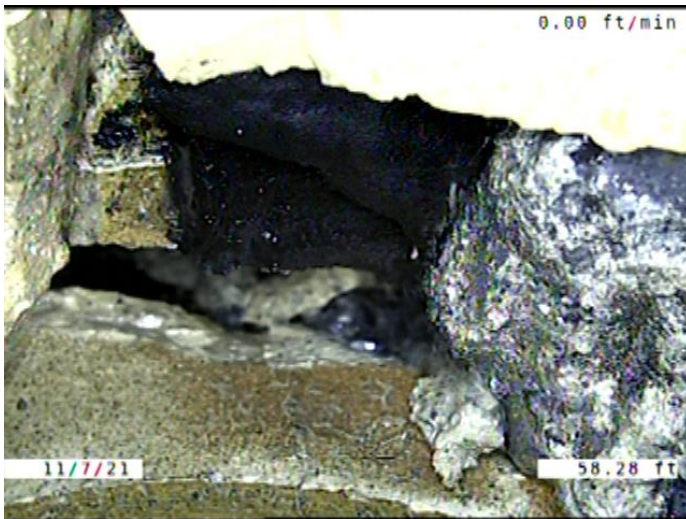
Code: **IRB**  
 Description: **Infiltration Runner Barrel**

Distance (ft): **58.3**  
 Structural Grade: **0**  
 O&M Grade: **4**  
 Clock Start/From: **4**  
 Clock To:  
 1st Value:  
 2nd Value:  
 Value Percent:  
 Continuous Index:  
 Within 8" of Joint: **YES**  
 Remarks:

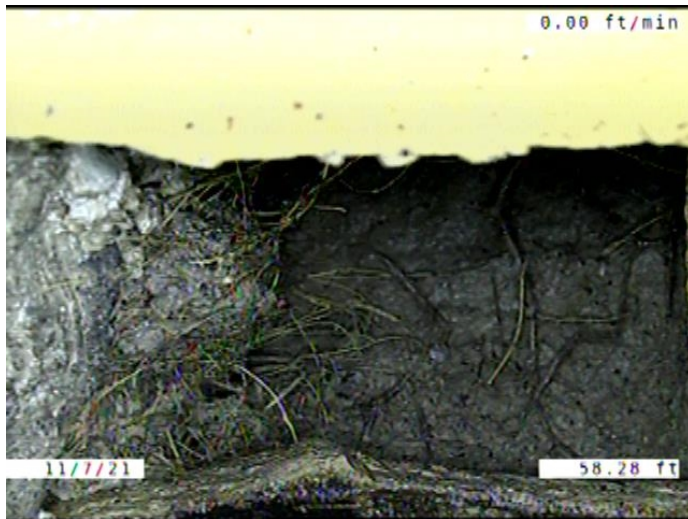
Code: **RFB**  
 Description: **Roots Fine Barrel**

Distance (ft): **58.3**  
 Structural Grade: **0**  
 O&M Grade: **2**  
 Clock Start/From: **9**  
 Clock To: **10**  
 1st Value:  
 2nd Value:  
 Value Percent:  
 Continuous Index:  
 Within 8" of Joint: **NO**  
 Remarks:

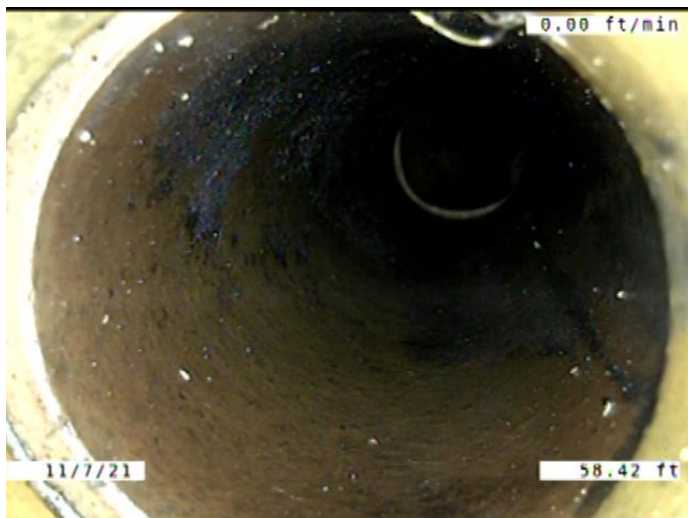
Code: **TBI**  
 Description: **Tap Break-in Intruding**

Distance (ft): **58.4**  
 Structural Grade: **0**  
 O&M Grade: **2**  
 Clock Start/From: **2**  
 Clock To:  
 1st Value: **4.000**  
 2nd Value: **1.000**  
 Value Percent:  
 Continuous Index:  
 Within 8" of Joint: **YES**  
 Remarks:

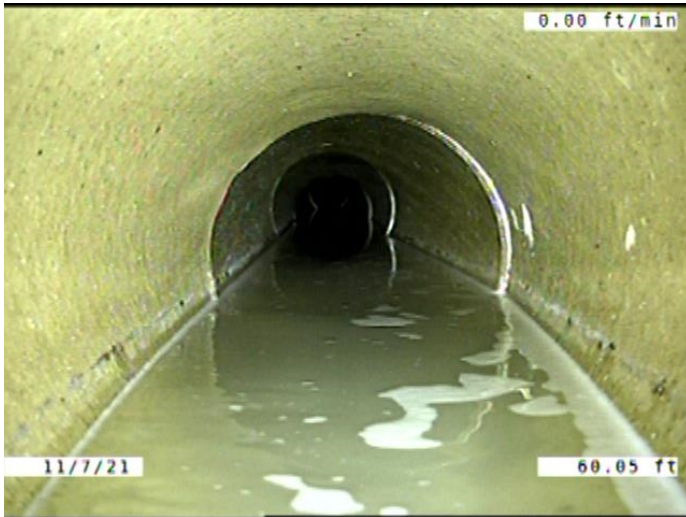
Code: **MWLS**  
 Description: **Miscellaneous Water Level Sag**

Distance (ft): **60.0**  
 Structural Grade: **2**  
 O&M Grade: **0**  
 Clock Start/From:  
 Clock To:  
 1st Value:  
 2nd Value:  
 Value Percent: **15.000**  
 Continuous Index: **S02**  
 Within 8" of Joint: **NO**  
 Remarks:

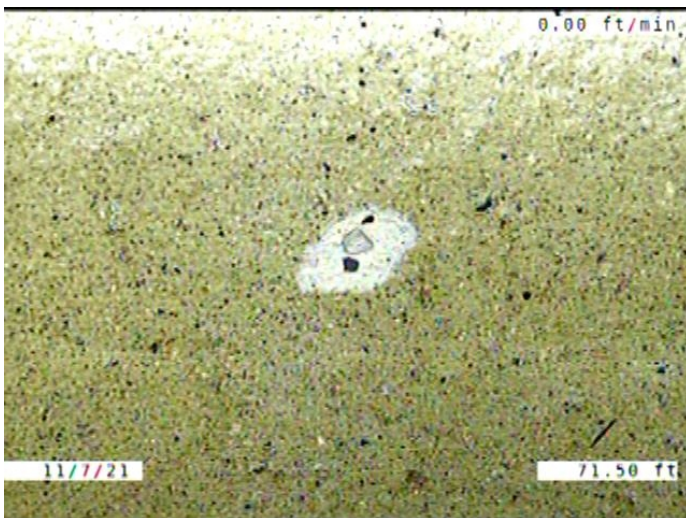
Code: **SSS**  
 Description: **Surface Damage Surface Spalling**

Distance (ft): **71.5**  
 Structural Grade: **2**  
 O&M Grade: **0**  
 Clock Start/From: **11**  
 Clock To:  
 1st Value:  
 2nd Value:  
 Value Percent:  
 Continuous Index:  
 Within 8" of Joint: **YES**  
 Remarks:

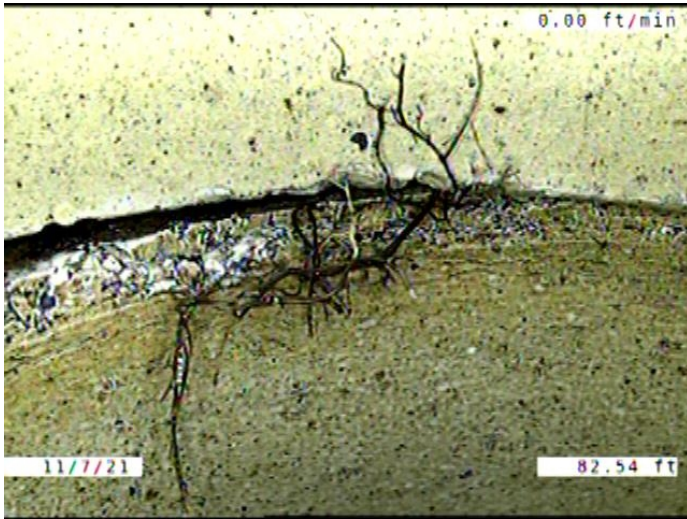
Code: **RFJ**  
 Description: **Roots Fine Joint**

Distance (ft): **82.5**  
 Structural Grade: **0**  
 O&M Grade: **1**  
 Clock Start/From: **10**  
 Clock To:  
 1st Value:  
 2nd Value:  
 Value Percent:  
 Continuous Index:  
 Within 8" of Joint: **YES**  
 Remarks:

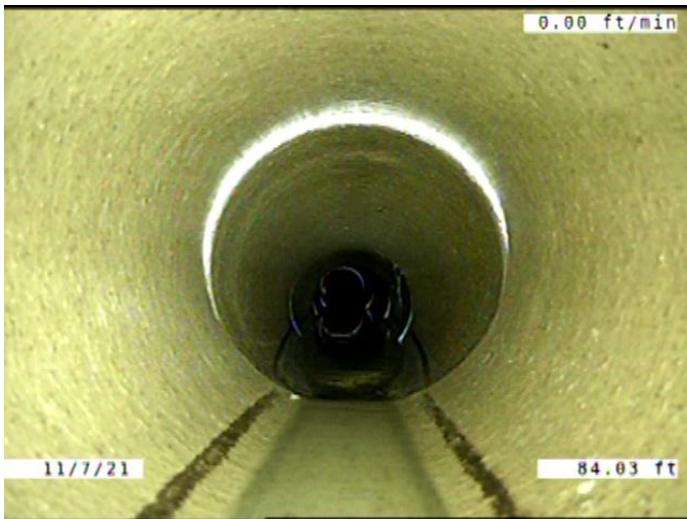
Code: **MWLS**  
 Description: **Miscellaneous Water Level Sag**

Distance (ft): **84.0**  
 Structural Grade: **2**  
 O&M Grade: **0**  
 Clock Start/From:  
 Clock To:  
 1st Value:  
 2nd Value:  
 Value Percent: **15.000**  
 Continuous Index: **F02**  
 Within 8" of Joint: **NO**  
 Remarks:

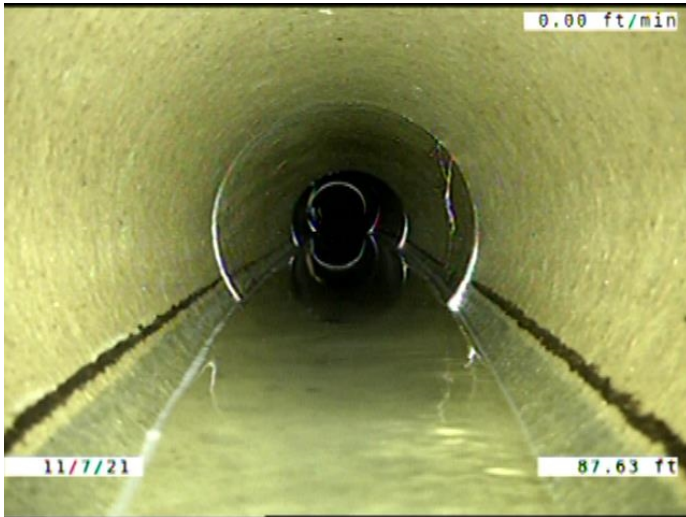
Code: **MWLS**  
 Description: **Miscellaneous Water Level Sag**

Distance (ft): **87.6**  
 Structural Grade: **2**  
 O&M Grade: **0**  
 Clock Start/From:  
 Clock To:  
 1st Value:  
 2nd Value:  
 Value Percent: **15.000**  
 Continuous Index: **S03**  
 Within 8" of Joint: **NO**  
 Remarks:

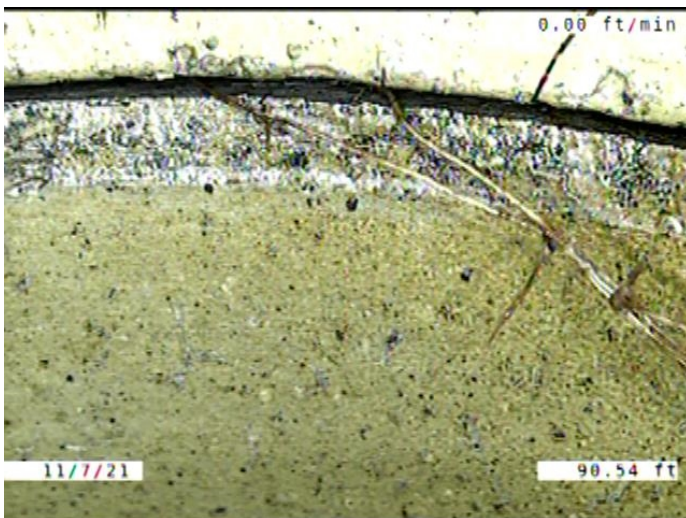
Code: **RFJ**  
 Description: **Roots Fine Joint**

Distance (ft): **90.5**  
 Structural Grade: **0**  
 O&M Grade: **1**  
 Clock Start/From: **1**  
 Clock To: **2**  
 1st Value:  
 2nd Value:  
 Value Percent:  
 Continuous Index:  
 Within 8" of Joint: **YES**  
 Remarks:

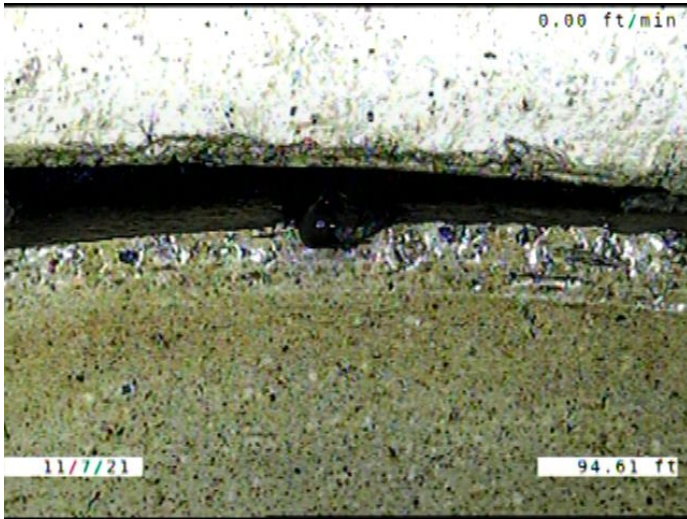
Code: **ISSRH**  
Description: **Intruding Sealing Material Sealing Ring Hanging**

Distance (ft): **94.6**  
Structural Grade: **0**  
O&M Grade: **2**  
Clock Start/From: **10**  
Clock To: **11**  
1st Value:  
2nd Value:  
Value Percent: **5.000**  
Continuous Index:  
Within 8" of Joint: **NO**  
Remarks:

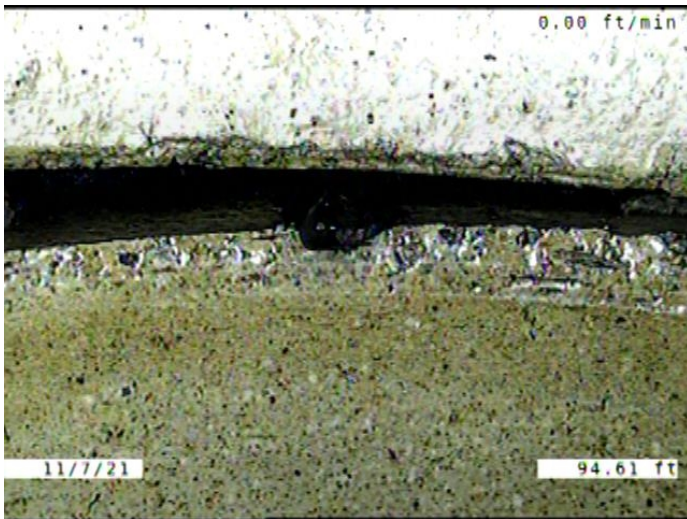
Code: **IWJ**  
Description: **Infiltration Weeper Joint**

Distance (ft): **94.6**  
Structural Grade: **0**  
O&M Grade: **2**  
Clock Start/From: **11**  
Clock To:  
1st Value:  
2nd Value:  
Value Percent:  
Continuous Index:  
Within 8" of Joint: **YES**  
Remarks:

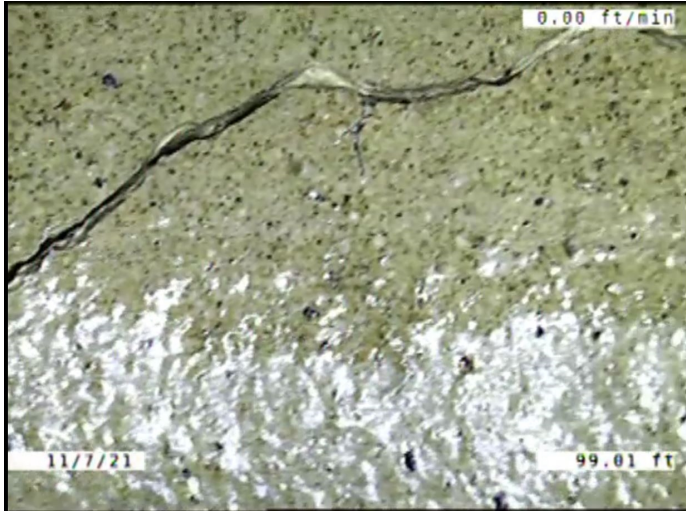
Code: **FM**  
Description: **Fracture Multiple**

Distance (ft): **99.0**  
Structural Grade: **4**  
O&M Grade: **0**  
Clock Start/From: **10**  
Clock To: **5**  
1st Value:  
2nd Value:  
Value Percent:  
Continuous Index:  
Within 8" of Joint: **NO**  
Remarks:

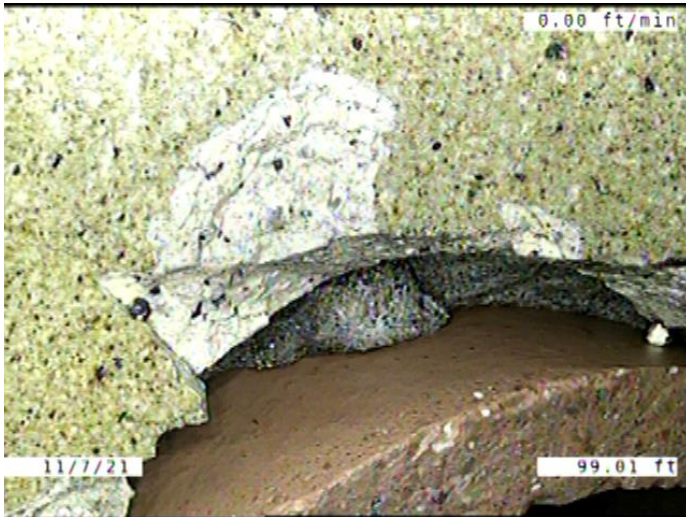
Code: **SSS**  
Description: **Surface Damage Surface Spalling**

Distance (ft): **99.0**  
Structural Grade: **2**  
O&M Grade: **0**  
Clock Start/From: **8**  
Clock To: **10**  
1st Value:  
2nd Value:  
Value Percent:  
Continuous Index:  
Within 8" of Joint: **YES**  
Remarks:

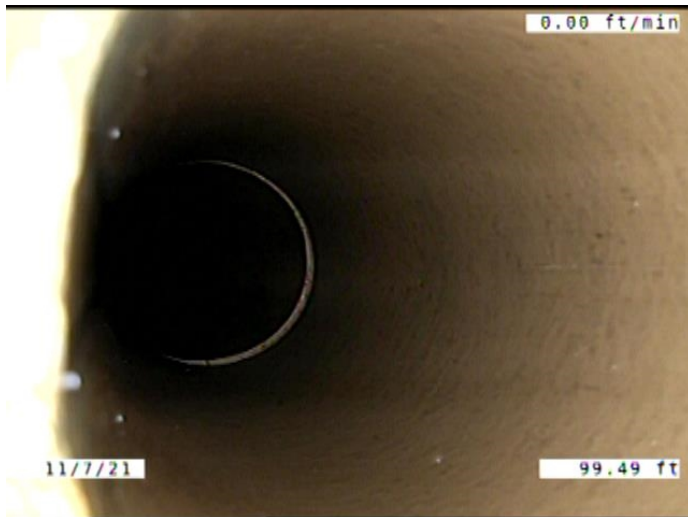
Code: **TBI**  
 Description: **Tap Break-in Intruding**

Distance (ft): **99.5**  
 Structural Grade: **0**  
 O&M Grade: **2**  
 Clock Start/From: **10**  
 Clock To:  
 1st Value: **4.000**  
 2nd Value: **1.000**  
 Value Percent:  
 Continuous Index:  
 Within 8" of Joint: **YES**  
 Remarks: **CONSTANTLY RUNNING WATER.**

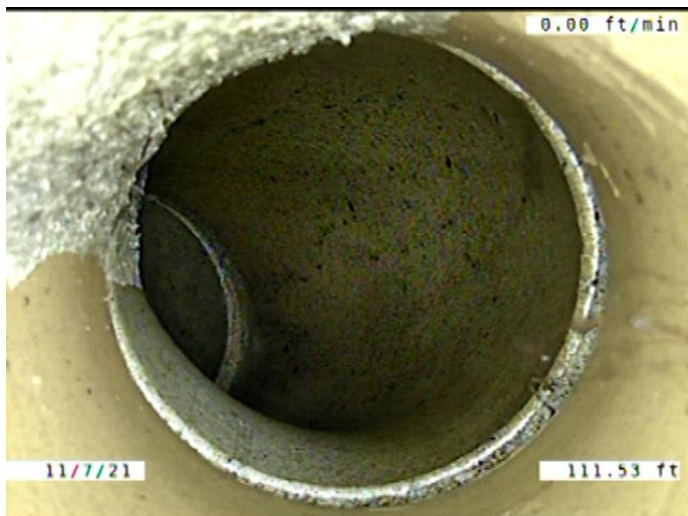
Code: **TF**  
 Description: **Tap Factory**

Distance (ft): **111.5**  
 Structural Grade: **0**  
 O&M Grade: **0**  
 Clock Start/From: **11**  
 Clock To:  
 1st Value: **4.000**  
 2nd Value:  
 Value Percent:  
 Continuous Index:  
 Within 8" of Joint: **YES**  
 Remarks: **ENCRUSTATION COMING DOWN THE TAP**

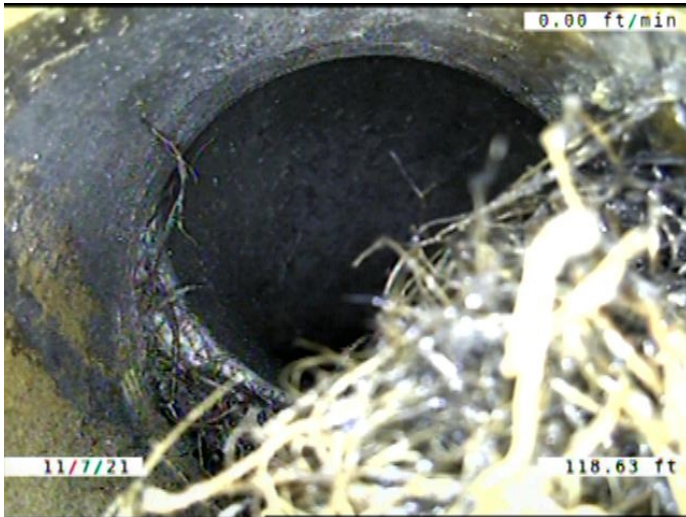
Code:	<b>TFD</b>
Description:	<b>Tap Factory Defective</b>
Distance (ft):	<b>118.6</b>
Structural Grade:	<b>0</b>
O&M Grade:	<b>3</b>
Clock Start/From:	<b>1</b>
Clock To:	
1st Value:	<b>4.000</b>
2nd Value:	
Value Percent:	
Continuous Index:	
Within 8" of Joint:	<b>YES</b>
Remarks:	<b>OFFSET. ROOTS GROWING FROM THE JOINTS</b>

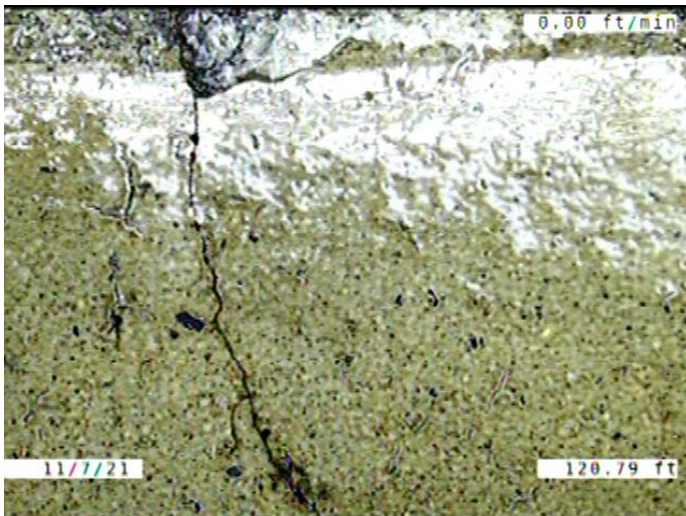
Code:	<b>CL</b>
Description:	<b>Crack Longitudinal</b>
Distance (ft):	<b>120.8</b>
Structural Grade:	<b>2</b>
O&M Grade:	<b>0</b>
Clock Start/From:	<b>1</b>
Clock To:	
1st Value:	
2nd Value:	
Value Percent:	
Continuous Index:	
Within 8" of Joint:	<b>YES</b>
Remarks:

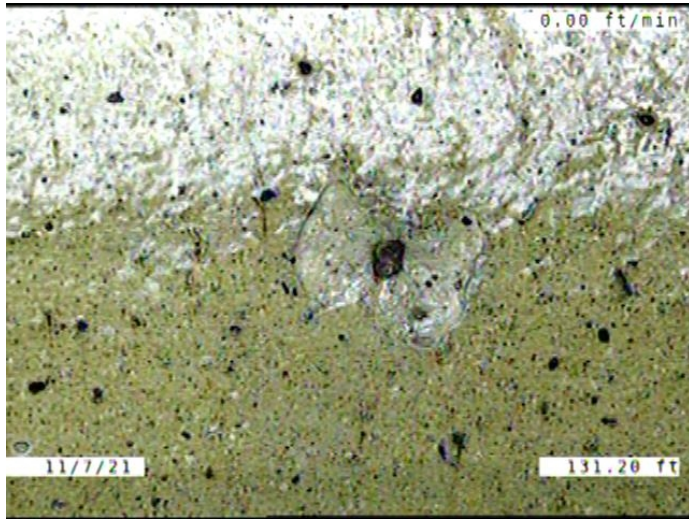
Code: **SSS**  
 Description: **Surface Damage Surface Spalling**

Distance (ft): **131.2**  
 Structural Grade: **2**  
 O&M Grade: **0**  
 Clock Start/From: **10**  
 Clock To:  
 1st Value:  
 2nd Value:  
 Value Percent:  
 Continuous Index:  
 Within 8" of Joint: **NO**  
 Remarks:

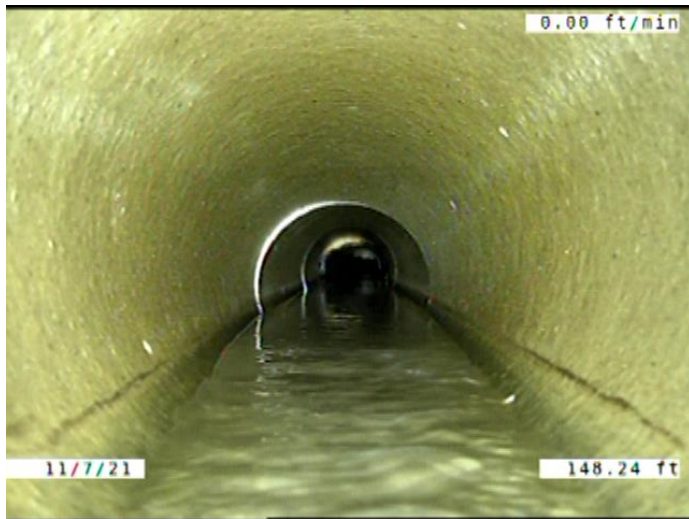
Code: **MWLS**  
 Description: **Miscellaneous Water Level Sag**

Distance (ft): **148.2**  
 Structural Grade: **2**  
 O&M Grade: **0**  
 Clock Start/From:  
 Clock To:  
 1st Value:  
 2nd Value:  
 Value Percent: **15.000**  
 Continuous Index: **F03**  
 Within 8" of Joint: **NO**  
 Remarks:

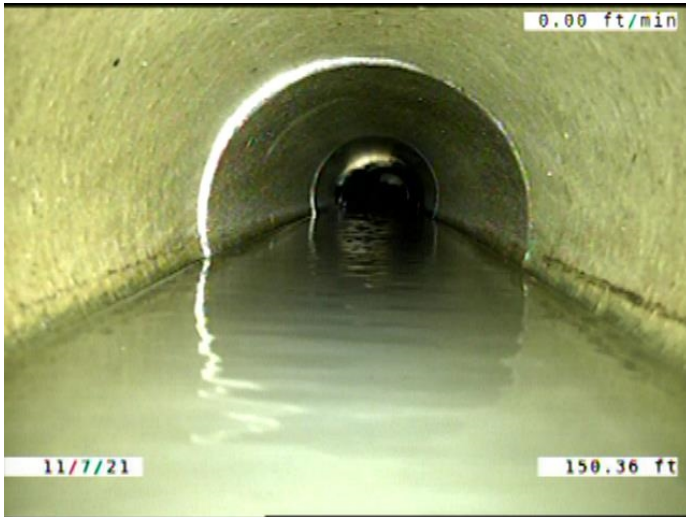
Code: **MWLS**  
 Description: **Miscellaneous Water Level Sag**

Distance (ft): **150.4**  
 Structural Grade: **2**  
 O&M Grade: **0**  
 Clock Start/From:  
 Clock To:  
 1st Value:  
 2nd Value:  
 Value Percent: **20.000**  
 Continuous Index: **S04**  
 Within 8" of Joint: **NO**  
 Remarks:

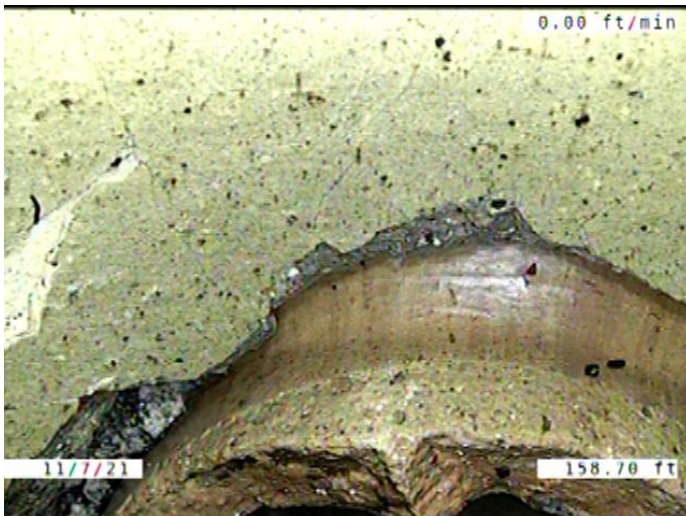
Code: **SSS**  
 Description: **Surface Damage Surface Spalling**

Distance (ft): **158.7**  
 Structural Grade: **2**  
 O&M Grade: **0**  
 Clock Start/From: **10**  
 Clock To: **1**  
 1st Value:  
 2nd Value:  
 Value Percent:  
 Continuous Index:  
 Within 8" of Joint: **YES**  
 Remarks:

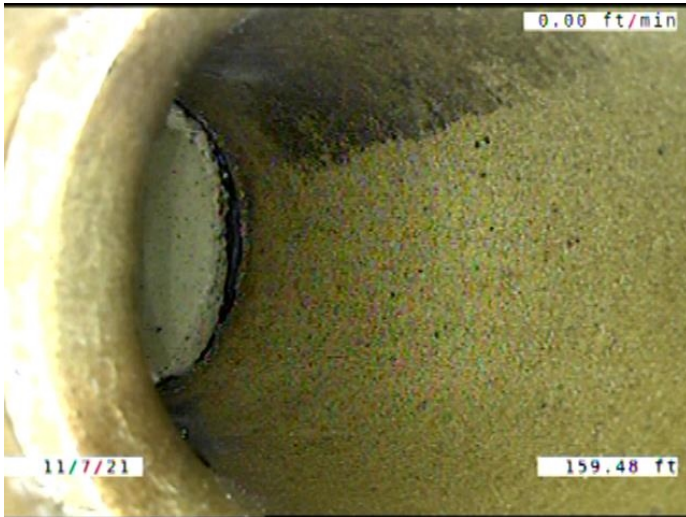
Code: **TBI**  
 Description: **Tap Break-in Intruding**

Distance (ft): **159.5**  
 Structural Grade: **0**  
 O&M Grade: **2**  
 Clock Start/From: **11**  
 Clock To:  
 1st Value: **4.000**  
 2nd Value: **1.000**  
 Value Percent:  
 Continuous Index:  
 Within 8" of Joint: **YES**  
 Remarks: **CONSTANTLY RUNNING WATER.**

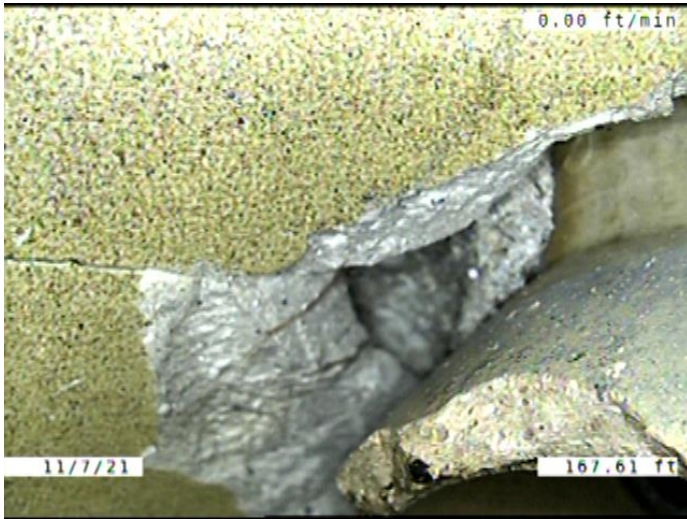
Code: **B**  
 Description: **Broken**

Distance (ft): **167.6**  
 Structural Grade: **4**  
 O&M Grade: **0**  
 Clock Start/From: **8**  
 Clock To: **4**  
 1st Value:  
 2nd Value:  
 Value Percent:  
 Continuous Index:  
 Within 8" of Joint: **YES**  
 Remarks:

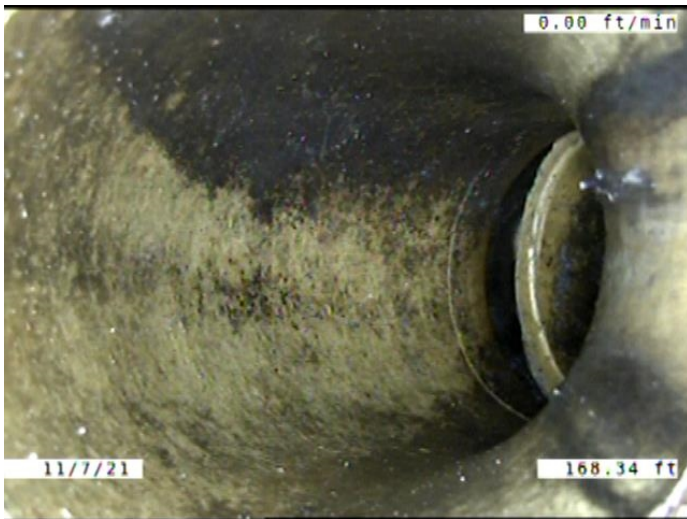
Code: **TBI**  
 Description: **Tap Break-in Intruding**

Distance (ft): **168.3**  
 Structural Grade: **0**  
 O&M Grade: **2**  
 Clock Start/From: **1**  
 Clock To:  
 1st Value: **4.000**  
 2nd Value: **2.000**  
 Value Percent:  
 Continuous Index:  
 Within 8" of Joint: **YES**  
 Remarks:

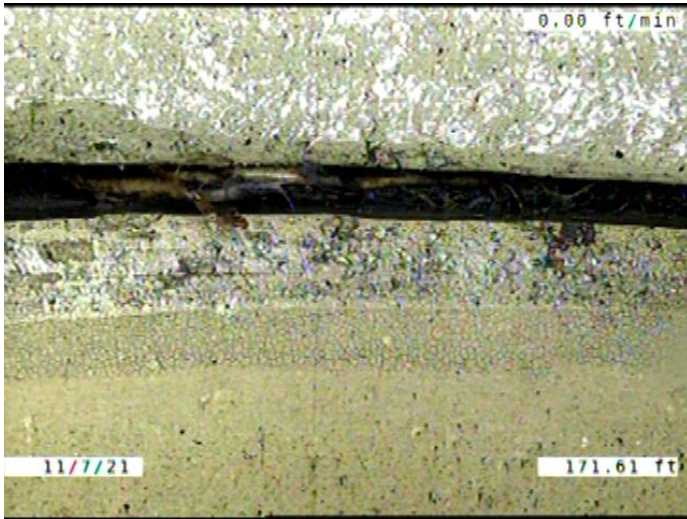
Code: **RFJ**  
Description: **Roots Fine Joint**

Distance (ft): **171.6**  
Structural Grade: **0**  
O&M Grade: **1**  
Clock Start/From: **10**  
Clock To: **1**  
1st Value:  
2nd Value:  
Value Percent:  
Continuous Index:  
Within 8" of Joint: **YES**  
Remarks:

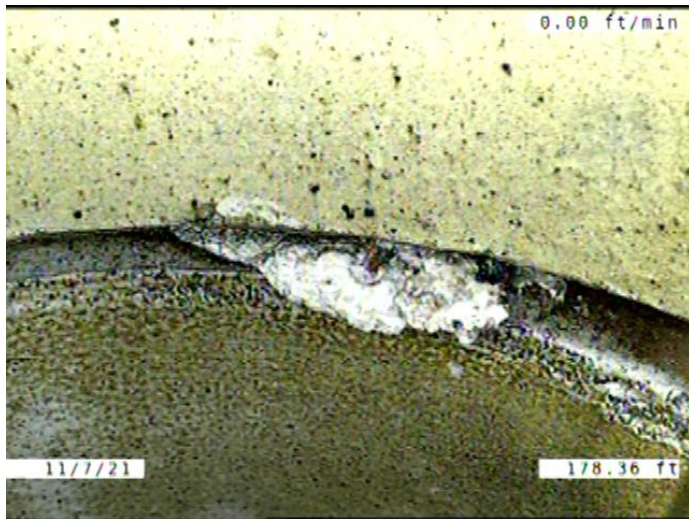
Code:	<b>DAE</b>
Description:	<b>Deposits Attached Encrustation</b>
Distance (ft):	<b>178.4</b>
Structural Grade:	<b>0</b>
O&M Grade:	<b>2</b>
Clock Start/From:	<b>2</b>
Clock To:	
1st Value:	
2nd Value:	
Value Percent:	<b>5.000</b>
Continuous Index:	
Within 8" of Joint:	<b>YES</b>
Remarks:

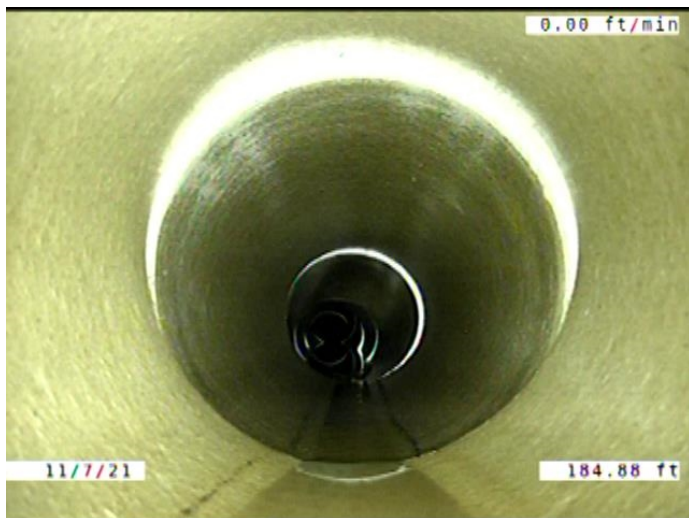
Code:	<b>MWLS</b>
Description:	<b>Miscellaneous Water Level Sag</b>
Distance (ft):	<b>184.9</b>
Structural Grade:	<b>2</b>
O&M Grade:	<b>0</b>
Clock Start/From:	
Clock To:	
1st Value:	
2nd Value:	
Value Percent:	<b>20.000</b>
Continuous Index:	<b>F04</b>
Within 8" of Joint:	<b>NO</b>
Remarks:

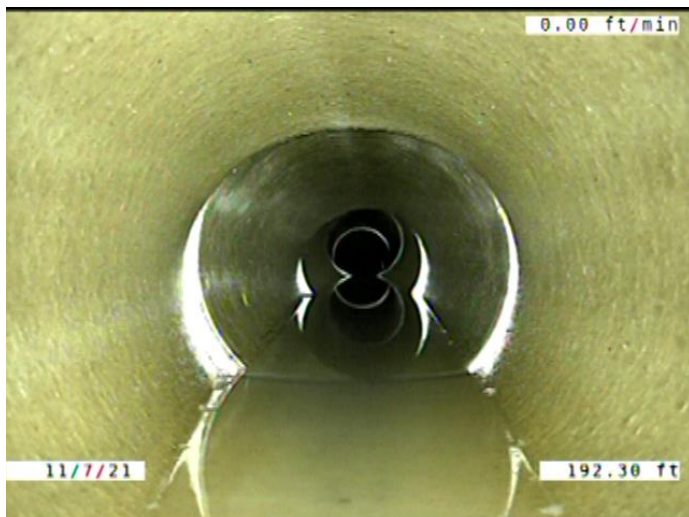
Code: **MWLS**  
Description: **Miscellaneous Water Level Sag**

Distance (ft): **192.3**  
Structural Grade: **2**  
O&M Grade: **0**  
Clock Start/From:  
Clock To:  
1st Value:  
2nd Value:  
Value Percent: **10.000**  
Continuous Index: **S05**  
Within 8" of Joint: **NO**  
Remarks:

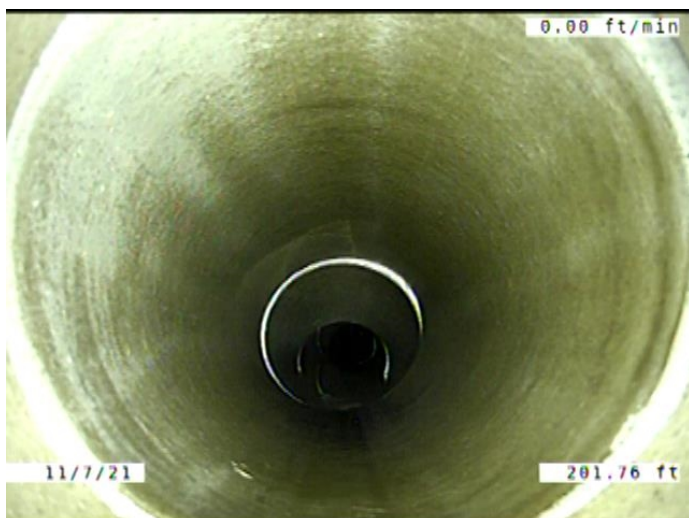
Code: **MWLS**  
Description: **Miscellaneous Water Level Sag**

Distance (ft): **201.8**  
Structural Grade: **2**  
O&M Grade: **0**  
Clock Start/From:  
Clock To:  
1st Value:  
2nd Value:  
Value Percent: **10.000**  
Continuous Index: **F05**  
Within 8" of Joint: **NO**  
Remarks:

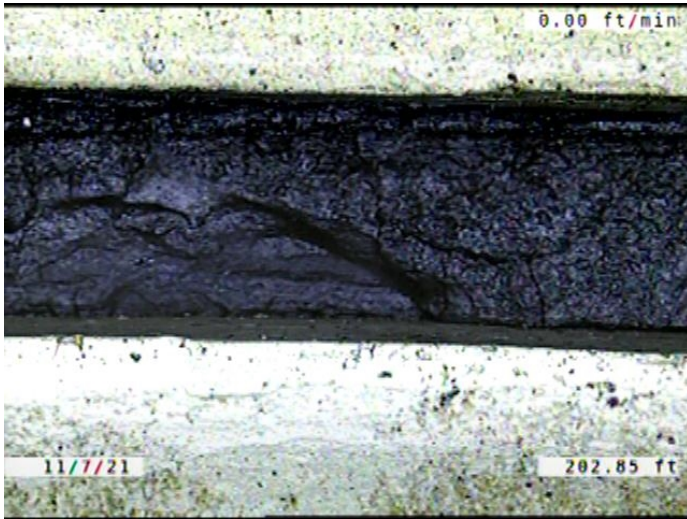
Code: **JAM**  
Description: **Joint Angular Medium**

Distance (ft): **202.9**  
Structural Grade: **3**  
O&M Grade: **0**  
Clock Start/From:  
Clock To:  
1st Value:  
2nd Value:  
Value Percent:  
Continuous Index:  
Within 8" of Joint: **NO**  
Remarks:

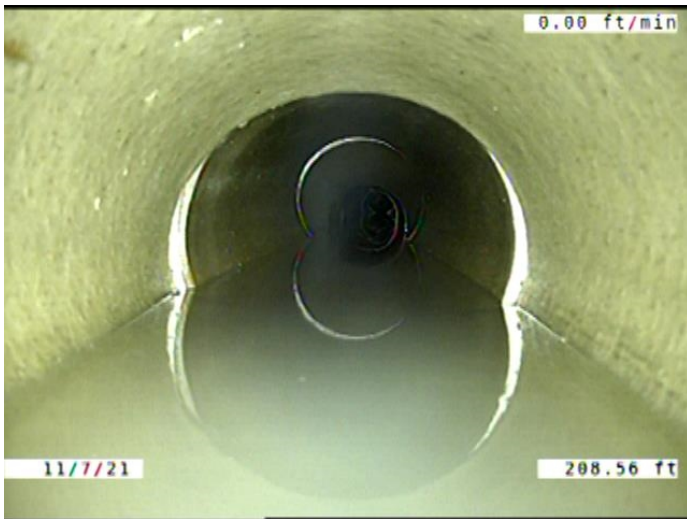
Code: **MWLS**  
Description: **Miscellaneous Water Level Sag**

Distance (ft): **208.6**  
Structural Grade: **2**  
O&M Grade: **0**  
Clock Start/From:  
Clock To:  
1st Value:  
2nd Value:  
Value Percent: **15.000**  
Continuous Index: **S06**  
Within 8" of Joint: **NO**  
Remarks:

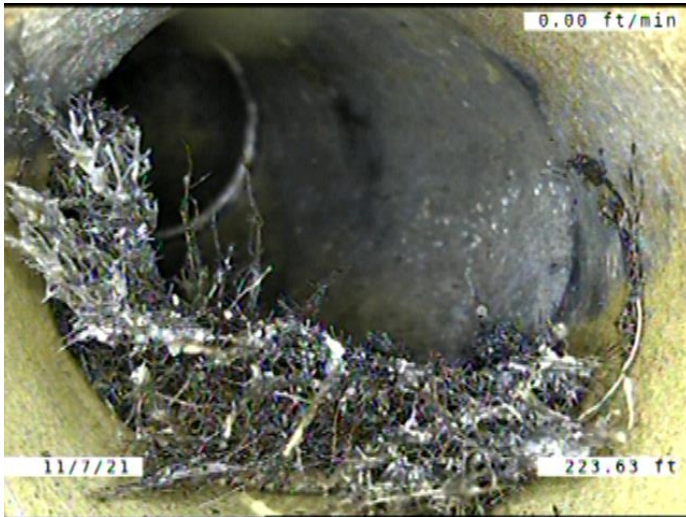
Code: **TF**  
 Description: **Tap Factory**

Distance (ft): **223.6**  
 Structural Grade: **0**  
 O&M Grade: **0**  
 Clock Start/From: **12**  
 Clock To:  
 1st Value: **4.000**

2nd Value:  
 Value Percent:  
 Continuous Index:  
 Within 8" of Joint: **YES**  
 Remarks: **ROOTS GROWING FROM THE JOINTS. CONSTANTLY RUNNING WA**
