# Profile/Photo Observation Report

Date:	<b>11/07/2021</b>	Weather:		Coding:	<b>PACP 7.0</b>
Pipe Length (ft):	<b>260.2</b>	Owner:	<b>City of Hobart</b>	Pre Clean:	<b>Heavy Cleaning</b>
P.O.#:	<b>YES502259</b>	Surveyor:	<b>Steven Bucklin</b>	PSR:	<b>P-505-068-069</b>
Customer:	<b>City of Hobart, IN (Red</b>	Clean Date:	<b>11/07/2021</b>	Shape:	<b>C</b>

Street:	<b>West 1st Place</b>	Flow Control:	<b>Not Controlled</b>
City:	<b>City of Hobart</b>	Year Renewed:	
Location:	<b>Alley</b>	Tape/Media #:	
Purpose:	<b>Routine Assessment</b>	Dia/Height:	<b>10"</b>
Use:	<b>Sanitary Sewage Pipe</b>	Material:	<b>VCP</b>
Drain Area:		Lining:	<b>None</b>
Category:	<b>NA</b>		
Comment:			
Location Details:		Direction of Survey:	<b>Downstream</b>
US MH:	<b>M-505-069</b>	DS MH:	<b>M-505-068</b>
		Total Length Surveyed (ft):	<b>260.2</b>

O&M Index:	<b>1.81</b>	O&M Quick:	<b>4132</b>	O&M Rating:	<b>47.00</b>
Structural Index:	<b>2.39</b>	Structural Quick:	<b>5444</b>	Structural Rating:	<b>129.00</b>
Overall Index:	<b>2.20</b>	Overall Quick:	<b>5445</b>	Overall Rating:	<b>176.00</b>

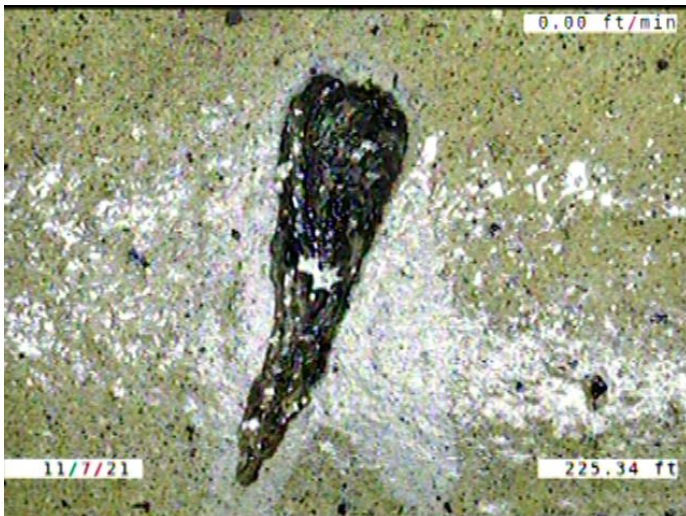
Code: **DAE**  
 Description: **Deposits Attached Encrustation**

Distance (ft): **225.3**  
 Structural Grade: **0**  
 O&M Grade: **2**  
 Clock Start/From: **1**  
 Clock To: **3**

1st Value:  
 2nd Value:  
 Value Percent: **5.000**  
 Continuous Index:  
 Within 8" of Joint: **YES**  
 Remarks:

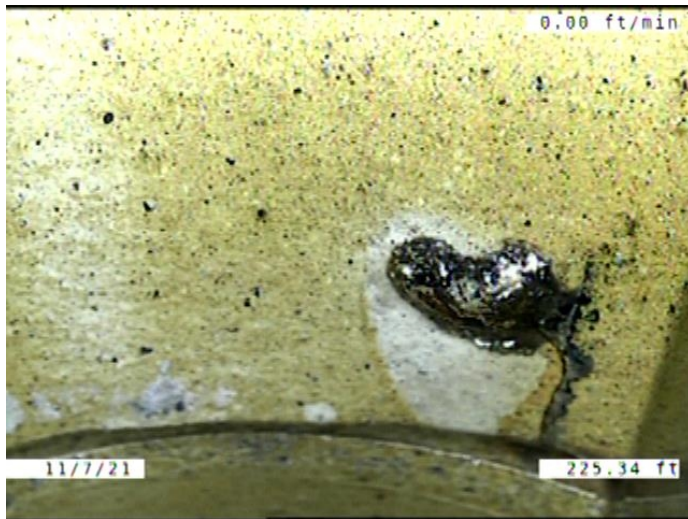
Code: **CL**  
 Description: **Crack Longitudinal**

Distance (ft): **225.3**  
 Structural Grade: **2**  
 O&M Grade: **0**  
 Clock Start/From: **3**  
 Clock To:  
 1st Value:  
 2nd Value:  
 Value Percent:  
 Continuous Index:  
 Within 8" of Joint: **YES**  
 Remarks:

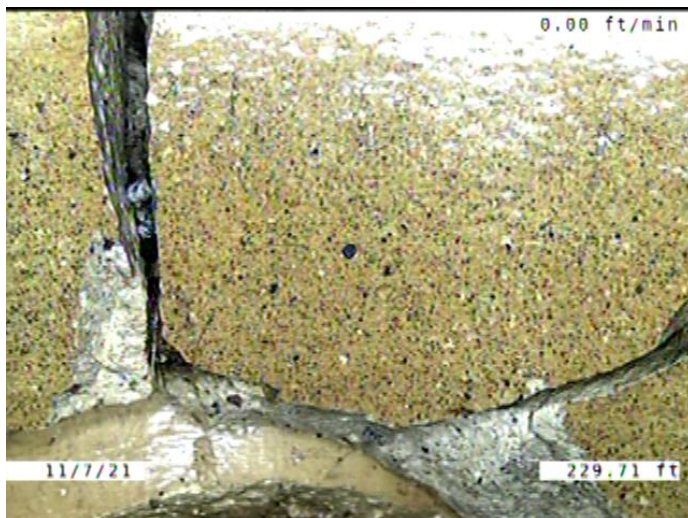
Code: **BSV**  
 Description: **Broken Soil Visible**

Distance (ft): **229.7**  
 Structural Grade: **5**  
 O&M Grade: **0**  
 Clock Start/From: **8**  
 Clock To: **4**  
 1st Value:  
 2nd Value:  
 Value Percent:  
 Continuous Index:  
 Within 8" of Joint: **YES**  
 Remarks:

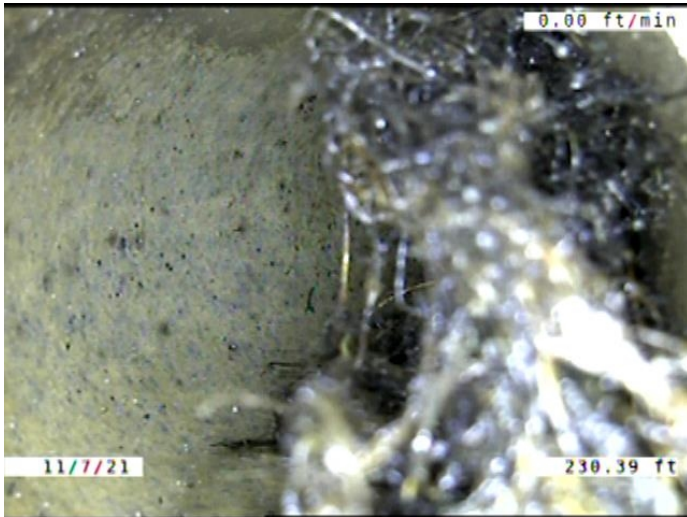
Code: **TBI**  
 Description: **Tap Break-in Intruding**

Distance (ft): **230.4**  
 Structural Grade: **0**  
 O&M Grade: **2**  
 Clock Start/From: **1**  
 Clock To:  
 1st Value: **4.000**  
 2nd Value: **1.000**

Value Percent:  
 Continuous Index:  
 Within 8" of Joint: **YES**  
 Remarks: **ROOTS GROWING INTO THE MAIN. CONSTANTLY RUNNING WATER.**

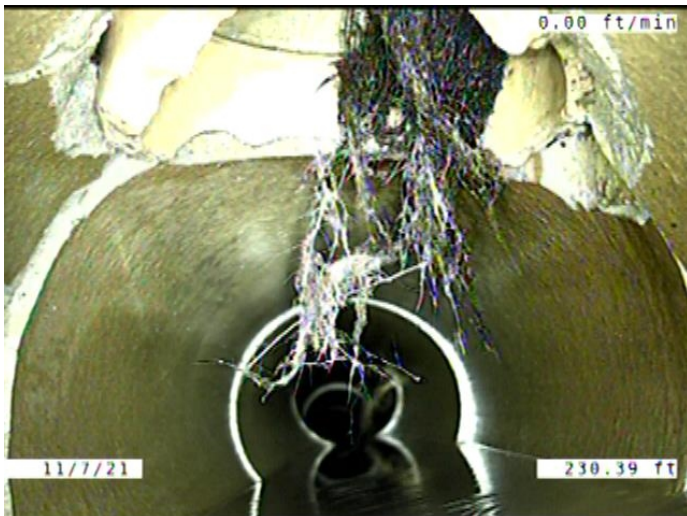
Code: **RFL**  
 Description: **Roots Fine Lateral**

Distance (ft): **230.4**  
 Structural Grade: **0**  
 O&M Grade: **1**  
 Clock Start/From: **1**  
 Clock To:  
 1st Value:  
 2nd Value:  
 Value Percent:

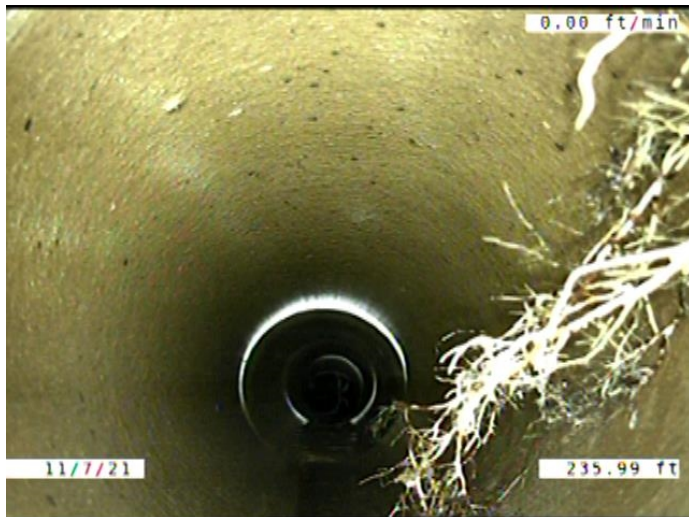
Code: **MWLS**  
 Description: **Miscellaneous Water Level Sag**

Distance (ft): **236.0**  
 Structural Grade: **2**  
 O&M Grade: **0**  
 Clock Start/From:  
 Clock To:  
 1st Value:  
 2nd Value:  
 Value Percent: **15.000**  
 Continuous Index: **F06**  
 Within 8" of Joint: **NO**  
 Remarks:

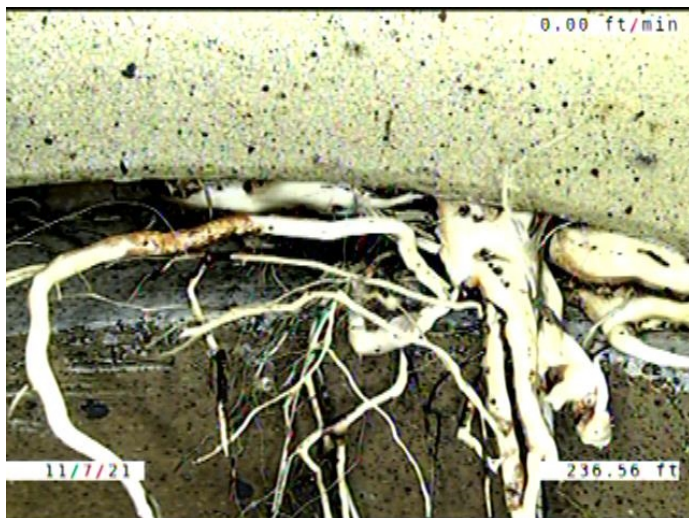
Code: **RMJ**  
 Description: **Roots Medium Joint**

Distance (ft): **236.6**  
 Structural Grade: **0**  
 O&M Grade: **3**  
 Clock Start/From: **12**  
 Clock To: **3**  
 1st Value:  
 2nd Value:  
 Value Percent: **5.000**  
 Continuous Index:  
 Within 8" of Joint: **YES**  
 Remarks:

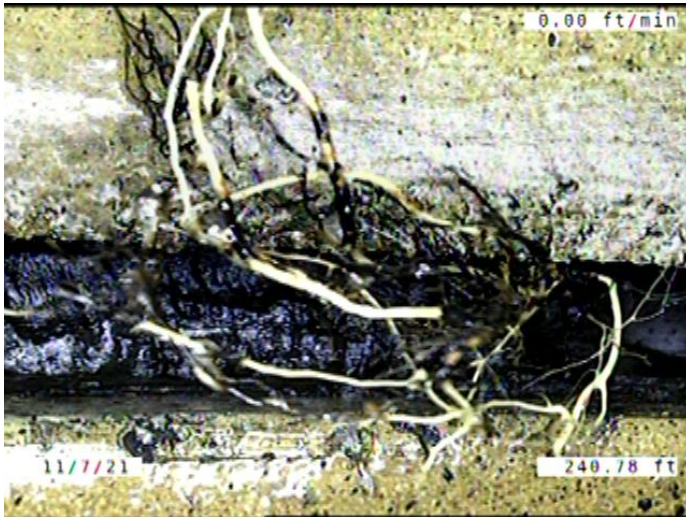
Code: **RFJ**  
 Description: **Roots Fine Joint**

Distance (ft): **240.8**  
 Structural Grade: **0**  
 O&M Grade: **1**  
 Clock Start/From: **2**  
 Clock To: **3**  
 1st Value:  
 2nd Value:  
 Value Percent:  
 Continuous Index:  
 Within 8" of Joint: **YES**  
 Remarks:

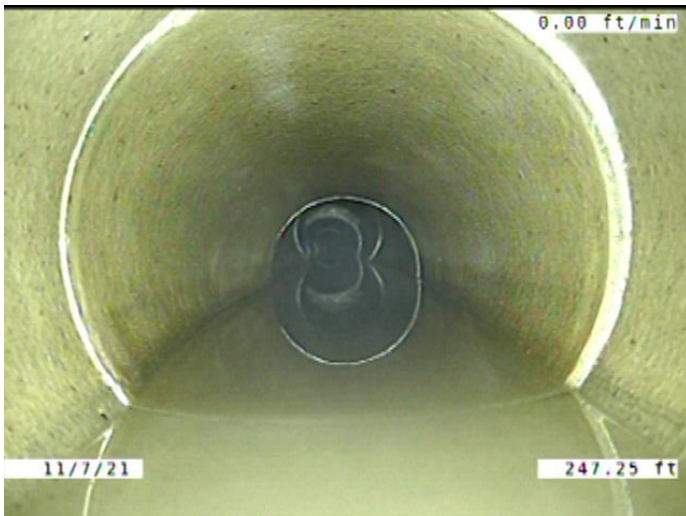
Code: **MWLS**  
 Description: **Miscellaneous Water Level Sag**

Distance (ft): **247.2**  
 Structural Grade: **2**  
 O&M Grade: **0**  
 Clock Start/From:  
 Clock To:  
 1st Value:  
 2nd Value:  
 Value Percent: **10.000**  
 Continuous Index: **S07**  
 Within 8" of Joint: **NO**  
 Remarks:

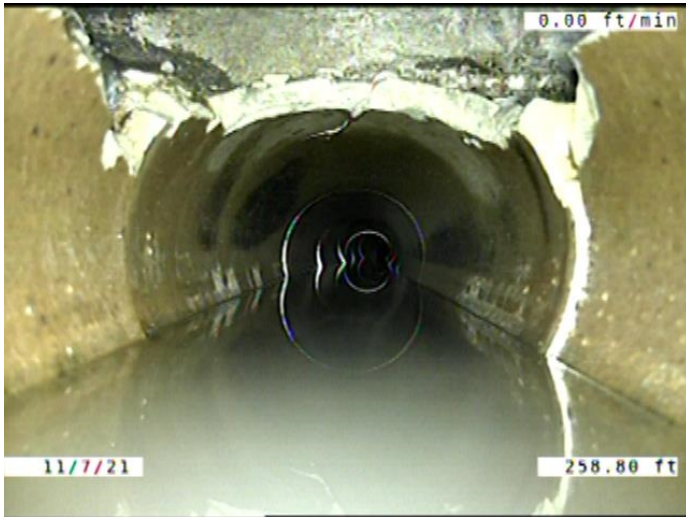
Code: **MWLS**  
 Description: **Miscellaneous Water Level Sag**

Distance (ft): **258.8**  
 Structural Grade: **2**  
 O&M Grade: **0**  
 Clock Start/From:  
 Clock To:  
 1st Value:  
 2nd Value:  
 Value Percent: **10.000**  
 Continuous Index: **F07**  
 Within 8" of Joint: **NO**  
 Remarks:
