Profile/Photo Observation Report

Date:	04/22/2018	Weather:		Coding:	PACP 6.0
Pipe Length (ft):	321.5	Owner:	NA	Pre Clean:	No Pre-Cleaning
P.O.#:		Surveyor:	Mark Ruby	PSR:	P-505-067-070
Customer:		Clean Date:	01/01/1900	Shape:	C

Street:	S WILSON ST	Flow Control:	Not Controlled
City:	Hobart, IN	Year Renewed:	
Location:	Light Highway	Tape/Media #:	
Purpose:	Routine Assessment	Dia/Height:	10"
Use:	Sanitary	Material:	VCP
Drain Area:	NA	Lining:	
Category:	NA		
Comment:	False O_C at 75 ft CU/debris .Flow direction wrong		
Location Details:		Direction of Survey:	Downstream
US MH:	M-505-070	DS MH:	M-505-067
		Total Length Surveyed (ft):	76.4

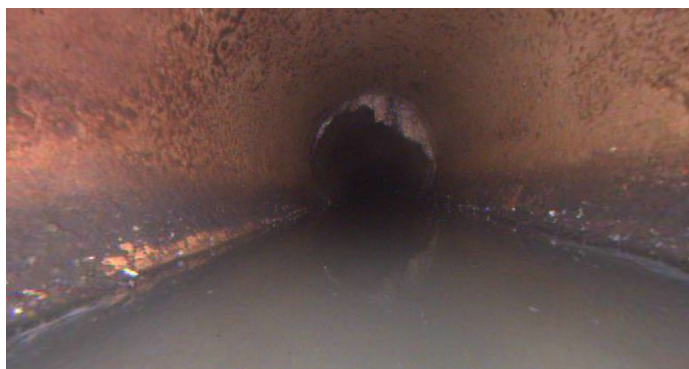
Code: **AMH**
Description: **Manhole**

Distance (ft): **.0**
Structural Grade: **0**
O&M Grade: **0**
Clock Start/From:
Clock To:
1st Value:
2nd Value:
Value Percent:
Continuous Index:
Within 8" of Joint: **NO**
Remarks: **M-505-070**

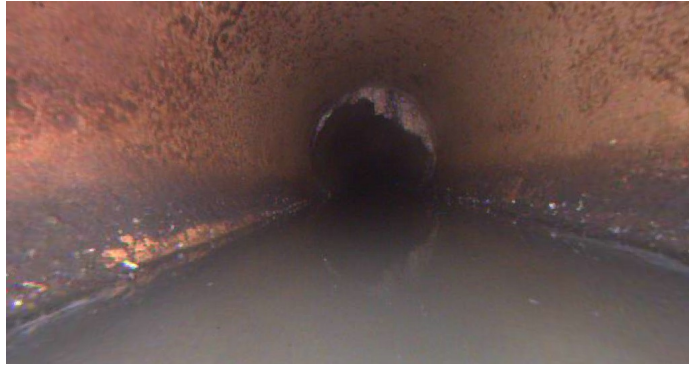
Code: **MWL**
Description: **Water Level**

Distance (ft): **.0**
Structural Grade: **0**
O&M Grade: **0**
Clock Start/From:
Clock To:
1st Value:
2nd Value:
Value Percent: **10.000**
Continuous Index:
Within 8" of Joint: **NO**
Remarks:

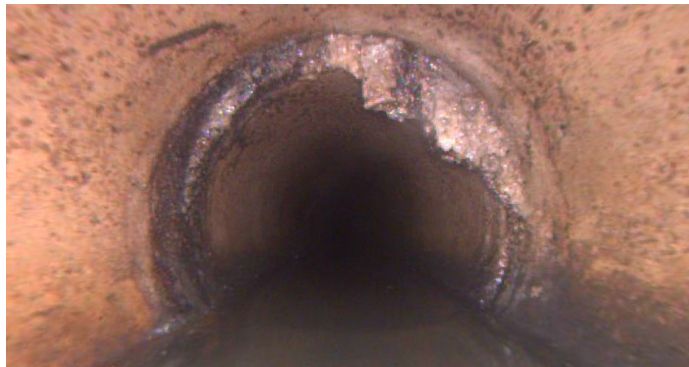
Code: **DAZ**
Description: **Deposits Attached Other**

Distance (ft): **2.5**
Structural Grade: **0**
O&M Grade: **2**
Clock Start/From: **7**
Clock To: **5**
1st Value:
2nd Value:
Value Percent: **5.000**
Continuous Index:
Within 8" of Joint: **YES**
Remarks:
