## Profile/Photo Observation Report

Date:	<b>04/22/2018</b>	Weather:		Coding:	<b>PACP 6.0</b>
Pipe Length (ft):	<b>321.5</b>	Owner:	<b>NA</b>	Pre Clean:	<b>No Pre-Cleaning</b>
P.O.#:		Surveyor:	<b>Mark Ruby</b>	PSR:	<b>P-505-067-070</b>
Customer:		Clean Date:	<b>01/01/1900</b>	Shape:	<b>C</b>

Street:	<b>FOXCROFT STREET</b>	Flow Control:	<b>Not Controlled</b>
City:	<b>Hobart, IN</b>	Year Renewed:	
Location:	<b>Light Highway</b>	Tape/Media #:	
Purpose:	<b>Routine Assessment</b>	Dia/Height:	<b>10"</b>
Use:	<b>Sanitary</b>	Material:	<b>VCP</b>
Drain Area:	<b>NA</b>	Lining:	
Category:	<b>NA</b>		
Comment:	<b>False O_C at 75 ft CU/debris .Flow direction wrong</b>		
Location Details:		Direction of Survey:	<b>Downstream</b>
US MH:	<b>M-505-070</b>	DS MH:	<b>M-505-067</b>
		Total Length Surveyed (ft):	<b>76.4</b>

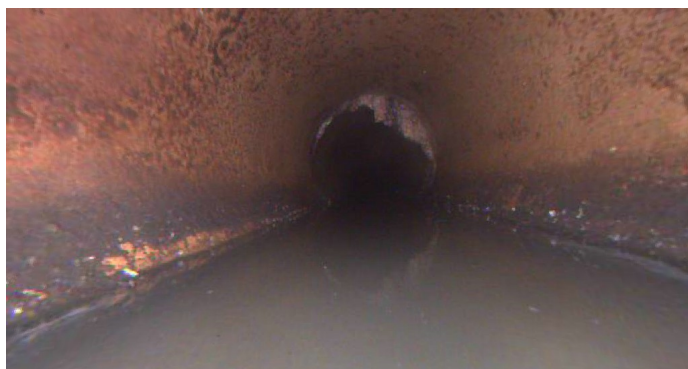
Code: **AMH**  
Description: **Manhole**

Distance (ft): **.0**  
Structural Grade: **0**  
O&M Grade: **0**  
Clock Start/From:  
Clock To:  
1st Value:  
2nd Value:  
Value Percent:  
Continuous Index:  
Within 8" of Joint: **NO**  
Remarks: **M-505-070**

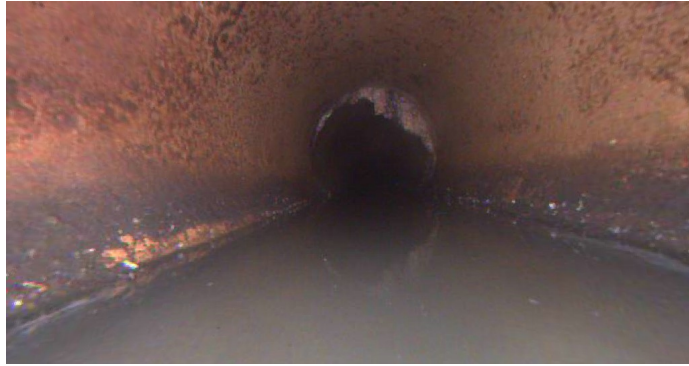
Code: **MWL**  
Description: **Water Level**

Distance (ft): **.0**  
Structural Grade: **0**  
O&M Grade: **0**  
Clock Start/From:  
Clock To:  
1st Value:  
2nd Value:  
Value Percent: **10.000**  
Continuous Index:  
Within 8" of Joint: **NO**  
Remarks:

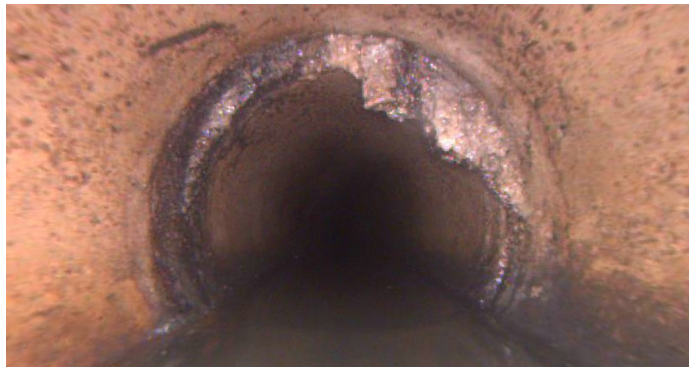
Code: **DAZ**  
Description: **Deposits Attached Other**

Distance (ft): **2.5**  
Structural Grade: **0**  
O&M Grade: **2**  
Clock Start/From: **7**  
Clock To: **5**  
1st Value:  
2nd Value:  
Value Percent: **5.000**  
Continuous Index:  
Within 8" of Joint: **YES**  
Remarks:
