RedZone<sup>®</sup>  
ROBOTICS

Street:	South Wilson Street		Flow Control:	Not Controlled	
City:	City of Hobart		Year Renewed:		
Location:	Local rural streets with light traffic, t		Tape/Media #:		
Purpose:	Routine Assessment		Dia/Height:	10"	
Use:	Sanitary Sewage Pipe		Material:	VCP	
Drain Area:			Lining:	None	
Category:	NA				
Comment:					
Location Details:			Direction of Survey:	Downstream	
US MH:	M-505-070	DS MH:	M-505-067	Total Length Surveyed (ft):	321.9

**Tuesday, April 25, 2023**

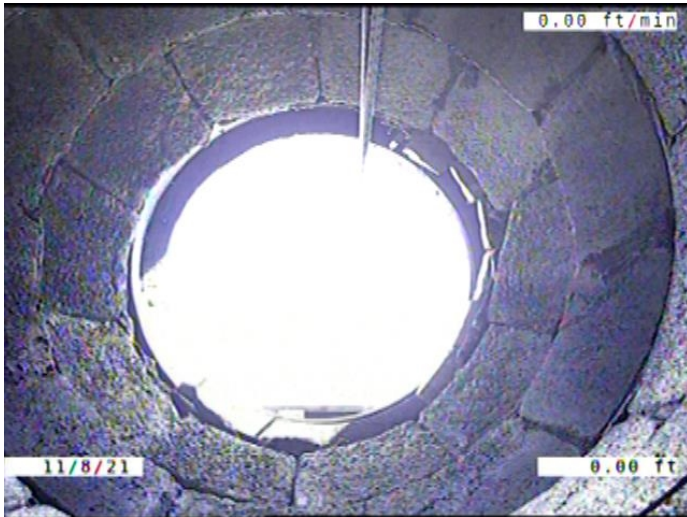
Code: **AMH**  
 Description: **Manhole**

Distance (ft): **.0**  
 Structural Grade: **0**  
 O&M Grade: **0**  
 Clock Start/From:  
 Clock To:  
 1st Value:  
 2nd Value:  
 Value Percent:  
 Continuous Index:  
 Within 8" of Joint: **NO**  
 Remarks: **M-505-070**

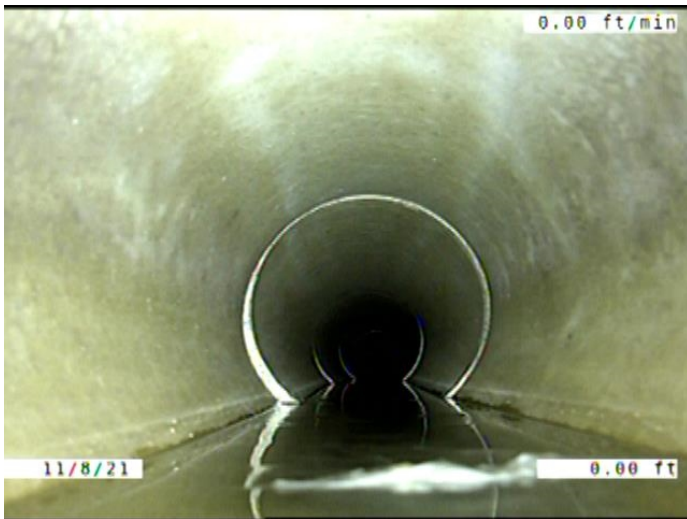
Code: **MWL**  
 Description: **Miscellaneous Water Level**

Distance (ft): **.0**  
 Structural Grade: **0**  
 O&M Grade: **0**  
 Clock Start/From:  
 Clock To:  
 1st Value:  
 2nd Value:  
 Value Percent: **5.000**  
 Continuous Index:  
 Within 8" of Joint: **NO**  
 Remarks:

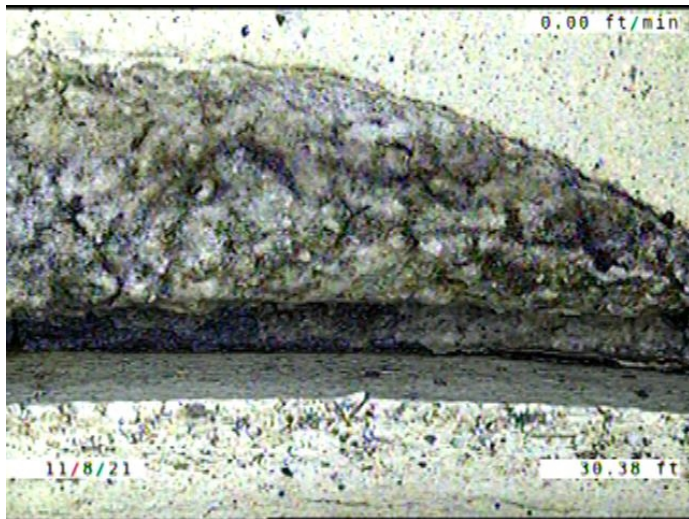
Code: **DAE**  
Description: **Deposits Attached Encrustation**

Distance (ft): **30.4**  
Structural Grade: **0**  
O&M Grade: **2**  
Clock Start/From: **8**  
Clock To: **11**  
1st Value:  
2nd Value:  
Value Percent: **5.000**  
Continuous Index:  
Within 8" of Joint: **YES**  
Remarks:

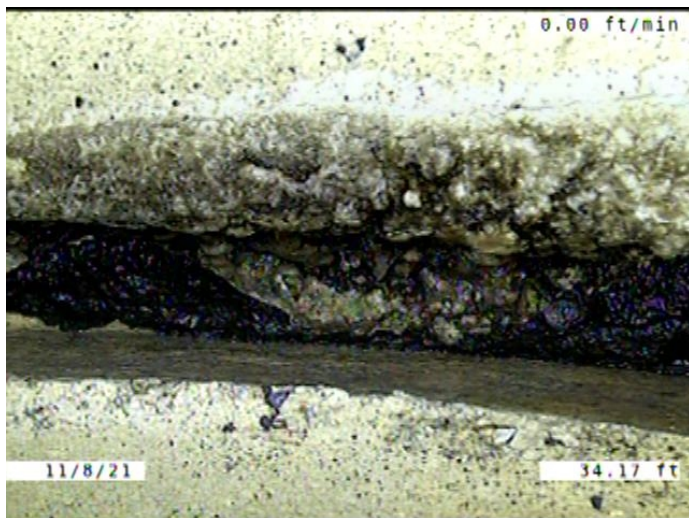
Code: **DAE**  
Description: **Deposits Attached Encrustation**

Distance (ft): **34.2**  
Structural Grade: **0**  
O&M Grade: **2**  
Clock Start/From: **12**  
Clock To: **3**  
1st Value:  
2nd Value:  
Value Percent: **5.000**  
Continuous Index:  
Within 8" of Joint: **YES**  
Remarks:

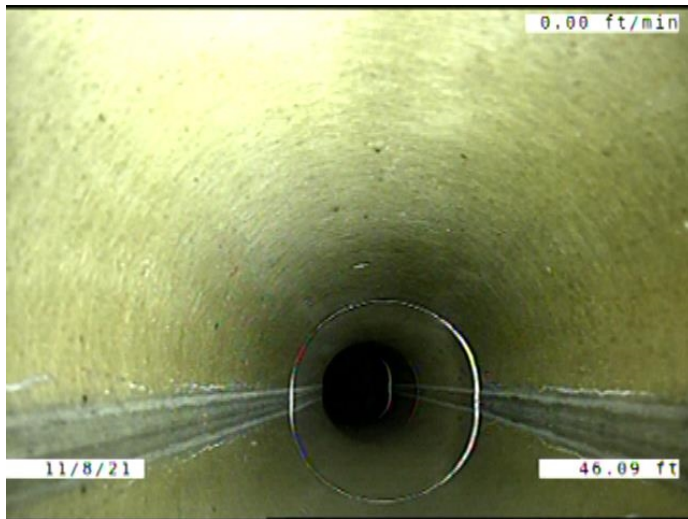
Code: **MWL**  
 Description: **Miscellaneous Water Level**

Distance (ft): **46.1**  
 Structural Grade: **0**  
 O&M Grade: **0**  
 Clock Start/From:  
 Clock To:  
 1st Value:  
 2nd Value:  
 Value Percent: **20.000**  
 Continuous Index:  
 Within 8" of Joint: **NO**  
 Remarks:

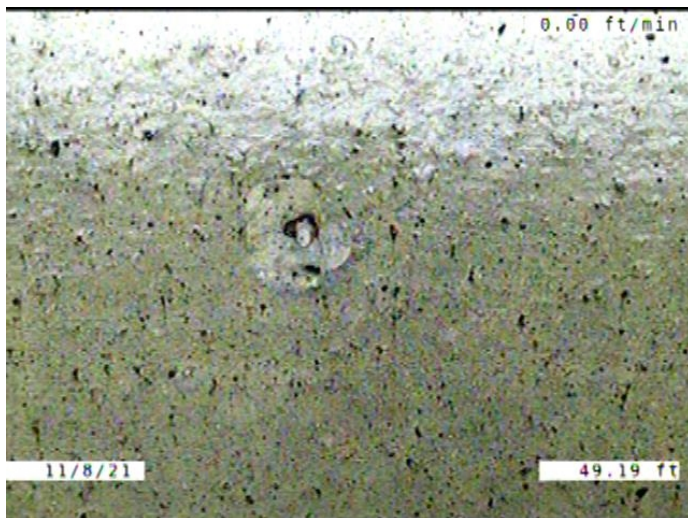
Code: **SSS**  
 Description: **Surface Damage Surface Spalling**

Distance (ft): **49.2**  
 Structural Grade: **2**  
 O&M Grade: **0**  
 Clock Start/From: **12**  
 Clock To:  
 1st Value:  
 2nd Value:  
 Value Percent:  
 Continuous Index:  
 Within 8" of Joint: **YES**  
 Remarks:

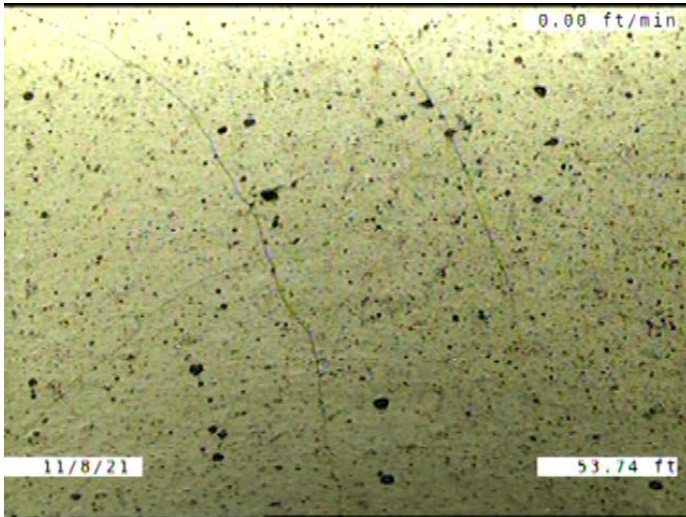
Code: **CM**  
Description: **Crack Multiple**

Distance (ft): **53.7**  
Structural Grade: **3**  
O&M Grade: **0**  
Clock Start/From: **10**  
Clock To: **12**  
1st Value:  
2nd Value:  
Value Percent:  
Continuous Index:  
Within 8" of Joint: **YES**  
Remarks:

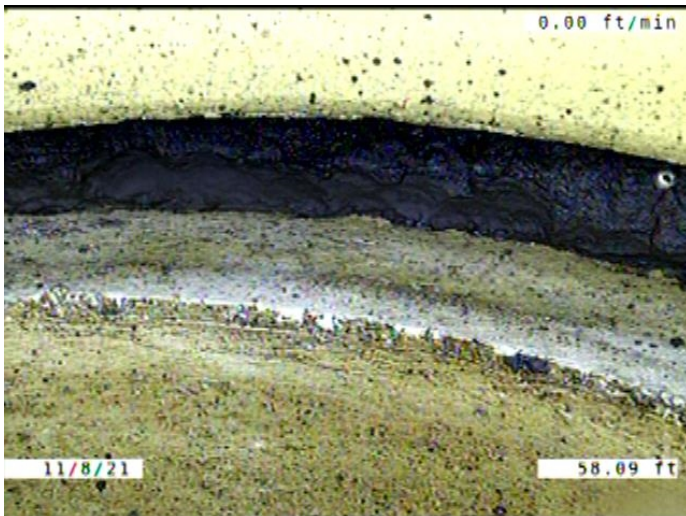
Code: **JAM**  
Description: **Joint Angular Medium**

Distance (ft): **58.1**  
Structural Grade: **3**  
O&M Grade: **0**  
Clock Start/From:  
Clock To:  
1st Value:  
2nd Value:  
Value Percent:  
Continuous Index:  
Within 8" of Joint: **NO**  
Remarks:

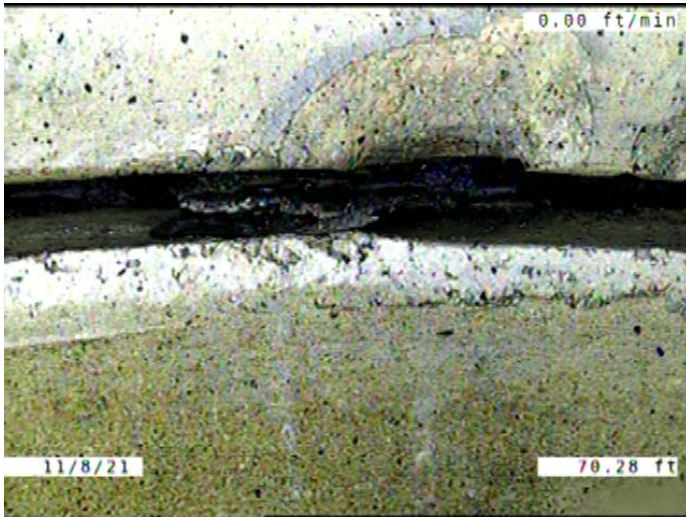
Code: **ISSRH**  
 Description: **Intruding Sealing Material Sealing Ring Hanging**

Distance (ft): **70.3**  
 Structural Grade: **0**  
 O&M Grade: **2**  
 Clock Start/From: **10**  
 Clock To: **11**  
 1st Value:  
 2nd Value:  
 Value Percent: **5.000**  
 Continuous Index:  
 Within 8" of Joint: **NO**  
 Remarks:

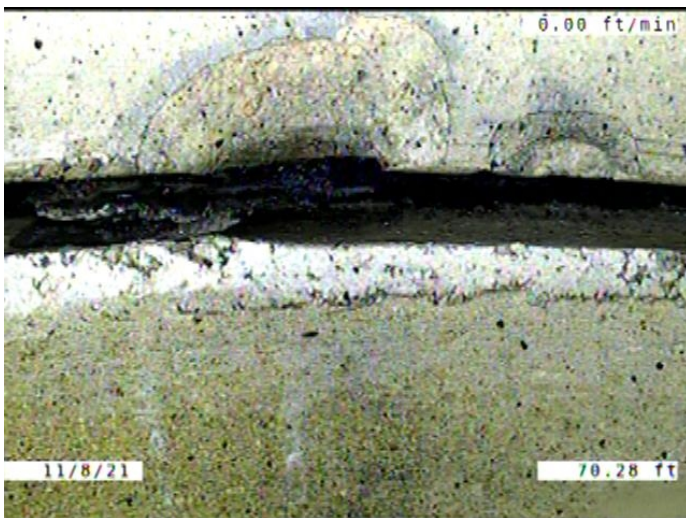
Code: **SSS**  
 Description: **Surface Damage Surface Spalling**

Distance (ft): **70.3**  
 Structural Grade: **2**  
 O&M Grade: **0**  
 Clock Start/From: **10**  
 Clock To: **11**  
 1st Value:  
 2nd Value:  
 Value Percent:  
 Continuous Index:  
 Within 8" of Joint: **YES**  
 Remarks:

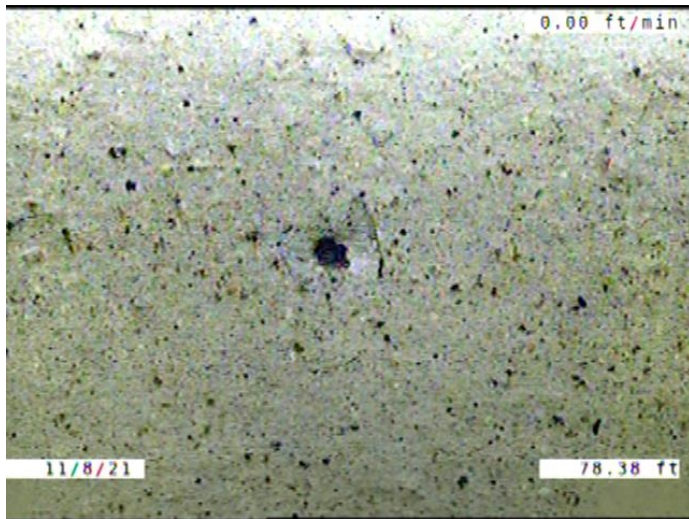
Code: **SSS**  
 Description: **Surface Damage Surface Spalling**

Distance (ft): **78.4**  
 Structural Grade: **2**  
 O&M Grade: **0**  
 Clock Start/From: **11**  
 Clock To: **1**  
 1st Value:  
 2nd Value:  
 Value Percent:  
 Continuous Index:  
 Within 8" of Joint: **YES**  
 Remarks:

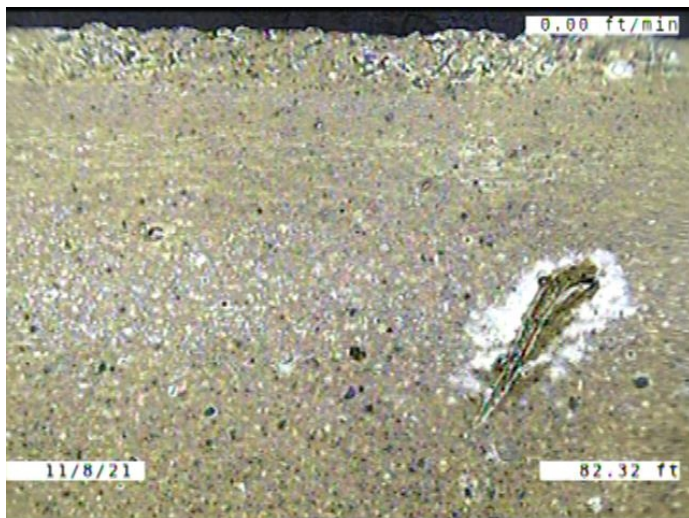
Code: **MWL**  
 Description: **Miscellaneous Water Level**

Distance (ft): **82.3**  
 Structural Grade: **0**  
 O&M Grade: **0**  
 Clock Start/From:  
 Clock To:  
 1st Value:  
 2nd Value:  
 Value Percent: **35.000**  
 Continuous Index:  
 Within 8" of Joint: **NO**  
 Remarks:

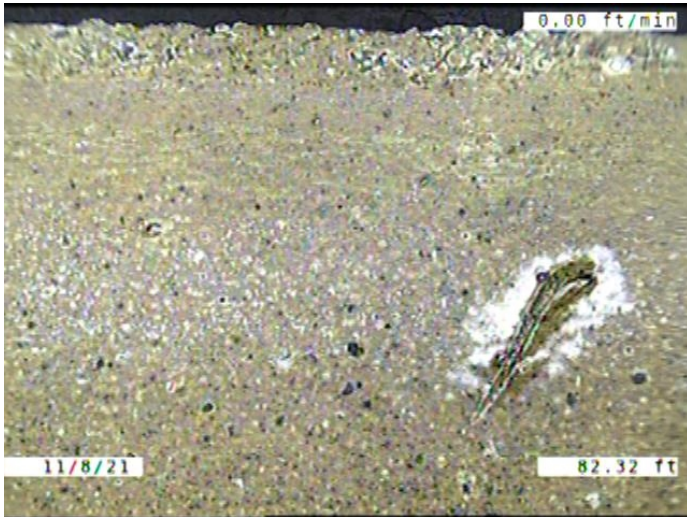
Code: **MCU**  
Description: **Miscellaneous Camera Underwater**

Distance (ft): **82.3**  
Structural Grade: **0**  
O&M Grade: **4**  
Clock Start/From:  
Clock To:  
1st Value:  
2nd Value:  
Value Percent:  
Continuous Index: **S01**  
Within 8" of Joint: **NO**  
Remarks:

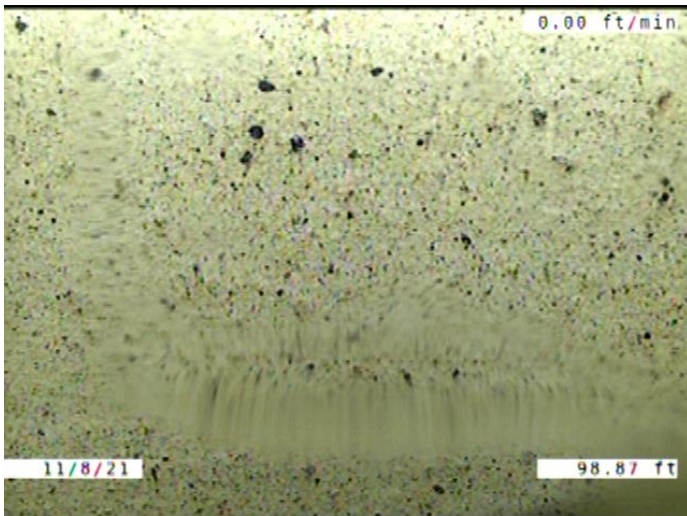
Code: **MCU**  
Description: **Miscellaneous Camera Underwater**

Distance (ft): **98.9**  
Structural Grade: **0**  
O&M Grade: **4**  
Clock Start/From:  
Clock To:  
1st Value:  
2nd Value:  
Value Percent:  
Continuous Index: **F01**  
Within 8" of Joint: **NO**  
Remarks:

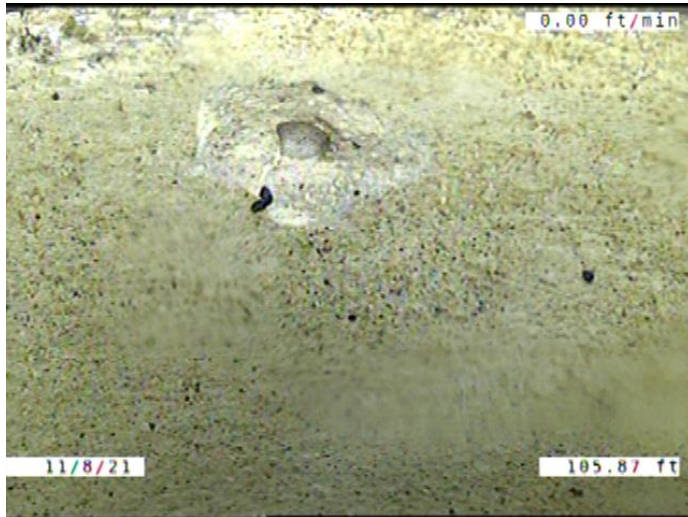
Code: **SSS**  
 Description: **Surface Damage Surface Spalling**

Distance (ft): **105.9**  
 Structural Grade: **2**  
 O&M Grade: **0**  
 Clock Start/From: **1**  
 Clock To:  
 1st Value:  
 2nd Value:  
 Value Percent:  
 Continuous Index:  
 Within 8" of Joint: **YES**  
 Remarks:

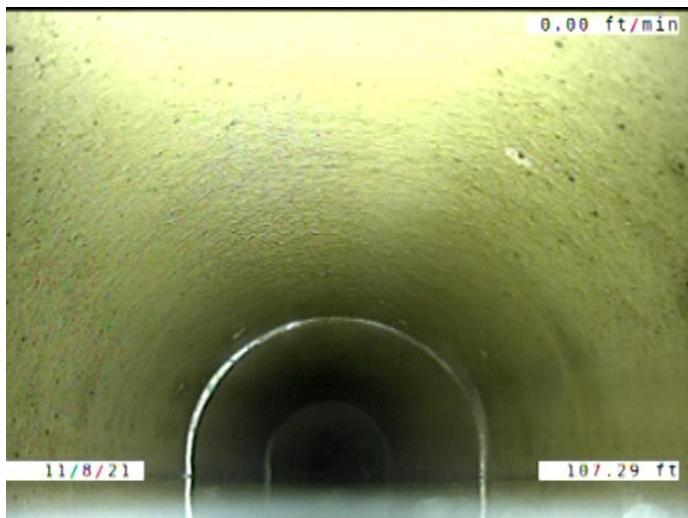
Code: **MWL**  
 Description: **Miscellaneous Water Level**

Distance (ft): **107.3**  
 Structural Grade: **0**  
 O&M Grade: **0**  
 Clock Start/From:  
 Clock To:  
 1st Value:  
 2nd Value:  
 Value Percent: **20.000**  
 Continuous Index:  
 Within 8" of Joint: **NO**  
 Remarks:

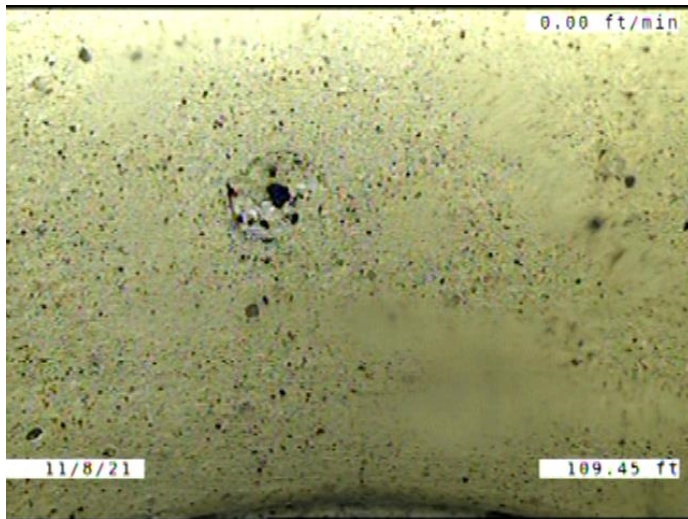
Code: **SSS**  
Description: **Surface Damage Surface Spalling**

Distance (ft): **109.4**  
Structural Grade: **2**  
O&M Grade: **0**  
Clock Start/From: **11**  
Clock To:  
1st Value:  
2nd Value:  
Value Percent:  
Continuous Index:  
Within 8" of Joint: **YES**  
Remarks:

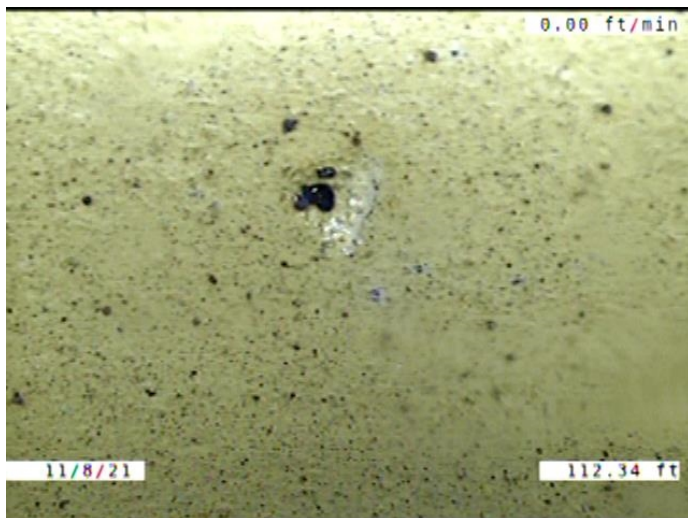
Code: **SSS**  
Description: **Surface Damage Surface Spalling**

Distance (ft): **112.3**  
Structural Grade: **2**  
O&M Grade: **0**  
Clock Start/From: **1**  
Clock To:  
1st Value:  
2nd Value:  
Value Percent:  
Continuous Index:  
Within 8" of Joint: **NO**  
Remarks:

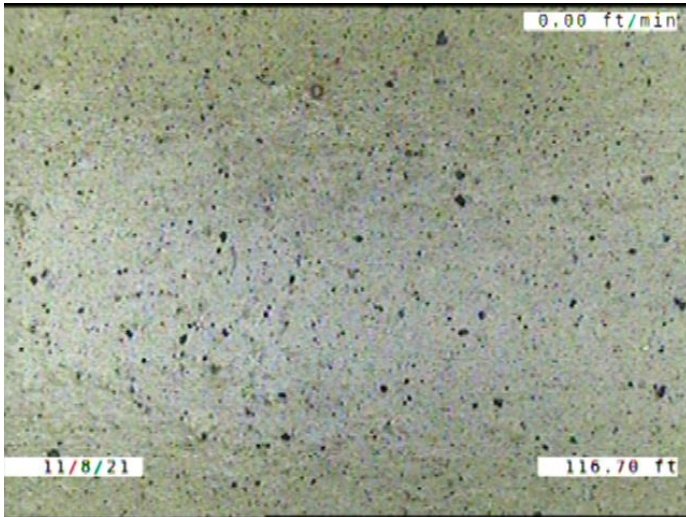
Code: **MWL**  
Description: **Miscellaneous Water Level**

Distance (ft): **116.7**  
Structural Grade: **0**  
O&M Grade: **0**  
Clock Start/From:  
Clock To:  
1st Value:  
2nd Value:  
Value Percent: **35.000**  
Continuous Index:  
Within 8" of Joint: **NO**  
Remarks:

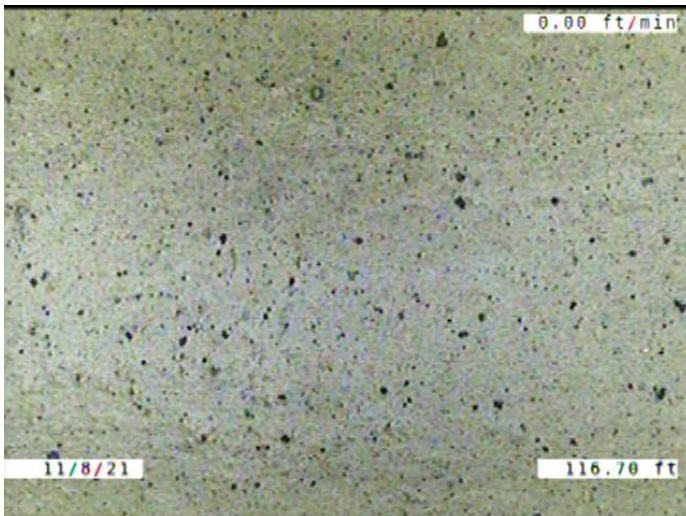
116.7	MCU(S02)	Miscellaneous Camera Underwater	1669	M 4
122.6	MCU(F02)	Miscellaneous Camera Underwater	1774	M 4
127.9	MCU(S03)	Miscellaneous Camera Underwater	1862	M 4

Code: **MCU**  
Description: **Miscellaneous Camera Underwater**

Distance (ft): **116.7**  
Structural Grade: **0**  
O&M Grade: **4**  
Clock Start/From:  
Clock To:  
1st Value:  
2nd Value:  
Value Percent:  
Continuous Index: **S02**  
Within 8" of Joint: **NO**  
Remarks:

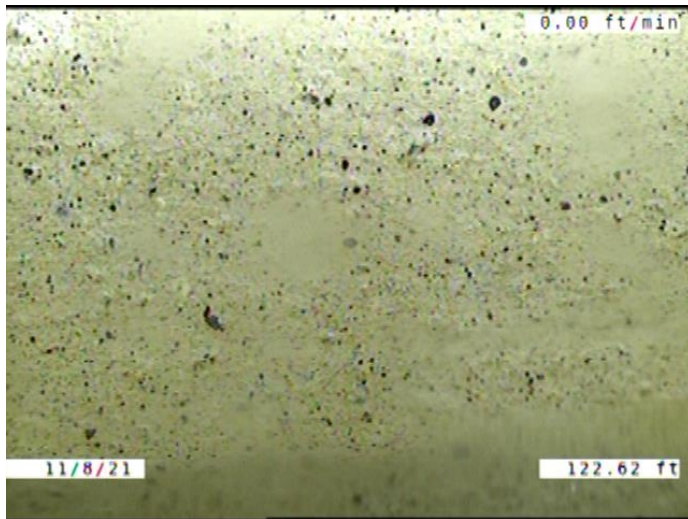
Code: **MCU**  
Description: **Miscellaneous Camera Underwater**

Distance (ft): **122.6**  
Structural Grade: **0**  
O&M Grade: **4**  
Clock Start/From:  
Clock To:  
1st Value:  
2nd Value:  
Value Percent:  
Continuous Index: **F02**  
Within 8" of Joint: **NO**  
Remarks:

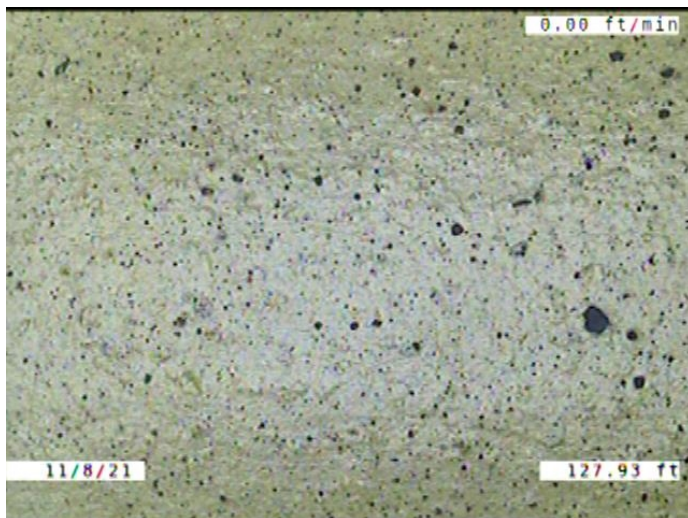
Code: **MCU**  
Description: **Miscellaneous Camera Underwater**

Distance (ft): **127.9**  
Structural Grade: **0**  
O&M Grade: **4**  
Clock Start/From:  
Clock To:  
1st Value:  
2nd Value:  
Value Percent:  
Continuous Index: **S03**  
Within 8" of Joint: **NO**  
Remarks:

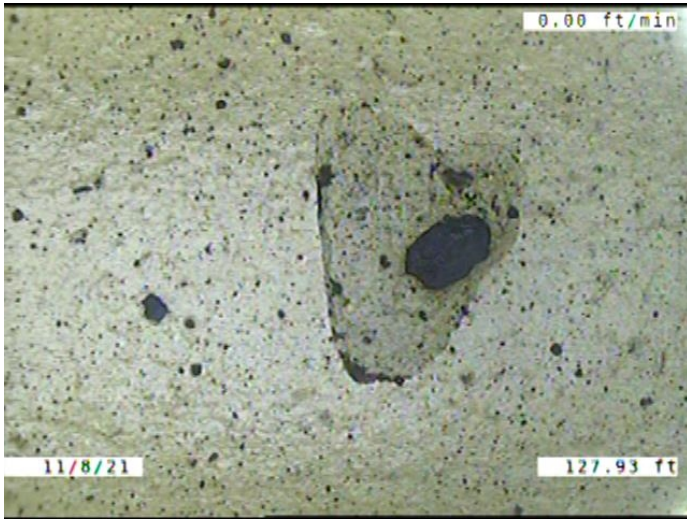
Code: **SSS**  
Description: **Surface Damage Surface Spalling**

Distance (ft): **127.9**  
Structural Grade: **2**  
O&M Grade: **0**  
Clock Start/From: **12**  
Clock To:  
1st Value:  
2nd Value:  
Value Percent:  
Continuous Index:  
Within 8" of Joint: **NO**  
Remarks:

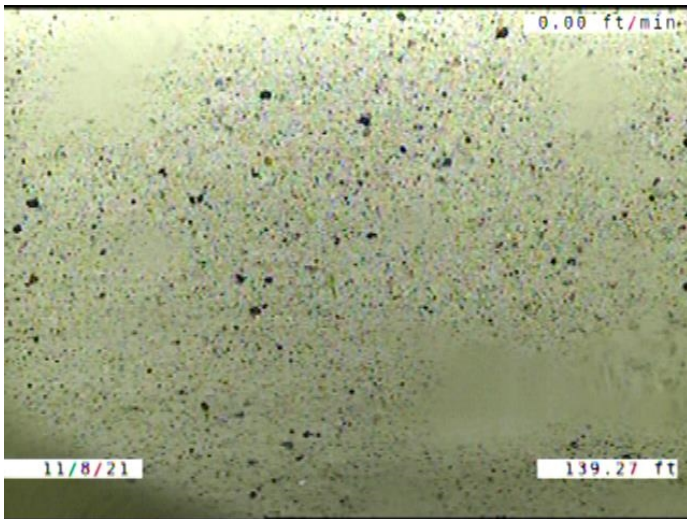
Code: **MCU**  
Description: **Miscellaneous Camera Underwater**

Distance (ft): **139.3**  
Structural Grade: **0**  
O&M Grade: **4**  
Clock Start/From:  
Clock To:  
1st Value:  
2nd Value:  
Value Percent:  
Continuous Index: **F03**  
Within 8" of Joint: **NO**  
Remarks:

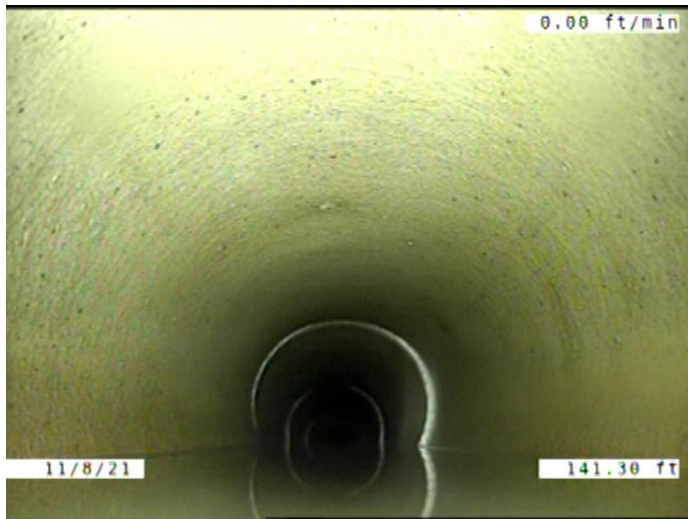
Code: **MWL**  
Description: **Miscellaneous Water Level**

Distance (ft): **141.3**  
Structural Grade: **0**  
O&M Grade: **0**  
Clock Start/From:  
Clock To:  
1st Value:  
2nd Value:  
Value Percent: **15.000**  
Continuous Index:  
Within 8" of Joint: **NO**  
Remarks:

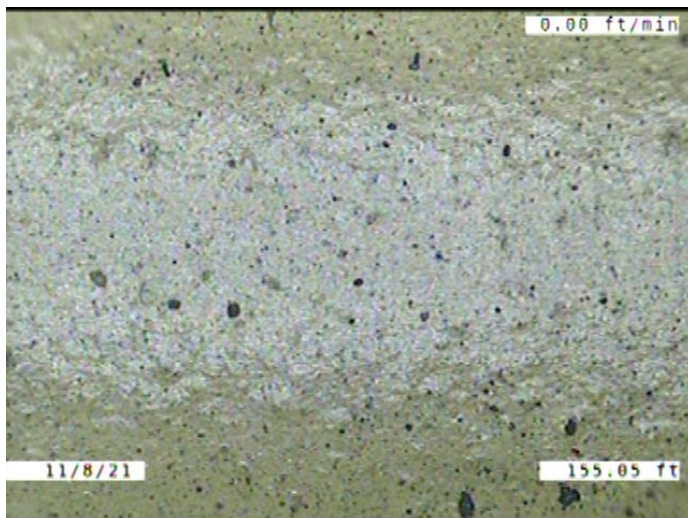
Code: **MWL**  
Description: **Miscellaneous Water Level**

Distance (ft): **155.0**  
Structural Grade: **0**  
O&M Grade: **0**  
Clock Start/From:  
Clock To:  
1st Value:  
2nd Value:  
Value Percent: **35.000**  
Continuous Index:  
Within 8" of Joint: **NO**  
Remarks:

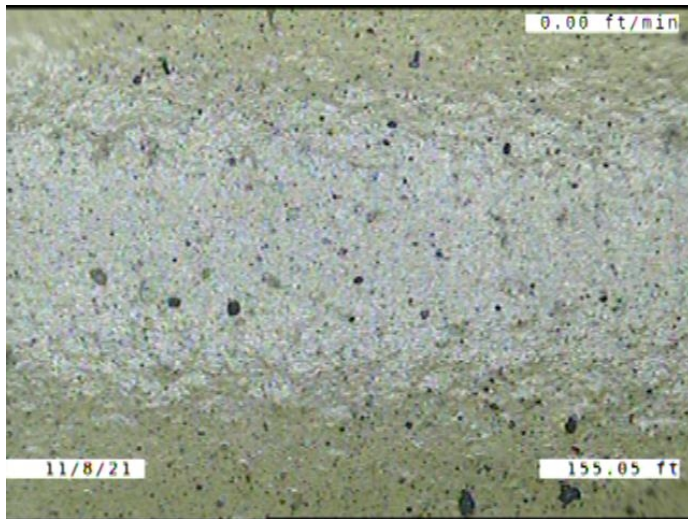
Code: **MCU**  
Description: **Miscellaneous Camera Underwater**

Distance (ft): **155.0**  
Structural Grade: **0**  
O&M Grade: **4**  
Clock Start/From:  
Clock To:  
1st Value:  
2nd Value:  
Value Percent:  
Continuous Index: **S04**  
Within 8" of Joint: **NO**  
Remarks:

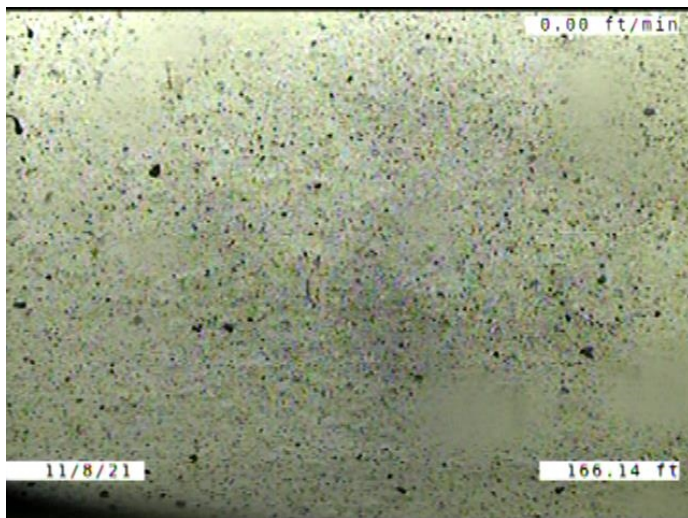
Code: **MCU**  
Description: **Miscellaneous Camera Underwater**

Distance (ft): **166.1**  
Structural Grade: **0**  
O&M Grade: **4**  
Clock Start/From:  
Clock To:  
1st Value:  
2nd Value:  
Value Percent:  
Continuous Index: **F04**  
Within 8" of Joint: **NO**  
Remarks:

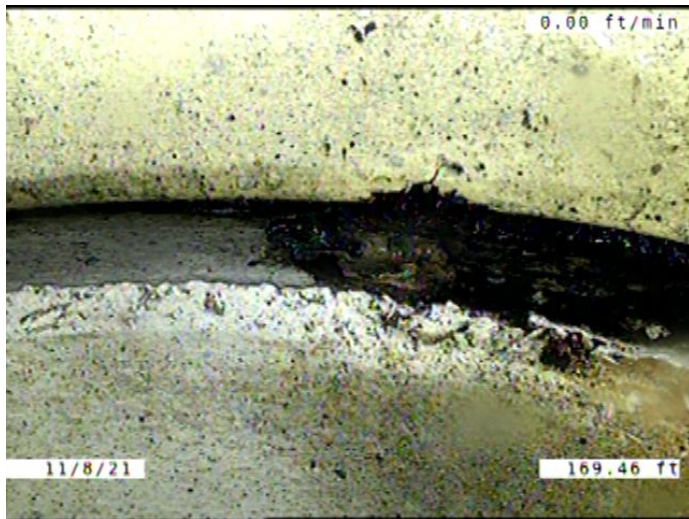
Code:	<b>DAE</b>
Description:	<b>Deposits Attached Encrustation</b>
Distance (ft):	<b>169.5</b>
Structural Grade:	<b>0</b>
O&M Grade:	<b>2</b>
Clock Start/From:	<b>2</b>
Clock To:	<b>3</b>
1st Value:	
2nd Value:	
Value Percent:	<b>5.000</b>
Continuous Index:	
Within 8" of Joint:	<b>YES</b>
Remarks:

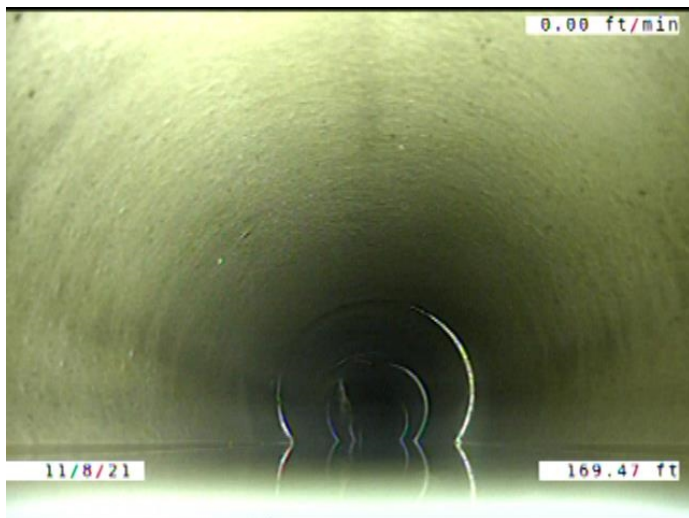
Code:	<b>MWL</b>
Description:	<b>Miscellaneous Water Level</b>
Distance (ft):	<b>169.5</b>
Structural Grade:	<b>0</b>
O&M Grade:	<b>0</b>
Clock Start/From:	
Clock To:	
1st Value:	
2nd Value:	
Value Percent:	<b>15.000</b>
Continuous Index:	
Within 8" of Joint:	<b>NO</b>
Remarks:

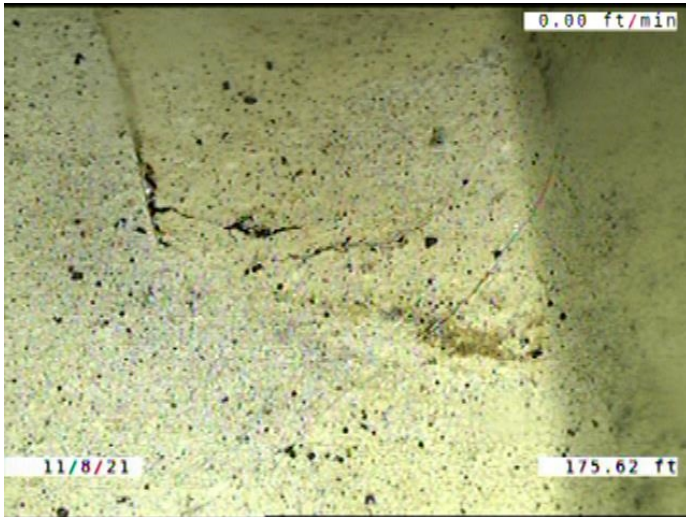
Code: **FM**  
 Description: **Fracture Multiple**

Distance (ft): **175.6**  
 Structural Grade: **4**  
 O&M Grade: **0**  
 Clock Start/From: **7**  
 Clock To: **5**  
 1st Value:  
 2nd Value:  
 Value Percent:  
 Continuous Index:  
 Within 8" of Joint: **YES**  
 Remarks:

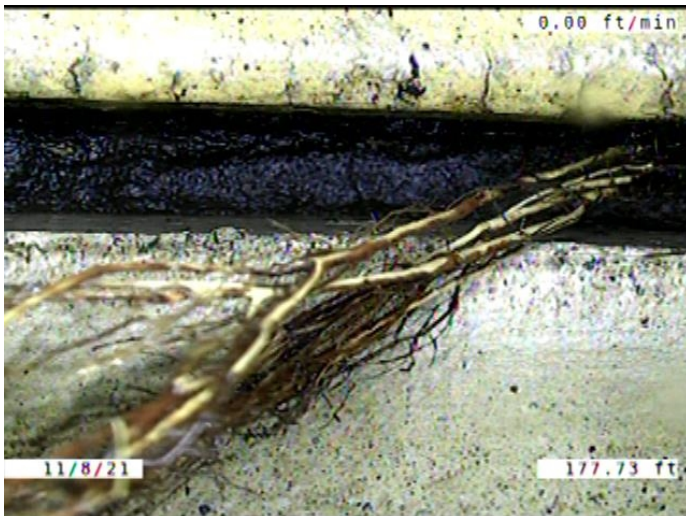
Code: **RFJ**  
 Description: **Roots Fine Joint**

Distance (ft): **177.7**  
 Structural Grade: **0**  
 O&M Grade: **1**  
 Clock Start/From: **10**  
 Clock To: **12**  
 1st Value:  
 2nd Value:  
 Value Percent:  
 Continuous Index:  
 Within 8" of Joint: **YES**  
 Remarks:

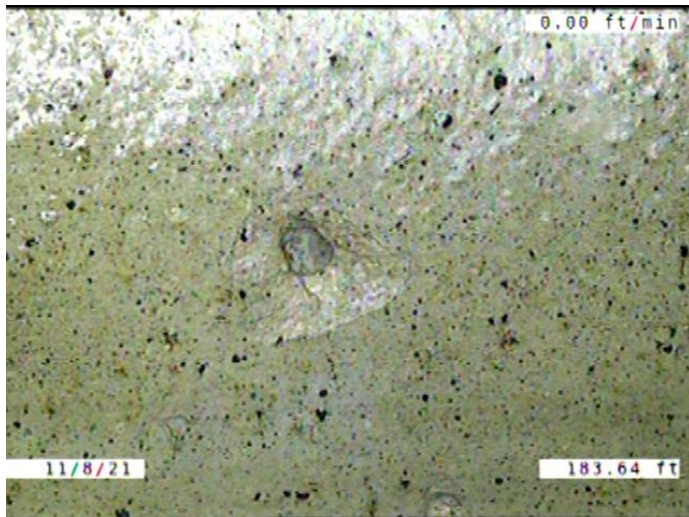
Code: **SSS**  
 Description: **Surface Damage Surface Spalling**

Distance (ft): **183.6**  
 Structural Grade: **2**  
 O&M Grade: **0**  
 Clock Start/From: **10**  
 Clock To:  
 1st Value:  
 2nd Value:  
 Value Percent:  
 Continuous Index:  
 Within 8" of Joint: **NO**  
 Remarks:

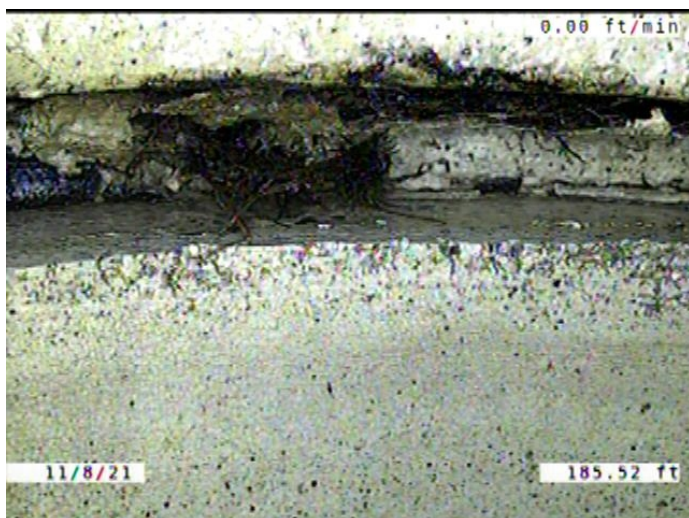
Code: **RFJ**  
 Description: **Roots Fine Joint**

Distance (ft): **185.5**  
 Structural Grade: **0**  
 O&M Grade: **1**  
 Clock Start/From: **9**  
 Clock To: **1**  
 1st Value:  
 2nd Value:  
 Value Percent:  
 Continuous Index:  
 Within 8" of Joint: **YES**  
 Remarks:

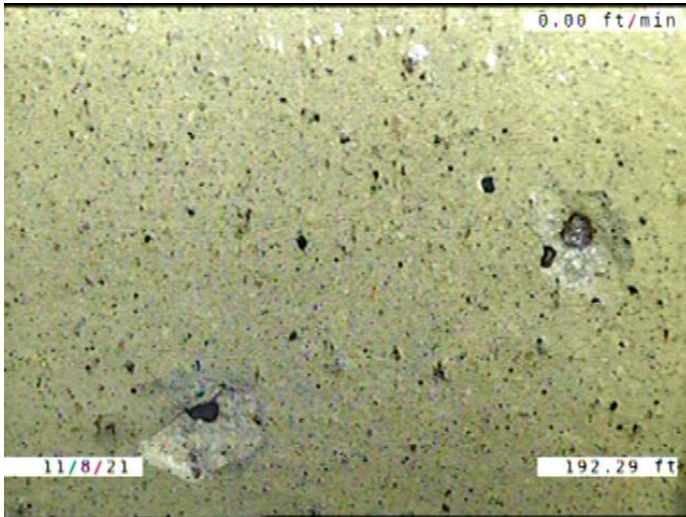
Code: **SSS**  
 Description: **Surface Damage Surface Spalling**

Distance (ft): **192.3**  
 Structural Grade: **2**  
 O&M Grade: **0**  
 Clock Start/From: **3**  
 Clock To: **4**  
 1st Value:  
 2nd Value:  
 Value Percent:  
 Continuous Index:  
 Within 8" of Joint: **NO**  
 Remarks:

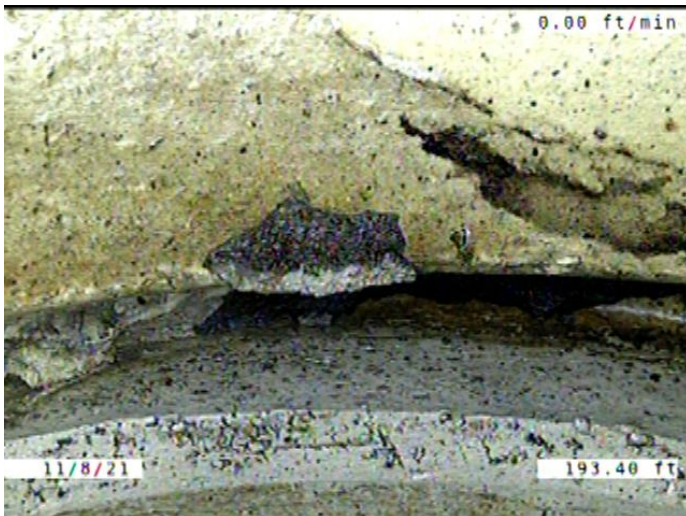
Code: **DAE**  
 Description: **Deposits Attached Encrustation**

Distance (ft): **193.4**  
 Structural Grade: **0**  
 O&M Grade: **2**  
 Clock Start/From: **9**  
 Clock To: **3**  
 1st Value:  
 2nd Value:  
 Value Percent: **5.000**  
 Continuous Index:  
 Within 8" of Joint: **YES**  
 Remarks:

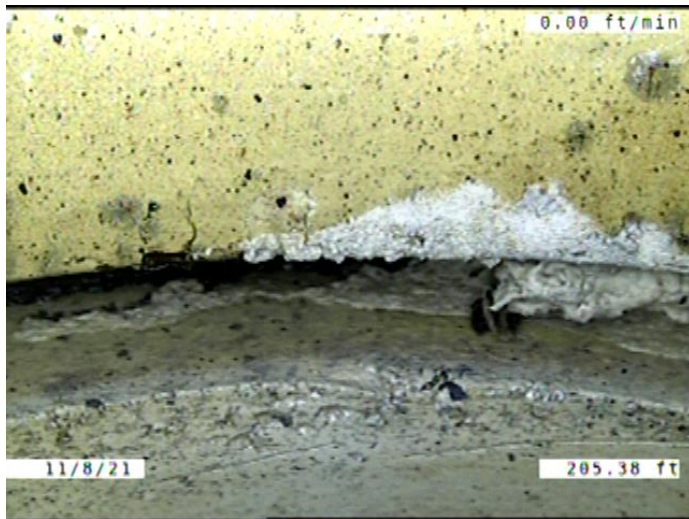
Code: **DAE**  
Description: **Deposits Attached Encrustation**

Distance (ft): **205.4**  
Structural Grade: **0**  
O&M Grade: **2**  
Clock Start/From: **9**  
Clock To: **3**  
1st Value:  
2nd Value:  
Value Percent: **5.000**  
Continuous Index:  
Within 8" of Joint: **YES**  
Remarks:

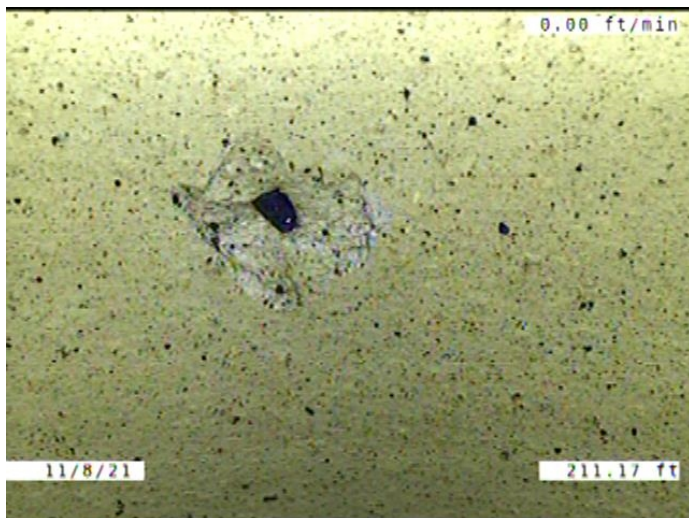
Code: **SSS**  
Description: **Surface Damage Surface Spalling**

Distance (ft): **211.2**  
Structural Grade: **2**  
O&M Grade: **0**  
Clock Start/From: **12**  
Clock To:  
1st Value:  
2nd Value:  
Value Percent:  
Continuous Index:  
Within 8" of Joint: **NO**  
Remarks:

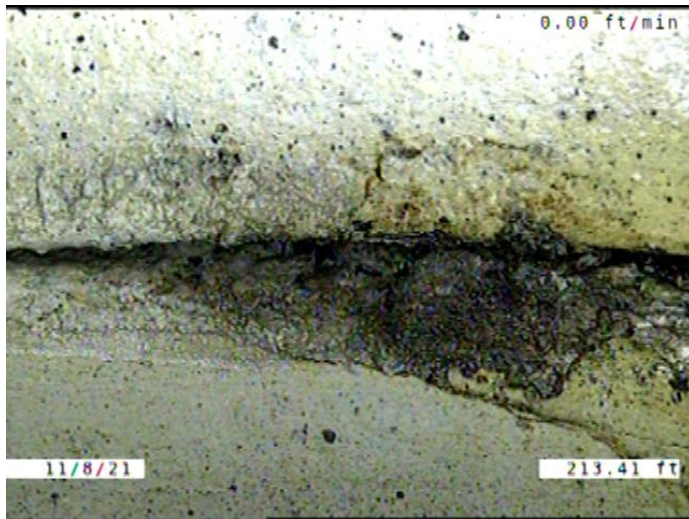
Code: **DAE**  
Description: **Deposits Attached Encrustation**

Distance (ft): **213.4**  
Structural Grade: **0**  
O&M Grade: **2**  
Clock Start/From: **9**  
Clock To: **3**  
1st Value:  
2nd Value:  
Value Percent: **5.000**  
Continuous Index:  
Within 8" of Joint: **YES**  
Remarks:

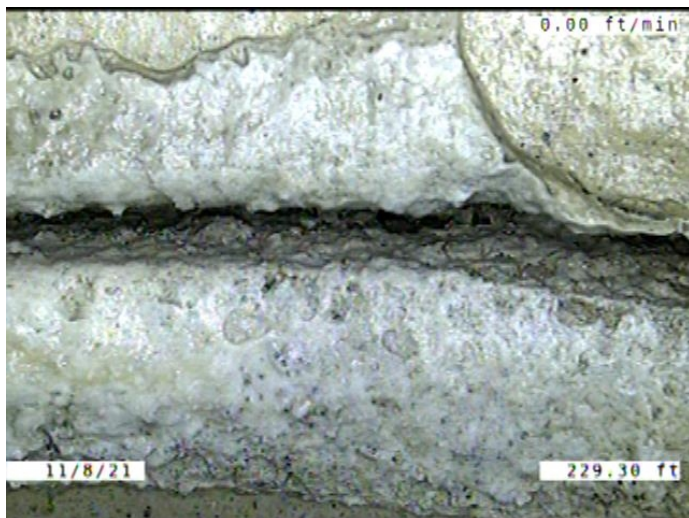
Code: **DAE**  
Description: **Deposits Attached Encrustation**

Distance (ft): **229.3**  
Structural Grade: **0**  
O&M Grade: **2**  
Clock Start/From: **9**  
Clock To: **3**  
1st Value:  
2nd Value:  
Value Percent: **5.000**  
Continuous Index:  
Within 8" of Joint: **YES**  
Remarks:

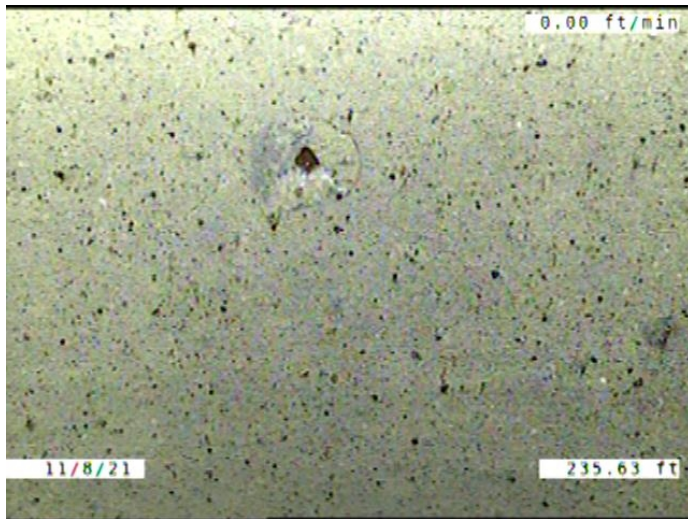
Code: **SSS**  
Description: **Surface Damage Surface Spalling**

Distance (ft): **235.6**  
Structural Grade: **2**  
O&M Grade: **0**  
Clock Start/From: **11**  
Clock To: **12**  
1st Value:  
2nd Value:  
Value Percent:  
Continuous Index:  
Within 8" of Joint: **YES**  
Remarks:

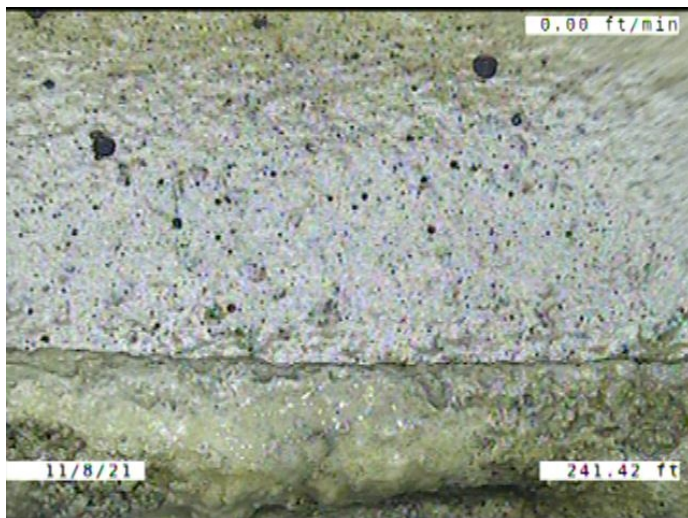
Code: **MWL**  
Description: **Miscellaneous Water Level**

Distance (ft): **241.4**  
Structural Grade: **0**  
O&M Grade: **0**  
Clock Start/From:  
Clock To:  
1st Value:  
2nd Value:  
Value Percent: **35.000**  
Continuous Index:  
Within 8" of Joint: **NO**  
Remarks:

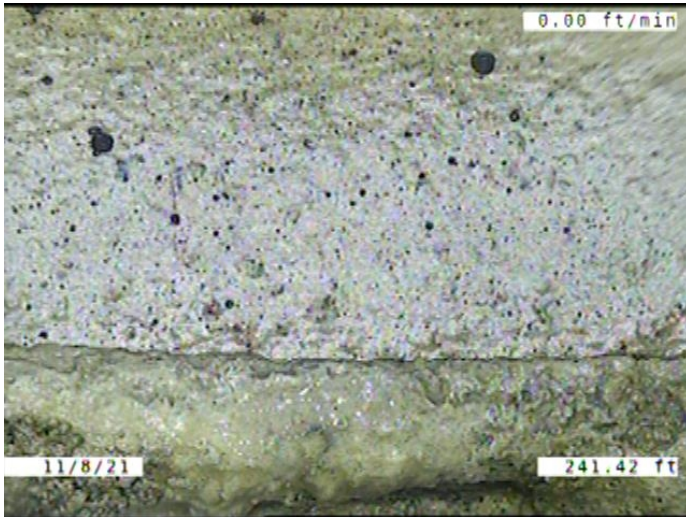
Code: **MCU**  
Description: **Miscellaneous Camera Underwater**

Distance (ft): **241.4**  
Structural Grade: **0**  
O&M Grade: **4**  
Clock Start/From:  
Clock To:  
1st Value:  
2nd Value:  
Value Percent:  
Continuous Index: **S05**  
Within 8" of Joint: **NO**  
Remarks:

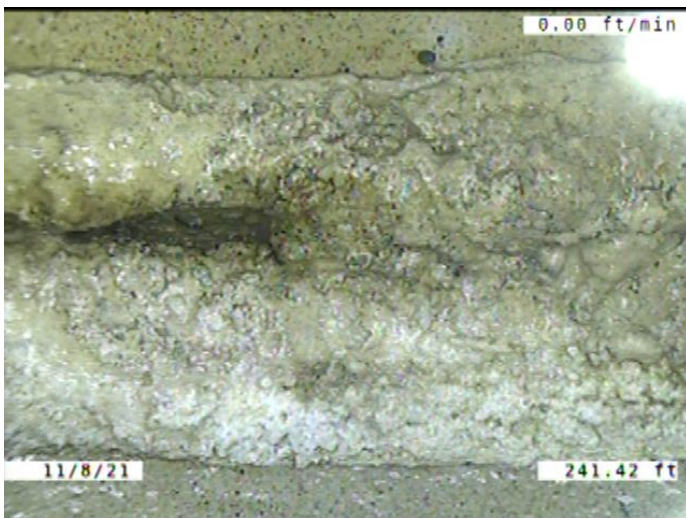
Code: **DAE**  
Description: **Deposits Attached Encrustation**

Distance (ft): **241.4**  
Structural Grade: **0**  
O&M Grade: **2**  
Clock Start/From: **10**  
Clock To: **2**  
1st Value:  
2nd Value:  
Value Percent: **5.000**  
Continuous Index:  
Within 8" of Joint: **YES**  
Remarks:

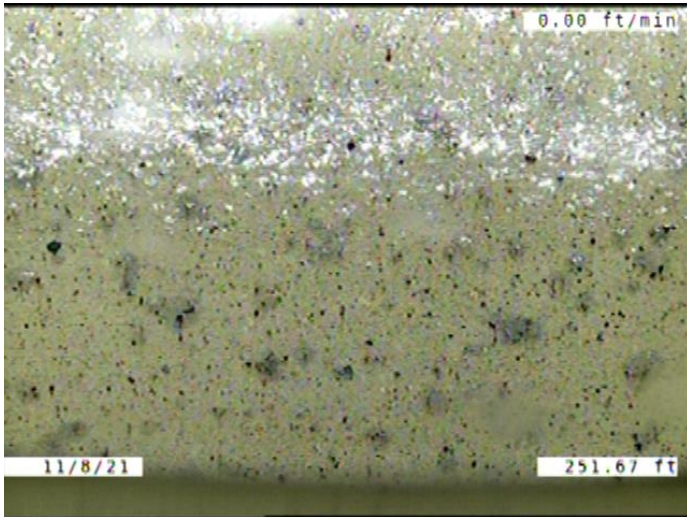
Code:	<b>MCU</b>
Description:	<b>Miscellaneous Camera Underwater</b>
Distance (ft):	<b>251.7</b>
Structural Grade:	<b>0</b>
O&M Grade:	<b>4</b>
Clock Start/From:	
Clock To:	
1st Value:	
2nd Value:	
Value Percent:	
Continuous Index:	<b>F05</b>
Within 8" of Joint:	<b>NO</b>
Remarks:

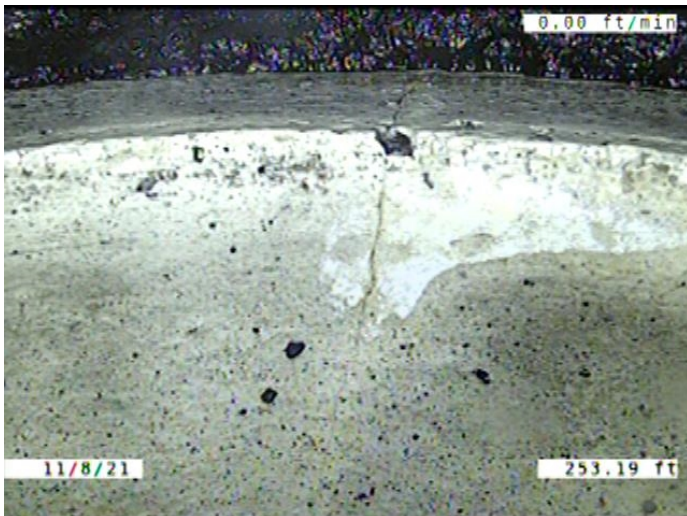
Code:	<b>CL</b>
Description:	<b>Crack Longitudinal</b>
Distance (ft):	<b>253.2</b>
Structural Grade:	<b>2</b>
O&M Grade:	<b>0</b>
Clock Start/From:	<b>12</b>
Clock To:	
1st Value:	
2nd Value:	
Value Percent:	
Continuous Index:	
Within 8" of Joint:	<b>YES</b>
Remarks:

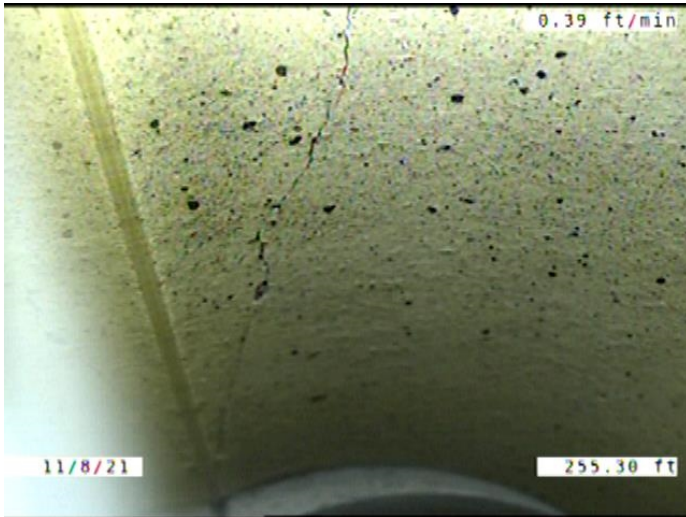
Code: **CS**  
 Description: **Crack Spiral**

Distance (ft): **255.3**  
 Structural Grade: **2**  
 O&M Grade: **0**  
 Clock Start/From: **9**  
 Clock To: **11**  
 1st Value:  
 2nd Value:  
 Value Percent:  
 Continuous Index:  
 Within 8" of Joint: **YES**  
 Remarks:

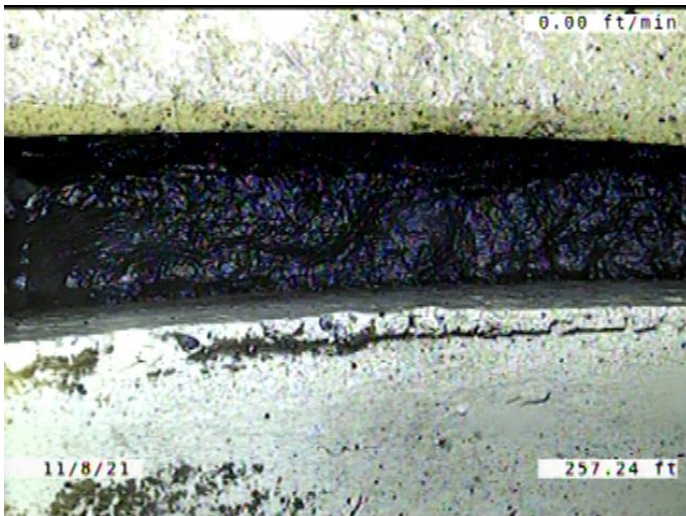
Code: **JAM**  
 Description: **Joint Angular Medium**

Distance (ft): **257.2**  
 Structural Grade: **3**  
 O&M Grade: **0**  
 Clock Start/From:  
 Clock To:  
 1st Value:  
 2nd Value:  
 Value Percent:  
 Continuous Index:  
 Within 8" of Joint: **NO**  
 Remarks:

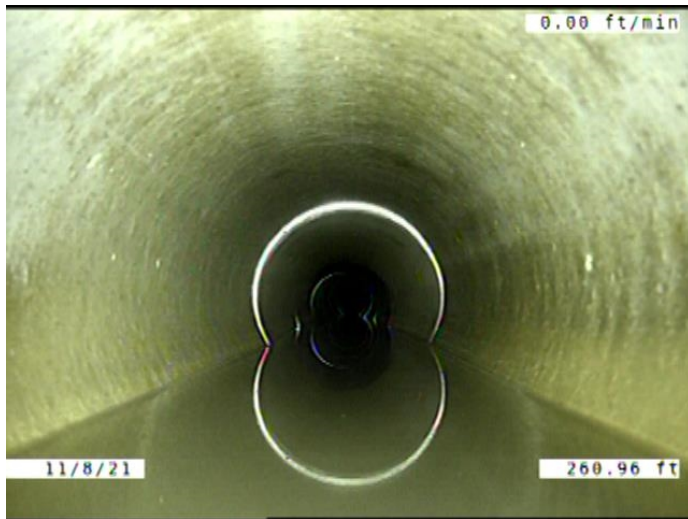
Code: **MWL**  
Description: **Miscellaneous Water Level**

Distance (ft): **261.0**  
Structural Grade: **0**  
O&M Grade: **0**  
Clock Start/From:  
Clock To:  
1st Value:  
2nd Value:  
Value Percent: **15.000**  
Continuous Index:  
Within 8" of Joint: **NO**  
Remarks:

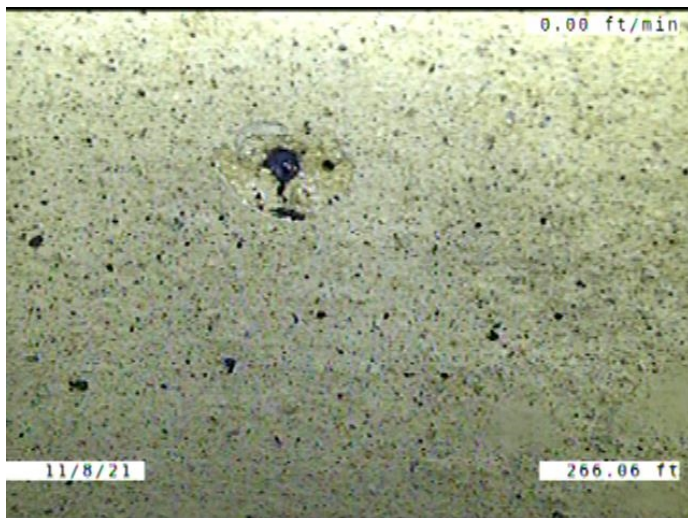
Code: **SSS**  
Description: **Surface Damage Surface Spalling**

Distance (ft): **266.1**  
Structural Grade: **2**  
O&M Grade: **0**  
Clock Start/From: **2**  
Clock To:  
1st Value:  
2nd Value:  
Value Percent:  
Continuous Index:  
Within 8" of Joint: **NO**  
Remarks:

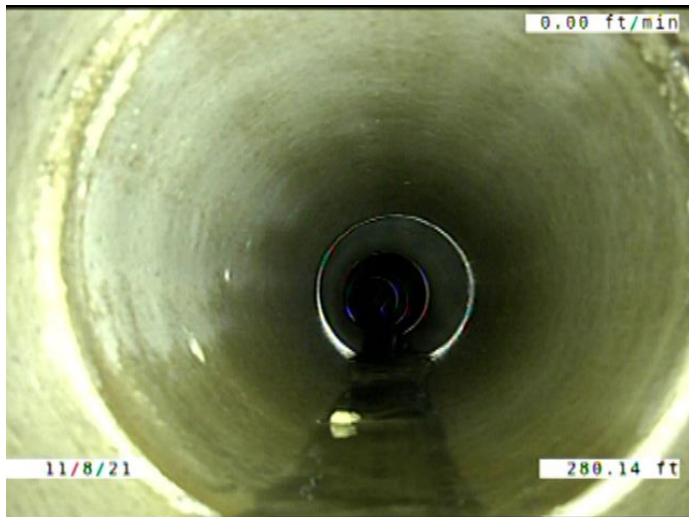
Code: **MWL**  
 Description: **Miscellaneous Water Level**

Distance (ft): **280.1**  
 Structural Grade: **0**  
 O&M Grade: **0**  
 Clock Start/From:  
 Clock To:  
 1st Value:  
 2nd Value:  
 Value Percent: **5.000**  
 Continuous Index:  
 Within 8" of Joint: **NO**  
 Remarks:

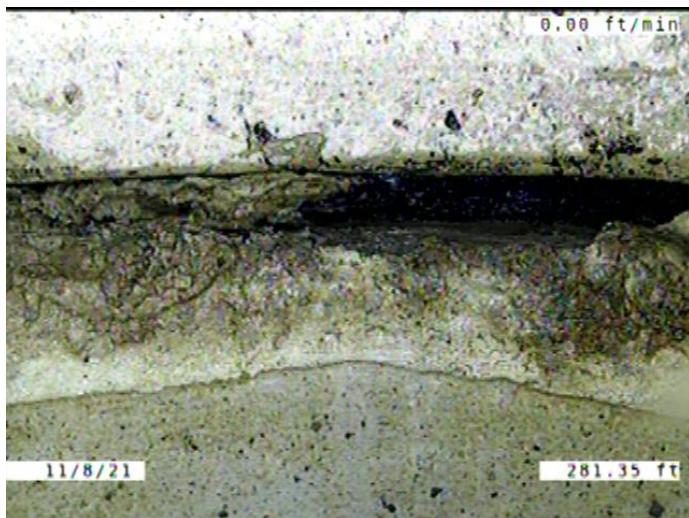
Code: **DAE**  
 Description: **Deposits Attached Encrustation**

Distance (ft): **281.3**  
 Structural Grade: **0**  
 O&M Grade: **2**  
 Clock Start/From: **8**  
 Clock To: **4**  
 1st Value:  
 2nd Value:  
 Value Percent: **5.000**  
 Continuous Index: **S06**  
 Within 8" of Joint: **YES**  
 Remarks:
