RedZone<sup>®</sup>  
ROBOTICS

Street:	South Wilson Street		Flow Control:	Not Controlled	
City:	City of Hobart		Year Renewed:		
Location:	Local rural streets with light traffic, t		Tape/Media #:		
Purpose:	Routine Assessment		Dia/Height:	10"	
Use:	Sanitary Sewage Pipe		Material:	VCP	
Drain Area:			Lining:	None	
Category:	NA				
Comment:					
Location Details:			Direction of Survey:	Downstream	
US MH:	M-505-070	DS MH:	M-505-067	Total Length Surveyed (ft):	321.9

**Tuesday, April 25, 2023**

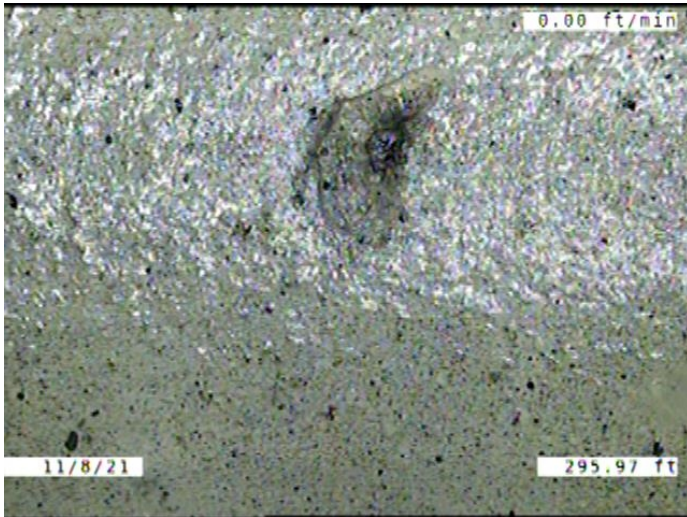
Code: **SSS**  
 Description: **Surface Damage Surface Spalling**

Distance (ft): **296.0**  
 Structural Grade: **2**  
 O&M Grade: **0**  
 Clock Start/From: **1**  
 Clock To:  
 1st Value:  
 2nd Value:  
 Value Percent:  
 Continuous Index:  
 Within 8" of Joint: **NO**  
 Remarks:

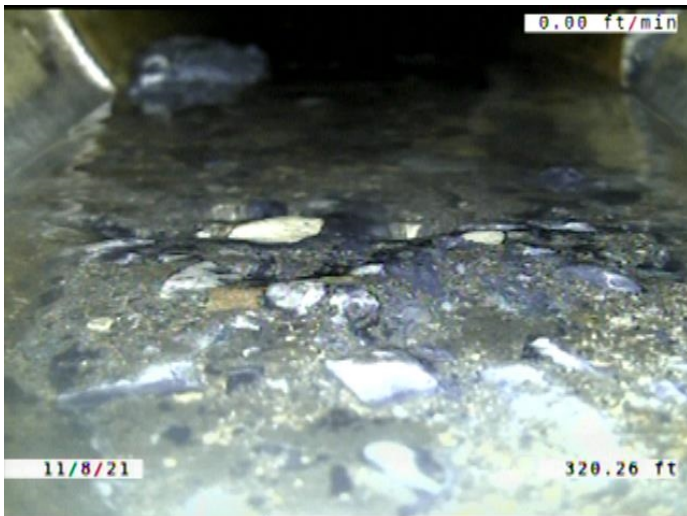
Code: **DSC**  
 Description: **Deposits Settled Hard/Compacted**

Distance (ft): **320.3**  
 Structural Grade: **0**  
 O&M Grade: **2**  
 Clock Start/From: **5**  
 Clock To: **7**  
 1st Value:  
 2nd Value:  
 Value Percent: **5.000**  
 Continuous Index:  
 Within 8" of Joint: **YES**  
 Remarks:

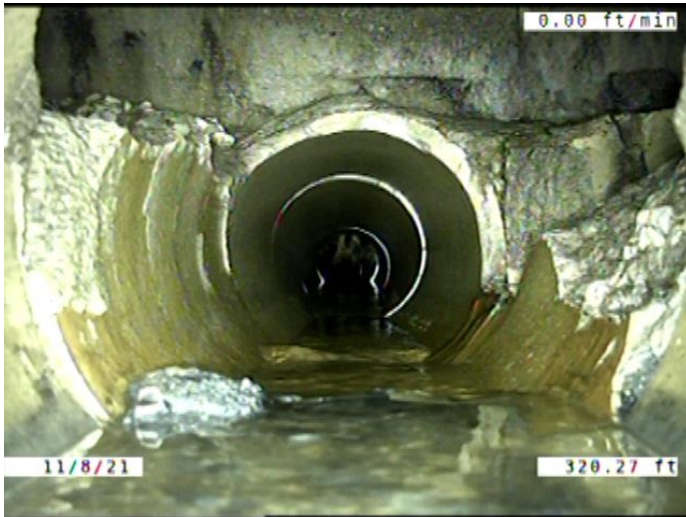
Code: **DAE**  
 Description: **Deposits Attached Encrustation**

Distance (ft): **320.3**  
 Structural Grade: **0**  
 O&M Grade: **2**  
 Clock Start/From: **8**  
 Clock To: **4**  
 1st Value:  
 2nd Value:  
 Value Percent: **5.000**  
 Continuous Index: **F06**  
 Within 8" of Joint: **YES**  
 Remarks:

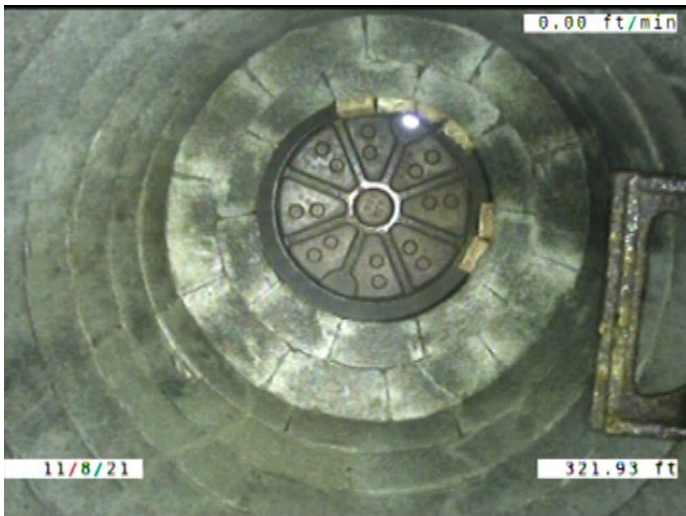
Code: **AMH**  
 Description: **Manhole**

Distance (ft): **321.9**  
 Structural Grade: **0**  
 O&M Grade: **0**  
 Clock Start/From:  
 Clock To:  
 1st Value:  
 2nd Value:  
 Value Percent:  
 Continuous Index:  
 Within 8" of Joint: **NO**  
 Remarks: **M-505-067**
