# Profile/Photo Observation Report

Date:	<b>11/08/2021</b>	Weather:		Coding:	<b>PACP 7.0</b>
Pipe Length (ft):	<b>321.9</b>	Owner:	<b>City of Hobart</b>	Pre Clean:	<b>Heavy Cleaning</b>
P.O.#:	<b>YES502259</b>	Surveyor:	<b>Steven Bucklin</b>	PSR:	<b>P-505-067-070</b>
Customer:	<b>City of Hobart, IN (Red</b>	Clean Date:	<b>11/07/2021</b>	Shape:	<b>C</b>

Street:	<b>South Wilson Street</b>	Flow Control:	<b>Not Controlled</b>
City:	<b>City of Hobart</b>	Year Renewed:	
Location:	<b>Local rural streets with light traffic, t</b>	Tape/Media #:	
Purpose:	<b>Routine Assessment</b>	Dia/Height:	<b>10"</b>
Use:	<b>Sanitary Sewage Pipe</b>	Material:	<b>VCP</b>
Drain Area:		Lining:	<b>None</b>
Category:	<b>NA</b>		
Comment:			
Location Details:		Direction of Survey:	<b>Downstream</b>
US MH:	<b>M-505-070</b>	DS MH:	<b>M-505-067</b>
		Total Length Surveyed (ft):	<b>321.9</b>

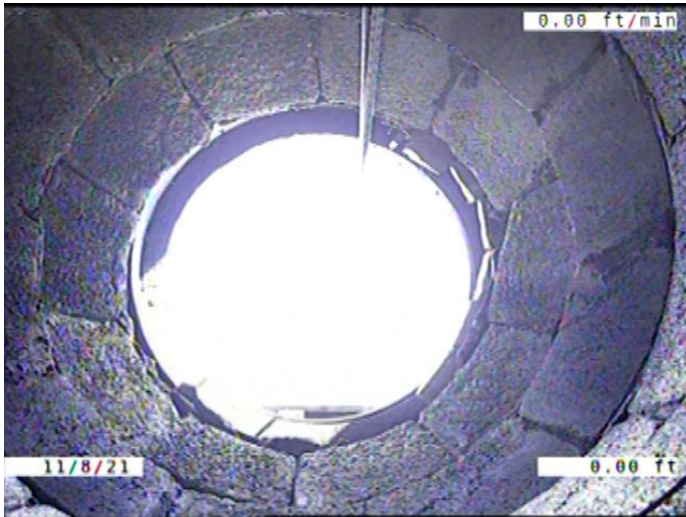
Code: **AMH**  
 Description: **Manhole**

Distance (ft): **.0**  
 Structural Grade: **0**  
 O&M Grade: **0**  
 Clock Start/From:  
 Clock To:  
 1st Value:  
 2nd Value:  
 Value Percent:  
 Continuous Index:  
 Within 8" of Joint: **NO**  
 Remarks: **M-505-070**

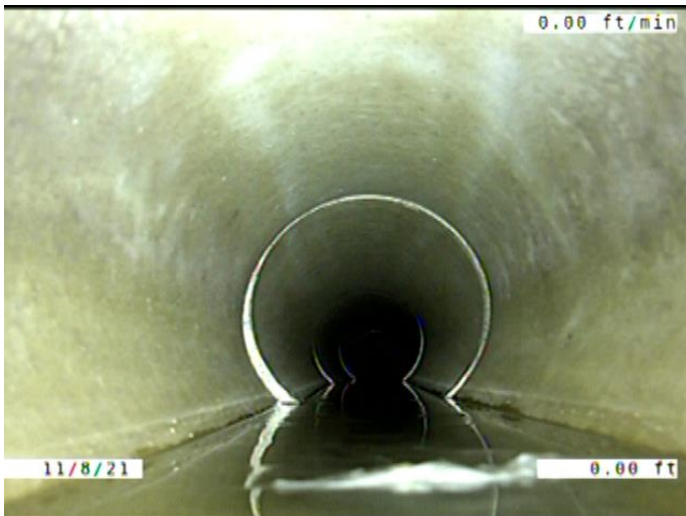
Code: **MWL**  
 Description: **Miscellaneous Water Level**

Distance (ft): **.0**  
 Structural Grade: **0**  
 O&M Grade: **0**  
 Clock Start/From:  
 Clock To:  
 1st Value:  
 2nd Value:  
 Value Percent: **5.000**  
 Continuous Index:  
 Within 8" of Joint: **NO**  
 Remarks:

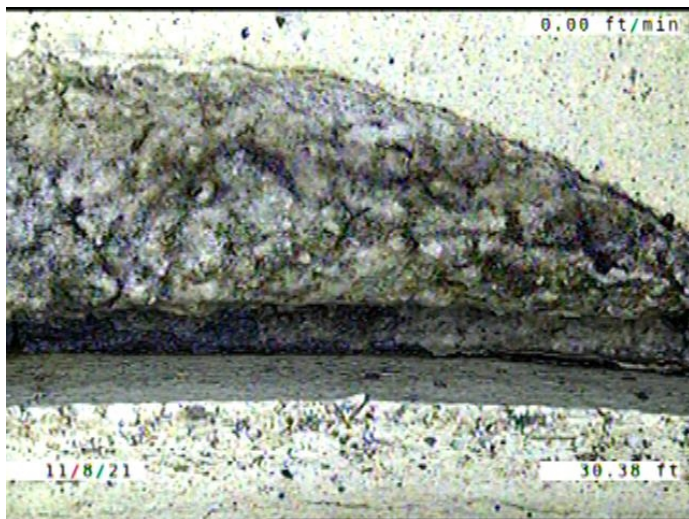
Code: **DAE**  
 Description: **Deposits Attached Encrustation**

Distance (ft): **30.4**  
 Structural Grade: **0**  
 O&M Grade: **2**  
 Clock Start/From: **8**  
 Clock To: **11**  
 1st Value:  
 2nd Value:  
 Value Percent: **5.000**  
 Continuous Index:  
 Within 8" of Joint: **YES**  
 Remarks:

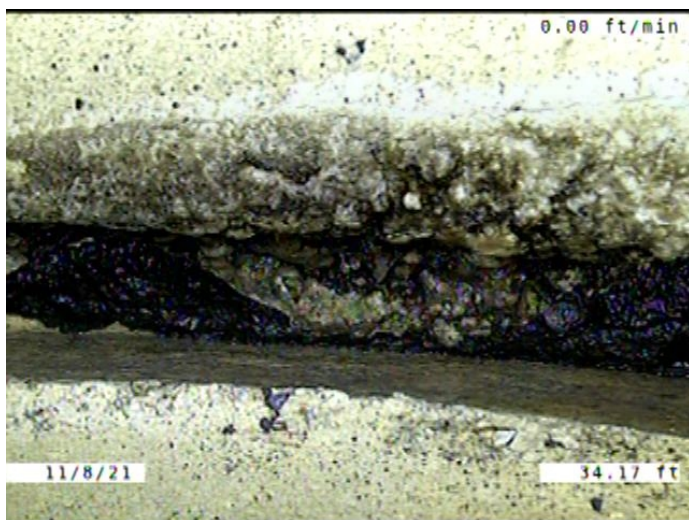
Code: **DAE**  
 Description: **Deposits Attached Encrustation**

Distance (ft): **34.2**  
 Structural Grade: **0**  
 O&M Grade: **2**  
 Clock Start/From: **12**  
 Clock To: **3**  
 1st Value:  
 2nd Value:  
 Value Percent: **5.000**  
 Continuous Index:  
 Within 8" of Joint: **YES**  
 Remarks:

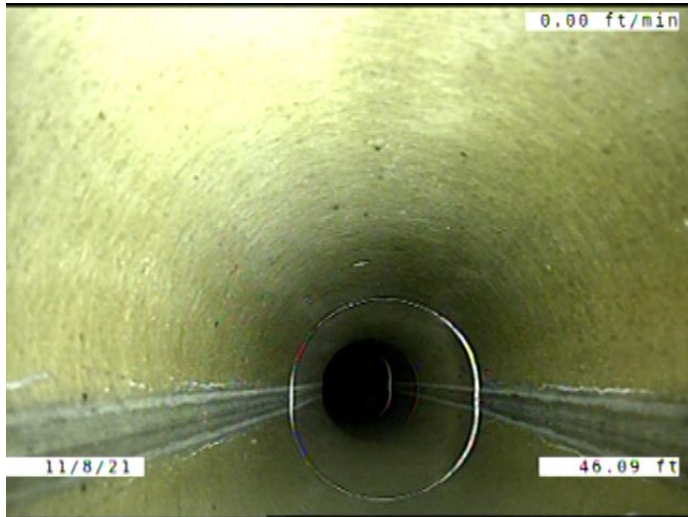
Code: **MWL**  
 Description: **Miscellaneous Water Level**

Distance (ft): **46.1**  
 Structural Grade: **0**  
 O&M Grade: **0**  
 Clock Start/From:  
 Clock To:  
 1st Value:  
 2nd Value:  
 Value Percent: **20.000**  
 Continuous Index:  
 Within 8" of Joint: **NO**  
 Remarks:

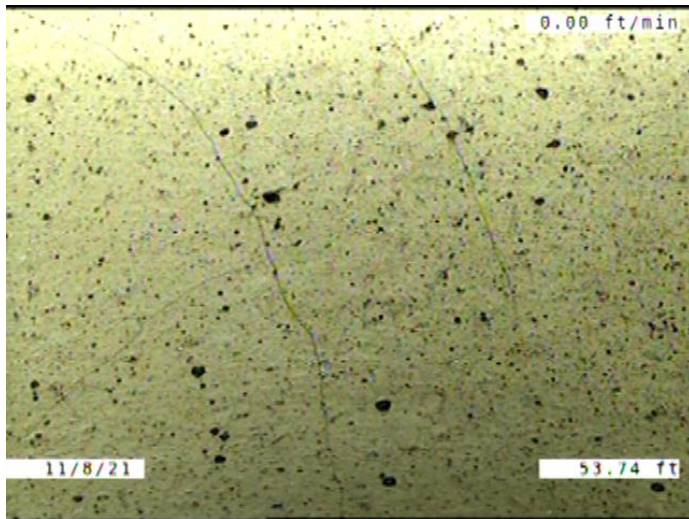
Code: **CM**  
 Description: **Crack Multiple**

Distance (ft): **53.7**  
 Structural Grade: **3**  
 O&M Grade: **0**  
 Clock Start/From: **10**  
 Clock To: **12**  
 1st Value:  
 2nd Value:  
 Value Percent:  
 Continuous Index:  
 Within 8" of Joint: **YES**  
 Remarks:

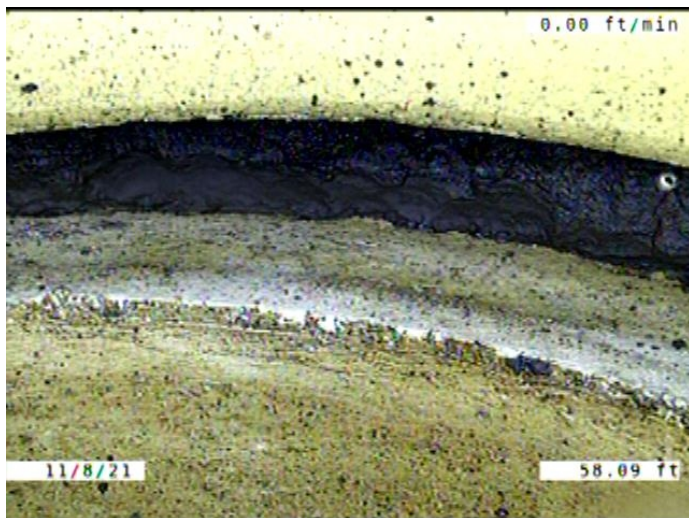
Code: **JAM**  
 Description: **Joint Angular Medium**

Distance (ft): **58.1**  
 Structural Grade: **3**  
 O&M Grade: **0**  
 Clock Start/From:  
 Clock To:  
 1st Value:  
 2nd Value:  
 Value Percent:  
 Continuous Index:  
 Within 8" of Joint: **NO**  
 Remarks:

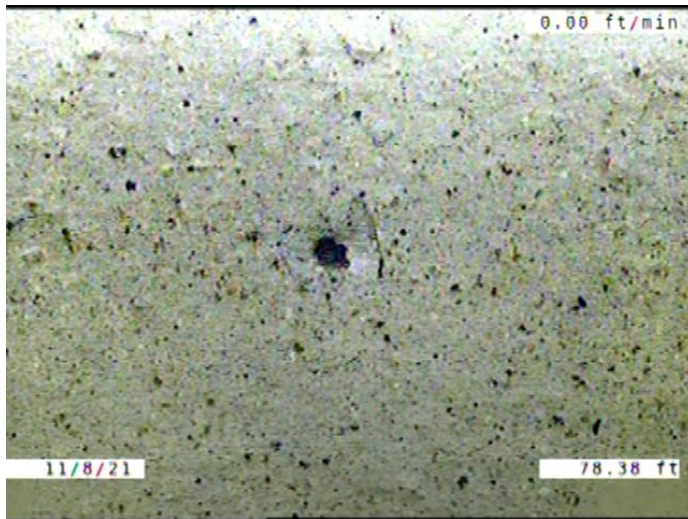
Code: **SSS**  
Description: **Surface Damage Surface Spalling**

Distance (ft): **78.4**  
Structural Grade: **2**  
O&M Grade: **0**  
Clock Start/From: **11**  
Clock To: **1**  
1st Value:  
2nd Value:  
Value Percent:  
Continuous Index:  
Within 8" of Joint: **YES**  
Remarks:

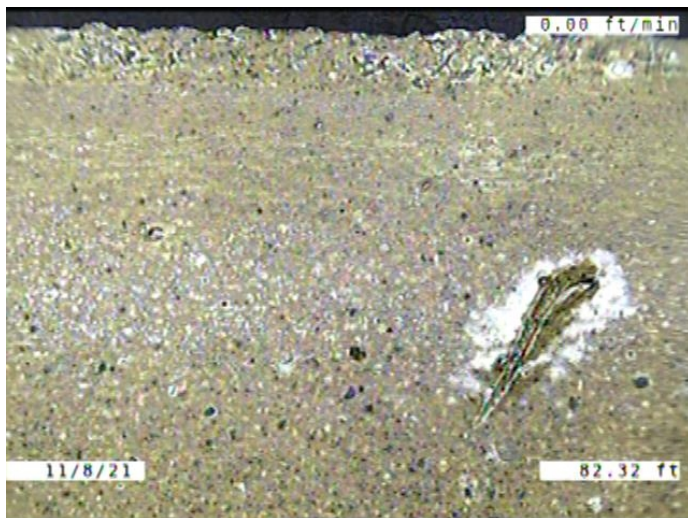
Code: **MWL**  
Description: **Miscellaneous Water Level**

Distance (ft): **82.3**  
Structural Grade: **0**  
O&M Grade: **0**  
Clock Start/From:  
Clock To:  
1st Value:  
2nd Value:  
Value Percent: **35.000**  
Continuous Index:  
Within 8" of Joint: **NO**  
Remarks:

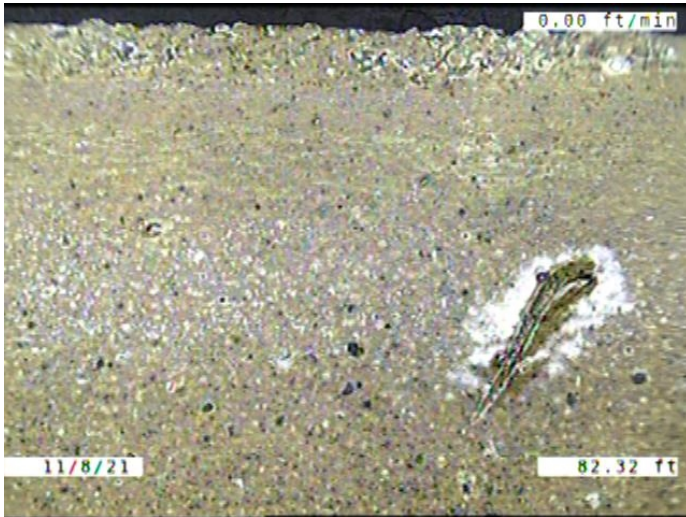
Code: **MCU**  
Description: **Miscellaneous Camera Underwater**

Distance (ft): **82.3**  
Structural Grade: **0**  
O&M Grade: **4**  
Clock Start/From:  
Clock To:  
1st Value:  
2nd Value:  
Value Percent:  
Continuous Index: **S01**  
Within 8" of Joint: **NO**  
Remarks:

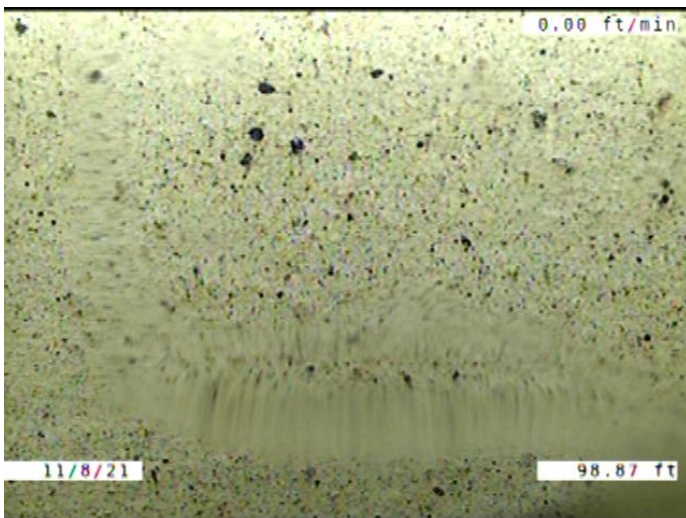
Code: **MCU**  
Description: **Miscellaneous Camera Underwater**

Distance (ft): **98.9**  
Structural Grade: **0**  
O&M Grade: **4**  
Clock Start/From:  
Clock To:  
1st Value:  
2nd Value:  
Value Percent:  
Continuous Index: **F01**  
Within 8" of Joint: **NO**  
Remarks:

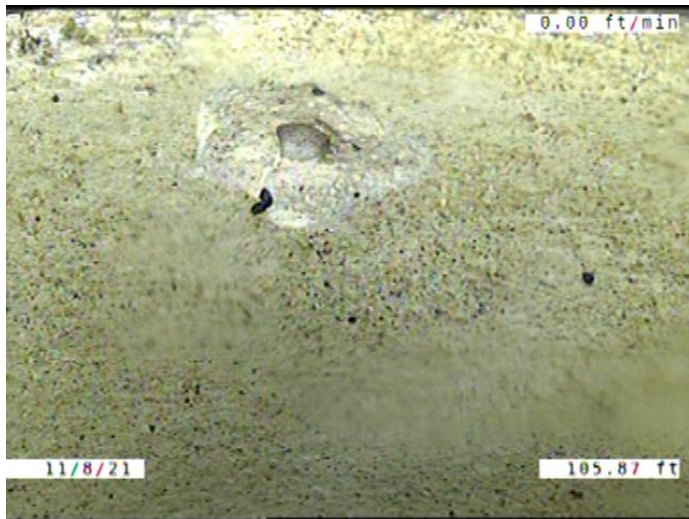
Code: **SSS**  
 Description: **Surface Damage Surface Spalling**

Distance (ft): **105.9**  
 Structural Grade: **2**  
 O&M Grade: **0**  
 Clock Start/From: **1**  
 Clock To:  
 1st Value:  
 2nd Value:  
 Value Percent:  
 Continuous Index:  
 Within 8" of Joint: **YES**  
 Remarks:

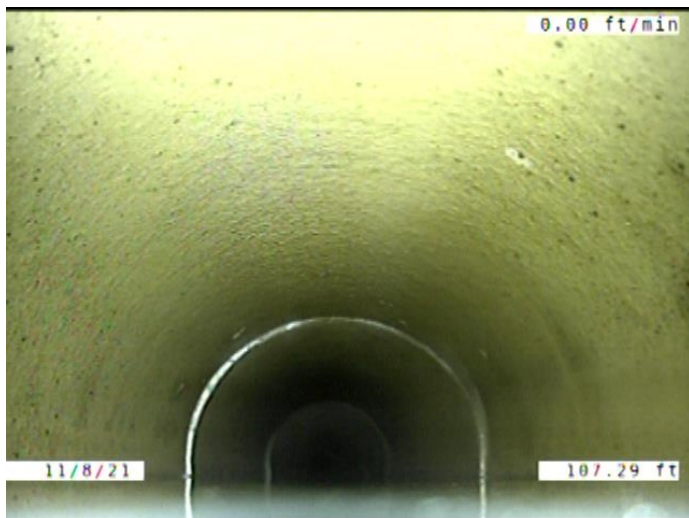
Code: **MWL**  
 Description: **Miscellaneous Water Level**

Distance (ft): **107.3**  
 Structural Grade: **0**  
 O&M Grade: **0**  
 Clock Start/From:  
 Clock To:  
 1st Value:  
 2nd Value:  
 Value Percent: **20.000**  
 Continuous Index:  
 Within 8" of Joint: **NO**  
 Remarks:

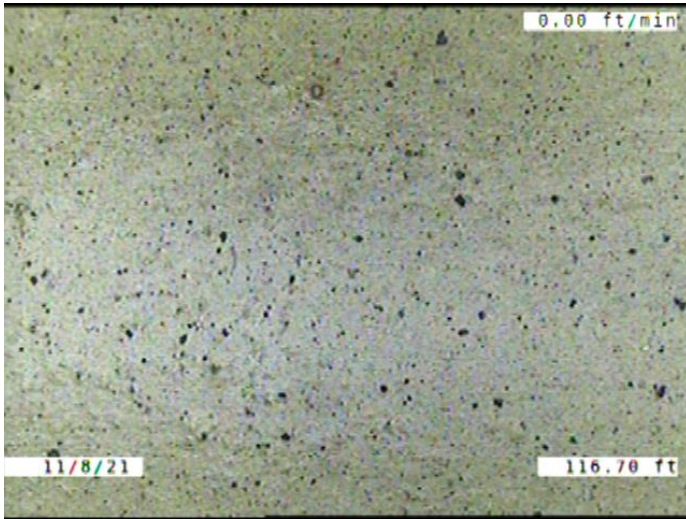
Code: **MWL**  
Description: **Miscellaneous Water Level**

Distance (ft): **116.7**  
Structural Grade: **0**  
O&M Grade: **0**  
Clock Start/From:  
Clock To:  
1st Value:  
2nd Value:  
Value Percent: **35.000**  
Continuous Index:  
Within 8" of Joint: **NO**  
Remarks:

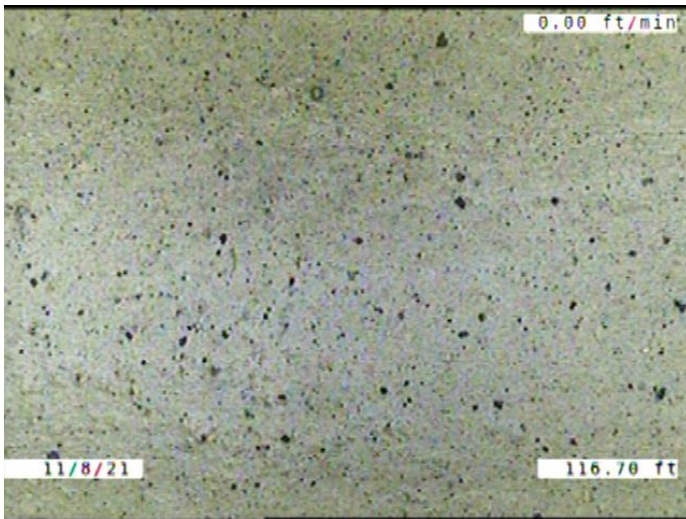
Code: **MCU**  
Description: **Miscellaneous Camera Underwater**

Distance (ft): **116.7**  
Structural Grade: **0**  
O&M Grade: **4**  
Clock Start/From:  
Clock To:  
1st Value:  
2nd Value:  
Value Percent:  
Continuous Index: **S02**  
Within 8" of Joint: **NO**  
Remarks:

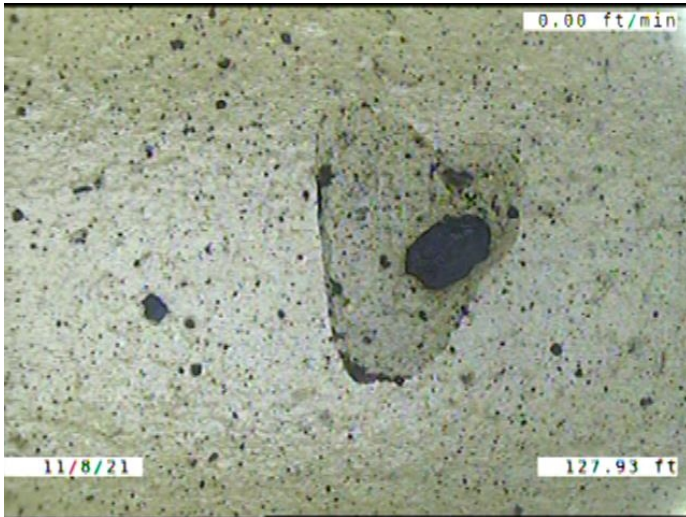
Code: **SSS**  
Description: **Surface Damage Surface Spalling**

Distance (ft): **127.9**  
Structural Grade: **2**  
O&M Grade: **0**  
Clock Start/From: **12**  
Clock To:  
1st Value:  
2nd Value:  
Value Percent:  
Continuous Index:  
Within 8" of Joint: **NO**  
Remarks:

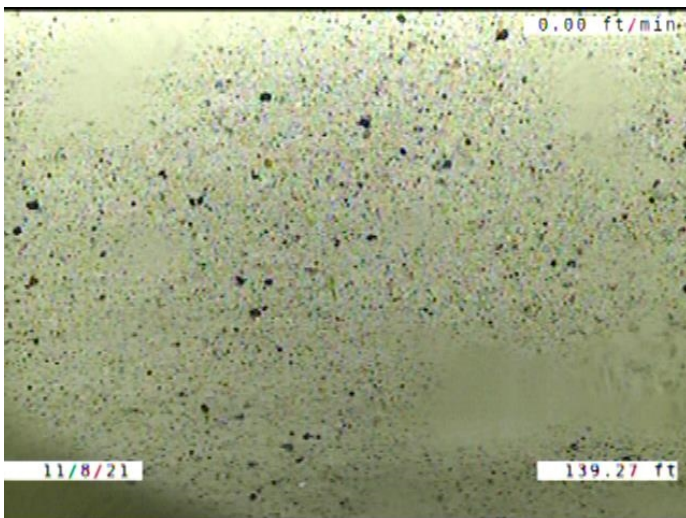
Code: **MCU**  
Description: **Miscellaneous Camera Underwater**

Distance (ft): **139.3**  
Structural Grade: **0**  
O&M Grade: **4**  
Clock Start/From:  
Clock To:  
1st Value:  
2nd Value:  
Value Percent:  
Continuous Index: **F03**  
Within 8" of Joint: **NO**  
Remarks:

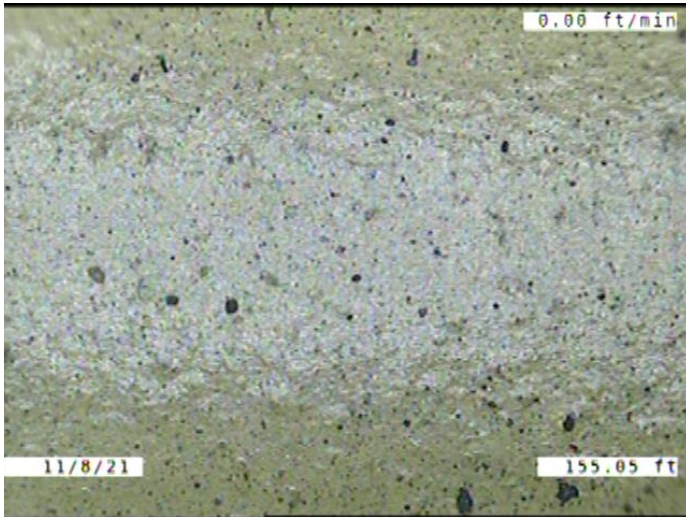
Code: **MCU**  
Description: **Miscellaneous Camera Underwater**

Distance (ft): **155.0**  
Structural Grade: **0**  
O&M Grade: **4**  
Clock Start/From:  
Clock To:  
1st Value:  
2nd Value:  
Value Percent:  
Continuous Index: **S04**  
Within 8" of Joint: **NO**  
Remarks:

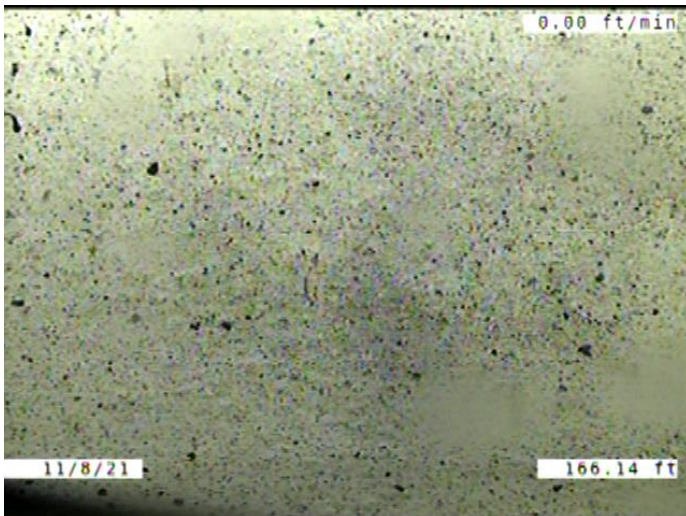
Code: **MCU**  
Description: **Miscellaneous Camera Underwater**

Distance (ft): **166.1**  
Structural Grade: **0**  
O&M Grade: **4**  
Clock Start/From:  
Clock To:  
1st Value:  
2nd Value:  
Value Percent:  
Continuous Index: **F04**  
Within 8" of Joint: **NO**  
Remarks:

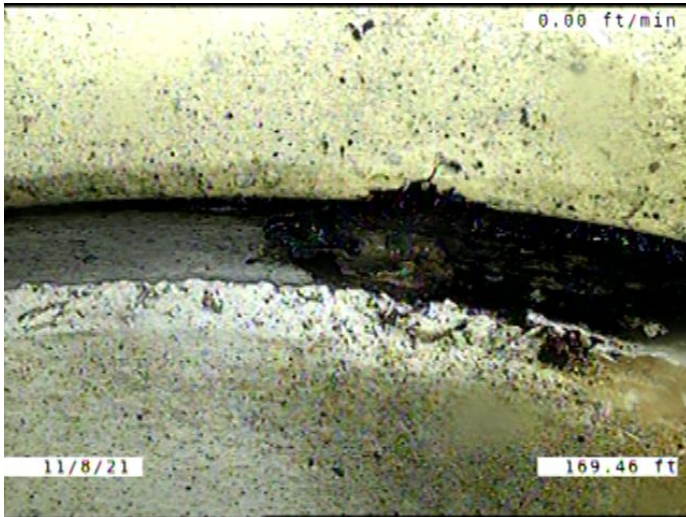
Code: **DAE**  
 Description: **Deposits Attached Encrustation**

Distance (ft): **169.5**  
 Structural Grade: **0**  
 O&M Grade: **2**  
 Clock Start/From: **2**  
 Clock To: **3**  
 1st Value:  
 2nd Value:  
 Value Percent: **5.000**  
 Continuous Index:  
 Within 8" of Joint: **YES**  
 Remarks:

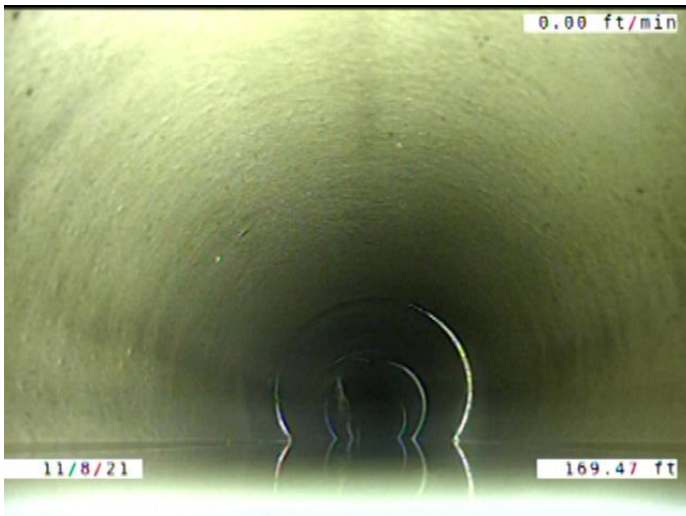
Code: **MWL**  
 Description: **Miscellaneous Water Level**

Distance (ft): **169.5**  
 Structural Grade: **0**  
 O&M Grade: **0**  
 Clock Start/From:  
 Clock To:  
 1st Value:  
 2nd Value:  
 Value Percent: **15.000**  
 Continuous Index:  
 Within 8" of Joint: **NO**  
 Remarks:

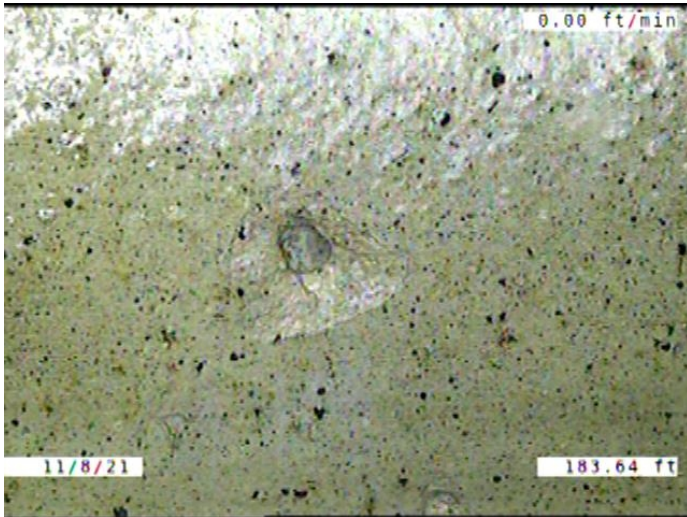
Code: **SSS**  
 Description: **Surface Damage Surface Spalling**

Distance (ft): **183.6**  
 Structural Grade: **2**  
 O&M Grade: **0**  
 Clock Start/From: **10**  
 Clock To:  
 1st Value:  
 2nd Value:  
 Value Percent:  
 Continuous Index:  
 Within 8" of Joint: **NO**  
 Remarks:

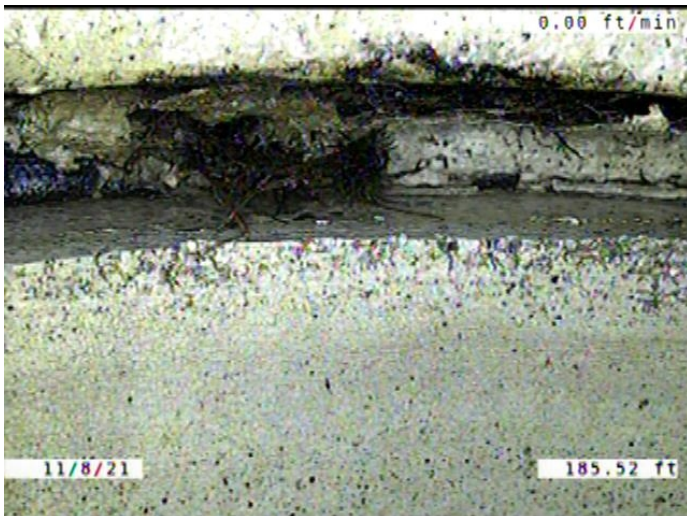
Code: **RFJ**  
 Description: **Roots Fine Joint**

Distance (ft): **185.5**  
 Structural Grade: **0**  
 O&M Grade: **1**  
 Clock Start/From: **9**  
 Clock To: **1**  
 1st Value:  
 2nd Value:  
 Value Percent:  
 Continuous Index:  
 Within 8" of Joint: **YES**  
 Remarks:

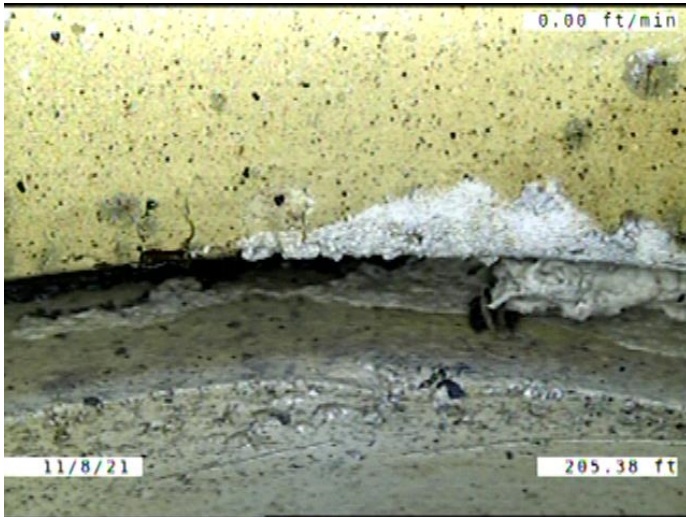
Code: **DAE**  
 Description: **Deposits Attached Encrustation**

Distance (ft): **205.4**  
 Structural Grade: **0**  
 O&M Grade: **2**  
 Clock Start/From: **9**  
 Clock To: **3**  
 1st Value:  
 2nd Value:  
 Value Percent: **5.000**  
 Continuous Index:  
 Within 8" of Joint: **YES**  
 Remarks:

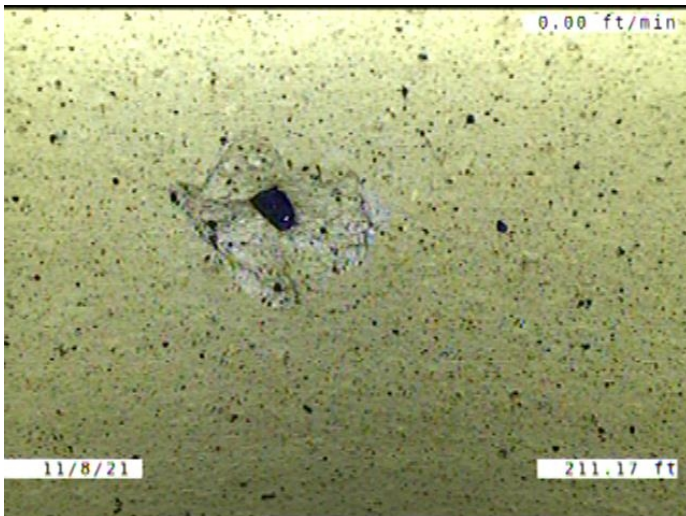
Code: **SSS**  
 Description: **Surface Damage Surface Spalling**

Distance (ft): **211.2**  
 Structural Grade: **2**  
 O&M Grade: **0**  
 Clock Start/From: **12**  
 Clock To:  
 1st Value:  
 2nd Value:  
 Value Percent:  
 Continuous Index:  
 Within 8" of Joint: **NO**  
 Remarks:

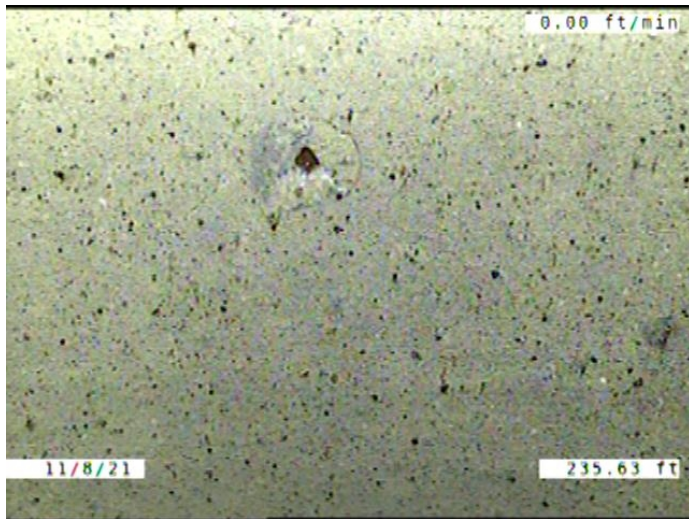
Code: **SSS**  
 Description: **Surface Damage Surface Spalling**

Distance (ft): **235.6**  
 Structural Grade: **2**  
 O&M Grade: **0**  
 Clock Start/From: **11**  
 Clock To: **12**  
 1st Value:  
 2nd Value:  
 Value Percent:  
 Continuous Index:  
 Within 8" of Joint: **YES**  
 Remarks:

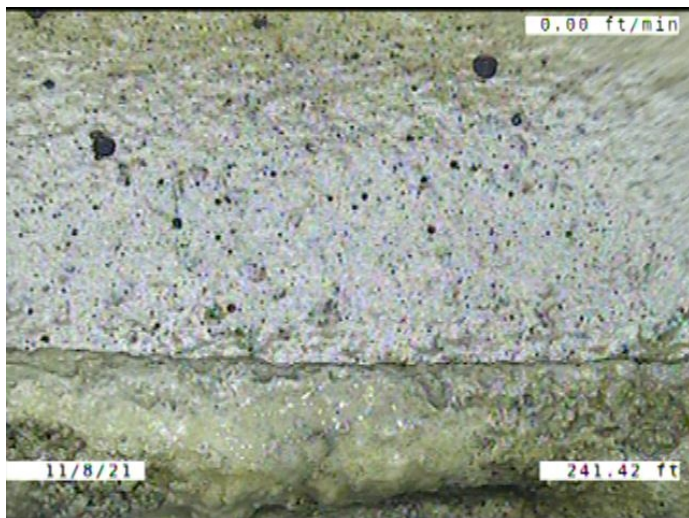
Code: **MWL**  
 Description: **Miscellaneous Water Level**

Distance (ft): **241.4**  
 Structural Grade: **0**  
 O&M Grade: **0**  
 Clock Start/From:  
 Clock To:  
 1st Value:  
 2nd Value:  
 Value Percent: **35.000**  
 Continuous Index:  
 Within 8" of Joint: **NO**  
 Remarks:

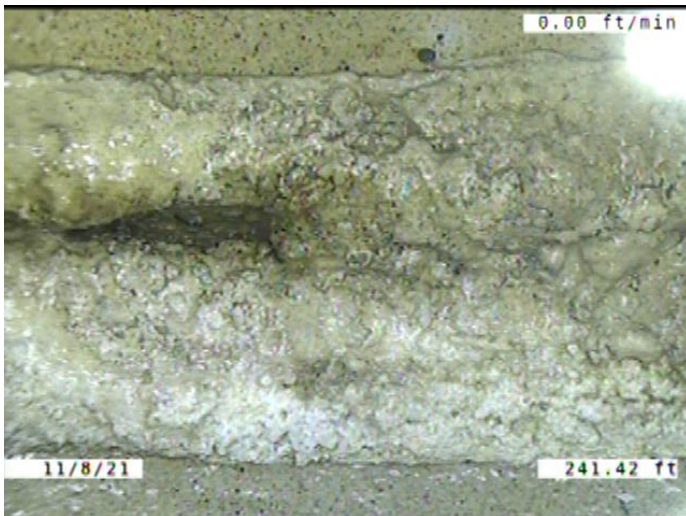
Code: **DAE**  
 Description: **Deposits Attached Encrustation**

Distance (ft): **241.4**  
 Structural Grade: **0**  
 O&M Grade: **2**  
 Clock Start/From: **10**  
 Clock To: **2**  
 1st Value:  
 2nd Value:  
 Value Percent: **5.000**  
 Continuous Index:  
 Within 8" of Joint: **YES**  
 Remarks:

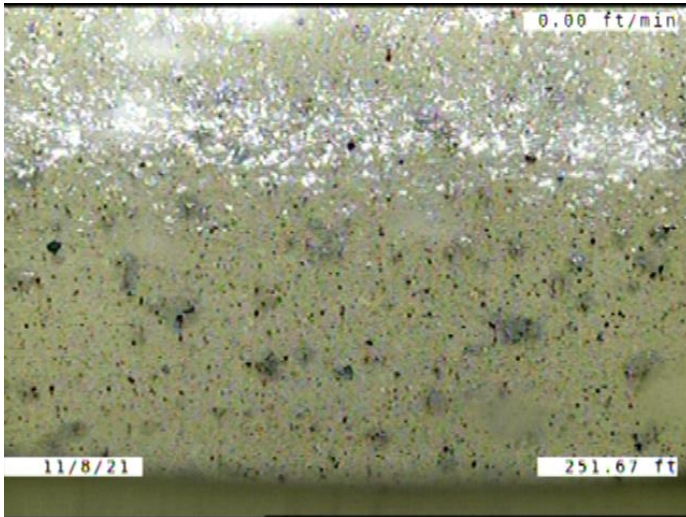
Code: **MCU**  
Description: **Miscellaneous Camera Underwater**

Distance (ft): **251.7**  
Structural Grade: **0**  
O&M Grade: **4**  
Clock Start/From:  
Clock To:  
1st Value:  
2nd Value:  
Value Percent:  
Continuous Index: **F05**  
Within 8" of Joint: **NO**  
Remarks:

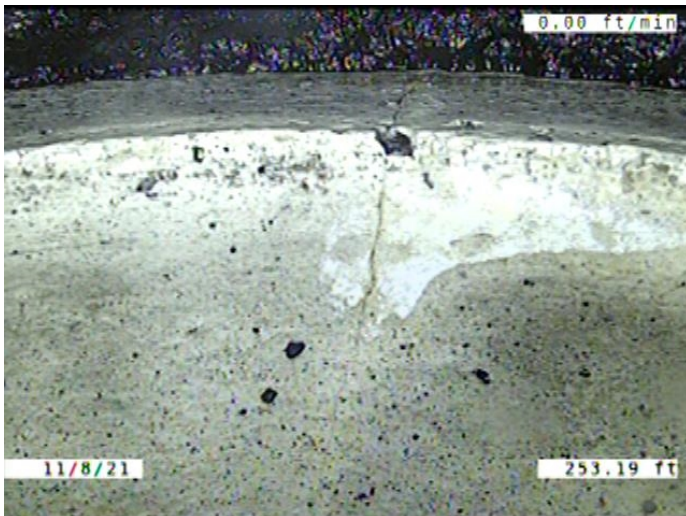
Code: **CL**  
Description: **Crack Longitudinal**

Distance (ft): **253.2**  
Structural Grade: **2**  
O&M Grade: **0**  
Clock Start/From: **12**  
Clock To:  
1st Value:  
2nd Value:  
Value Percent:  
Continuous Index:  
Within 8" of Joint: **YES**  
Remarks:

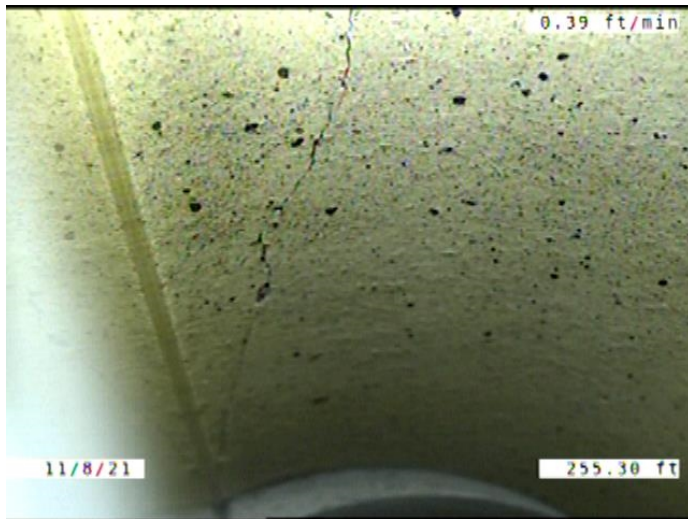
Code: **CS**  
Description: **Crack Spiral**

Distance (ft): **255.3**  
Structural Grade: **2**  
O&M Grade: **0**  
Clock Start/From: **9**  
Clock To: **11**  
1st Value:  
2nd Value:  
Value Percent:  
Continuous Index:  
Within 8" of Joint: **YES**  
Remarks:

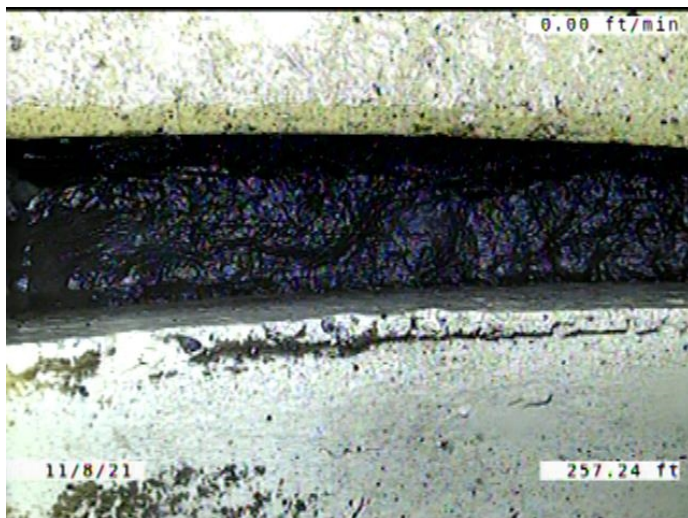
Code: **JAM**  
Description: **Joint Angular Medium**

Distance (ft): **257.2**  
Structural Grade: **3**  
O&M Grade: **0**  
Clock Start/From:  
Clock To:  
1st Value:  
2nd Value:  
Value Percent:  
Continuous Index:  
Within 8" of Joint: **NO**  
Remarks:

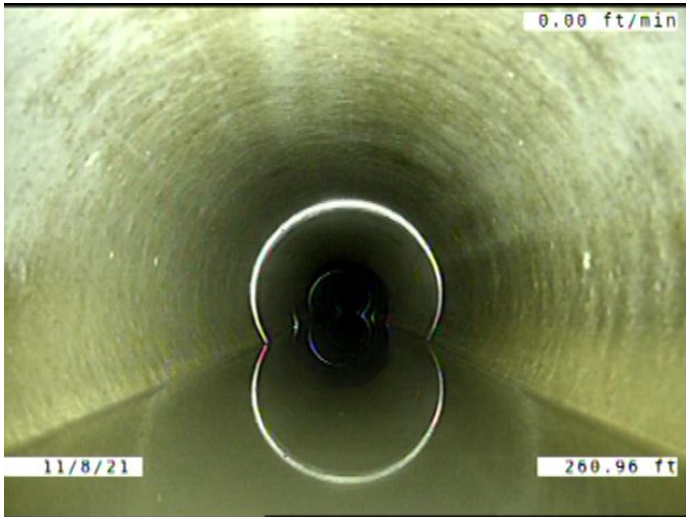
Code: **MWL**  
Description: **Miscellaneous Water Level**

Distance (ft): **261.0**  
Structural Grade: **0**  
O&M Grade: **0**  
Clock Start/From:  
Clock To:  
1st Value:  
2nd Value:  
Value Percent: **15.000**  
Continuous Index:  
Within 8" of Joint: **NO**  
Remarks:

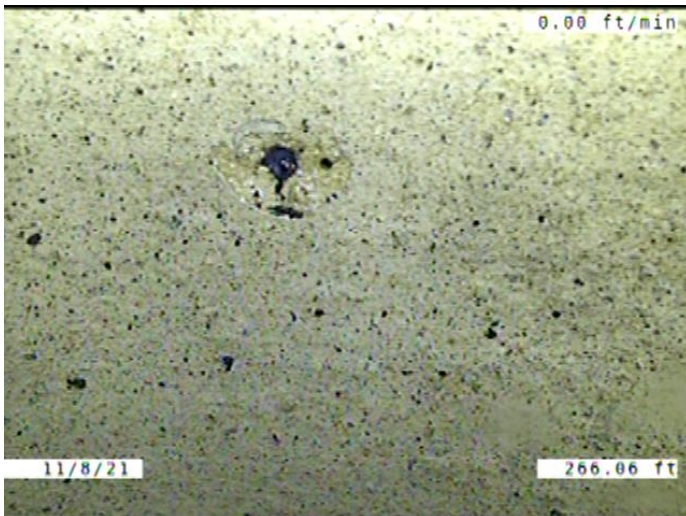
Code: **SSS**  
Description: **Surface Damage Surface Spalling**

Distance (ft): **266.1**  
Structural Grade: **2**  
O&M Grade: **0**  
Clock Start/From: **2**  
Clock To:  
1st Value:  
2nd Value:  
Value Percent:  
Continuous Index:  
Within 8" of Joint: **NO**  
Remarks:

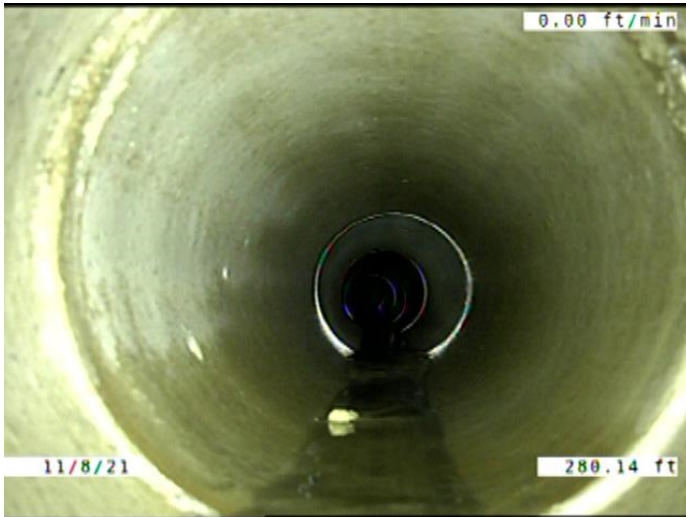
Code: **MWL**  
 Description: **Miscellaneous Water Level**

Distance (ft): **280.1**  
 Structural Grade: **0**  
 O&M Grade: **0**  
 Clock Start/From:  
 Clock To:  
 1st Value:  
 2nd Value:  
 Value Percent: **5.000**  
 Continuous Index:  
 Within 8" of Joint: **NO**  
 Remarks:

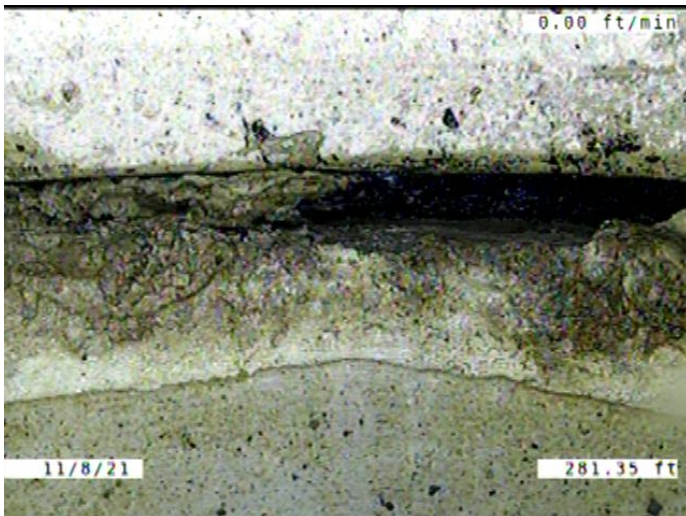
Code: **DAE**  
 Description: **Deposits Attached Encrustation**

Distance (ft): **281.3**  
 Structural Grade: **0**  
 O&M Grade: **2**  
 Clock Start/From: **8**  
 Clock To: **4**  
 1st Value:  
 2nd Value:  
 Value Percent: **5.000**  
 Continuous Index: **S06**  
 Within 8" of Joint: **YES**  
 Remarks:

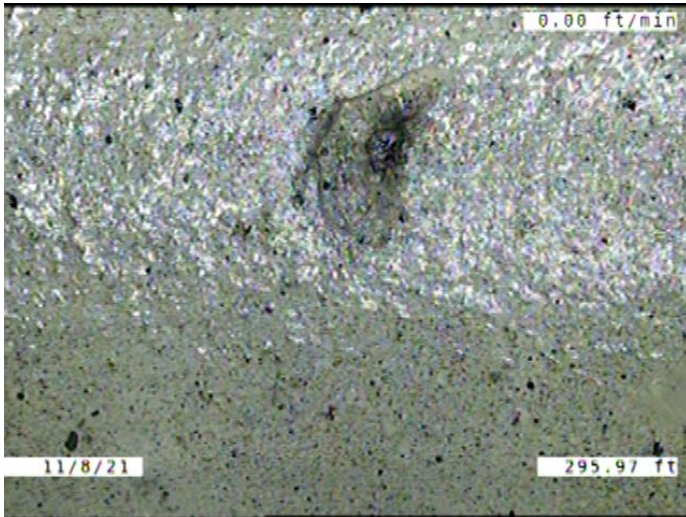
Code: **SSS**  
 Description: **Surface Damage Surface Spalling**

Distance (ft): **296.0**  
 Structural Grade: **2**  
 O&M Grade: **0**  
 Clock Start/From: **1**  
 Clock To:  
 1st Value:  
 2nd Value:  
 Value Percent:  
 Continuous Index:  
 Within 8" of Joint: **NO**  
 Remarks:

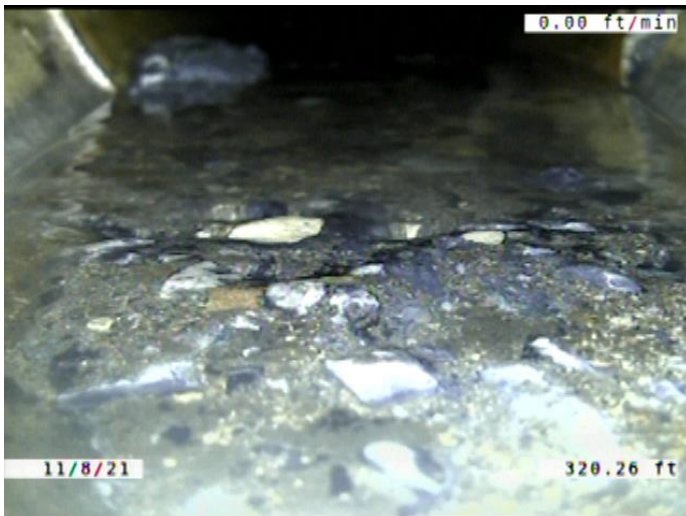
Code: **DSC**  
 Description: **Deposits Settled Hard/Compacted**

Distance (ft): **320.3**  
 Structural Grade: **0**  
 O&M Grade: **2**  
 Clock Start/From: **5**  
 Clock To: **7**  
 1st Value:  
 2nd Value:  
 Value Percent: **5.000**  
 Continuous Index:  
 Within 8" of Joint: **YES**  
 Remarks:
