Profile/Photo Observation Report

Date:	04/22/2018	Weather:		Coding:	PACP 6.0
Pipe Length (ft):	257.5	Owner:	NA	Pre Clean:	No Pre-Cleaning
P.O.#:		Surveyor:	Jen Costello	PSR:	P-505-069-070
Customer:		Clean Date:	01/01/1900	Shape:	C

Street:	S WILSON ST	Flow Control:	Not Controlled
City:	Hobart, IN	Year Renewed:	
Location:	Light Highway	Tape/Media #:	
Purpose:	Routine Assessment	Dia/Height:	10"
Use:	Sanitary	Material:	VCP
Drain Area:	NA	Lining:	
Category:	NA		
Comment:	P_C at 16 ft debris / grit Flow direction wrong		
Location Details:		Direction of Survey:	Upstream
US MH:	M-505-070	DS MH:	M-505-069
		Total Length Surveyed (ft):	18.0

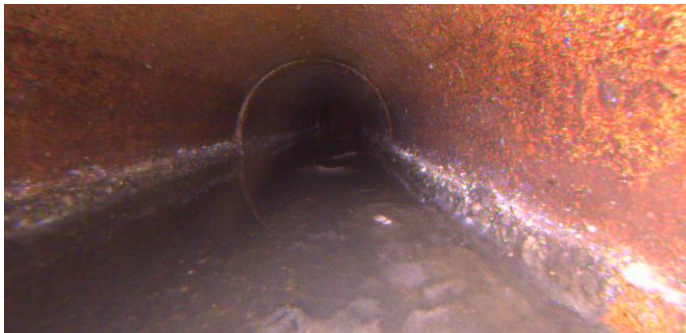
Code: **AMH**
Description: **Manhole**

Distance (ft):	.0
Structural Grade:	0
O&M Grade:	0
Clock Start/From:	
Clock To:	
1st Value:	
2nd Value:	
Value Percent:	
Continuous Index:	
Within 8" of Joint:	NO
Remarks:	M-505-069

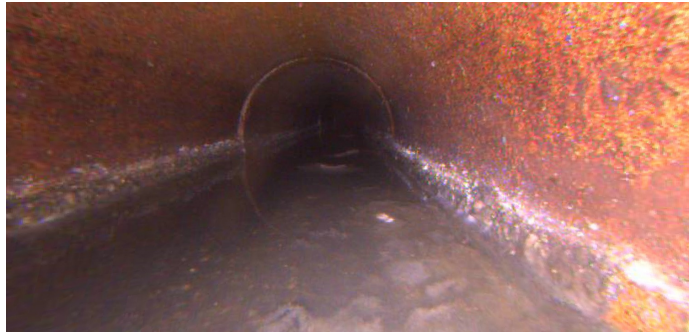
Code: **MWL**
Description: **Water Level**

Distance (ft): **.0**
Structural Grade: **0**
O&M Grade: **0**
Clock Start/From:
Clock To:
1st Value:
2nd Value:
Value Percent: **30.000**
Continuous Index:
Within 8" of Joint: **NO**
Remarks:

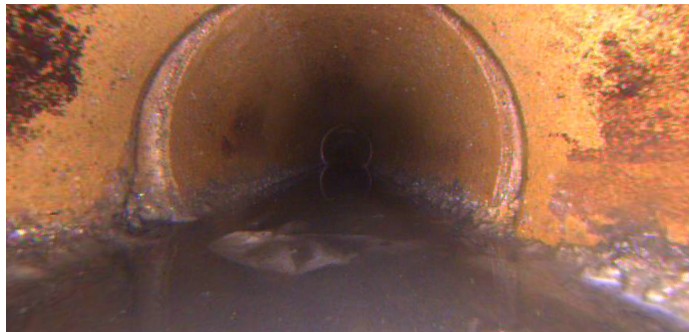
Code: **MSA**
Description: **Abandoned Survey**

Distance (ft): **18.0**
Structural Grade: **0**
O&M Grade: **0**
Clock Start/From:
Clock To:
1st Value:
2nd Value:
Value Percent:
Continuous Index:
Within 8" of Joint: **NO**
Remarks: **debris under water**
