Profile/Photo Observation Report

Date:	04/22/2018	Weather:		Coding:	PACP 6.0
Pipe Length (ft):	257.5	Owner:	NA	Pre Clean:	No Pre-Cleaning
P.O.#:		Surveyor:	Jen Costello	PSR:	P-505-069-070
Customer:		Clean Date:	01/01/1900	Shape:	C

Street:	FOXCROFT STREET	Flow Control:	Not Controlled
City:	Hobart, IN	Year Renewed:	
Location:	Light Highway	Tape/Media #:	
Purpose:	Routine Assessment	Dia/Height:	10"
Use:	Sanitary	Material:	VCP
Drain Area:	NA	Lining:	
Category:	NA		
Comment:	P_C at 16 ft debris / grit Flow direction wrong		
Location Details:		Direction of Survey:	Upstream
US MH:	M-505-070	DS MH:	M-505-069
		Total Length Surveyed (ft):	18.0

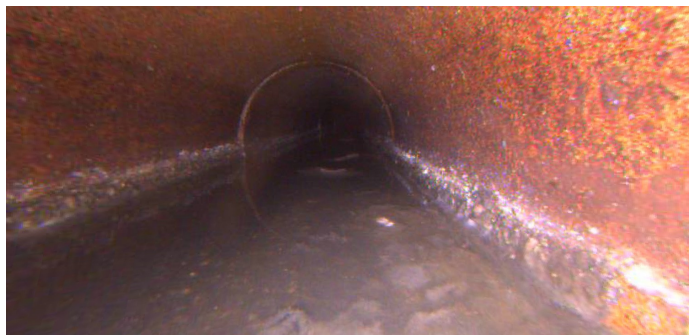
Code: **AMH**
Description: **Manhole**

Distance (ft): **.0**
Structural Grade: **0**
O&M Grade: **0**
Clock Start/From:
Clock To:
1st Value:
2nd Value:
Value Percent:
Continuous Index:
Within 8" of Joint: **NO**
Remarks: **M-505-069**

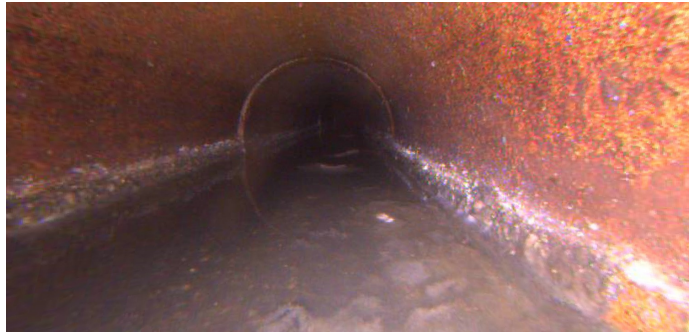
Code: **MWL**
Description: **Water Level**

Distance (ft): **.0**
Structural Grade: **0**
O&M Grade: **0**
Clock Start/From:
Clock To:
1st Value:
2nd Value:
Value Percent: **30.000**
Continuous Index:
Within 8" of Joint: **NO**
Remarks:

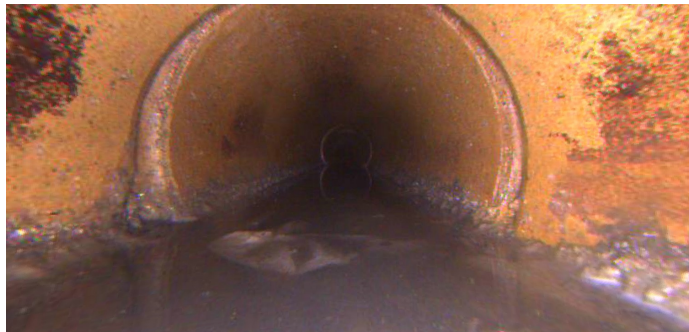
Code: **MSA**
Description: **Abandoned Survey**

Distance (ft): **18.0**
Structural Grade: **0**
O&M Grade: **0**
Clock Start/From:
Clock To:
1st Value:
2nd Value:
Value Percent:
Continuous Index:
Within 8" of Joint: **NO**
Remarks: **debris under water**
