## **Profile/Photo Observation Report**

Date: 11/07/2021 Weather: **PACP 7.0** Coding: Pipe Length (ft): 260.2 Owner: **City of Hobart** Pre Clean: **Heavy Cleaning** P.O.#: YES502259 Steven Bucklin PSR: P-505-069-070 Surveyor:

Street: West 1st Place Flow Control: Not Controlled

US MH: M-505-070 DS MH: M-505-069 Total Length Surveyed (ft): 260.2

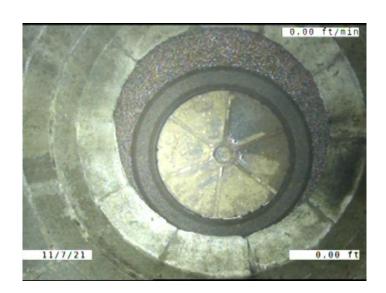
Code: AMH
Description: Manhole

Remarks: M-505-070

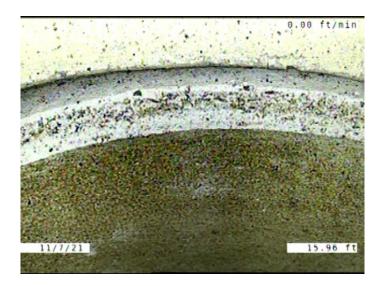
Code: **JOM**

Description: Joint Offset Medium

Distance (ft): 16.0
Structural Grade: 3
O&M Grade: 0

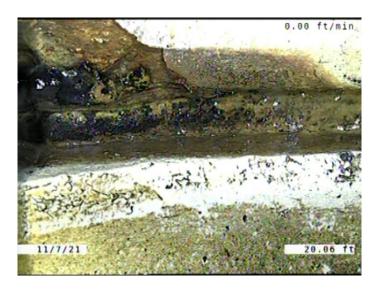
Code: ISJ

Description: Infiltration Stain Joint

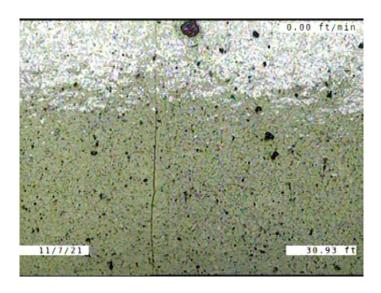
Code: CL

Description: Crack Longitudinal

Distance (ft): 30.9
Structural Grade: 2
O&M Grade: 0
Clock Start/From: 12
Clock To:
1st Value:

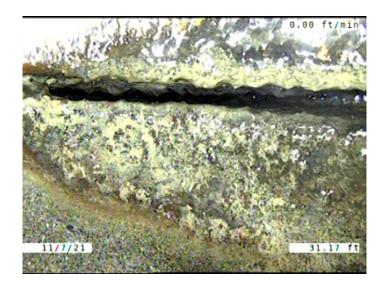
Code: DAE

Description: Deposits Attached Encrustation

Distance (ft): 31.2
Structural Grade: 0

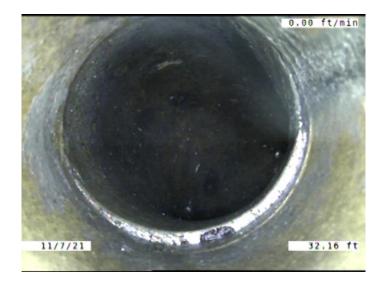
Code: **TF**

Description: Tap Factory

Distance (ft): 32.2
Structural Grade: 0
O&M Grade: 0
Clock Start/From: 1

Remarks: CONSTANTLY RUNNING WATER.

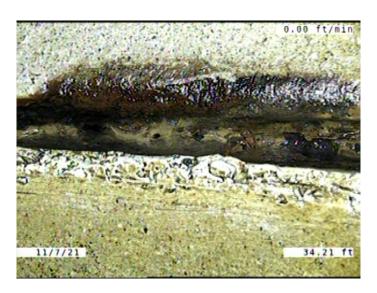
Code: DAE

Description: Deposits Attached Encrustation

Distance (ft): 34.2
Structural Grade: 0

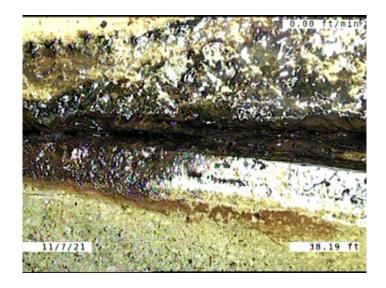
Code: DAE

Description: Deposits Attached Encrustation

Distance (ft): 38.2
Structural Grade: 0
O&M Grade: 2
Clock Start/From: 9
Clock To: 3

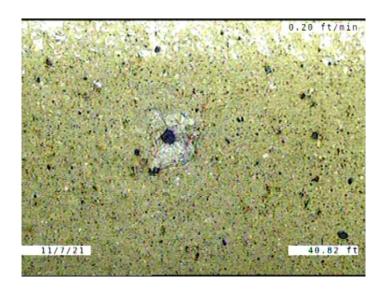
Code: SSS

Description: Surface Damage Surface Spalling

Distance (ft): 40.8
Structural Grade: 2
O&M Grade: 0
Clock Start/From: 1
Clock To:
1st Value:
2nd Value:

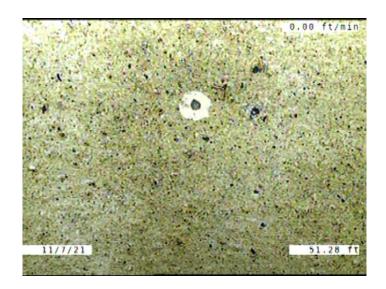
Code: SSS

Description: Surface Damage Surface Spalling

Distance (ft): 51.3
Structural Grade: 2
O&M Grade: 0
Clock Start/From: 1

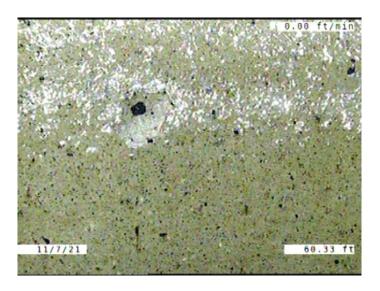
Code: SSS

Description: Surface Damage Surface Spalling

Distance (ft): 60.3
Structural Grade: 2
O&M Grade: 0
Clock Start/From: 11
Clock To:

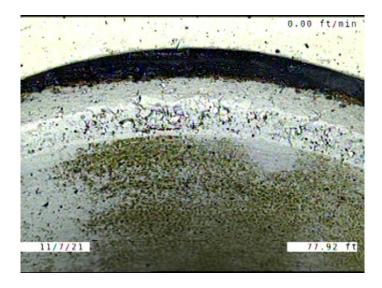
Code: **JOM**

Description: Joint Offset Medium

Distance (ft): 77.9
Structural Grade: 3
O&M Grade: 0

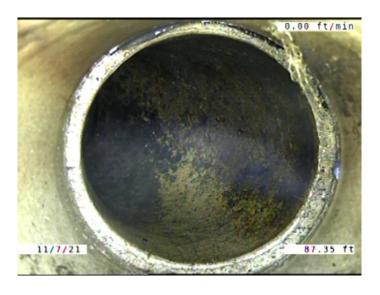
Code: **TF**

Description: Tap Factory

Distance (ft): 87.3
Structural Grade: 0

Remarks: ROOTS GROWING INTO THE MAIN

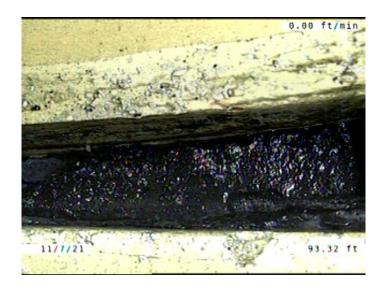
Code: JAM

Description: Joint Angular Medium

Distance (ft): 93.3 Structural Grade: 3 0 O&M Grade:

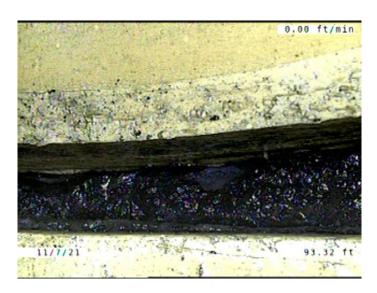
Code: IWJ

Description: **Infiltration Weeper Joint**

Distance (ft): 93.3 Structural Grade: 0 O&M Grade: 2 Clock Start/From: 10 Clock To:

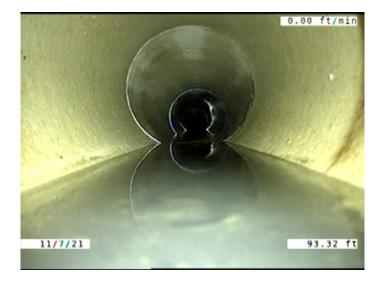
Code: **DSF**

Description: Deposits Settled Fine

Distance (ft): 93.3
Structural Grade: 0
O&M Grade: 2
Clock Start/From: 5
Clock To: 7

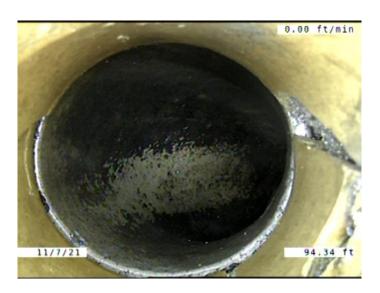
Code: **TFD**

Description: Tap Factory Defective

Distance (ft): 94.3
Structural Grade: 0

Remarks: BROKEN. SOIL VISIBLE

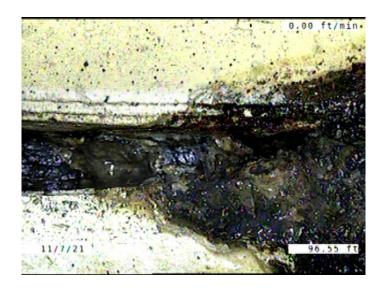
Code: DAE

Description: **Deposits Attached Encrustation**

Distance (ft): 96.5 Structural Grade: 0 2 O&M Grade: Clock Start/From: 2 Clock To: 5

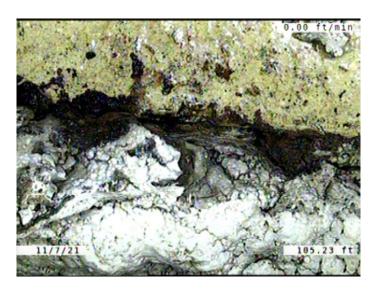
Code: DAE

Description: **Deposits Attached Encrustation**

Distance (ft): 105.2 Structural Grade: 0 O&M Grade: 2 Clock Start/From: 8 Clock To: 1st Value:

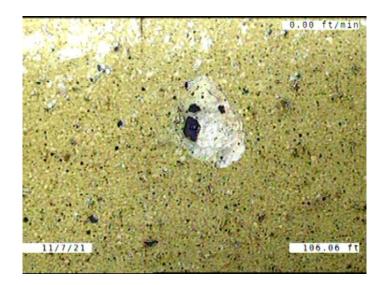
Code: SSS

Description: Surface Damage Surface Spalling

Distance (ft): 106.1
Structural Grade: 2
O&M Grade: 0
Clock Start/From: 9

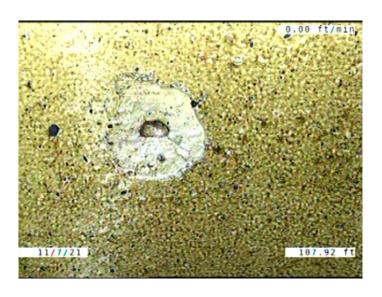
Code: SSS

Description: Surface Damage Surface Spalling

Distance (ft): 107.9
Structural Grade: 2
O&M Grade: 0
Clock Start/From: 8
Clock To: 9
1st Value:
2nd Value:
Value Percent:
Continuous Index:

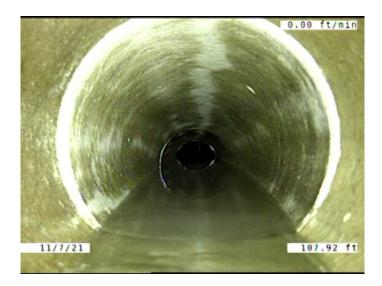
Code: MWLS

Description: Miscellaneous Water Level Sag

Distance (ft): 107.9
Structural Grade: 3
O&M Grade: 0

Value Percent: 50.000
Continuous Index: S01
Within 8" of Joint: NO

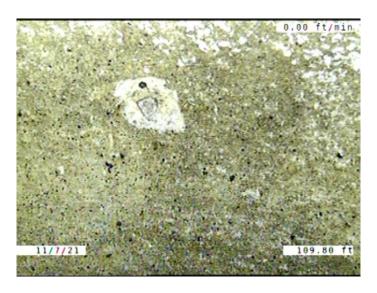
Code: SSS

Description: Surface Damage Surface Spalling

Distance (ft): 109.8
Structural Grade: 2
O&M Grade: 0
Clock Start/From: 1

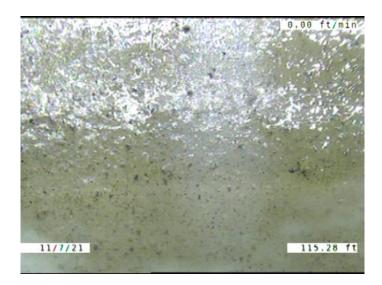
Code: MCU

Description: Miscellaneous Camera Underwater

Distance (ft): 115.3
Structural Grade: 0
O&M Grade: 4

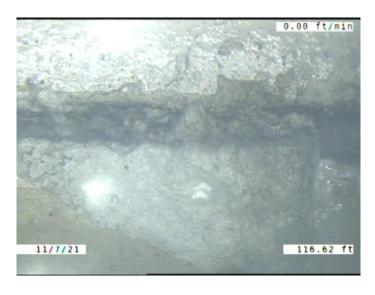
Code: DAE

Description: Deposits Attached Encrustation

Distance (ft): 116.6
Structural Grade: 0
O&M Grade: 2
Clock Start/From: 10
Clock To: 2
1st Value:

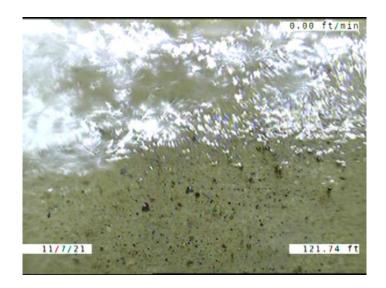
Code: MCU

Description: Miscellaneous Camera Underwater

Distance (ft): 121.7
Structural Grade: 0
O&M Grade: 4

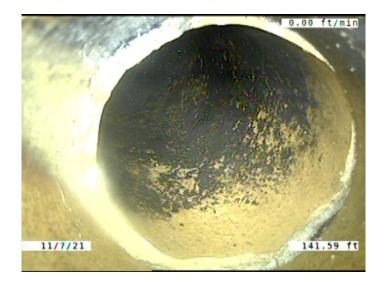
Code: **TF**

Description: Tap Factory

Distance (ft): 141.6
Structural Grade: 0
O&M Grade: 0
Clock Start/From: 11

Remarks: CONSTANTLY RUNNING WATER. FIRST JOINT BACK BROKEN

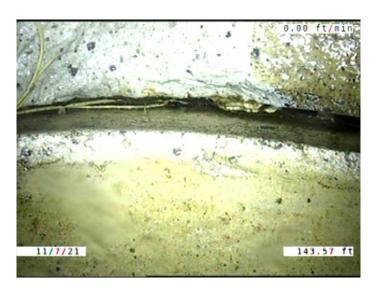
Code: DAE

Description: Deposits Attached Encrustation

Distance (ft): 143.6
Structural Grade: 0
O&M Grade: 2
Clock Start/From: 8
Clock To: 4
1st Value:

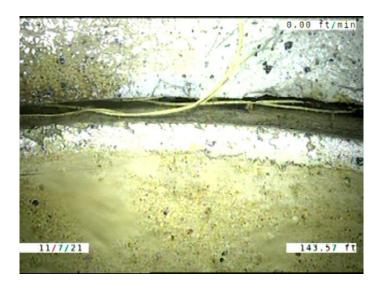
Code: RFJ

Description: **Roots Fine Joint**

Distance (ft): 143.6 Structural Grade: 0 O&M Grade: 1 Clock Start/From: 11 1

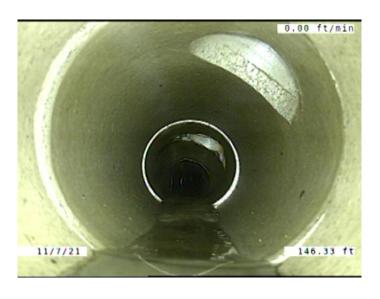
Code: **MWLS**

Description: **Miscellaneous Water Level Sag**

Distance (ft): 146.3 Structural Grade: 3 O&M Grade: 0

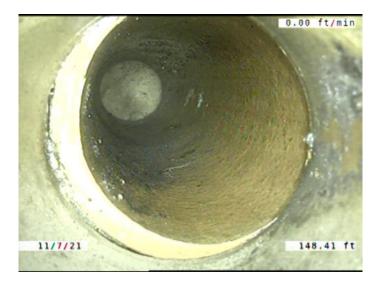
Code: **TFC**

Description: Tap Factory Capped

Remarks: OFFSET

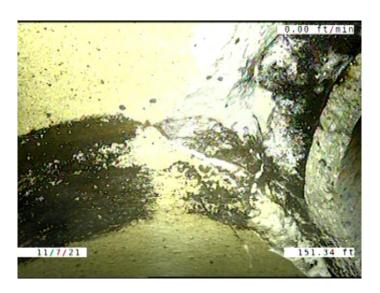
Code: ISC

Description: Infiltration Stain Connection

Distance (ft): 151.3
Structural Grade: 0
O&M Grade: 1
Clock Start/From: 9
Clock To: 5
1st Value:
2nd Value:
Value Percent:
Continuous Index:

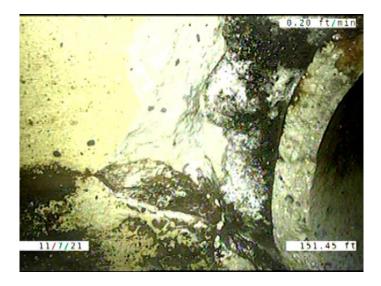
Code: B
Description: Broken

Distance (ft): 151.4 Structural Grade: 4 O&M Grade: 0 Clock Start/From: 11 Clock To: 2 1st Value: 2nd Value: Value Percent: Continuous Index: Within 8" of Joint: YES

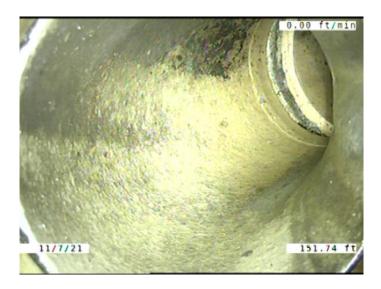
Code: TBI

Description: Tap Break-in Intruding

Distance (ft): 151.7
Structural Grade: 0
O&M Grade: 2
Clock Start/From: 1

Remarks: OFFSET. CONSTANTLY RUNNING

WATER.

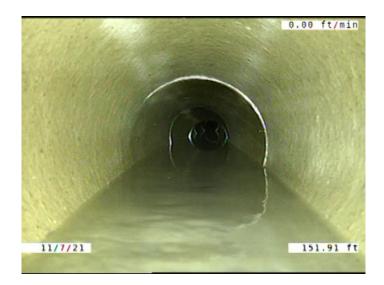
Code: MWLS

Description: Miscellaneous Water Level Sag

Distance (ft): 151.9
Structural Grade: 3
O&M Grade: 0

Value Percent: 35.000
Continuous Index: S03
Within 8" of Joint: NO

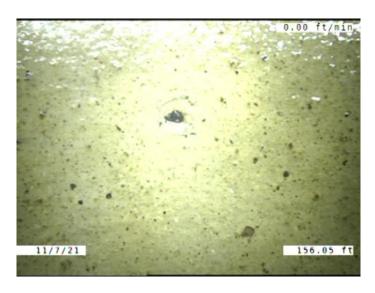
Code: SSS

Description: Surface Damage Surface Spalling

Distance (ft): 156.0
Structural Grade: 2
O&M Grade: 0
Clock Start/From: 12

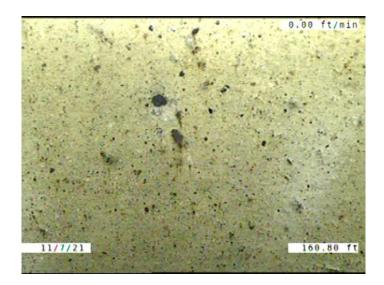
Code: SSS

Description: Surface Damage Surface Spalling

Distance (ft): 160.8
Structural Grade: 2
O&M Grade: 0
Clock Start/From: 12

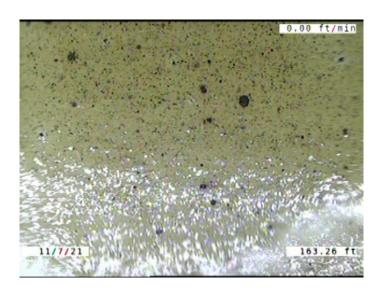
Code: MCU

Description: Miscellaneous Camera Underwater

Distance (ft): 163.3
Structural Grade: 0
O&M Grade: 4

Remarks: Out at 164.2

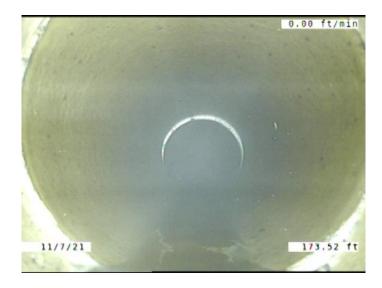
Code: **MWLS**

Description: **Miscellaneous Water Level Sag**

Distance (ft): 173.5 Structural Grade: 3 0 O&M Grade:

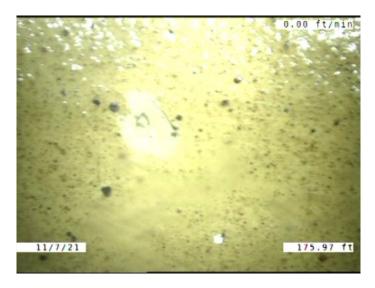
SSS Code:

Description: **Surface Damage Surface Spalling**

Distance (ft): 176.0 Structural Grade: 2 O&M Grade: 0 Clock Start/From: 2

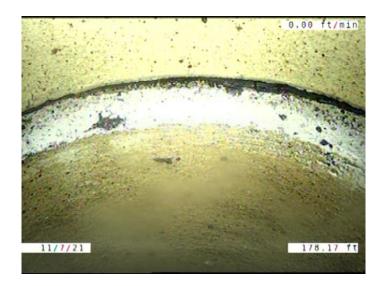
Code: **JOM**

Description: Joint Offset Medium

Distance (ft): 178.2
Structural Grade: 3
O&M Grade: 0

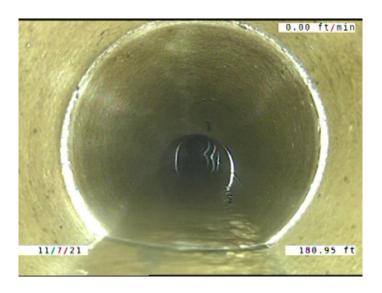
Code: MWLS

Description: Miscellaneous Water Level Sag

Distance (ft): 180.9
Structural Grade: 2
O&M Grade: 0

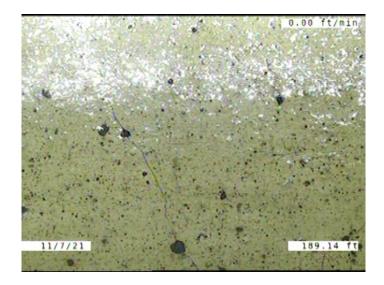
Code: CM
Description: Crack Multiple

Distance (ft): 189.1
Structural Grade: 3
O&M Grade: 0
Clock Start/From: 9
Clock To: 3
1st Value:
2nd Value:
Value Percent:

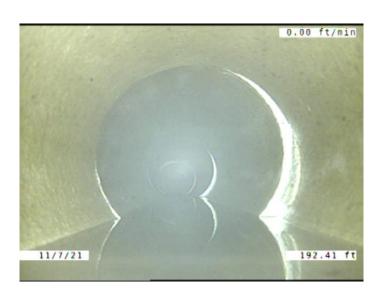
Code: CM

Description: Crack Multiple

Distance (ft): 192.4
Structural Grade: 3
O&M Grade: 0
Clock Start/From: 9
Clock To: 3
1st Value:
2nd Value:
Value Percent:
Continuous Index: F05

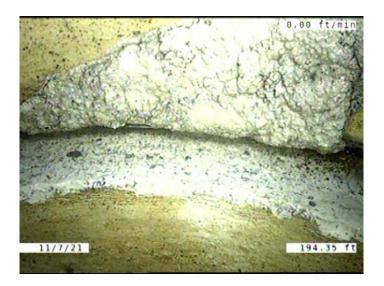
Code: DAE

Description: **Deposits Attached Encrustation**

Distance (ft): 194.4 Structural Grade: 0 2 O&M Grade: Clock Start/From: 2

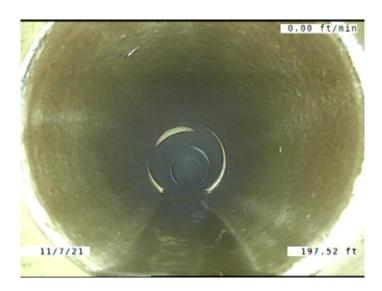
Code: **MWLS**

Description: **Miscellaneous Water Level Sag**

Distance (ft): 197.5 Structural Grade: 2 O&M Grade: 0

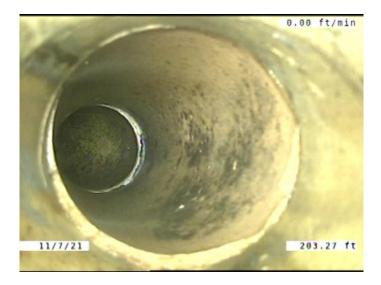
Code: **TF**

Description: Tap Factory

Distance (ft): 203.3
Structural Grade: 0
O&M Grade: 0
Clock Start/From: 11

Remarks: FIRST JOINT BACK BROKEN

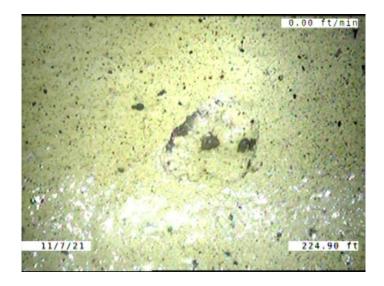
Code: SSS

Description: **Surface Damage Surface Spalling**

Distance (ft): 224.9 Structural Grade: 2 O&M Grade: 0 Clock Start/From: 7

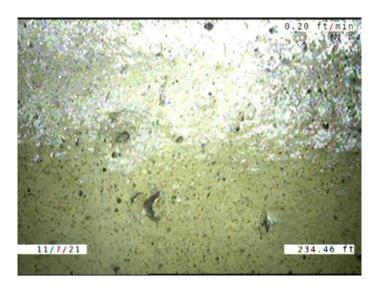
SSS Code:

Description: **Surface Damage Surface Spalling**

Distance (ft): 234.5 Structural Grade: 2 O&M Grade: 0 Clock Start/From: 11

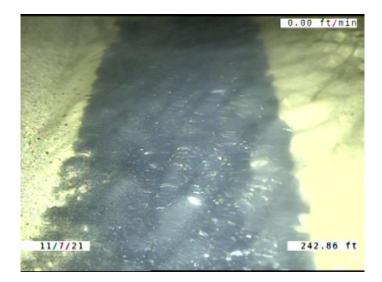
Code: SSS

Description: Surface Damage Surface Spalling

Distance (ft): 242.9
Structural Grade: 2
O&M Grade: 0
Clock Start/From: 6

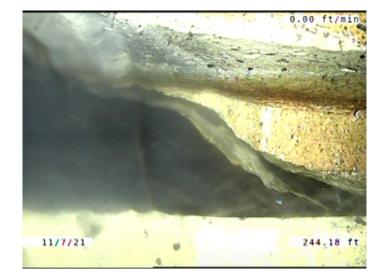
Code: BVV

Description: Broken Void Visible

Distance (ft): 244.2
Structural Grade: 5
O&M Grade: 0
Clock Start/From: 3
Clock To: 8

Remarks: OUTSIDE OF THE JOINT

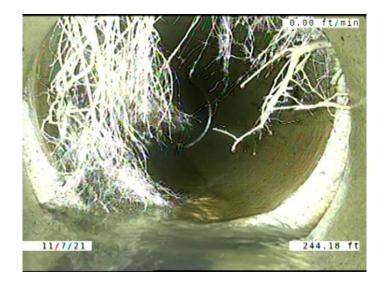
Code: **JOMD**

Description: Joint Offset Medium Defective

Distance (ft): 244.2
Structural Grade: 3
O&M Grade: 0

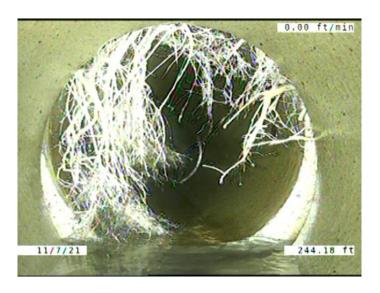
Code: RMJ

Description: Roots Medium Joint

Distance (ft): 244.2
Structural Grade: 0
O&M Grade: 3
Clock Start/From: 9
Clock To: 3
1st Value:

Value Percent: 20.000

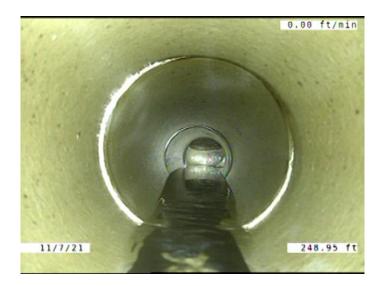
Code: **DSF**

Description: Deposits Settled Fine

Distance (ft): 248.9
Structural Grade: 0
O&M Grade: 2
Clock Start/From: 5
Clock To: 7

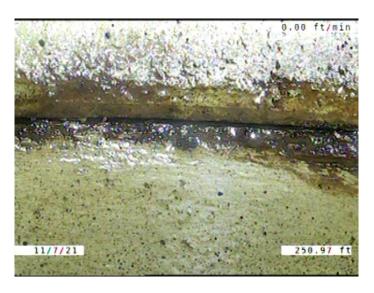
Code: IDJ

Description: Infiltration Dripper Joint

Distance (ft): 251.0
Structural Grade: 0
O&M Grade: 3
Clock Start/From: 1
Clock To:

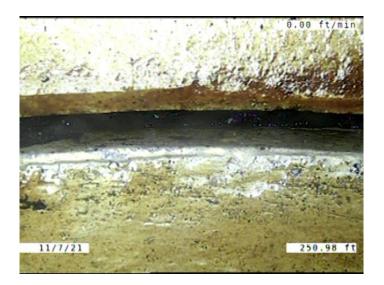
Code: ISJ

Description: **Infiltration Stain Joint**

Distance (ft): 251.0 Structural Grade: 0 O&M Grade: 1 Clock Start/From: 8 4

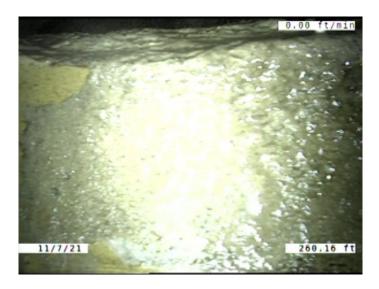
DSF Code:

Description: **Deposits Settled Fine**

Distance (ft): 260.2 Structural Grade: 0 O&M Grade: 2 Clock Start/From: 5 7 Clock To:
