Profile/Photo Observation Report

Date: 11/07/2021 Weather: **PACP 7.0** Coding: Pipe Length (ft): 260.2 Owner: **City of Hobart** Pre Clean: **Heavy Cleaning** P.O.#: YES502259 Surveyor: Steven Bucklin PSR: P-505-069-070

Street: West 1st Place Flow Control: Not Controlled

US MH: M-505-070 DS MH: M-505-069 Total Length Surveyed (ft): 260.2

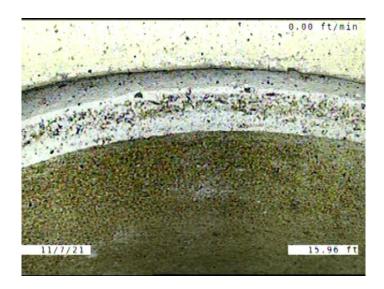
Code: JOM

Description: **Joint Offset Medium**

Distance (ft): 16.0 Structural Grade: 3 0 O&M Grade:

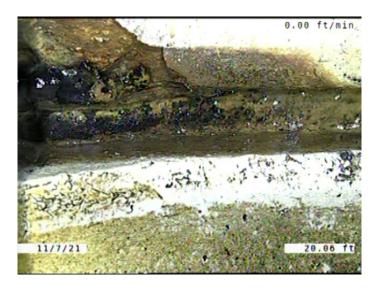
ISJ Code:

Description: **Infiltration Stain Joint**

Distance (ft): 20.1 Structural Grade: 0 O&M Grade: 1 Clock Start/From: 9 Clock To: 10 1st Value: 2nd Value: Value Percent: Continuous Index: Within 8" of Joint:

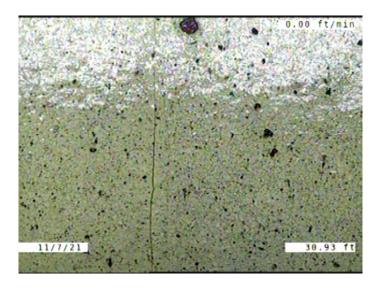
Code: CL

Description: Crack Longitudinal

Distance (ft): 30.9
Structural Grade: 2
O&M Grade: 0
Clock Start/From: 12
Clock To:
1st Value:

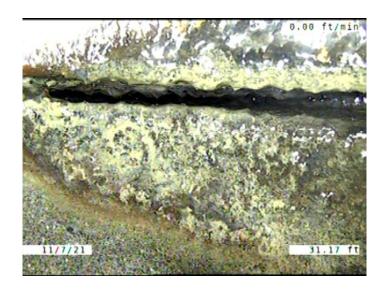
Code: DAE

Description: Deposits Attached Encrustation

Distance (ft): 31.2
Structural Grade: 0

O&M Grade: 2

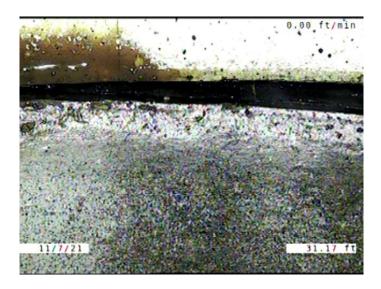
Code: IDJ

Description: Infiltration Dripper Joint

Distance (ft): 31.2
Structural Grade: 0
O&M Grade: 3
Clock Start/From: 12
Clock To:
1st Value:
2nd Value:

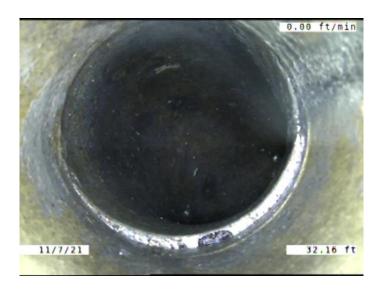
Code: **TF**

Description: Tap Factory

Distance (ft): 32.2
Structural Grade: 0
O&M Grade: 0
Clock Start/From: 1

Remarks: CONSTANTLY RUNNING WATER.

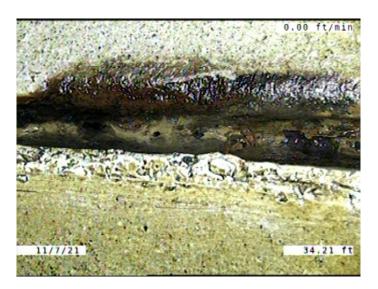
Code: DAE

Description: Deposits Attached Encrustation

Distance (ft): 34.2
Structural Grade: 0
O&M Grade: 2
Clock Start/From: 1
Clock To: 3
1st Value:

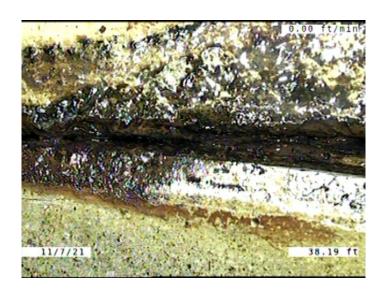
Code: DAE

Description: Deposits Attached Encrustation

Distance (ft): 38.2
Structural Grade: 0
O&M Grade: 2
Clock Start/From: 9
Clock To: 3

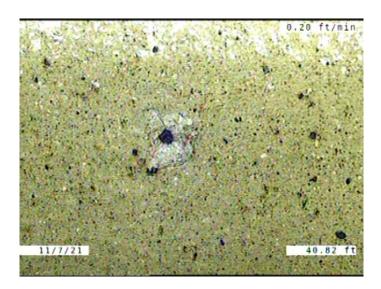
Code: SSS

Description: Surface Damage Surface Spalling

Distance (ft): 40.8
Structural Grade: 2

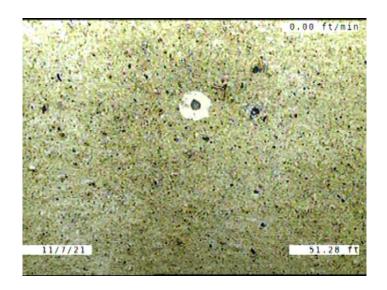
Code: SSS

Description: Surface Damage Surface Spalling

Distance (ft): 51.3
Structural Grade: 2
O&M Grade: 0
Clock Start/From: 1

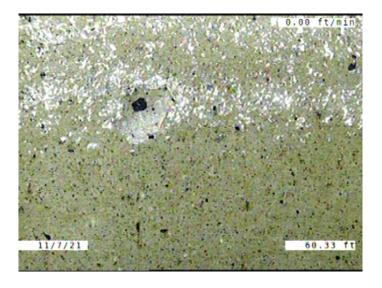
Code: SSS

Description: Surface Damage Surface Spalling

Distance (ft): 60.3
Structural Grade: 2
O&M Grade: 0
Clock Start/From: 11
Clock To:
1st Value:

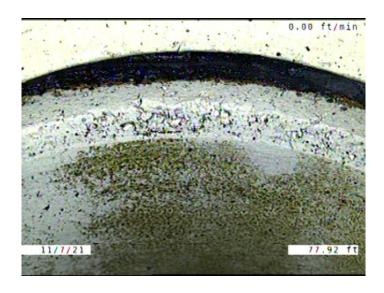
Code: **JOM**

Description: Joint Offset Medium

Distance (ft): 77.9
Structural Grade: 3
O&M Grade: 0

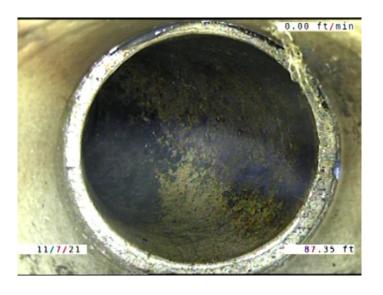
Code: TF

Description: Tap Factory

Distance (ft): 87.3
Structural Grade: 0

Remarks: ROOTS GROWING INTO THE MAIN

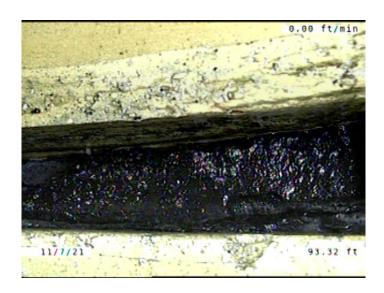
Code: JAM

Description: Joint Angular Medium

Distance (ft): 93.3
Structural Grade: 3
O&M Grade: 0

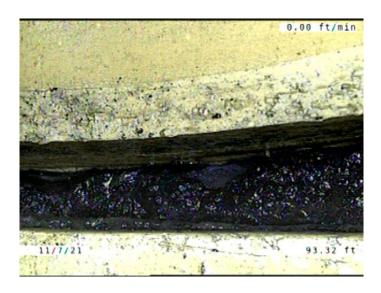
Code: IWJ

Description: Infiltration Weeper Joint

Distance (ft): 93.3
Structural Grade: 0
O&M Grade: 2
Clock Start/From: 10
Clock To:

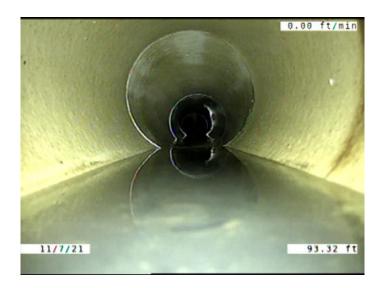
Code: **DSF**

Description: Deposits Settled Fine

Distance (ft): 93.3
Structural Grade: 0
O&M Grade: 2
Clock Start/From: 5
Clock To: 7

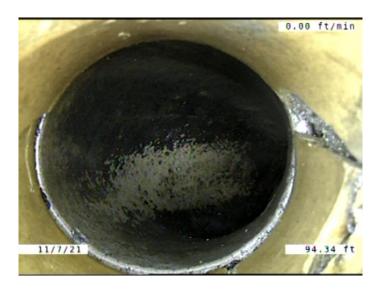
Code: **TFD**

Description: Tap Factory Defective

Distance (ft): 94.3
Structural Grade: 0

O&M Grade: 3

Remarks: BROKEN. SOIL VISIBLE

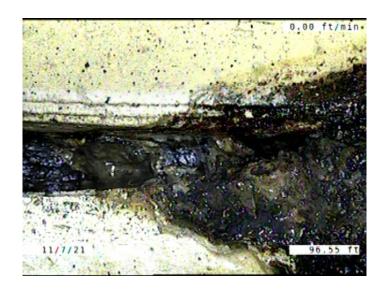
Code: DAE

Description: Deposits Attached Encrustation

Distance (ft): 96.5
Structural Grade: 0
O&M Grade: 2
Clock Start/From: 2
Clock To: 5

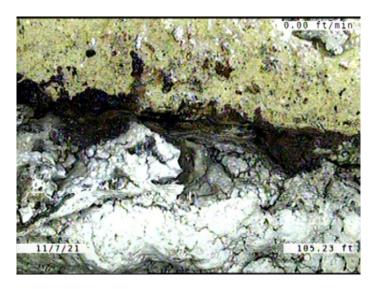
Code: DAE

Description: Deposits Attached Encrustation

Distance (ft): 105.2
Structural Grade: 0
O&M Grade: 2
Clock Start/From: 8
Clock To: 4
1st Value:
2nd Value:

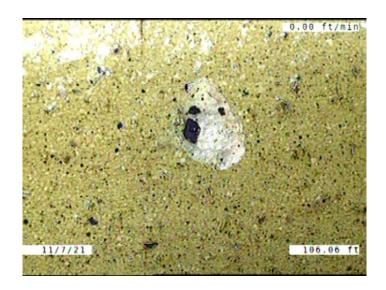
Code: SSS

Description: Surface Damage Surface Spalling

Distance (ft): 106.1
Structural Grade: 2
O&M Grade: 0
Clock Start/From: 9

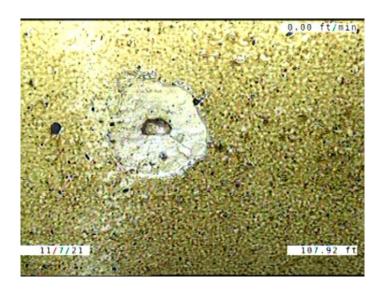
Code: SSS

Description: Surface Damage Surface Spalling

107.9 Distance (ft): Structural Grade: 2 O&M Grade: 0 Clock Start/From: 8 9 Clock To: 1st Value: 2nd Value: Value Percent: Continuous Index: Within 8" of Joint: NO

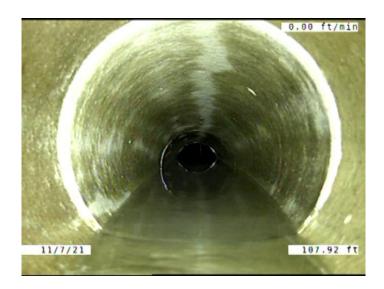
Code: MWLS

Description: Miscellaneous Water Level Sag

Distance (ft): 107.9
Structural Grade: 3
O&M Grade: 0

Value Percent: 50.000
Continuous Index: S01
Within 8" of Joint: NO

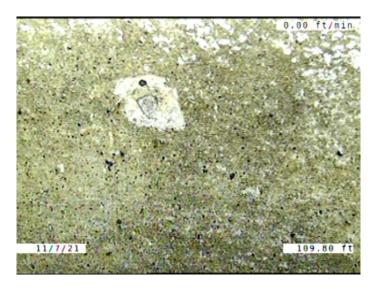
Code: SSS

Description: Surface Damage Surface Spalling

Distance (ft): 109.8
Structural Grade: 2
O&M Grade: 0
Clock Start/From: 1

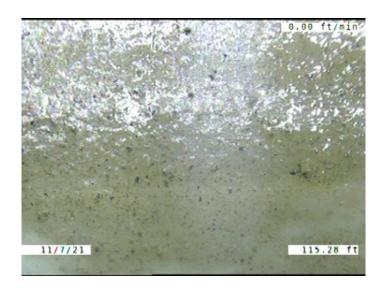
Code: MCU

Description: Miscellaneous Camera Underwater

Distance (ft): 115.3
Structural Grade: 0
O&M Grade: 4

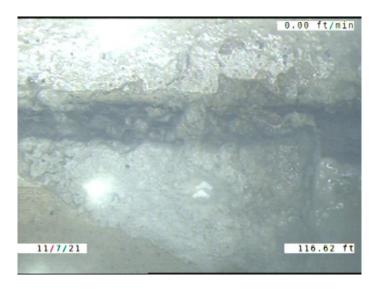
Code: DAE

Description: Deposits Attached Encrustation

Distance (ft): 116.6
Structural Grade: 0
O&M Grade: 2
Clock Start/From: 10
Clock To: 2
1st Value:

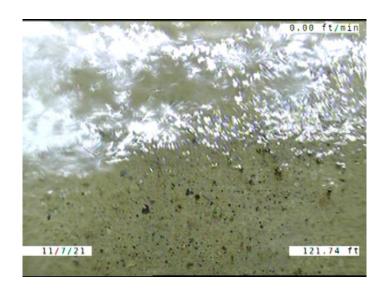
Code: MCU

Description: Miscellaneous Camera Underwater

Distance (ft): 121.7
Structural Grade: 0
O&M Grade: 4

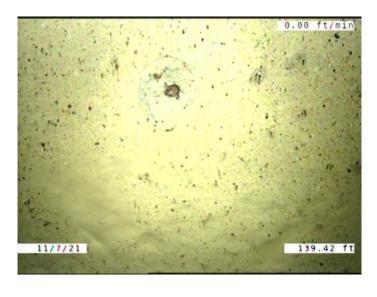
Code: SSS

Description: Surface Damage Surface Spalling

Distance (ft): 139.4
Structural Grade: 2
O&M Grade: 0
Clock Start/From: 12

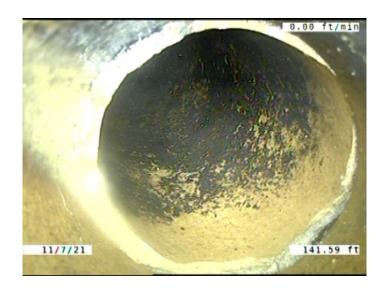
Code: **TF**

Description: Tap Factory

Distance (ft): 141.6
Structural Grade: 0
O&M Grade: 0
Clock Start/From: 11

Remarks: **CONSTANTLY RUNNING WATER.**

FIRST JOINT BACK BROKEN

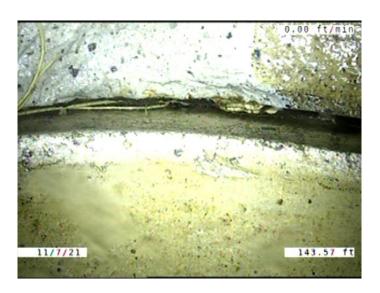
Code: DAE

Description: Deposits Attached Encrustation

Distance (ft): 143.6
Structural Grade: 0
O&M Grade: 2
Clock Start/From: 8
Clock To: 4
1st Value:

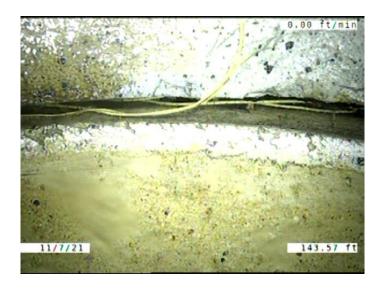
Code: RFJ

Description: **Roots Fine Joint**

Distance (ft): 143.6 Structural Grade: 0 O&M Grade: 1 Clock Start/From: 11 Clock To: 1

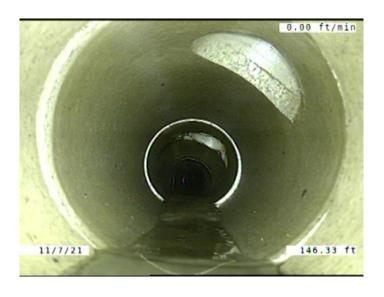
Code: **MWLS**

Description: **Miscellaneous Water Level Sag**

Distance (ft): 146.3 Structural Grade: 3 O&M Grade: 0

Value Percent: 50.000 Continuous Index: F01 Within 8" of Joint: NO

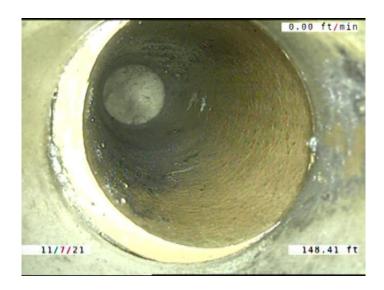
Code: TFC

Description: Tap Factory Capped

Distance (ft): 148.4
Structural Grade: 0
O&M Grade: 0
Clock Start/From: 1

Remarks: OFFSET

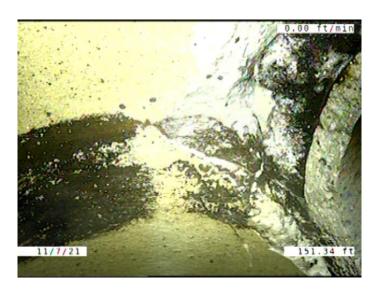
Code: ISC

Description: Infiltration Stain Connection

Distance (ft): 151.3

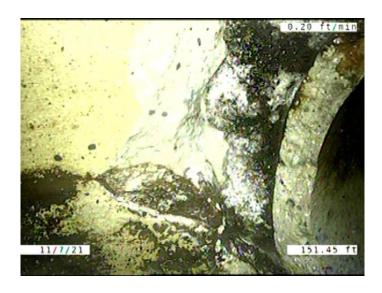
Code: B
Description: Broken

Distance (ft): 151.4 Structural Grade: 4 O&M Grade: 0 Clock Start/From: 11 Clock To: 2 1st Value: 2nd Value: Value Percent: Continuous Index: Within 8" of Joint: YES

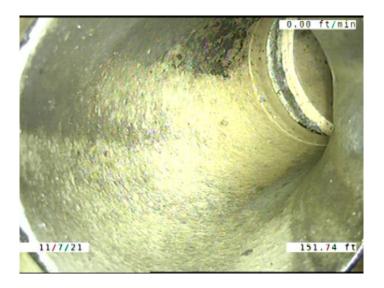
Code: TBI

Description: Tap Break-in Intruding

Distance (ft): 151.7
Structural Grade: 0
O&M Grade: 2
Clock Start/From: 1

Remarks: OFFSET. CONSTANTLY RUNNING

WATER.

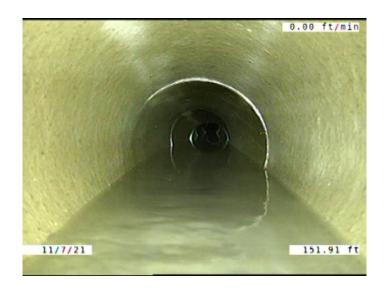
Code: MWLS

Description: Miscellaneous Water Level Sag

Distance (ft): 151.9
Structural Grade: 3
O&M Grade: 0

Value Percent: 35.000
Continuous Index: S03
Within 8" of Joint: NO

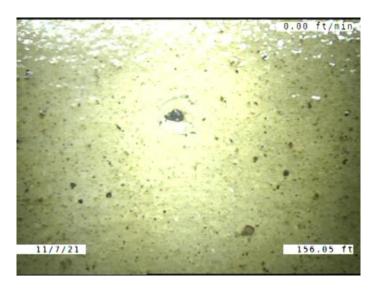
Code: SSS

Description: Surface Damage Surface Spalling

Distance (ft): 156.0
Structural Grade: 2
O&M Grade: 0
Clock Start/From: 12

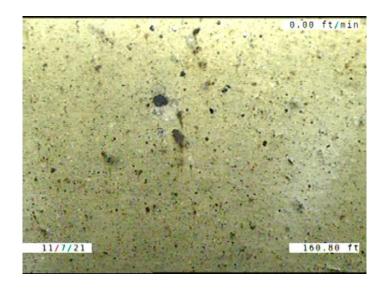
Code: SSS

Description: Surface Damage Surface Spalling

Distance (ft): 160.8
Structural Grade: 2
O&M Grade: 0
Clock Start/From: 12

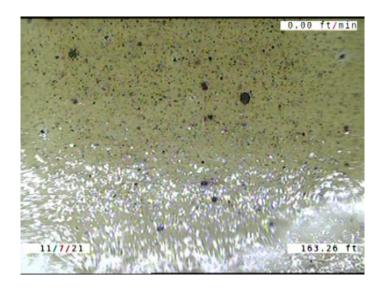
Code: MCU

Description: Miscellaneous Camera Underwater

Distance (ft): 163.3
Structural Grade: 0
O&M Grade: 4

Remarks: Out at 164.2

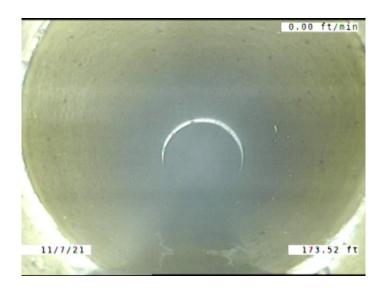
Code: MWLS

Description: Miscellaneous Water Level Sag

Distance (ft): 173.5
Structural Grade: 3
O&M Grade: 0

Value Percent: 35.000
Continuous Index: F03
Within 8" of Joint: NO

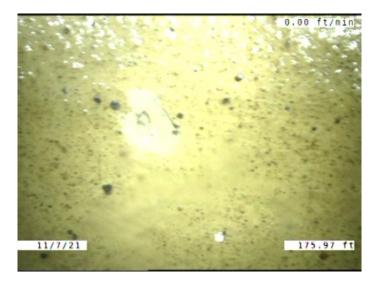
Code: SSS

Description: Surface Damage Surface Spalling

Distance (ft): 176.0
Structural Grade: 2
O&M Grade: 0
Clock Start/From: 2

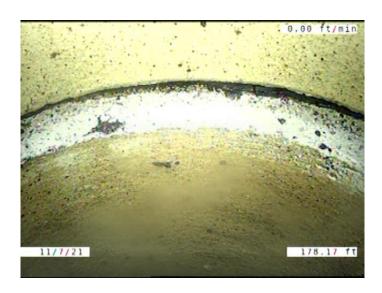
Code: JOM

Description: **Joint Offset Medium**

Distance (ft): 178.2 Structural Grade: 3 0 O&M Grade:

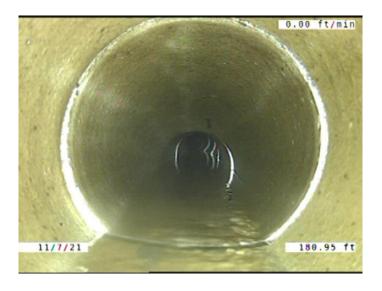
Code: **MWLS**

Description: **Miscellaneous Water Level Sag**

Distance (ft): 180.9 Structural Grade: 2 O&M Grade: 0

Value Percent: 15.000 Continuous Index: **S04** Within 8" of Joint: NO

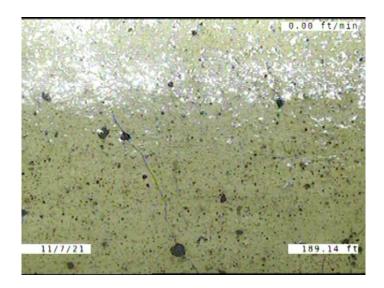
Code: CM
Description: Crack Multiple

Distance (ft): 189.1
Structural Grade: 3
O&M Grade: 0
Clock Start/From: 9
Clock To: 3
1st Value:
2nd Value:

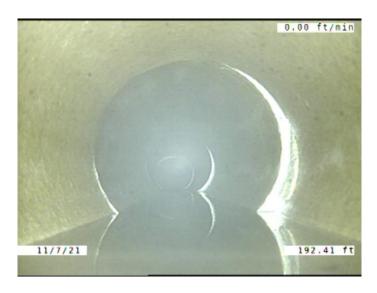
Code: CM

Description: Crack Multiple

Distance (ft): 192.4
Structural Grade: 3
O&M Grade: 0
Clock Start/From: 9
Clock To: 3
1st Value:
2nd Value:
Value Percent:
Continuous Index: F05

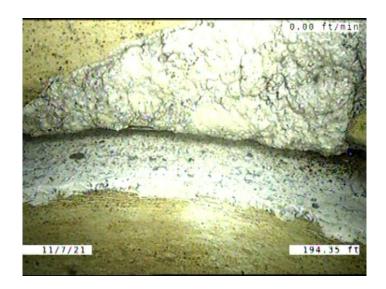
Code: DAE

Description: Deposits Attached Encrustation

Distance (ft): 194.4
Structural Grade: 0
O&M Grade: 2
Clock Start/From: 2

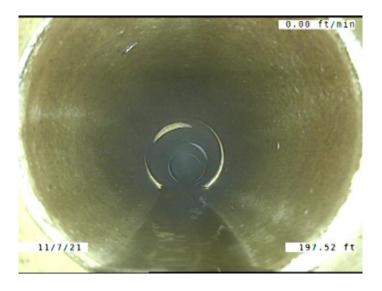
Code: MWLS

Description: Miscellaneous Water Level Sag

Distance (ft): 197.5
Structural Grade: 2
O&M Grade: 0

Value Percent: 15.000
Continuous Index: F04
Within 8" of Joint: NO

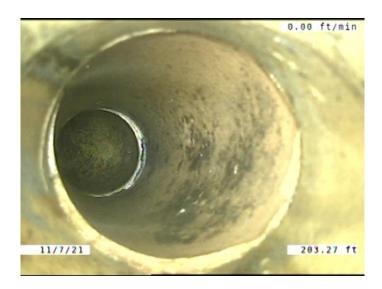
Code: **TF**

Description: Tap Factory

Distance (ft): 203.3
Structural Grade: 0
O&M Grade: 0
Clock Start/From: 11

Remarks: FIRST JOINT BACK BROKEN

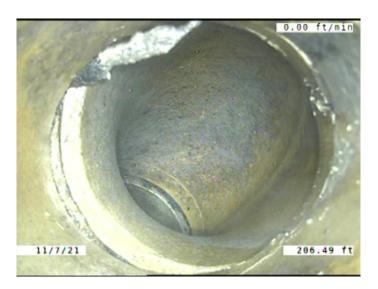
Code: **TFD**

Description: Tap Factory Defective

Distance (ft): 206.5
Structural Grade: 0
O&M Grade: 3
Clock Start/From: 1

Remarks: OFFSET. BROKEN. ROOTS GROWING

IN THE JOINT

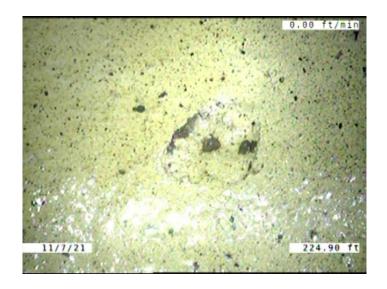
Code: SSS

Description: Surface Damage Surface Spalling

Distance (ft): 224.9
Structural Grade: 2
O&M Grade: 0
Clock Start/From: 7

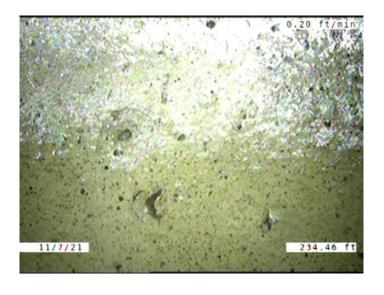
Code: SSS

Description: Surface Damage Surface Spalling

Distance (ft): 234.5
Structural Grade: 2
O&M Grade: 0
Clock Start/From: 11

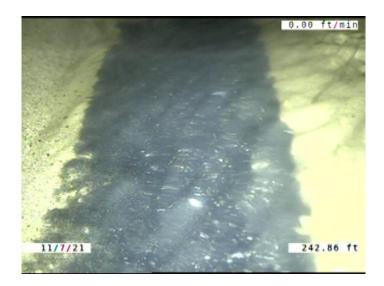
Code: SSS

Description: Surface Damage Surface Spalling

Distance (ft): 242.9
Structural Grade: 2
O&M Grade: 0
Clock Start/From: 6
Clock To: 7

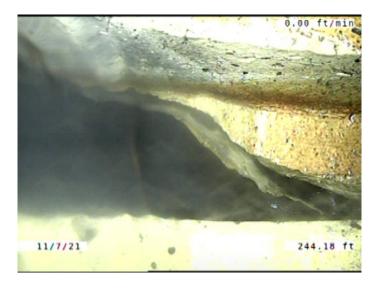
Code: **BVV**

Description: Broken Void Visible

Distance (ft): 244.2
Structural Grade: 5
O&M Grade: 0
Clock Start/From: 3
Clock To: 8
1st Value:
2nd Value:

Remarks: OUTSIDE OF THE JOINT

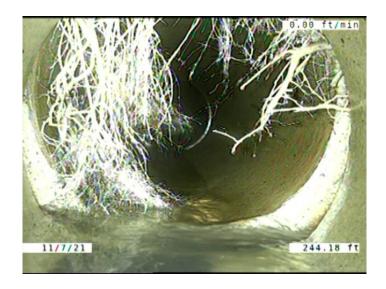
Code: **JOMD**

Description: Joint Offset Medium Defective

Distance (ft): 244.2
Structural Grade: 3
O&M Grade: 0

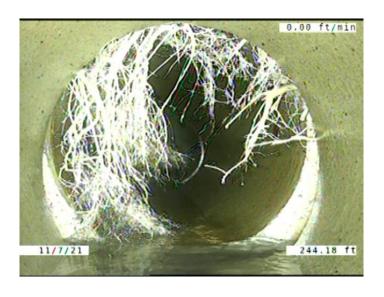
Code: RMJ

Description: Roots Medium Joint

Distance (ft): 244.2
Structural Grade: 0
O&M Grade: 3
Clock Start/From: 9
Clock To: 3
1st Value:

Value Percent: 20.000

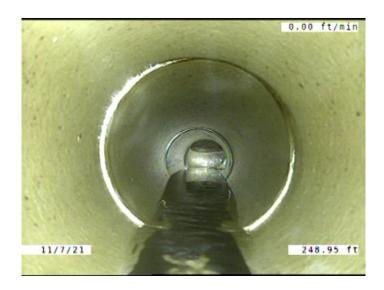
Code: **DSF**

Description: Deposits Settled Fine

Distance (ft): 248.9
Structural Grade: 0
O&M Grade: 2
Clock Start/From: 5
Clock To: 7

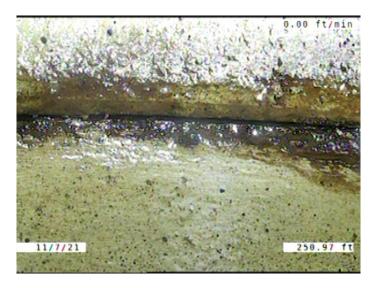
Code: IDJ

Description: Infiltration Dripper Joint

Distance (ft): 251.0
Structural Grade: 0
O&M Grade: 3
Clock Start/From: 1
Clock To:
1st Value:

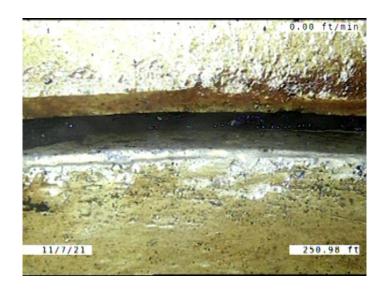
Code: ISJ

Description: **Infiltration Stain Joint**

Distance (ft): 251.0 Structural Grade: 0 O&M Grade: 1 Clock Start/From: 8 Clock To: 4

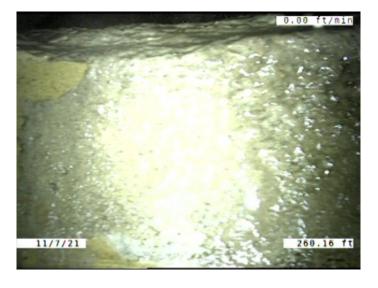
DSF Code:

Description: **Deposits Settled Fine**

Distance (ft): 260.2 Structural Grade: 0 O&M Grade: 2 Clock Start/From: 5 7 Clock To:
