Profile/Photo Observation Report

| Street: | W 4TH PL | Flow Control: | Not Controlled |
| City: | Hobart, IN | Year Renewed: | |
| US MH: | M-505-077 | DS MH: | M-505-084 |

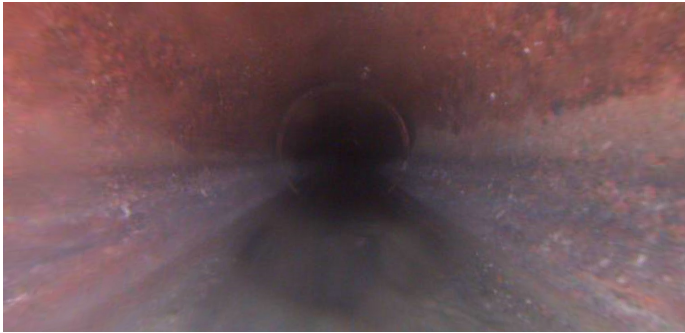
| Code: | MWL |
| Description: | Water Level |

| Value Percent: | 10.000 |

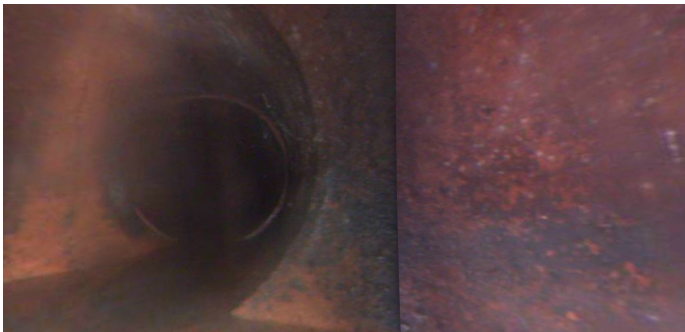
| Code: | TF |
| Description: | Tap Factory |

| Distance (ft): | 8.6 |
| Clock Start/From: | 9 |
| 1st Value: | 4.000 |

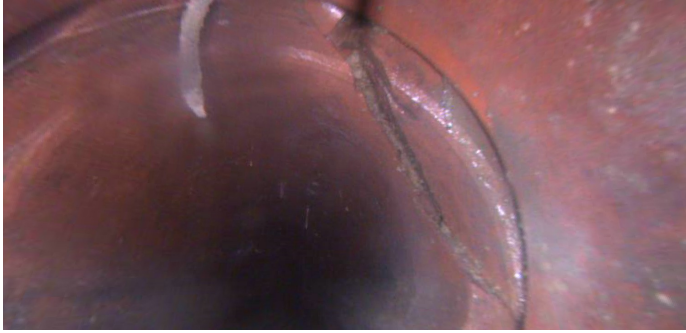
| Position | Code | Observation | Video (sec) | Grade |
|---|---|---|---|---|
| 9.1 | FC | Fracture Circumferential | 65 | S 2 |

Code: **FC**
Description: **Fracture Circumferential**

Distance (ft): **9.1**
Structural Grade: **2**
O&M Grade: **0**
Clock Start/From: **1**
Clock To: **4**
1st Value:
2nd Value:
Value Percent:
Continuous Index:
Within 8" of Joint: **YES**
Remarks:

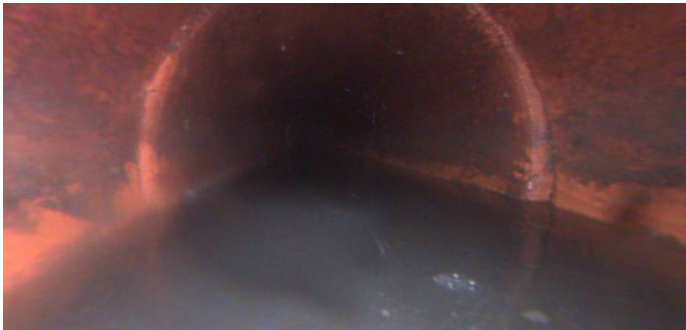
Code: **MWL**
Description: **Water Level**

Distance (ft): **23.6**
Structural Grade: **0**
O&M Grade: **0**
Clock Start/From:
Clock To:
1st Value:
2nd Value:
Value Percent: **30.000**
Continuous Index:
Within 8" of Joint: **NO**
Remarks:

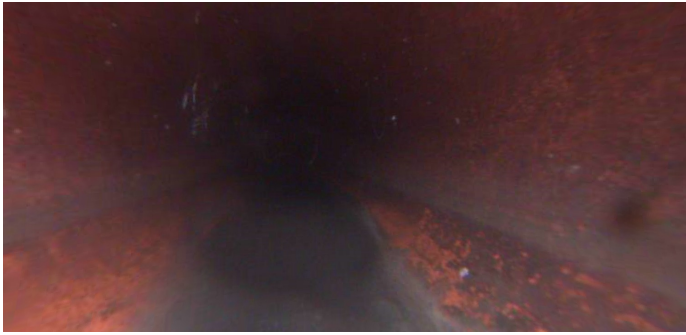
Code: **MWL**
Description: **Water Level**

Distance (ft): **39.5**
Structural Grade: **0**
O&M Grade: **0**
Clock Start/From:
Clock To:
1st Value:
2nd Value:
Value Percent: **5.000**
Continuous Index:
Within 8" of Joint: **NO**
Remarks:

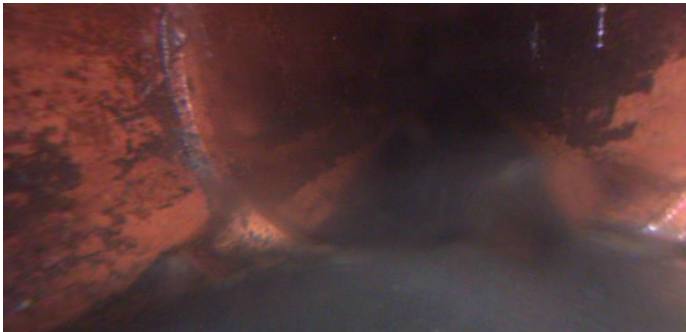
| Position | Code | Observation | Video (sec) | Grade |
|---|---|---|---|---|
| 48.5 | FL | Fracture Longitudinal | 178 | S 3 |

Code: **FL**
Description: **Fracture Longitudinal**

Distance (ft): **48.5**
Structural Grade: **3**
O&M Grade: **0**
Clock Start/From: **8**
Clock To:
1st Value:
2nd Value:
Value Percent:
Continuous Index:
Within 8" of Joint: **YES**
Remarks:

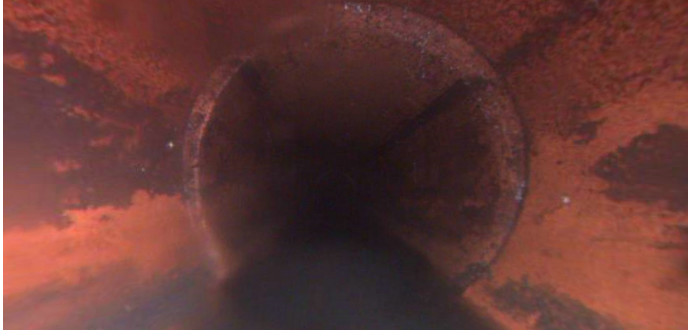
| Code: | MSA |
| Description: | Abandoned Survey |
| Distance (ft): | 83.4 |
| Remarks: | DSF |
