Profile/Photo Observation Report

Date:	04/14/2018	Weather:		Coding:	PACP 6.0
Pipe Length (ft):	144.5	Owner:	NA	Pre Clean:	No Pre-Cleaning
P.O.#:		Surveyor:	Jen Costello	PSR:	P-505-077-084
Customer:		Clean Date:	01/01/1900	Shape:	C

Street:	FOXCROFT STREET	Flow Control:	Not Controlled
City:	Hobart, IN	Year Renewed:	
Location:	Yard	Tape/Media #:	
Purpose:	Routine Assessment	Dia/Height:	10"
Use:	Sanitary	Material:	VCP
Drain Area:	NA	Lining:	
Category:	NA		
Comment:

Location Details:		Direction of Survey:	Downstream
US MH:	M-505-077	DS MH:	M-505-084
		Total Length Surveyed (ft):	83.4

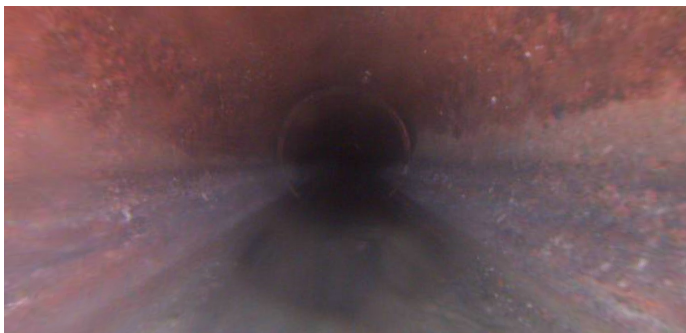
Code: **AMH**
Description: **Manhole**

Distance (ft): **.0**
Structural Grade: **0**
O&M Grade: **0**
Clock Start/From:
Clock To:
1st Value:
2nd Value:
Value Percent:
Continuous Index:
Within 8" of Joint: **NO**
Remarks: **M-505-077**

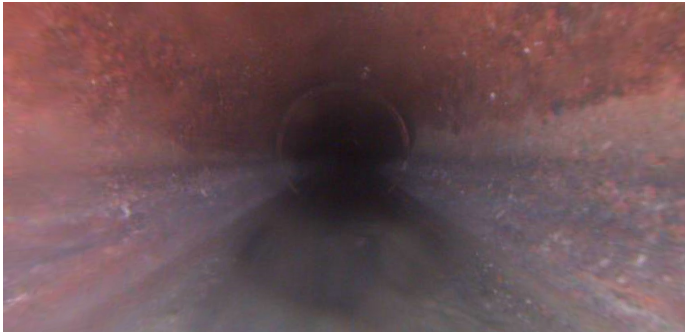
Code:	MWL
Description:	Water Level

Distance (ft):	.0
Structural Grade:	0
O&M Grade:	0
Clock Start/From:	
Clock To:	
1st Value:	
2nd Value:	
Value Percent:	10.000
Continuous Index:	
Within 8" of Joint:	NO
Remarks:

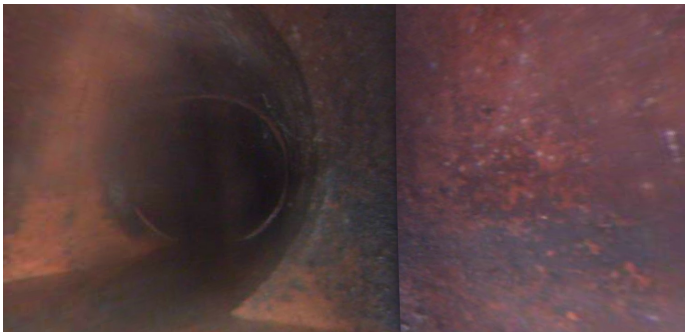
Code:	TF
Description:	Tap Factory

Distance (ft):	8.6
Structural Grade:	0
O&M Grade:	0
Clock Start/From:	9
Clock To:	
1st Value:	4.000
2nd Value:	
Value Percent:	
Continuous Index:	
Within 8" of Joint:	
Remarks:

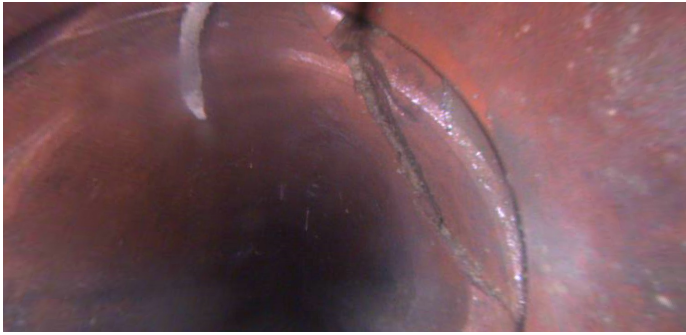
Code: **FC**
Description: **Fracture Circumferential**

Distance (ft): **9.1**
Structural Grade: **2**
O&M Grade: **0**
Clock Start/From: **1**
Clock To: **4**
1st Value:
2nd Value:
Value Percent:
Continuous Index:
Within 8" of Joint: **YES**
Remarks:

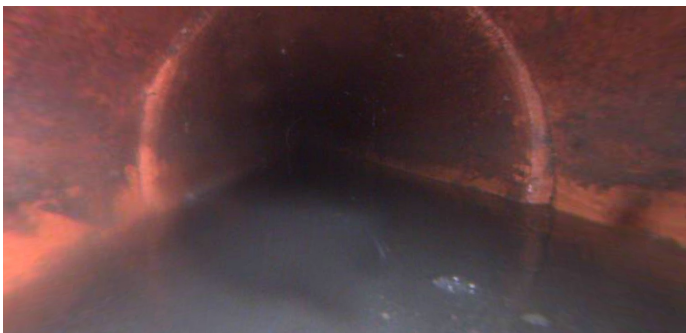
Code: **MWL**
Description: **Water Level**

Distance (ft): **23.6**
Structural Grade: **0**
O&M Grade: **0**
Clock Start/From:
Clock To:
1st Value:
2nd Value:
Value Percent: **30.000**
Continuous Index:
Within 8" of Joint: **NO**
Remarks:

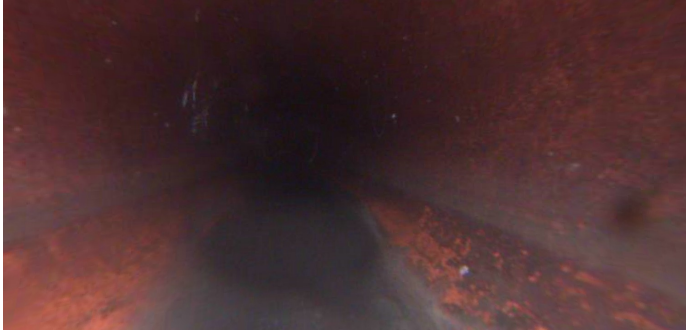
Code: **MWL**
Description: **Water Level**

Distance (ft): **39.5**
Structural Grade: **0**
O&M Grade: **0**
Clock Start/From:
Clock To:
1st Value:
2nd Value:
Value Percent: **5.000**
Continuous Index:
Within 8" of Joint: **NO**
Remarks:

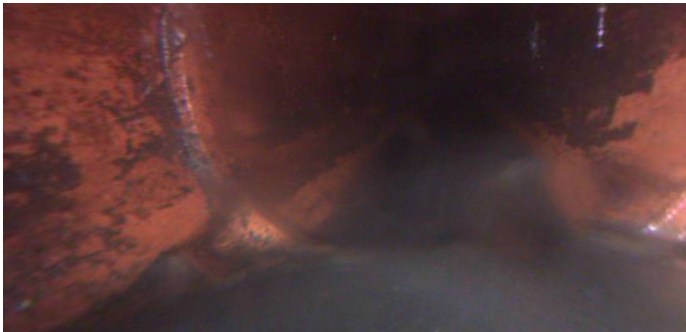
Code: **FL**
Description: **Fracture Longitudinal**

Distance (ft): **48.5**
Structural Grade: **3**
O&M Grade: **0**
Clock Start/From: **8**
Clock To:
1st Value:
2nd Value:
Value Percent:
Continuous Index:
Within 8" of Joint: **YES**
Remarks:

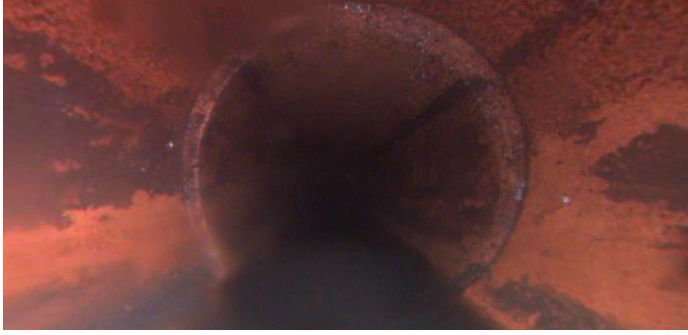
Code:	MSA
Description:	Abandoned Survey
Distance (ft):	83.4
Structural Grade:	0
O&M Grade:	0
Clock Start/From:	
Clock To:	
1st Value:	
2nd Value:	
Value Percent:	
Continuous Index:	
Within 8" of Joint:	NO
Remarks:	DSF
