Profile/Photo Observation Report

Date:	01/13/2022	Weather:		Coding:	PACP 7.0
Pipe Length (ft):	144.9	Owner:	City of Hobart	Pre Clean:	Light Cleaning
P.O.#:	YES502259	Surveyor:	S. Bucklin	PSR:	P-505-077-084
Customer:	City of Hobart	Clean Date:	01/12/2021	Shape:	C

Street:	West 4th Street	Flow Control:	Not Controlled
City:	Hobart, IN	Year Renewed:	
Location:	Yard	Tape/Media #:	
Purpose:	Routine Assessment	Dia/Height:	10"
Use:	Sanitary Sewage Pipe	Material:	VCP
Drain Area:		Lining:	None
Category:	NA		
Comment:			
Location Details:		Direction of Survey:	Downstream
US MH:	M-505-077	DS MH:	M-505-084
		Total Length Surveyed (ft):	144.9

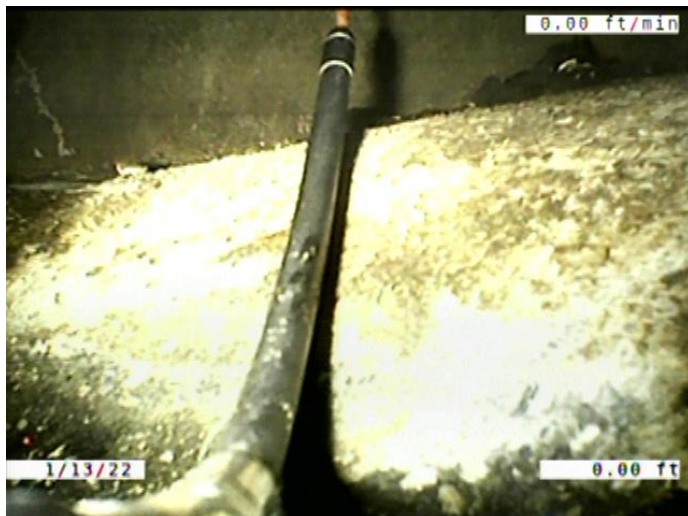
Code: **AMH**
Description: **Manhole**

Distance (ft): **.0**
Structural Grade: **0**
O&M Grade: **0**
Clock Start/From:
Clock To:
1st Value:
2nd Value:
Value Percent:
Continuous Index:
Within 8" of Joint: **NO**
Remarks: **M-505-077**

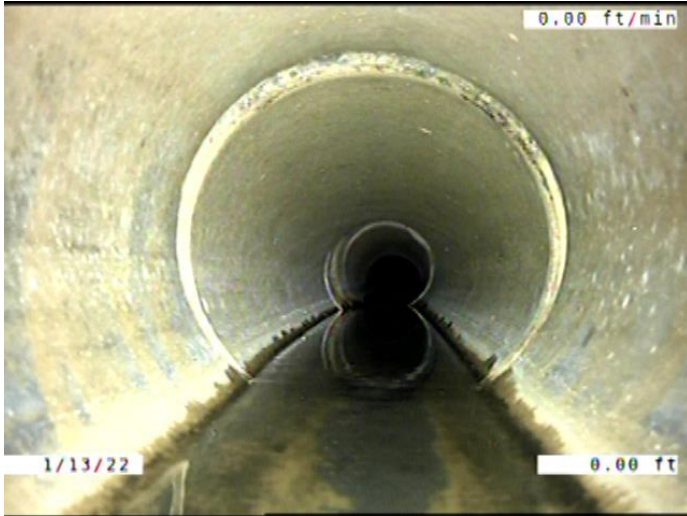
Code: **MWL**
Description: **Miscellaneous Water Level**

Distance (ft): **.0**
Structural Grade: **0**
O&M Grade: **0**
Clock Start/From:
Clock To:
1st Value:
2nd Value:
Value Percent: **5.000**
Continuous Index:
Within 8" of Joint: **NO**
Remarks:

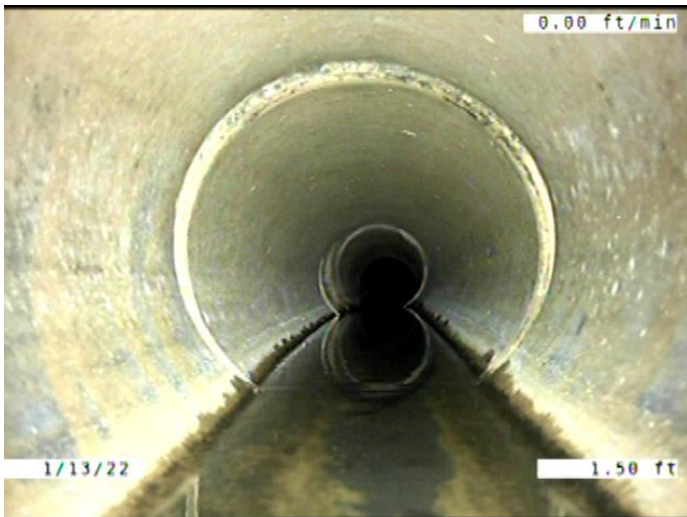
Code: **MGO**
Description: **Miscellaneous General Observation**

Distance (ft): **1.5**
Structural Grade: **0**
O&M Grade: **0**
Clock Start/From:
Clock To:
1st Value:
2nd Value:
Value Percent:
Continuous Index:
Within 8" of Joint: **NO**
Remarks: **TIGHT ACCESS IN THE MANHOLE.
HAD TO START IN THE PIPE.**

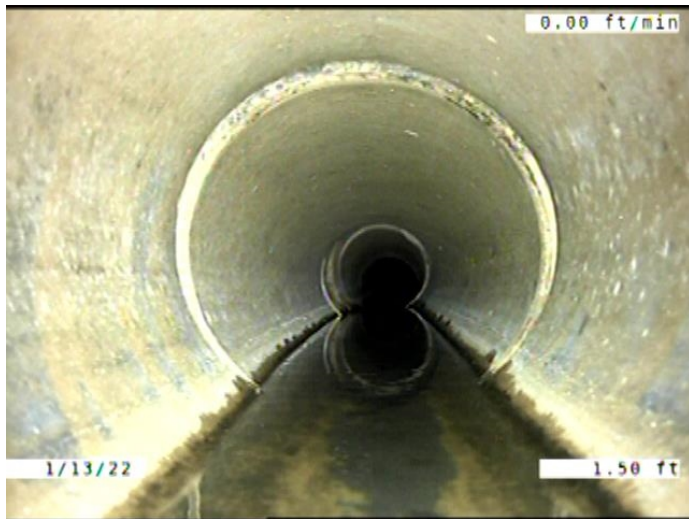
Code: **DSF**
Description: **Deposits Settled Fine**

Distance (ft): **1.5**
Structural Grade: **0**
O&M Grade: **2**
Clock Start/From: **5**
Clock To: **7**
1st Value:
2nd Value:
Value Percent: **5.000**
Continuous Index: **S01**
Within 8" of Joint: **YES**
Remarks:

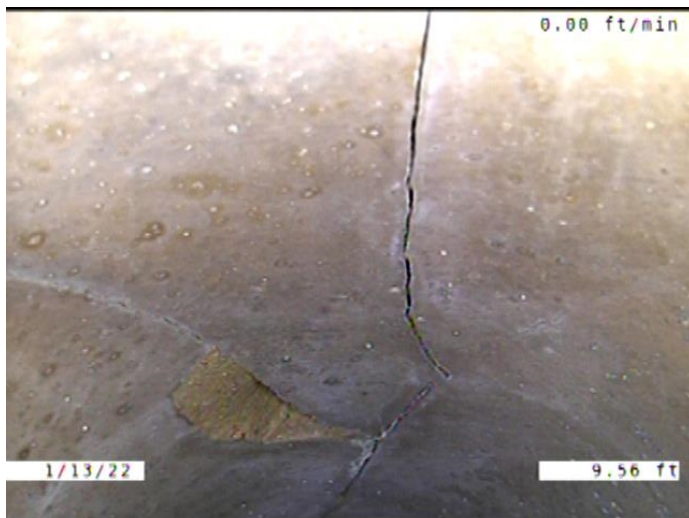
Code: **FM**
Description: **Fracture Multiple**

Distance (ft): **9.6**
Structural Grade: **4**
O&M Grade: **0**
Clock Start/From: **6**
Clock To: **12**
1st Value:
2nd Value:
Value Percent:
Continuous Index:
Within 8" of Joint: **YES**
Remarks:

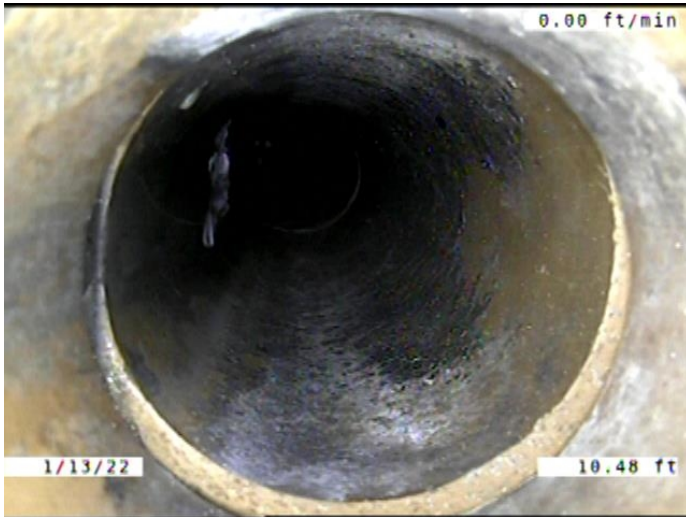
Code: **TF**
 Description: **Tap Factory**

Distance (ft): **10.5**
 Structural Grade: **0**
 O&M Grade: **0**
 Clock Start/From: **9**
 Clock To:
 1st Value: **6.000**
 2nd Value:
 Value Percent:
 Continuous Index:
 Within 8" of Joint: **YES**
 Remarks:

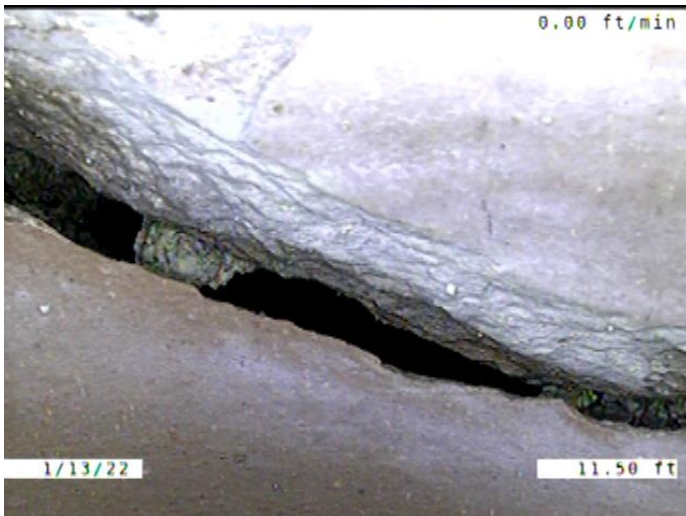
Code: **BSV**
 Description: **Broken Soil Visible**

Distance (ft): **11.5**
 Structural Grade: **5**
 O&M Grade: **0**
 Clock Start/From: **12**
 Clock To: **4**
 1st Value:
 2nd Value:
 Value Percent:
 Continuous Index:
 Within 8" of Joint: **YES**
 Remarks:

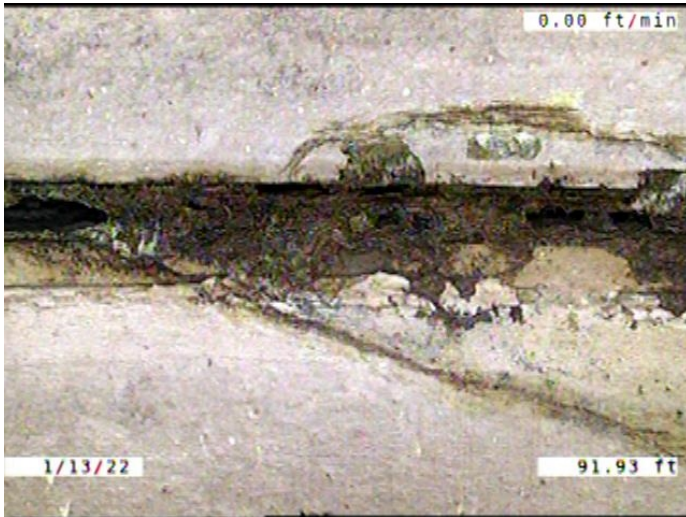
Code: **DAE**
 Description: **Deposits Attached Encrustation**

Distance (ft): **91.9**
 Structural Grade: **0**
 O&M Grade: **2**
 Clock Start/From: **9**
 Clock To: **3**
 1st Value:
 2nd Value:
 Value Percent: **5.000**
 Continuous Index:
 Within 8" of Joint: **YES**
 Remarks:

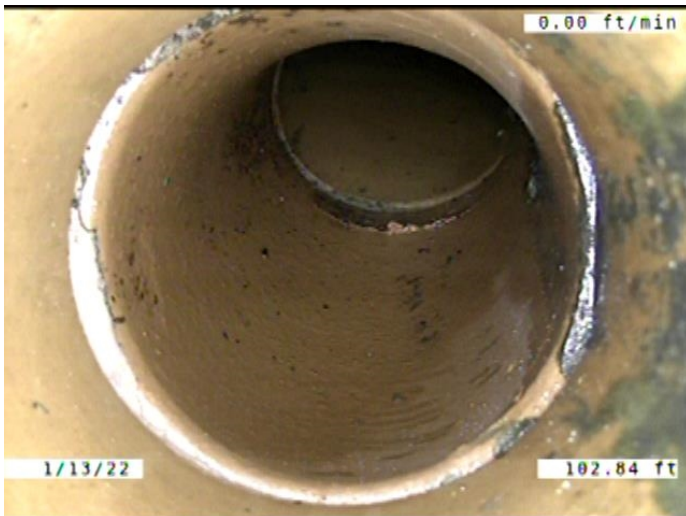
Code: **TF**
 Description: **Tap Factory**

Distance (ft): **102.8**
 Structural Grade: **0**
 O&M Grade: **0**
 Clock Start/From: **3**
 Clock To:
 1st Value: **6.000**
 2nd Value:
 Value Percent:
 Continuous Index:
 Within 8" of Joint: **YES**
 Remarks:

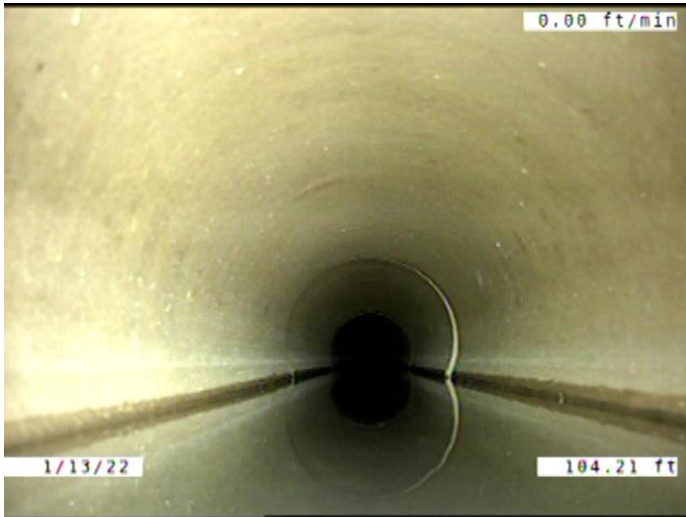
Code: **MWLS**
Description: **Miscellaneous Water Level Sag**

Distance (ft): **104.2**
Structural Grade: **2**
O&M Grade: **0**
Clock Start/From:
Clock To:
1st Value:
2nd Value:
Value Percent: **15.000**
Continuous Index: **S02**
Within 8" of Joint: **NO**
Remarks:

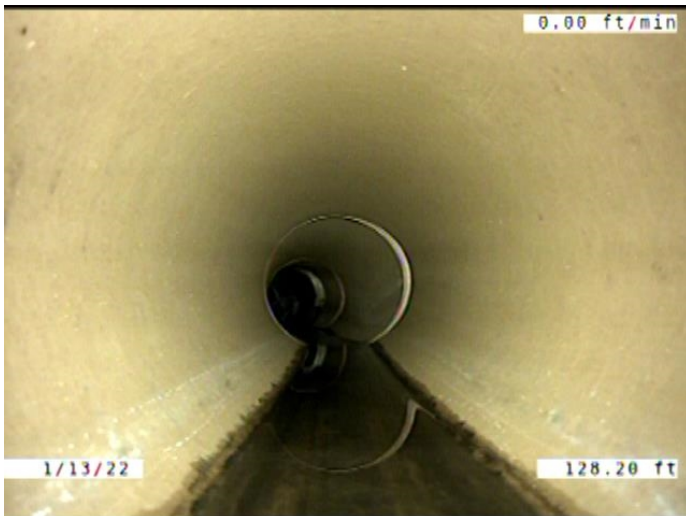
Code: **MWLS**
Description: **Miscellaneous Water Level Sag**

Distance (ft): **128.2**
Structural Grade: **2**
O&M Grade: **0**
Clock Start/From:
Clock To:
1st Value:
2nd Value:
Value Percent: **15.000**
Continuous Index: **F02**
Within 8" of Joint: **NO**
Remarks:

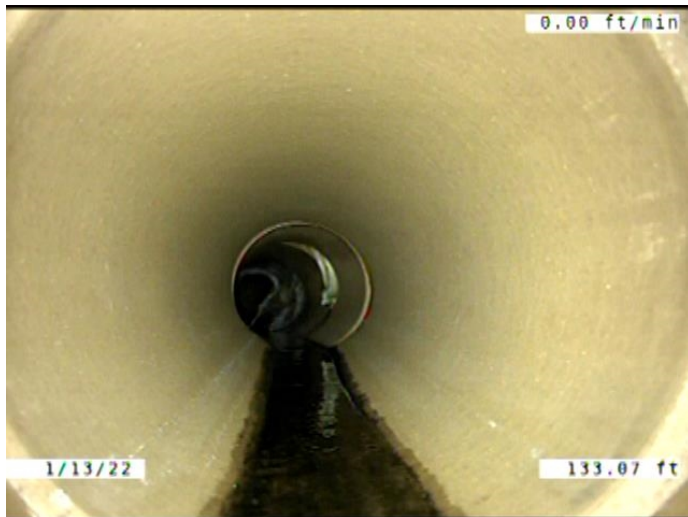
Code: **LL**
Description: **Line Left**

Distance (ft): **133.1**
Structural Grade: **0**
O&M Grade: **1**
Clock Start/From:
Clock To:
1st Value:
2nd Value:
Value Percent: **10.000**
Continuous Index: **S03**
Within 8" of Joint: **NO**
Remarks:

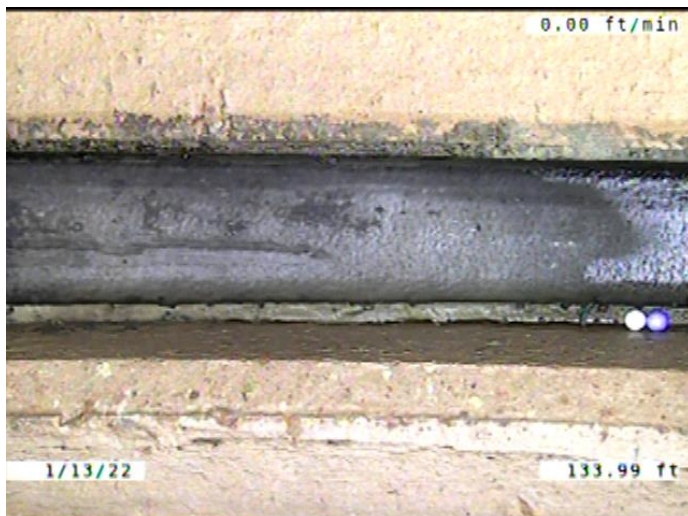
Code: **JAM**
Description: **Joint Angular Medium**

Distance (ft): **134.0**
Structural Grade: **3**
O&M Grade: **0**
Clock Start/From:
Clock To:
1st Value:
2nd Value:
Value Percent:
Continuous Index:
Within 8" of Joint: **NO**
Remarks:

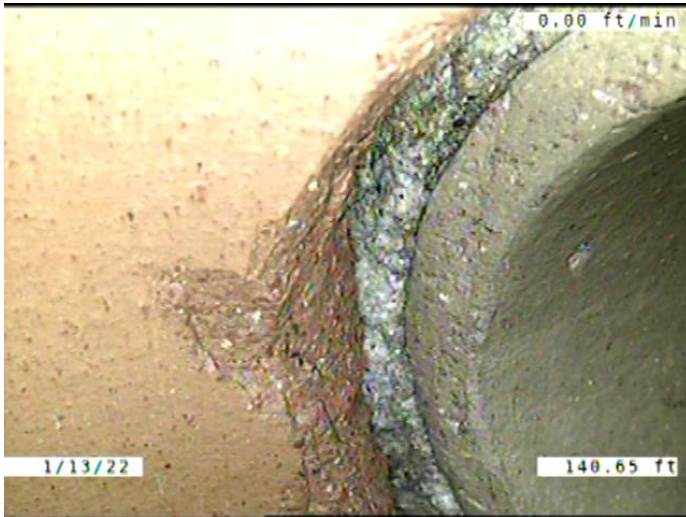
Code: **SSS**
 Description: **Surface Damage Surface Spalling**

Distance (ft): **140.7**
 Structural Grade: **2**
 O&M Grade: **0**
 Clock Start/From: **12**
 Clock To: **4**
 1st Value:
 2nd Value:
 Value Percent:
 Continuous Index:
 Within 8" of Joint: **YES**
 Remarks:

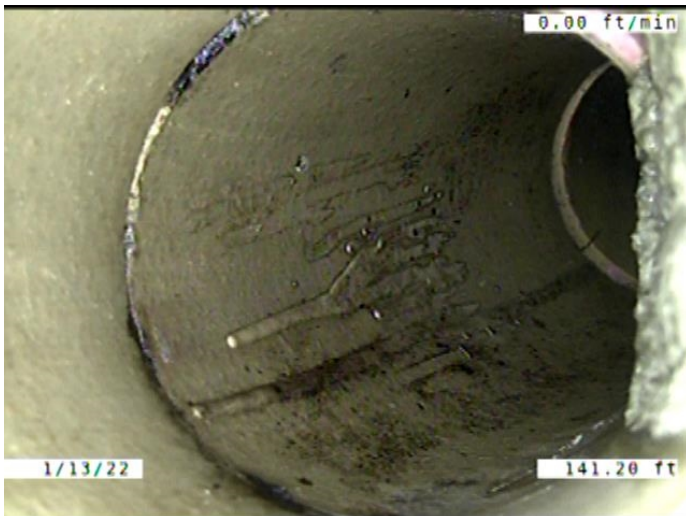
Code: **TBI**
 Description: **Tap Break-in Intruding**

Distance (ft): **141.2**
 Structural Grade: **0**
 O&M Grade: **2**
 Clock Start/From: **2**
 Clock To:
 1st Value: **6.000**
 2nd Value: **1.000**
 Value Percent:
 Continuous Index:
 Within 8" of Joint: **YES**
 Remarks: **CONSTANTLY DRIPPING WATER.**

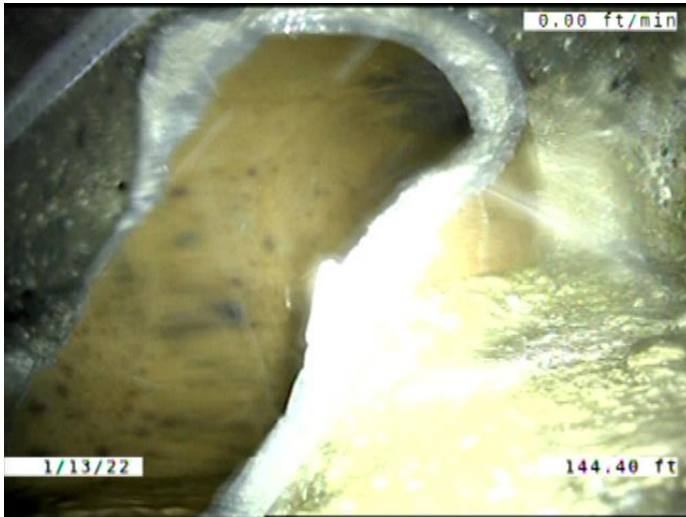
Code: **DSF**
 Description: **Deposits Settled Fine**

Distance (ft): **144.4**
 Structural Grade: **0**
 O&M Grade: **2**
 Clock Start/From: **5**
 Clock To: **7**
 1st Value:
 2nd Value:
 Value Percent: **5.000**
 Continuous Index: **F01**
 Within 8" of Joint: **YES**
 Remarks:

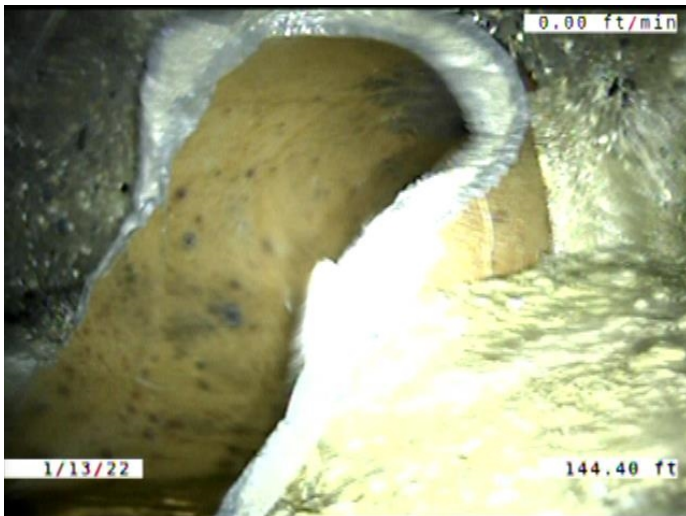
Code: **LL**
 Description: **Line Left**

Distance (ft): **144.4**
 Structural Grade: **0**
 O&M Grade: **1**
 Clock Start/From:
 Clock To:
 1st Value:
 2nd Value:
 Value Percent: **10.000**
 Continuous Index: **F03**
 Within 8" of Joint: **NO**
 Remarks:

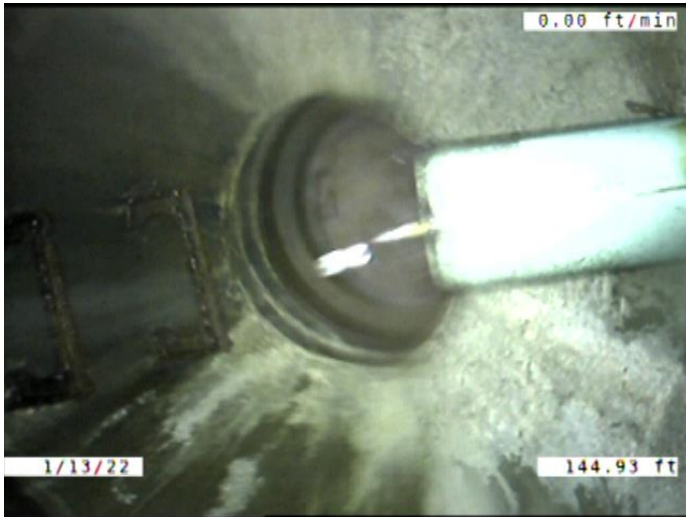
Code:	AMH
Description:	Manhole
Distance (ft):	144.9
Structural Grade:	0
O&M Grade:	0
Clock Start/From:	
Clock To:	
1st Value:	
2nd Value:	
Value Percent:	
Continuous Index:	
Within 8" of Joint:	NO
Remarks:	M-505-084
