Profile/Photo Observation Report

Date:	04/14/2018	Weather:		Coding:	PACP 6.0
Pipe Length (ft):	188.1	Owner:	NA	Pre Clean:	No Pre-Cleaning
P.O.#:		Surveyor:	Jen Costello	PSR:	P-505-078-077
Customer:		Clean Date:	01/01/1900	Shape:	C

Street:	W 4TH PL	Flow Control:	Not Controlled
City:	Hobart, IN	Year Renewed:	
Location:	Yard	Tape/Media #:	
Purpose:	Routine Assessment	Dia/Height:	10"
Use:	Sanitary	Material:	VCP
Drain Area:	NA	Lining:	
Category:	NA		
Comment:

Location Details:		Direction of Survey:	Upstream
US MH:	M-505-078	DS MH:	M-505-077
		Total Length Surveyed (ft):	124.2

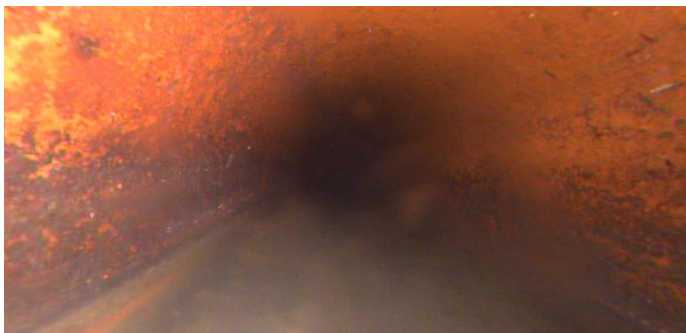
Code: **AMH**
Description: **Manhole**

Distance (ft): **.0**
Structural Grade: **0**
O&M Grade: **0**
Clock Start/From:
Clock To:
1st Value:
2nd Value:
Value Percent:
Continuous Index:
Within 8" of Joint: **NO**
Remarks: **M-505-077**

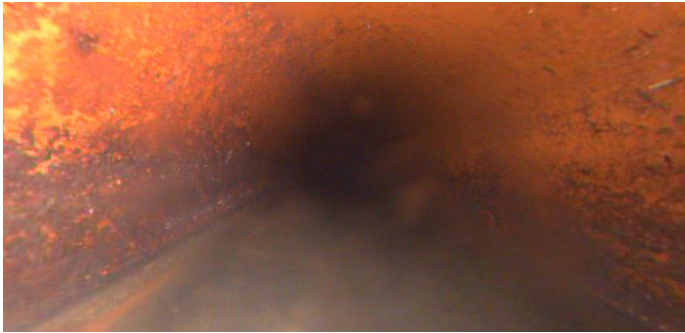
Code:	MWL
Description:	Water Level

Distance (ft):	.0
Structural Grade:	0
O&M Grade:	0
Clock Start/From:	
Clock To:	
1st Value:	
2nd Value:	
Value Percent:	20.000
Continuous Index:	
Within 8" of Joint:	NO
Remarks:

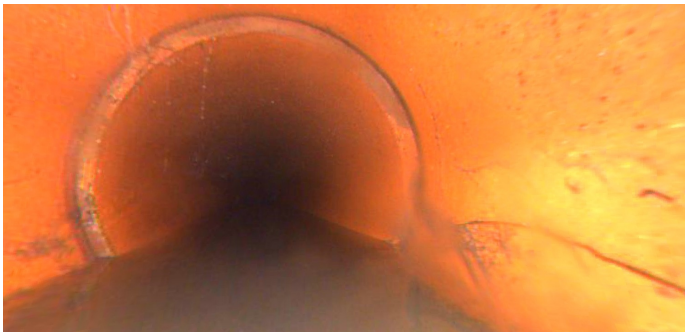
Code:	FL
Description:	Fracture Longitudinal

Distance (ft):	17.0
Structural Grade:	3
O&M Grade:	0
Clock Start/From:	3
Clock To:	
1st Value:	
2nd Value:	
Value Percent:	
Continuous Index:	
Within 8" of Joint:	
Remarks:

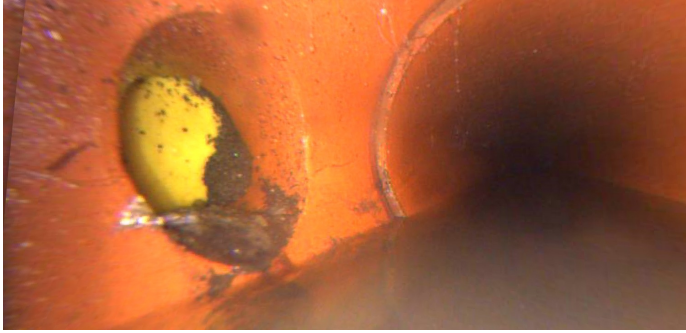
Code: **TFC**
Description: **Tap Factory Capped**

Distance (ft): **17.0**
Structural Grade: **0**
O&M Grade: **0**
Clock Start/From: **3**
Clock To:
1st Value: **4.000**
2nd Value:
Value Percent:
Continuous Index:
Within 8" of Joint:
Remarks:

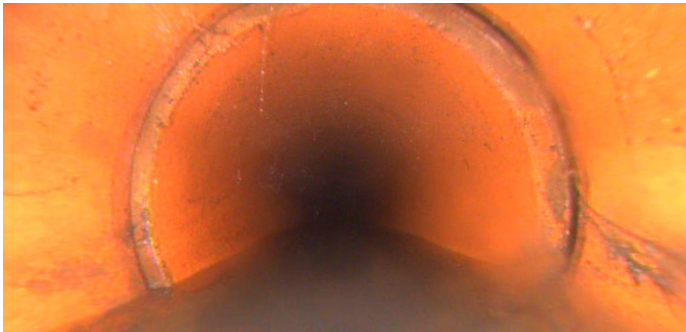
Code: **RFJ**
Description: **Roots Fine Joint**

Distance (ft): **17.2**
Structural Grade: **0**
O&M Grade: **1**
Clock Start/From: **3**
Clock To:
1st Value:
2nd Value:
Value Percent:
Continuous Index:
Within 8" of Joint: **YES**
Remarks:

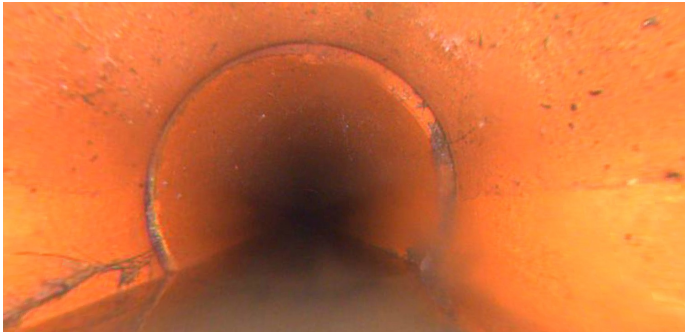
Code: **RFJ**
Description: **Roots Fine Joint**

Distance (ft): **21.9**
Structural Grade: **0**
O&M Grade: **1**
Clock Start/From: **8**
Clock To: **4**
1st Value:
2nd Value:
Value Percent:
Continuous Index: **S01**
Within 8" of Joint: **YES**
Remarks:

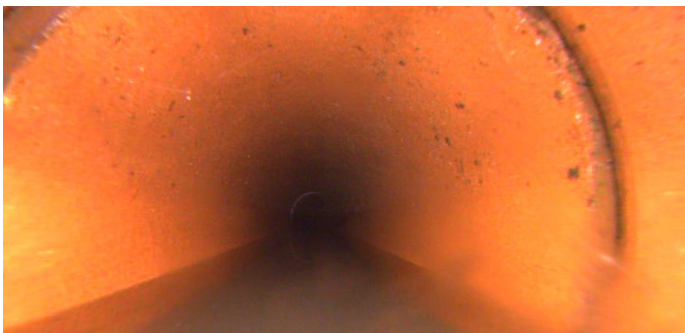
Code: **RFJ**
Description: **Roots Fine Joint**

Distance (ft): **42.0**
Structural Grade: **0**
O&M Grade: **1**
Clock Start/From: **8**
Clock To: **4**
1st Value:
2nd Value:
Value Percent:
Continuous Index: **F01**
Within 8" of Joint: **YES**
Remarks:

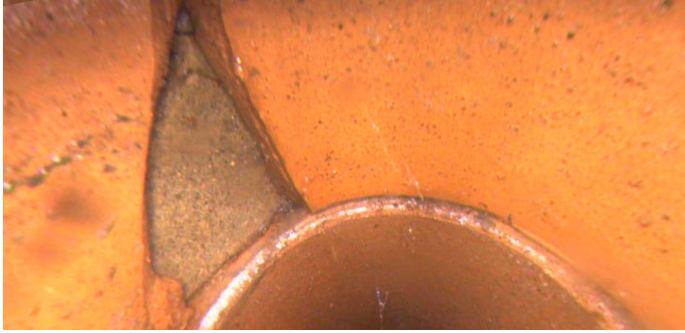
Code: **RPP**
Description: **Repair Patch**

Distance (ft): **56.5**
Structural Grade: **0**
O&M Grade: **0**
Clock Start/From: **10**
Clock To: **11**
1st Value:
2nd Value:
Value Percent:
Continuous Index:
Within 8" of Joint: **YES**
Remarks: **concrete**

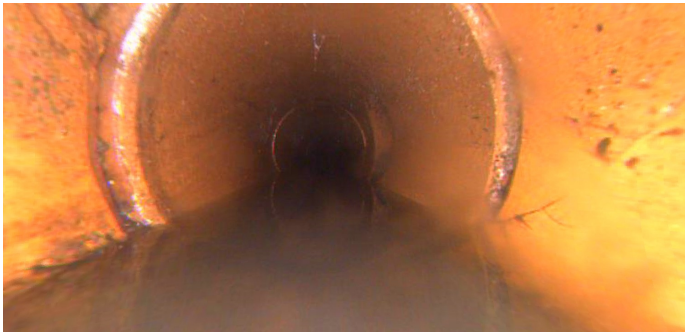
Code: **RFJ**
Description: **Roots Fine Joint**

Distance (ft): **56.5**
Structural Grade: **0**
O&M Grade: **1**
Clock Start/From: **8**
Clock To: **4**
1st Value:
2nd Value:
Value Percent:
Continuous Index:
Within 8" of Joint: **YES**
Remarks:

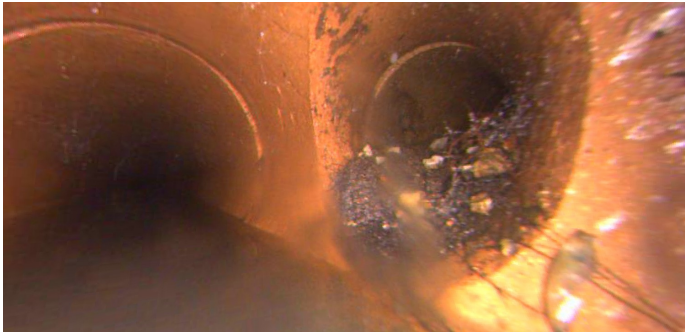
Code: **TFD**
Description: **Tap Factory Defective**

Distance (ft): **58.1**
Structural Grade: **0**
O&M Grade: **2**
Clock Start/From: **3**
Clock To:
1st Value: **4.000**
2nd Value:
Value Percent:
Continuous Index:
Within 8" of Joint:
Remarks: **roots**

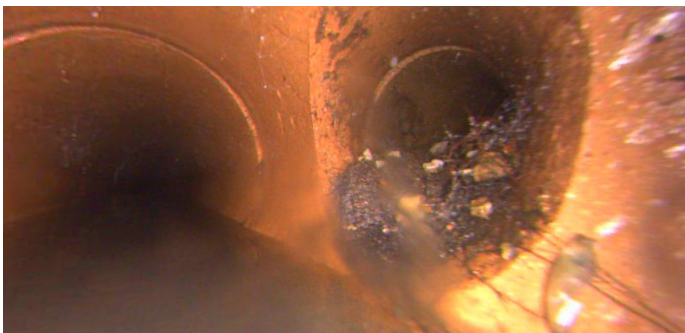
Code: **RFL**
Description: **Roots Fine Lateral**

Distance (ft): **58.1**
Structural Grade: **0**
O&M Grade: **1**
Clock Start/From: **3**
Clock To:
1st Value:
2nd Value:
Value Percent:
Continuous Index:
Within 8" of Joint: **NO**
Remarks:

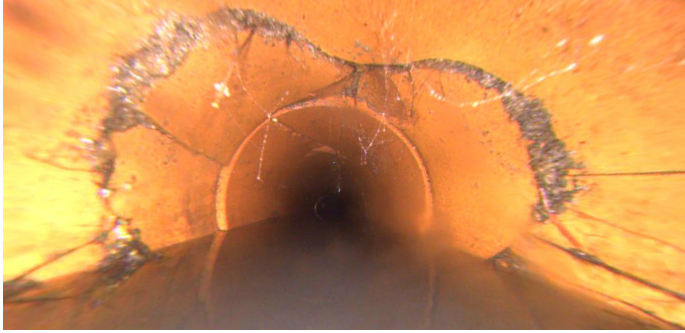
Code: **RFB**
Description: **Roots Fine Barrel**

Distance (ft): **73.1**
Structural Grade: **0**
O&M Grade: **2**
Clock Start/From: **8**
Clock To: **4**
1st Value:
2nd Value:
Value Percent:
Continuous Index:
Within 8" of Joint: **NO**
Remarks:

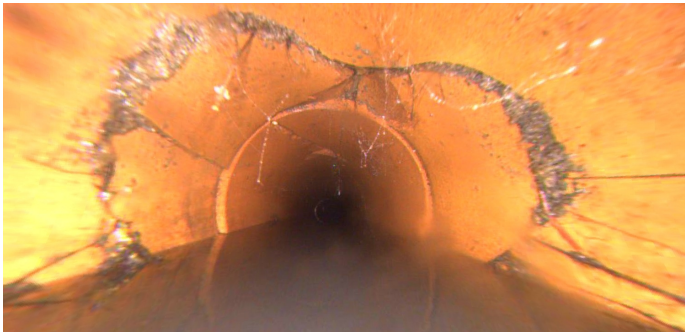
Code: **FM**
Description: **Fracture Multiple**

Distance (ft): **73.1**
Structural Grade: **4**
O&M Grade: **0**
Clock Start/From: **8**
Clock To: **4**
1st Value:
2nd Value:
Value Percent:
Continuous Index:
Within 8" of Joint: **YES**
Remarks:

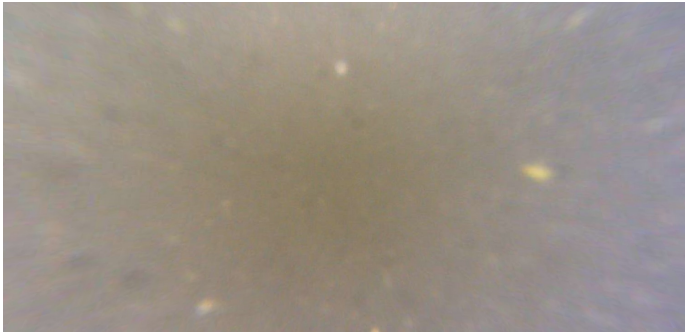
Code: **MWL**
Description: **Water Level**

Distance (ft): **90.2**
Structural Grade: **0**
O&M Grade: **0**
Clock Start/From:
Clock To:
1st Value:
2nd Value:
Value Percent: **100.000**
Continuous Index:
Within 8" of Joint: **NO**
Remarks:

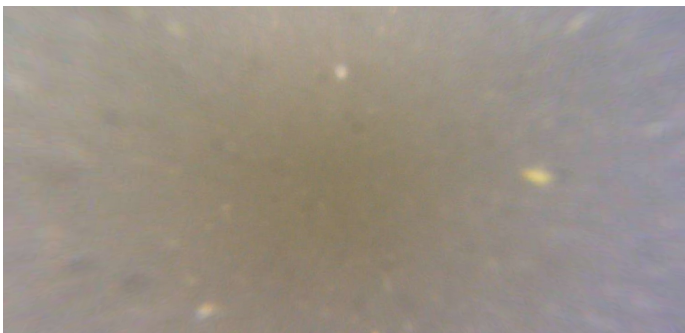
Code: **MCU**
Description: **Camera Underwater**

Distance (ft): **90.2**
Structural Grade: **0**
O&M Grade: **4**
Clock Start/From:
Clock To:
1st Value:
2nd Value:
Value Percent:
Continuous Index: **S02**
Within 8" of Joint: **NO**
Remarks:

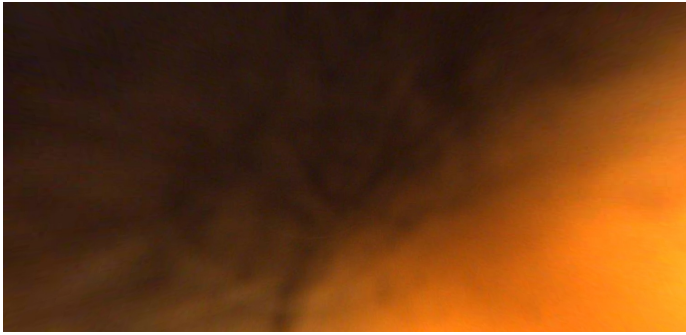
Code: **MCU**
Description: **Camera Underwater**

Distance (ft): **124.2**
Structural Grade: **0**
O&M Grade: **4**
Clock Start/From:
Clock To:
1st Value:
2nd Value:
Value Percent:
Continuous Index: **F02**
Within 8" of Joint: **NO**
Remarks:

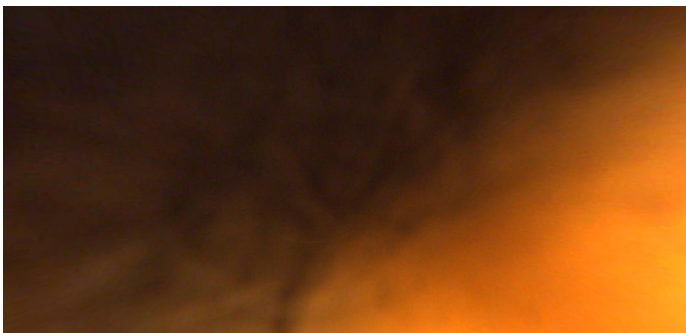
Code: **MSA**
Description: **Abandoned Survey**

Distance (ft): **124.2**
Structural Grade: **0**
O&M Grade: **0**
Clock Start/From:
Clock To:
1st Value:
2nd Value:
Value Percent:
Continuous Index:
Within 8" of Joint: **NO**
Remarks: **MCU**
