## Profile/Photo Observation Report

Date:	<b>04/14/2018</b>	Weather:		Coding:	<b>PACP 6.0</b>
Pipe Length (ft):	<b>188.1</b>	Owner:	<b>NA</b>	Pre Clean:	<b>No Pre-Cleaning</b>
P.O.#:		Surveyor:	<b>Jen Costello</b>	PSR:	<b>P-505-078-077</b>
Customer:		Clean Date:	<b>01/01/1900</b>	Shape:	<b>C</b>

Street:	<b>FOXCROFT STREET</b>	Flow Control:	<b>Not Controlled</b>
City:	<b>Hobart, IN</b>	Year Renewed:	
Location:	<b>Yard</b>	Tape/Media #:	
Purpose:	<b>Routine Assessment</b>	Dia/Height:	<b>10"</b>
Use:	<b>Sanitary</b>	Material:	<b>VCP</b>
Drain Area:	<b>NA</b>	Lining:	
Category:	<b>NA</b>		
Comment:

Location Details:		Direction of Survey:	<b>Upstream</b>
US MH:	<b>M-505-078</b>	DS MH:	<b>M-505-077</b>
		Total Length Surveyed (ft):	<b>124.2</b>

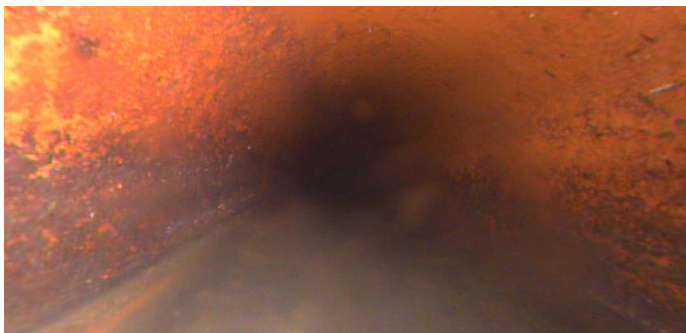
Code: **AMH**  
Description: **Manhole**

Distance (ft): **.0**  
Structural Grade: **0**  
O&M Grade: **0**  
Clock Start/From:  
Clock To:  
1st Value:  
2nd Value:  
Value Percent:  
Continuous Index:  
Within 8" of Joint: **NO**  
Remarks: **M-505-077**

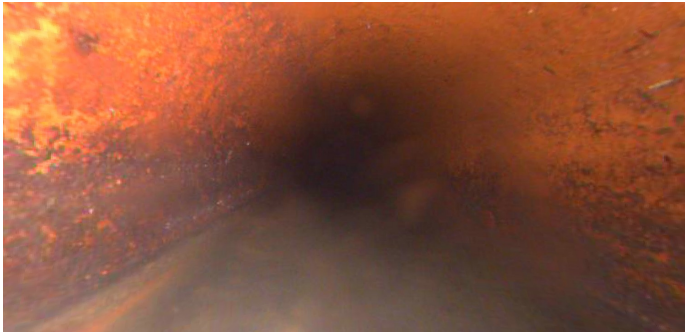
Code:	<b>MWL</b>
Description:	<b>Water Level</b>

Distance (ft):	<b>.0</b>
Structural Grade:	<b>0</b>
O&M Grade:	<b>0</b>
Clock Start/From:	
Clock To:	
1st Value:	
2nd Value:	
Value Percent:	<b>20.000</b>
Continuous Index:	
Within 8" of Joint:	<b>NO</b>
Remarks:

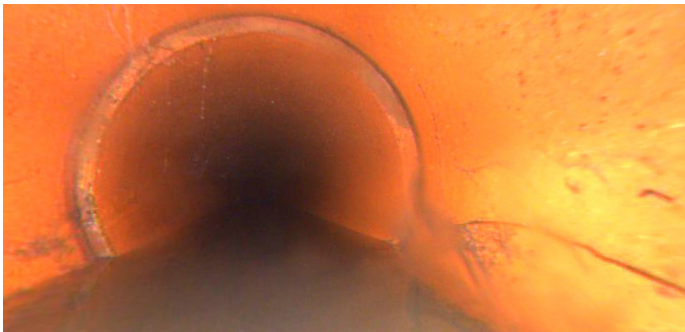
Code:	<b>FL</b>
Description:	<b>Fracture Longitudinal</b>

Distance (ft):	<b>17.0</b>
Structural Grade:	<b>3</b>
O&M Grade:	<b>0</b>
Clock Start/From:	<b>3</b>
Clock To:	
1st Value:	
2nd Value:	
Value Percent:	
Continuous Index:	
Within 8" of Joint:	
Remarks:

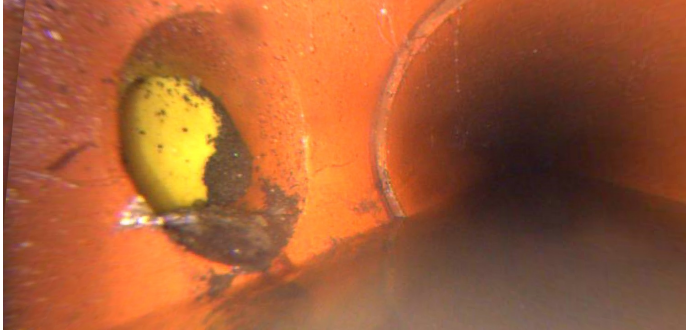
Code: **TFC**  
Description: **Tap Factory Capped**

Distance (ft): **17.0**  
Structural Grade: **0**  
O&M Grade: **0**  
Clock Start/From: **3**  
Clock To:  
1st Value: **4.000**  
2nd Value:  
Value Percent:  
Continuous Index:  
Within 8" of Joint:  
Remarks:

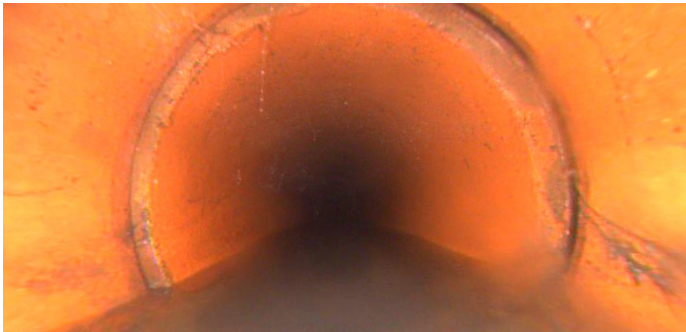
Code: **RFJ**  
Description: **Roots Fine Joint**

Distance (ft): **17.2**  
Structural Grade: **0**  
O&M Grade: **1**  
Clock Start/From: **3**  
Clock To:  
1st Value:  
2nd Value:  
Value Percent:  
Continuous Index:  
Within 8" of Joint: **YES**  
Remarks:

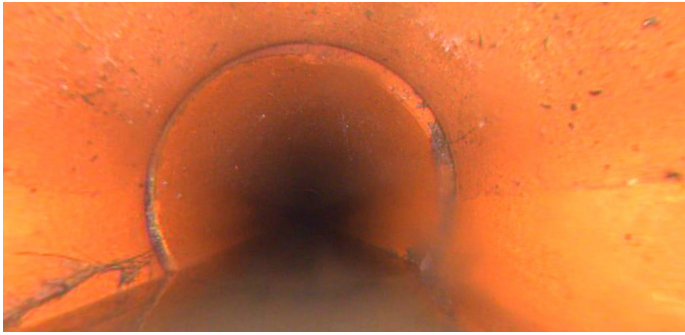
Code: **RFJ**  
Description: **Roots Fine Joint**

Distance (ft): **21.9**  
Structural Grade: **0**  
O&M Grade: **1**  
Clock Start/From: **8**  
Clock To: **4**  
1st Value:  
2nd Value:  
Value Percent:  
Continuous Index: **S01**  
Within 8" of Joint: **YES**  
Remarks:

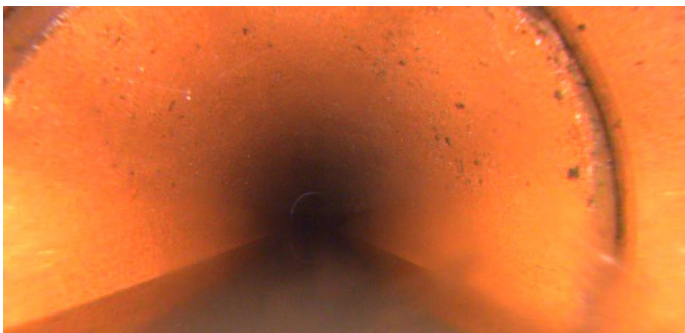
Code: **RFJ**  
Description: **Roots Fine Joint**

Distance (ft): **42.0**  
Structural Grade: **0**  
O&M Grade: **1**  
Clock Start/From: **8**  
Clock To: **4**  
1st Value:  
2nd Value:  
Value Percent:  
Continuous Index: **F01**  
Within 8" of Joint: **YES**  
Remarks:

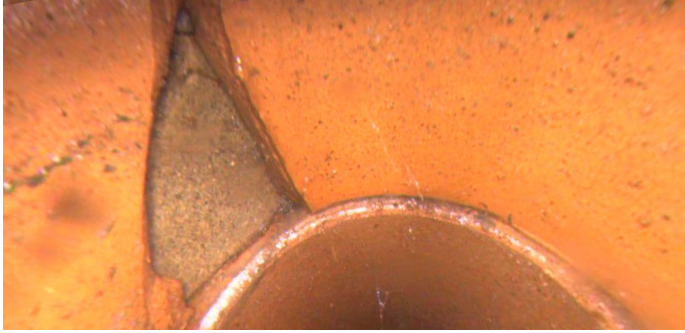
Code: **RPP**  
Description: **Repair Patch**

Distance (ft): **56.5**  
Structural Grade: **0**  
O&M Grade: **0**  
Clock Start/From: **10**  
Clock To: **11**  
1st Value:  
2nd Value:  
Value Percent:  
Continuous Index:  
Within 8" of Joint: **YES**  
Remarks: **concrete**

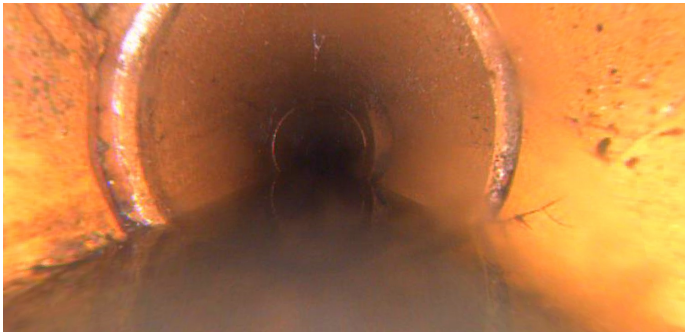
Code: **RFJ**  
Description: **Roots Fine Joint**

Distance (ft): **56.5**  
Structural Grade: **0**  
O&M Grade: **1**  
Clock Start/From: **8**  
Clock To: **4**  
1st Value:  
2nd Value:  
Value Percent:  
Continuous Index:  
Within 8" of Joint: **YES**  
Remarks:

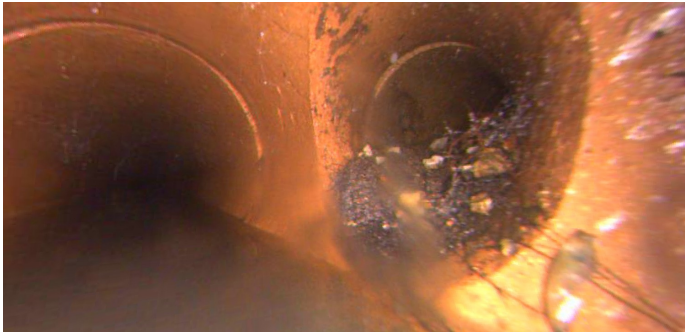
Code: **TFD**  
Description: **Tap Factory Defective**

Distance (ft): **58.1**  
Structural Grade: **0**  
O&M Grade: **2**  
Clock Start/From: **3**  
Clock To:  
1st Value: **4.000**  
2nd Value:  
Value Percent:  
Continuous Index:  
Within 8" of Joint:  
Remarks: **roots**

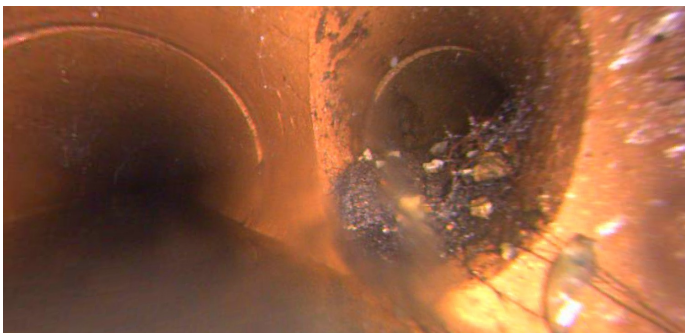
Code: **RFL**  
Description: **Roots Fine Lateral**

Distance (ft): **58.1**  
Structural Grade: **0**  
O&M Grade: **1**  
Clock Start/From: **3**  
Clock To:  
1st Value:  
2nd Value:  
Value Percent:  
Continuous Index:  
Within 8" of Joint: **NO**  
Remarks:

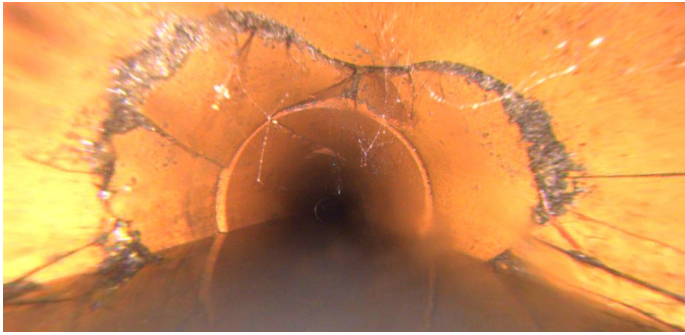
Code: **RFB**  
Description: **Roots Fine Barrel**

Distance (ft): **73.1**  
Structural Grade: **0**  
O&M Grade: **2**  
Clock Start/From: **8**  
Clock To: **4**  
1st Value:  
2nd Value:  
Value Percent:  
Continuous Index:  
Within 8" of Joint: **NO**  
Remarks:

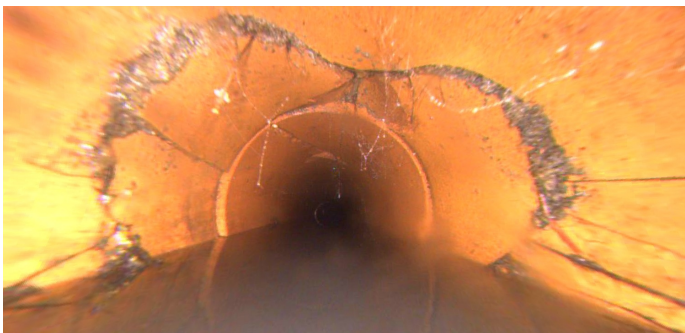
Code: **FM**  
Description: **Fracture Multiple**

Distance (ft): **73.1**  
Structural Grade: **4**  
O&M Grade: **0**  
Clock Start/From: **8**  
Clock To: **4**  
1st Value:  
2nd Value:  
Value Percent:  
Continuous Index:  
Within 8" of Joint: **YES**  
Remarks:

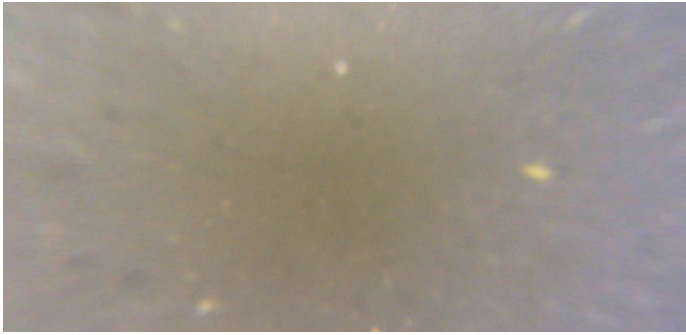
Code: **MWL**  
Description: **Water Level**

Distance (ft): **90.2**  
Structural Grade: **0**  
O&M Grade: **0**  
Clock Start/From:  
Clock To:  
1st Value:  
2nd Value:  
Value Percent: **100.000**  
Continuous Index:  
Within 8" of Joint: **NO**  
Remarks:

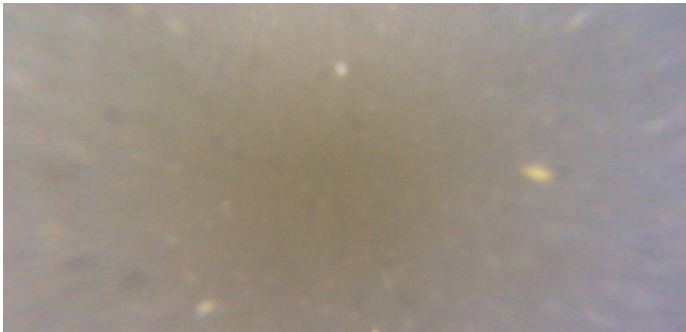
Code: **MCU**  
Description: **Camera Underwater**

Distance (ft): **90.2**  
Structural Grade: **0**  
O&M Grade: **4**  
Clock Start/From:  
Clock To:  
1st Value:  
2nd Value:  
Value Percent:  
Continuous Index: **S02**  
Within 8" of Joint: **NO**  
Remarks:

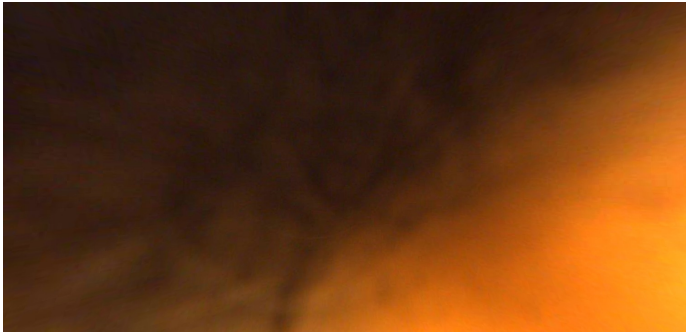
Code: **MCU**  
Description: **Camera Underwater**

Distance (ft): **124.2**  
Structural Grade: **0**  
O&M Grade: **4**  
Clock Start/From:  
Clock To:  
1st Value:  
2nd Value:  
Value Percent:  
Continuous Index: **F02**  
Within 8" of Joint: **NO**  
Remarks:

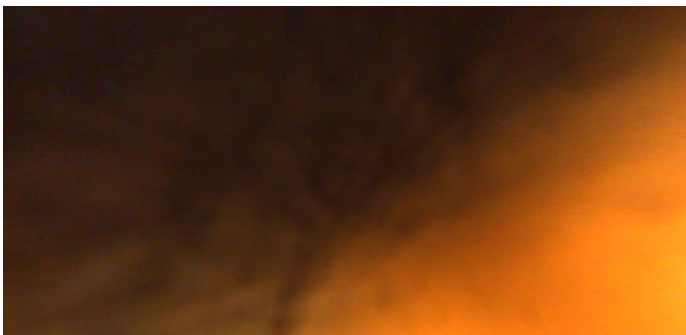
Code: **MSA**  
Description: **Abandoned Survey**

Distance (ft): **124.2**  
Structural Grade: **0**  
O&M Grade: **0**  
Clock Start/From:  
Clock To:  
1st Value:  
2nd Value:  
Value Percent:  
Continuous Index:  
Within 8" of Joint: **NO**  
Remarks: **MCU**
