Profile/Photo Observation Report

Date:	04/14/2018	Weather:		Coding:	PACP 6.0
Pipe Length (ft):	278.7	Owner:	NA	Pre Clean:	No Pre-Cleaning
P.O.#:		Surveyor:	Jen Costello	PSR:	P-505-079-078
Customer:		Clean Date:	01/01/1900	Shape:	C

Street:	W 4TH PL	Flow Control:	Not Controlled
City:	Hobart, IN	Year Renewed:	
Location:	Yard	Tape/Media #:	
Purpose:	Routine Assessment	Dia/Height:	10"
Use:	Sanitary	Material:	VCP
Drain Area:	NA	Lining:	
Category:	NA		
Comment:			
Location Details:		Direction of Survey:	Downstream
US MH:	M-505-079	DS MH:	M-505-078
		Total Length Surveyed (ft):	5.4

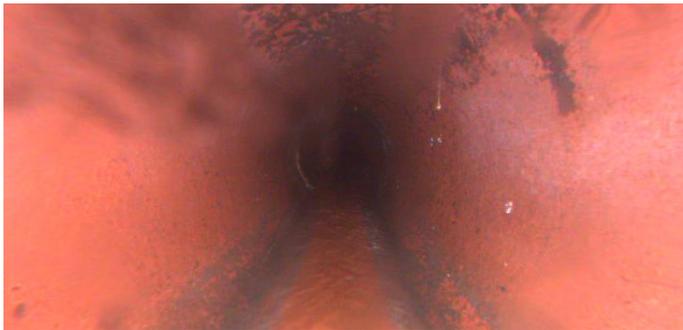
Code: **AMH**
 Description: **Manhole**
 Distance (ft): **.0**
 Structural Grade: **0**
 O&M Grade: **0**
 Clock Start/From:
 Clock To:
 1st Value:
 2nd Value:
 Value Percent:
 Continuous Index:
 Within 8" of Joint: **NO**
 Remarks: **M-505-079**

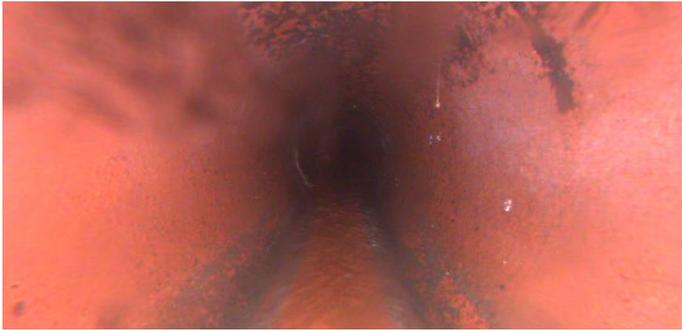
Code: **MWL**
Description: **Water Level**

Distance (ft): **.0**
Structural Grade: **0**
O&M Grade: **0**
Clock Start/From:
Clock To:
1st Value:
2nd Value:
Value Percent: **5.000**
Continuous Index:
Within 8" of Joint: **NO**
Remarks:

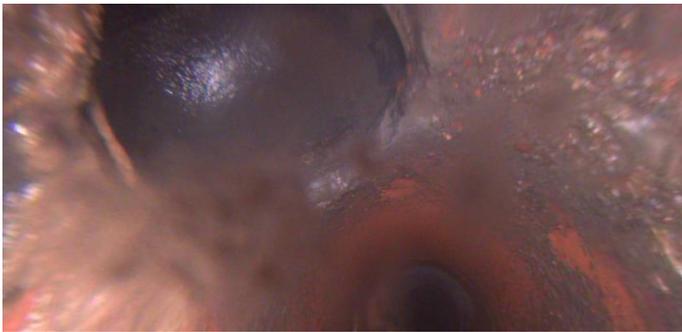
Code: **TBA**
Description: **Tap Break-in Active**

Distance (ft): **3.1**
Structural Grade: **0**
O&M Grade: **0**
Clock Start/From: **11**
Clock To:
1st Value: **4.000**
2nd Value:
Value Percent:
Continuous Index:
Within 8" of Joint:
Remarks:

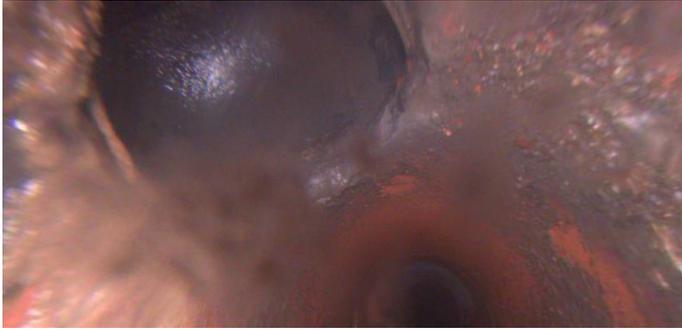
Code: **DAGS**
Description: **Deposits Attached Grease**

Distance (ft): **3.1**
Structural Grade: **0**
O&M Grade: **2**
Clock Start/From: **8**
Clock To: **4**
1st Value:
2nd Value:
Value Percent: **5.000**
Continuous Index:
Within 8" of Joint: **NO**
Remarks:

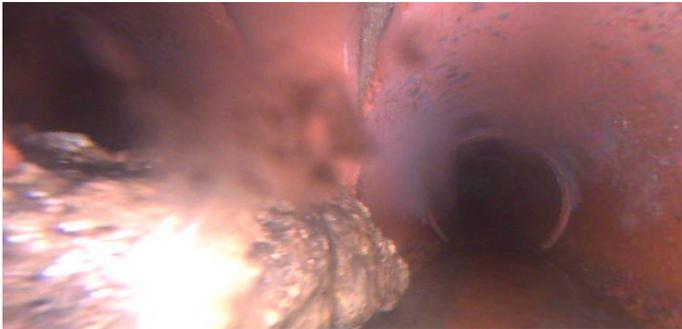
Code: **DAE**
Description: **Deposits Attached Encrustation**

Distance (ft): **5.0**
Structural Grade: **0**
O&M Grade: **2**
Clock Start/From: **7**
Clock To: **9**
1st Value:
2nd Value:
Value Percent: **10.000**
Continuous Index:
Within 8" of Joint: **NO**
Remarks:

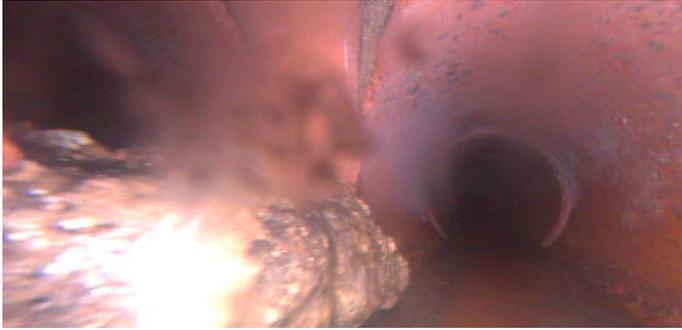
Code: **TBD**
Description: **Tap Break-in Defective**

Distance (ft): **5.0**
Structural Grade: **0**
O&M Grade: **3**
Clock Start/From: **9**
Clock To:
1st Value: **4.000**
2nd Value:
Value Percent:
Continuous Index:
Within 8" of Joint:
Remarks: **dae**

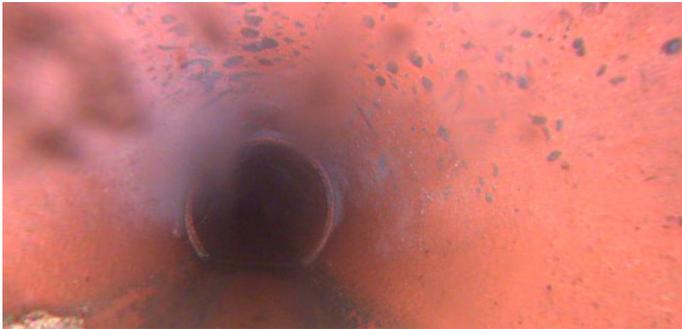
Code: **MSA**
Description: **Abandoned Survey**

Distance (ft): **5.4**
Structural Grade: **0**
O&M Grade: **0**
Clock Start/From:
Clock To:
1st Value:
2nd Value:
Value Percent:
Continuous Index:
Within 8" of Joint: **NO**
Remarks: **dae**
