Profile/Photo Observation Report

Date:	04/14/2018	Weather:		Coding:	PACP 6.0
Pipe Length (ft):	278.7	Owner:	NA	Pre Clean:	No Pre-Cleaning
P.O.#:		Surveyor:	Jen Costello	PSR:	P-505-079-078
Customer:		Clean Date:	01/01/1900	Shape:	C

Street:	FOXCROFT STREET	Flow Control:	Not Controlled
City:	Hobart, IN	Year Renewed:	
Location:	Yard	Tape/Media #:	
Purpose:	Routine Assessment	Dia/Height:	10"
Use:	Sanitary	Material:	VCP
Drain Area:	NA	Lining:	
Category:	NA		
Comment:

Location Details:		Direction of Survey:	Downstream
US MH:	M-505-079	DS MH:	M-505-078
		Total Length Surveyed (ft):	5.4

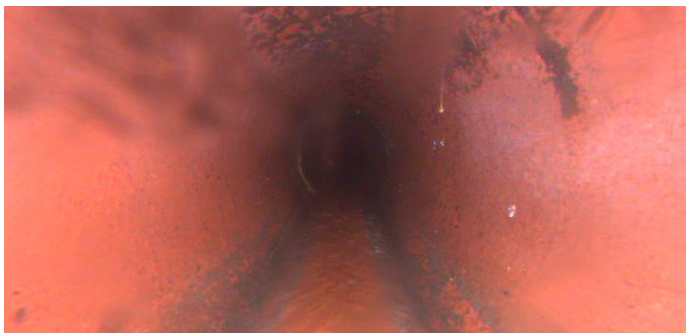
Code: **AMH**
Description: **Manhole**

Distance (ft): **.0**
Structural Grade: **0**
O&M Grade: **0**
Clock Start/From:
Clock To:
1st Value:
2nd Value:
Value Percent:
Continuous Index:
Within 8" of Joint: **NO**
Remarks: **M-505-079**

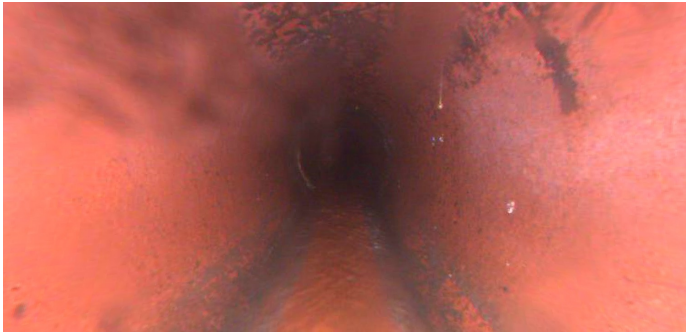
Code:	MWL
Description:	Water Level

Distance (ft):	.0
Structural Grade:	0
O&M Grade:	0
Clock Start/From:	
Clock To:	
1st Value:	
2nd Value:	
Value Percent:	5.000
Continuous Index:	
Within 8" of Joint:	NO
Remarks:

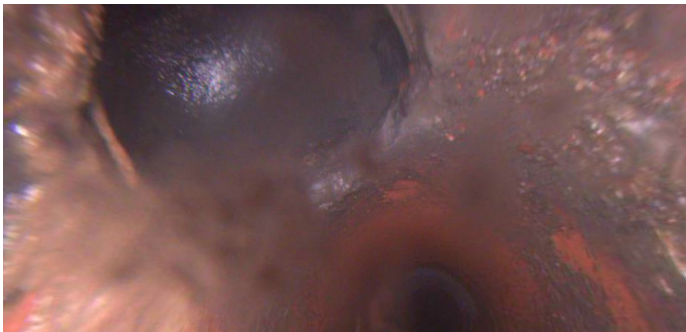
Code:	TBA
Description:	Tap Break-in Active

Distance (ft):	3.1
Structural Grade:	0
O&M Grade:	0
Clock Start/From:	11
Clock To:	
1st Value:	4.000
2nd Value:	
Value Percent:	
Continuous Index:	
Within 8" of Joint:	
Remarks:

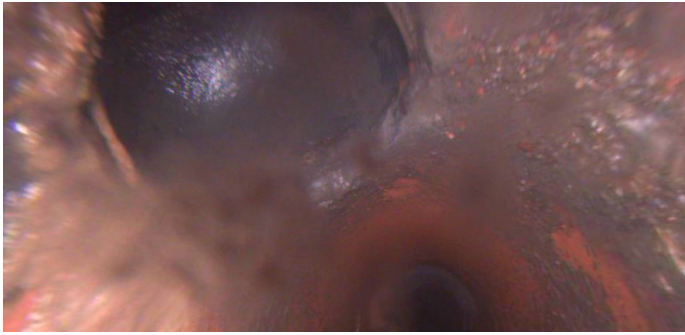
Code: **DAGS**
Description: **Deposits Attached Grease**

Distance (ft): **3.1**
Structural Grade: **0**
O&M Grade: **2**
Clock Start/From: **8**
Clock To: **4**
1st Value:
2nd Value:
Value Percent: **5.000**
Continuous Index:
Within 8" of Joint: **NO**
Remarks:

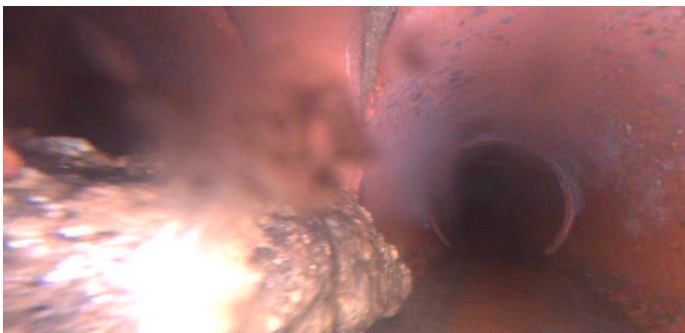
Code: **DAE**
Description: **Deposits Attached Encrustation**

Distance (ft): **5.0**
Structural Grade: **0**
O&M Grade: **2**
Clock Start/From: **7**
Clock To: **9**
1st Value:
2nd Value:
Value Percent: **10.000**
Continuous Index:
Within 8" of Joint: **NO**
Remarks:

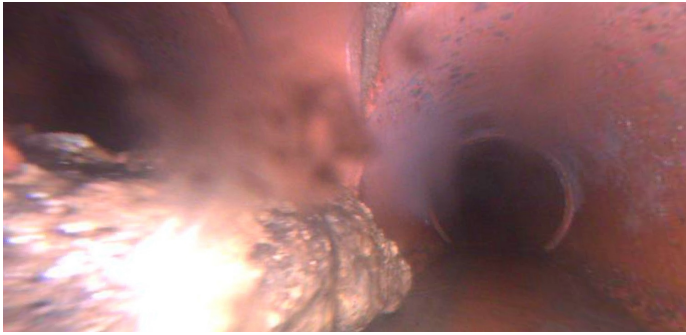
Code: **TBD**
Description: **Tap Break-in Defective**

Distance (ft): **5.0**
Structural Grade: **0**
O&M Grade: **3**
Clock Start/From: **9**
Clock To:
1st Value: **4.000**
2nd Value:
Value Percent:
Continuous Index:
Within 8" of Joint:
Remarks: **dae**

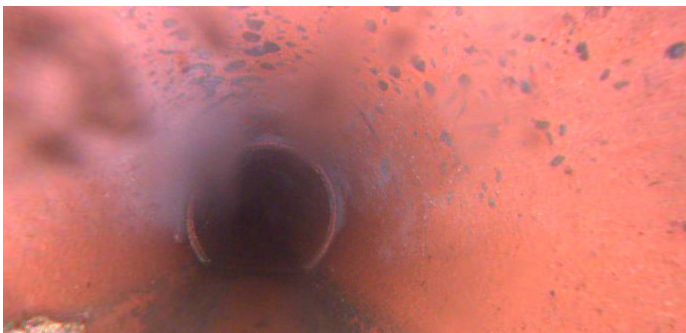
Code: **MSA**
Description: **Abandoned Survey**

Distance (ft): **5.4**
Structural Grade: **0**
O&M Grade: **0**
Clock Start/From:
Clock To:
1st Value:
2nd Value:
Value Percent:
Continuous Index:
Within 8" of Joint: **NO**
Remarks: **dae**
