Profile/Photo Observation Report

Date:	01/13/2022	Weather:		Coding:	PACP 7.0
Pipe Length (ft):	305.1	Owner:	City of Hobart	Pre Clean:	Light Cleaning
P.O.#:	YES502259	Surveyor:	S. Bucklin	PSR:	P-505-079-078
Customer:	City of Hobart	Clean Date:	01/12/2021	Shape:	C

Street:	West 4th Street	Flow Control:	Not Controlled
City:	Hobart, IN	Year Renewed:	
Location:	Local rural streets with light traffic, t	Tape/Media #:	
Purpose:	Routine Assessment	Dia/Height:	8"
Use:	Sanitary Sewage Pipe	Material:	VCP
Drain Area:		Lining:	None
Category:	NA		
Comment:			
Location Details:		Direction of Survey:	Downstream
US MH:	M-505-079	DS MH:	M-505-078
		Total Length Surveyed (ft):	305.1

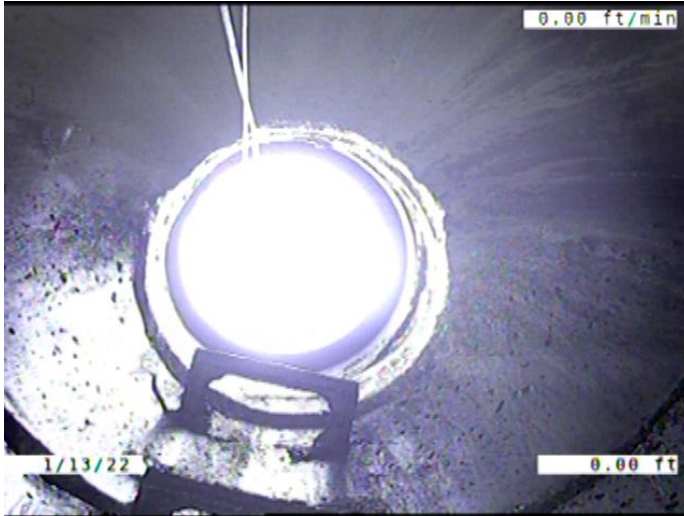
Code: **AMH**
Description: **Manhole**

Distance (ft): **.0**
Structural Grade: **0**
O&M Grade: **0**
Clock Start/From:
Clock To:
1st Value:
2nd Value:
Value Percent:
Continuous Index:
Within 8" of Joint: **NO**
Remarks: **M-505-079**

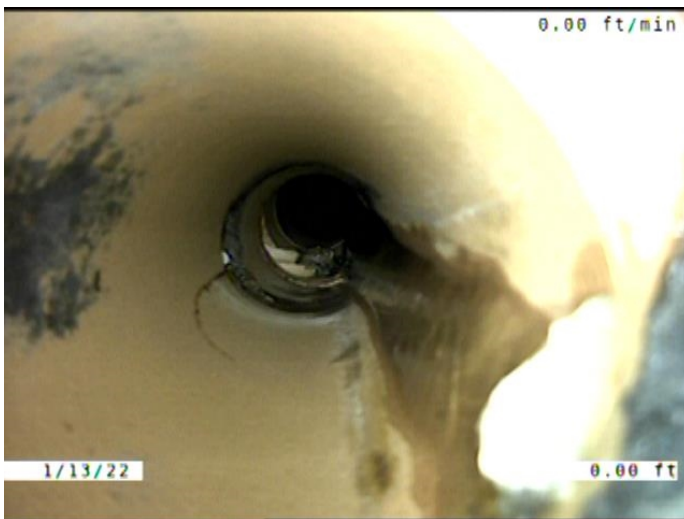
Code: **MWL**
Description: **Miscellaneous Water Level**

Distance (ft): **.0**
Structural Grade: **0**
O&M Grade: **0**
Clock Start/From:
Clock To:
1st Value:
2nd Value:
Value Percent: **5.000**
Continuous Index:
Within 8" of Joint: **NO**
Remarks:

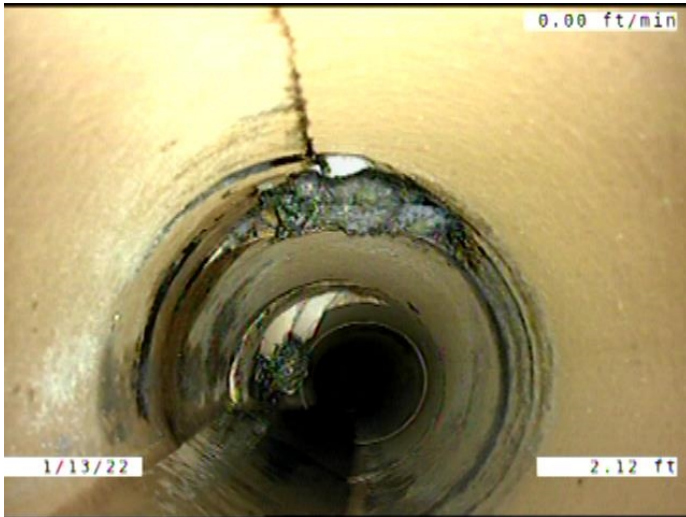
Code: **CL**
Description: **Crack Longitudinal**

Distance (ft): **2.1**
Structural Grade: **2**
O&M Grade: **0**
Clock Start/From: **11**
Clock To:
1st Value:
2nd Value:
Value Percent:
Continuous Index:
Within 8" of Joint: **YES**
Remarks:

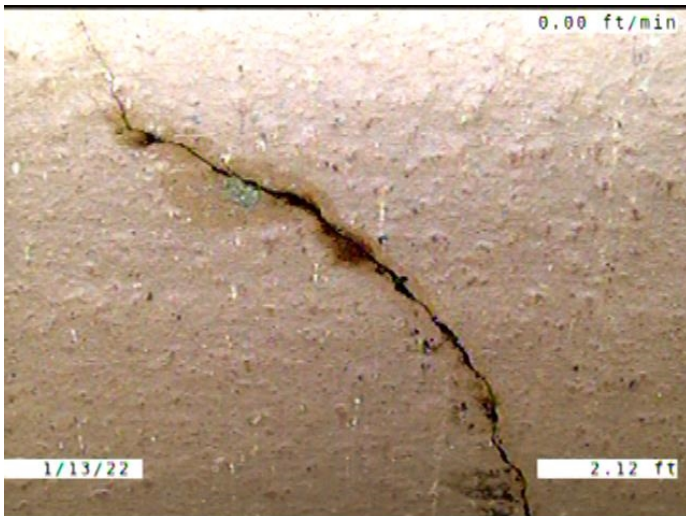
Code: **ISB**
Description: **Infiltration Stain Barrel**

Distance (ft): **2.1**
Structural Grade: **0**
O&M Grade: **1**
Clock Start/From: **9**
Clock To: **11**
1st Value:
2nd Value:
Value Percent:
Continuous Index:
Within 8" of Joint: **YES**
Remarks:

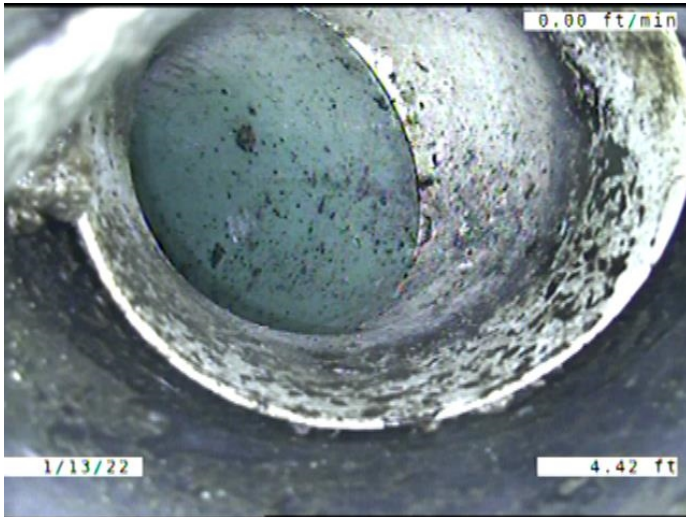
Code: **TBD**
Description: **Tap Break-in/Hammer Defective**

Distance (ft): **4.4**
Structural Grade: **0**
O&M Grade: **3**
Clock Start/From: **11**
Clock To:
1st Value: **4.000**
2nd Value:
Value Percent:
Continuous Index:
Within 8" of Joint: **YES**
Remarks: **SOIL VISIBLE AROUND THE BOOT**

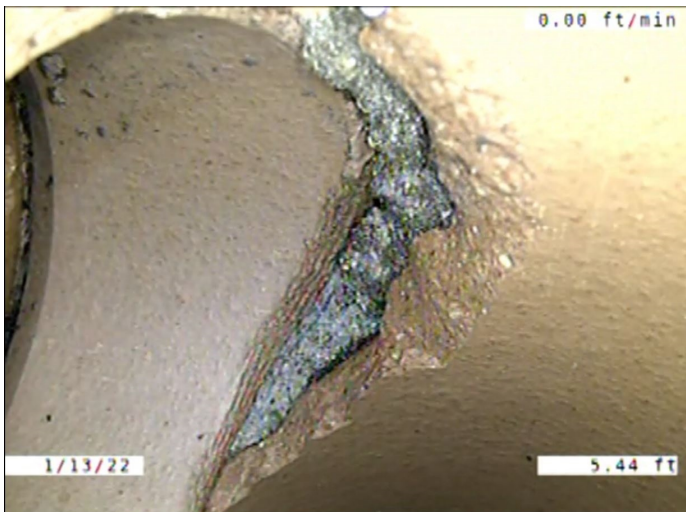
Code: **SSS**
Description: **Surface Damage Surface Spalling**

Distance (ft): **4.5**
Structural Grade: **2**
O&M Grade: **0**
Clock Start/From: **11**
Clock To:
1st Value:
2nd Value:
Value Percent:
Continuous Index:
Within 8" of Joint: **NO**
Remarks:

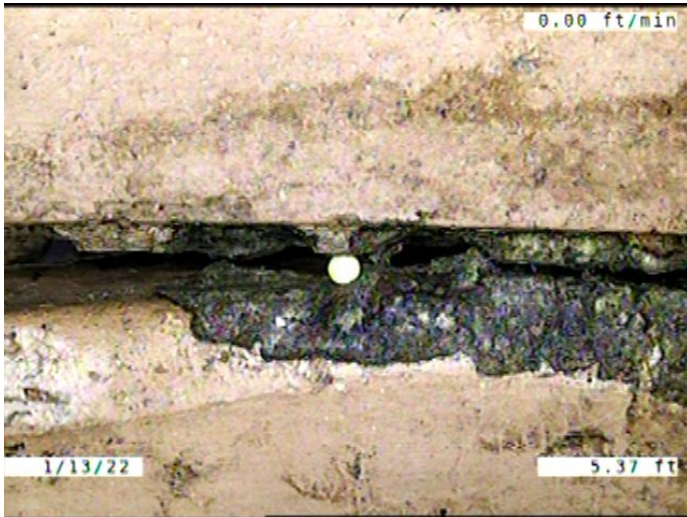
Code: **DAE**
 Description: **Deposits Attached Encrustation**

Distance (ft): **5.4**
 Structural Grade: **0**
 O&M Grade: **2**
 Clock Start/From: **8**
 Clock To: **9**
 1st Value:
 2nd Value:
 Value Percent: **5.000**
 Continuous Index:
 Within 8" of Joint: **YES**
 Remarks:

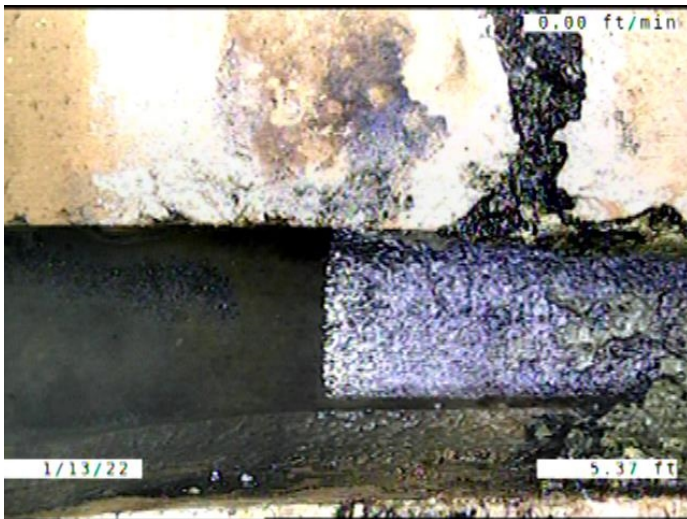
Code: **JAL**
 Description: **Joint Angular Large**

Distance (ft): **5.4**
 Structural Grade: **4**
 O&M Grade: **0**
 Clock Start/From:
 Clock To:
 1st Value:
 2nd Value:
 Value Percent:
 Continuous Index:
 Within 8" of Joint: **NO**
 Remarks:

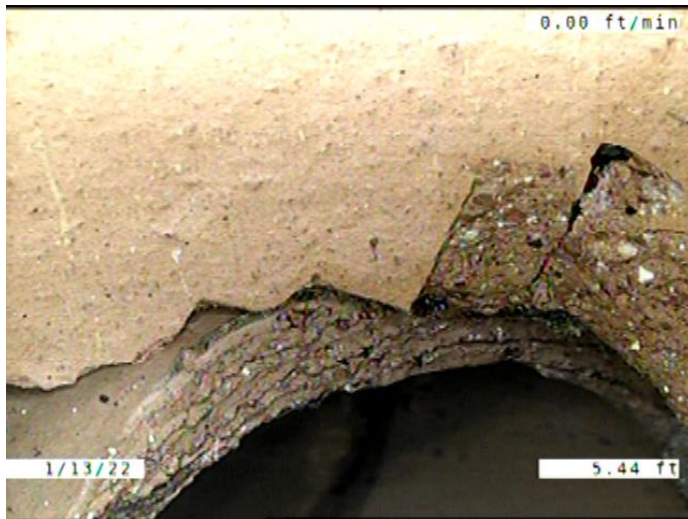
Code: **B**
 Description: **Broken**

Distance (ft): **5.4**
 Structural Grade: **4**
 O&M Grade: **0**
 Clock Start/From: **8**
 Clock To: **10**
 1st Value:
 2nd Value:
 Value Percent:
 Continuous Index:
 Within 8" of Joint: **YES**
 Remarks:

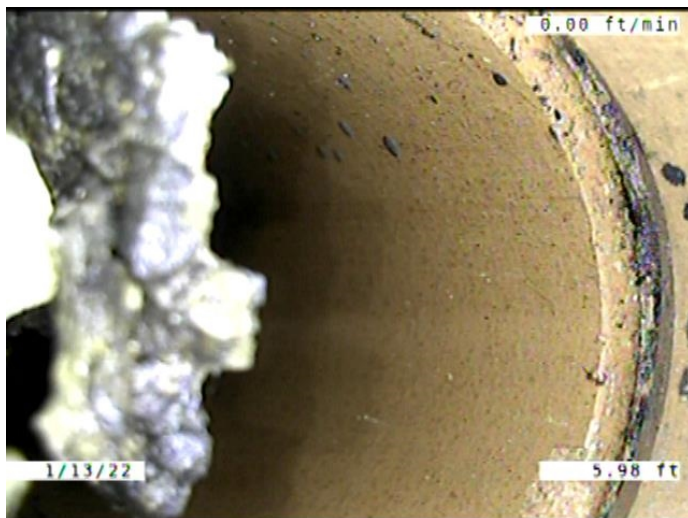
Code: **TBI**
 Description: **Tap Break-in Intruding**

Distance (ft): **6.0**
 Structural Grade: **0**
 O&M Grade: **2**
 Clock Start/From: **10**
 Clock To:
 1st Value: **4.000**
 2nd Value: **2.000**
 Value Percent:
 Continuous Index:
 Within 8" of Joint: **YES**
 Remarks:

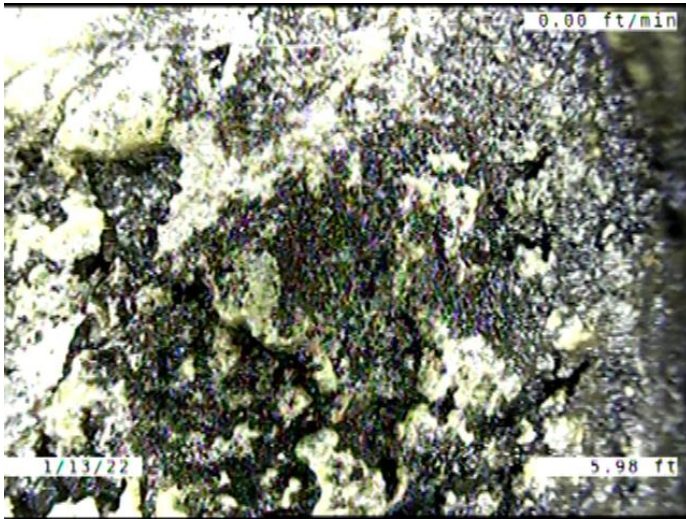
Code: **DAE**
 Description: **Deposits Attached Encrustation**

Distance (ft): **6.0**
 Structural Grade: **0**
 O&M Grade: **2**
 Clock Start/From: **7**
 Clock To: **9**
 1st Value:
 2nd Value:
 Value Percent: **5.000**
 Continuous Index:
 Within 8" of Joint: **YES**
 Remarks: **COMING OUT OF THE TAP AND INTO THE MAIN**

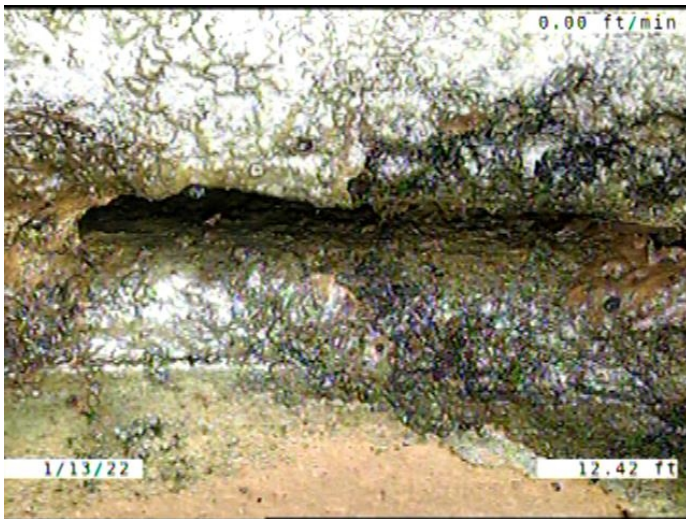
Code: **DAE**
 Description: **Deposits Attached Encrustation**

Distance (ft): **12.4**
 Structural Grade: **0**
 O&M Grade: **2**
 Clock Start/From: **7**
 Clock To: **5**
 1st Value:
 2nd Value:
 Value Percent: **5.000**
 Continuous Index: **S01**
 Within 8" of Joint: **YES**
 Remarks:

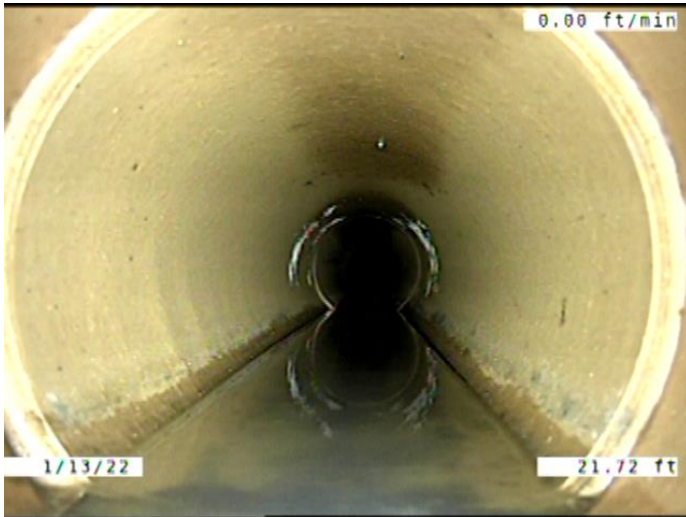
Code: **MWLS**
 Description: **Miscellaneous Water Level Sag**

Distance (ft): **21.7**
 Structural Grade: **2**
 O&M Grade: **0**
 Clock Start/From:
 Clock To:
 1st Value:
 2nd Value:
 Value Percent: **5.000**
 Continuous Index:
 Within 8" of Joint: **NO**
 Remarks:

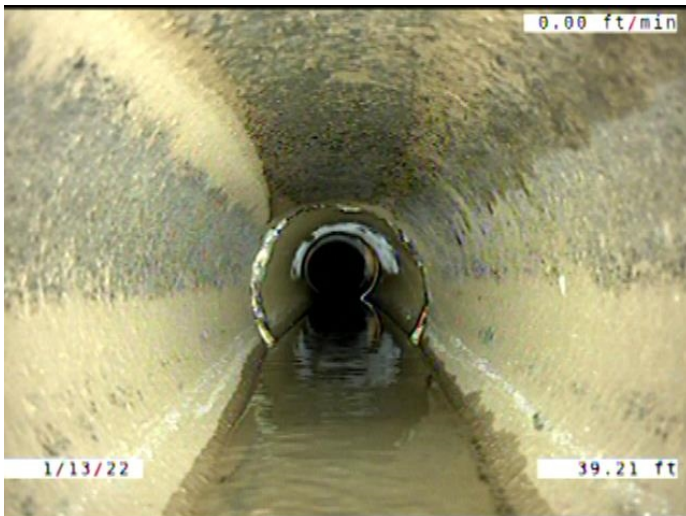
Code: **MWLS**
 Description: **Miscellaneous Water Level Sag**

Distance (ft): **39.2**
 Structural Grade: **2**
 O&M Grade: **0**
 Clock Start/From:
 Clock To:
 1st Value:
 2nd Value:
 Value Percent: **10.000**
 Continuous Index: **S02**
 Within 8" of Joint: **NO**
 Remarks:

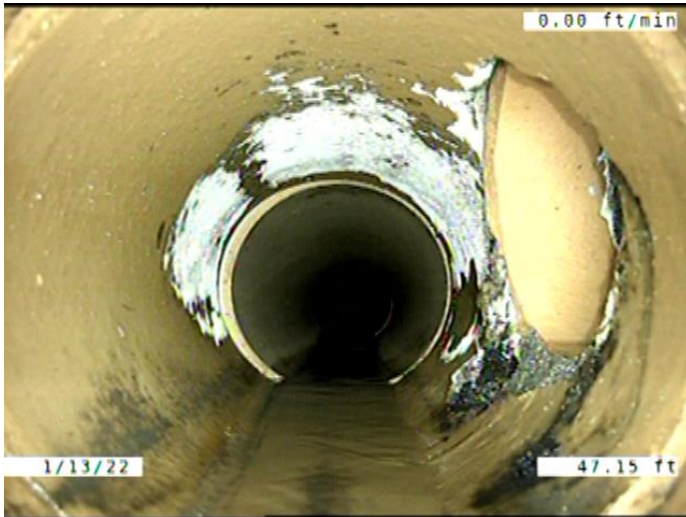
Code: **MWLS**
 Description: **Miscellaneous Water Level Sag**

Distance (ft): **47.1**
 Structural Grade: **2**
 O&M Grade: **0**
 Clock Start/From:
 Clock To:
 1st Value:
 2nd Value:
 Value Percent: **10.000**
 Continuous Index: **F02**
 Within 8" of Joint: **NO**
 Remarks:

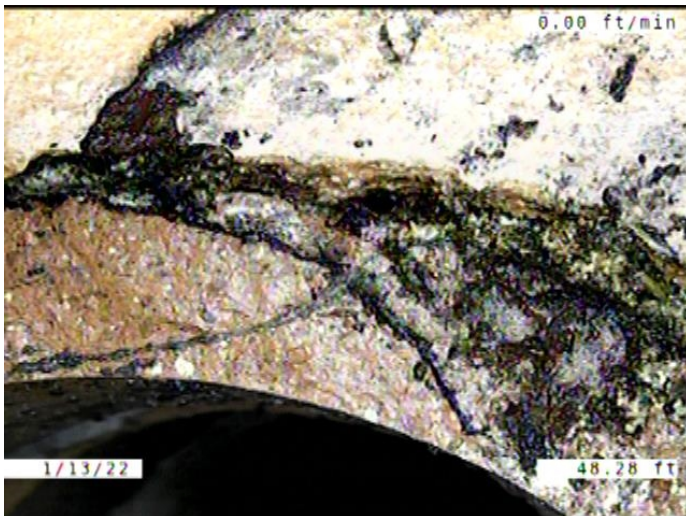
Code: **B**
 Description: **Broken**

Distance (ft): **48.3**
 Structural Grade: **4**
 O&M Grade: **0**
 Clock Start/From: **1**
 Clock To: **4**
 1st Value:
 2nd Value:
 Value Percent:
 Continuous Index:
 Within 8" of Joint: **YES**
 Remarks:

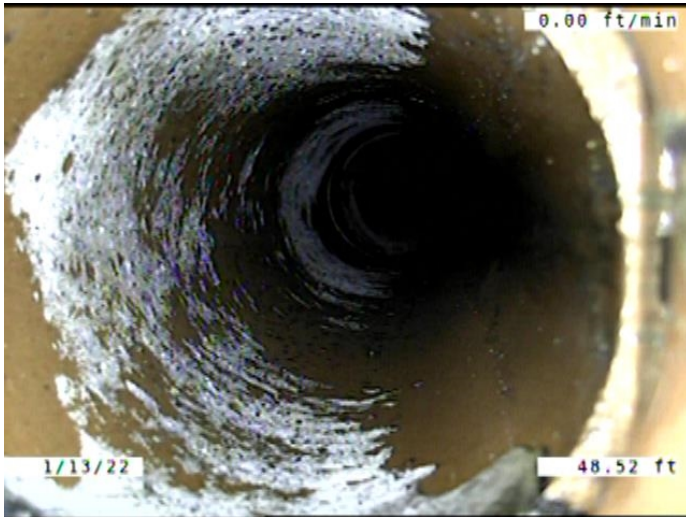
Code: **TBI**
 Description: **Tap Break-in Intruding**

Distance (ft): **48.5**
 Structural Grade: **0**
 O&M Grade: **2**
 Clock Start/From: **3**
 Clock To:
 1st Value: **4.000**
 2nd Value: **1.000**
 Value Percent:
 Continuous Index:
 Within 8" of Joint: **YES**
 Remarks:

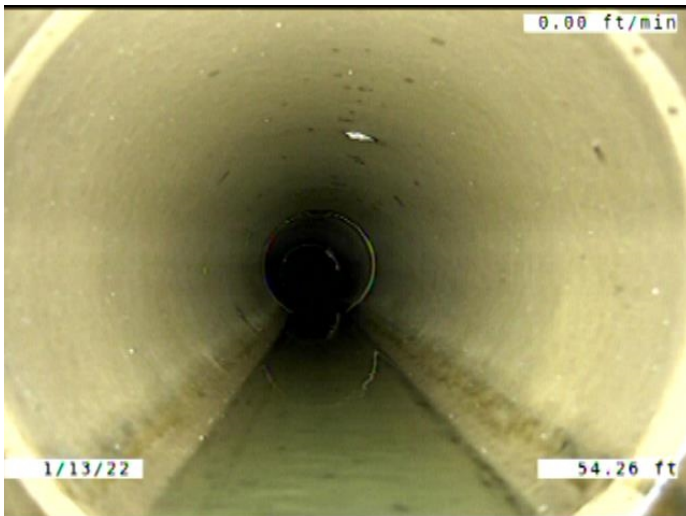
Code: **MWLS**
 Description: **Miscellaneous Water Level Sag**

Distance (ft): **54.3**
 Structural Grade: **2**
 O&M Grade: **0**
 Clock Start/From:
 Clock To:
 1st Value:
 2nd Value:
 Value Percent: **5.000**
 Continuous Index:
 Within 8" of Joint: **NO**
 Remarks:

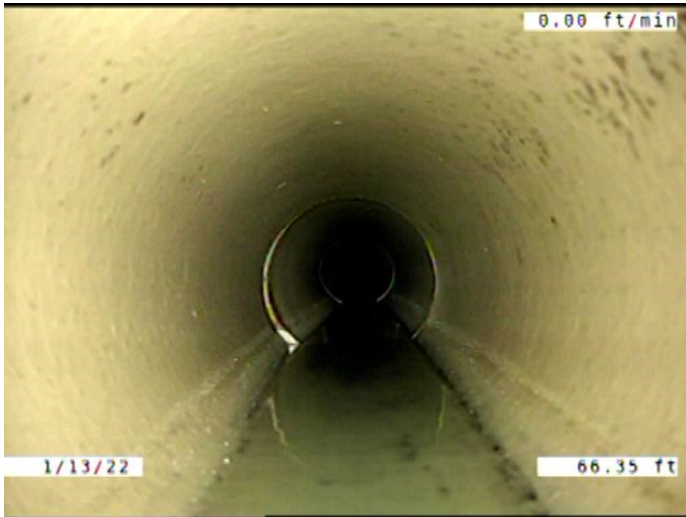
Code: **MWLS**
Description: **Miscellaneous Water Level Sag**

Distance (ft): **66.4**
Structural Grade: **2**
O&M Grade: **0**
Clock Start/From:
Clock To:
1st Value:
2nd Value:
Value Percent: **10.000**
Continuous Index: **S03**
Within 8" of Joint: **NO**
Remarks:

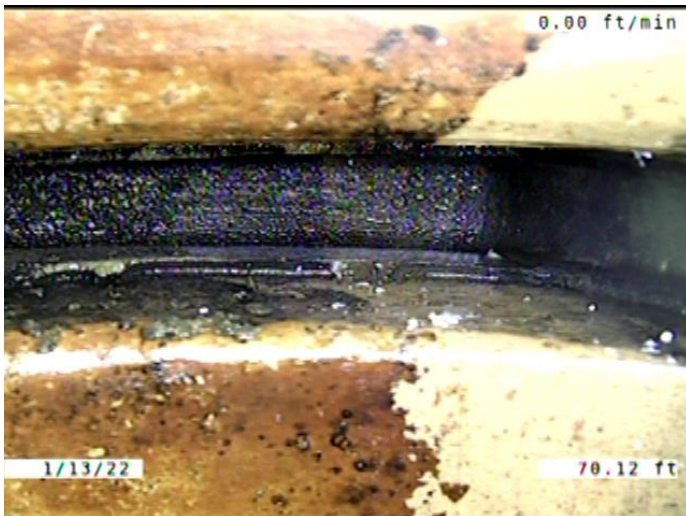
Code: **JAM**
Description: **Joint Angular Medium**

Distance (ft): **70.1**
Structural Grade: **3**
O&M Grade: **0**
Clock Start/From:
Clock To:
1st Value:
2nd Value:
Value Percent:
Continuous Index:
Within 8" of Joint: **NO**
Remarks:

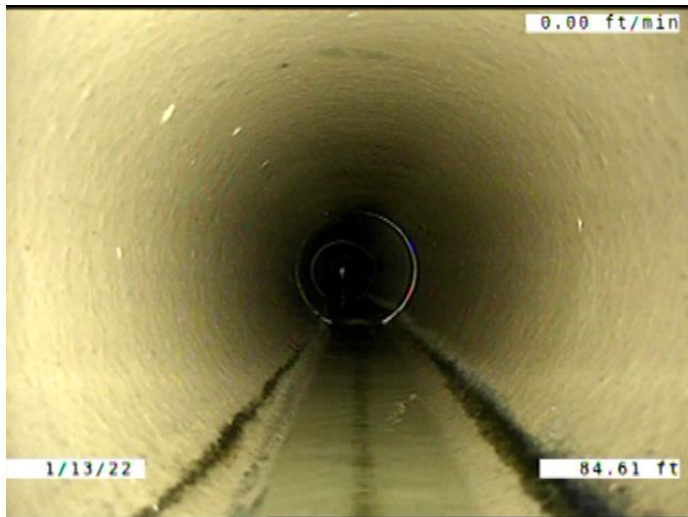
Code: **MWLS**
 Description: **Miscellaneous Water Level Sag**

Distance (ft): **84.6**
 Structural Grade: **2**
 O&M Grade: **0**
 Clock Start/From:
 Clock To:
 1st Value:
 2nd Value:
 Value Percent: **10.000**
 Continuous Index: **F03**
 Within 8" of Joint: **NO**
 Remarks:

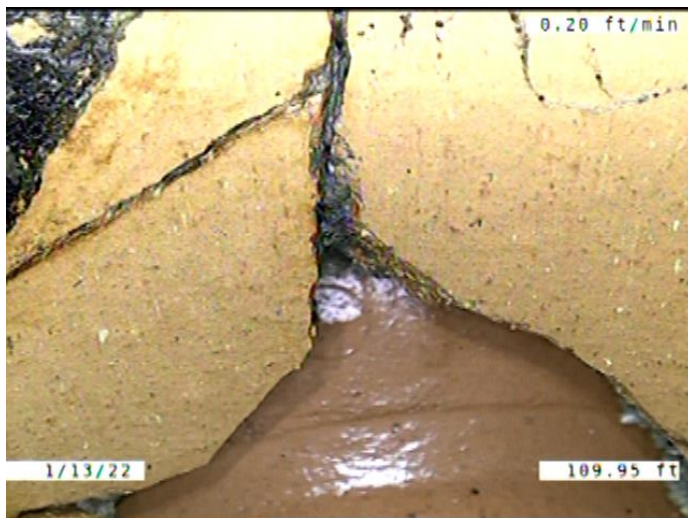
Code: **B**
 Description: **Broken**

Distance (ft): **109.9**
 Structural Grade: **4**
 O&M Grade: **0**
 Clock Start/From: **7**
 Clock To: **1**
 1st Value:
 2nd Value:
 Value Percent:
 Continuous Index:
 Within 8" of Joint: **YES**
 Remarks:

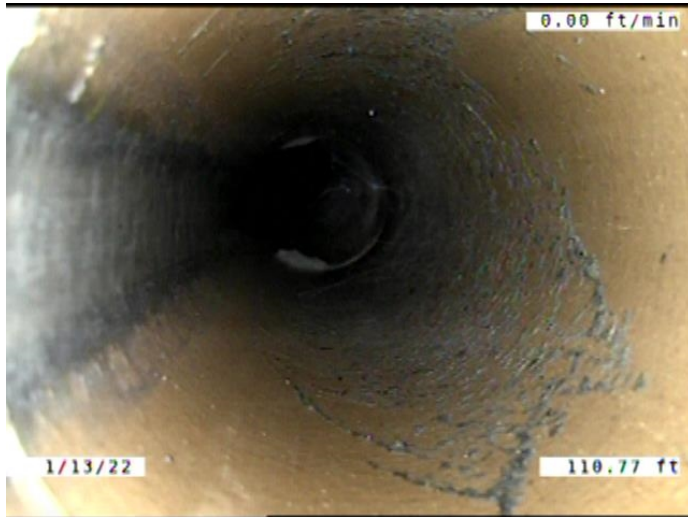
Code: **TBI**
 Description: **Tap Break-in Intruding**

Distance (ft): **110.8**
 Structural Grade: **0**
 O&M Grade: **2**
 Clock Start/From: **9**
 Clock To:
 1st Value: **6.000**
 2nd Value: **1.000**
 Value Percent:
 Continuous Index:
 Within 8" of Joint: **YES**
 Remarks:

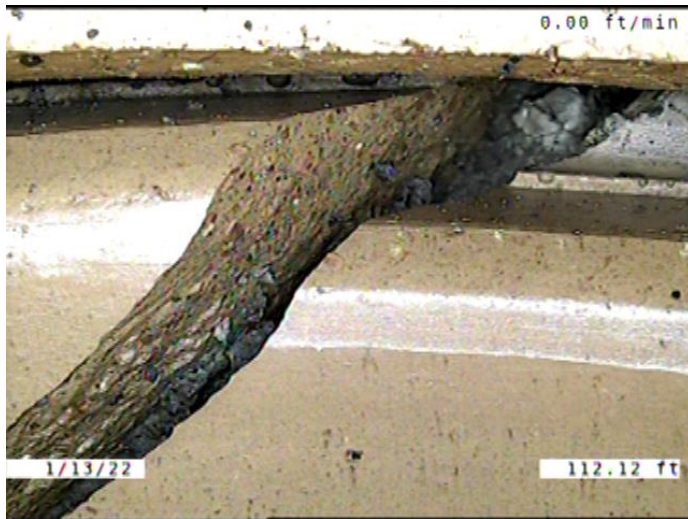
Code: **BSV**
 Description: **Broken Soil Visible**

Distance (ft): **112.1**
 Structural Grade: **5**
 O&M Grade: **0**
 Clock Start/From: **8**
 Clock To: **12**
 1st Value:
 2nd Value:
 Value Percent:
 Continuous Index:
 Within 8" of Joint: **YES**
 Remarks:

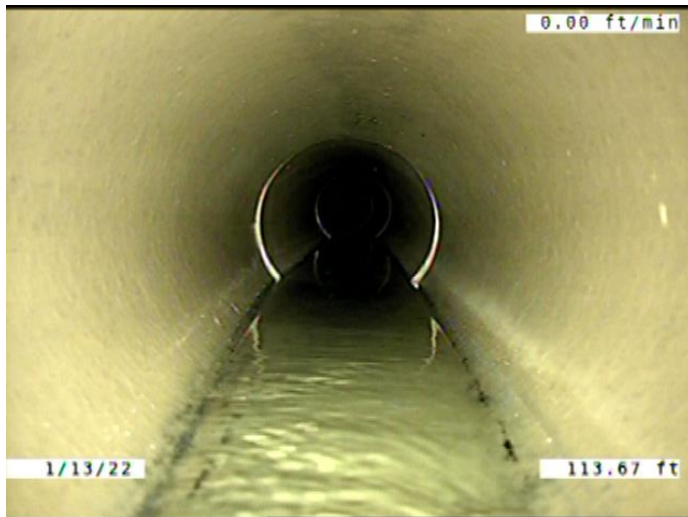
Code: **MWLS**
Description: **Miscellaneous Water Level Sag**

Distance (ft): **113.7**
Structural Grade: **2**
O&M Grade: **0**
Clock Start/From:
Clock To:
1st Value:
2nd Value:
Value Percent: **10.000**
Continuous Index: **S04**
Within 8" of Joint: **NO**
Remarks:

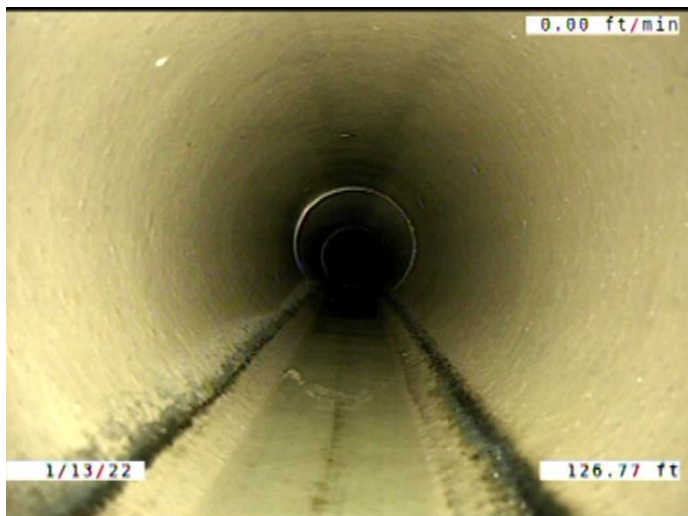
Code: **MWLS**
Description: **Miscellaneous Water Level Sag**

Distance (ft): **126.8**
Structural Grade: **2**
O&M Grade: **0**
Clock Start/From:
Clock To:
1st Value:
2nd Value:
Value Percent: **10.000**
Continuous Index: **F04**
Within 8" of Joint: **NO**
Remarks:

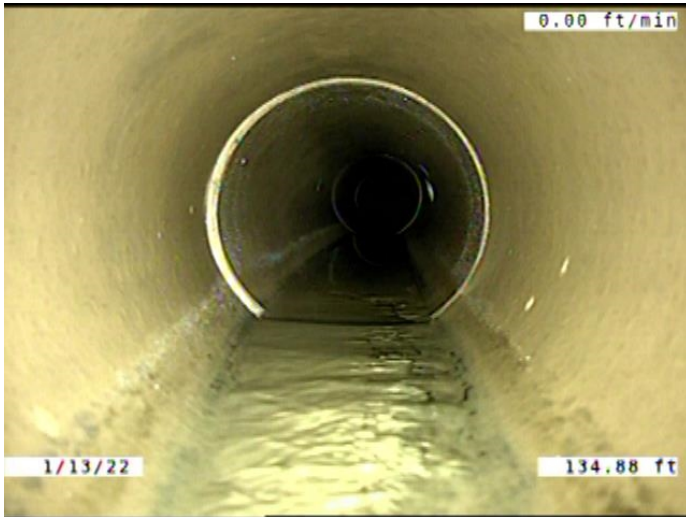
Code: **MWLS**
Description: **Miscellaneous Water Level Sag**

Distance (ft): **134.9**
Structural Grade: **2**
O&M Grade: **0**
Clock Start/From:
Clock To:
1st Value:
2nd Value:
Value Percent: **5.000**
Continuous Index: **S05**
Within 8" of Joint: **NO**
Remarks:

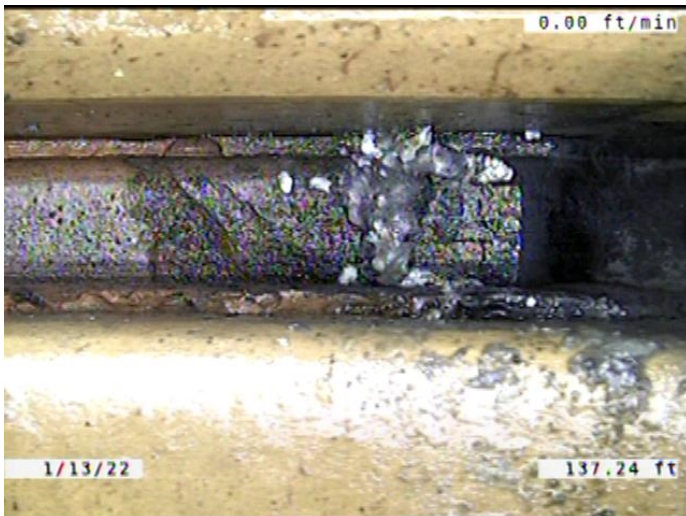
Code: **JAM**
Description: **Joint Angular Medium**

Distance (ft): **137.2**
Structural Grade: **3**
O&M Grade: **0**
Clock Start/From:
Clock To:
1st Value:
2nd Value:
Value Percent:
Continuous Index:
Within 8" of Joint: **NO**
Remarks:

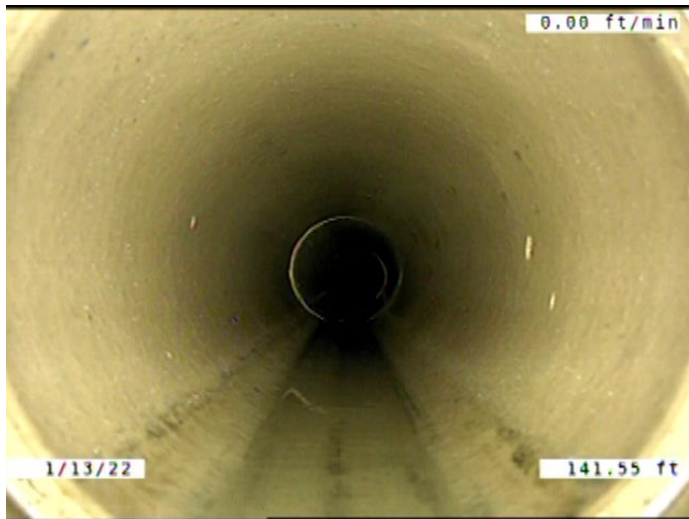
Code: **MWLS**
Description: **Miscellaneous Water Level Sag**

Distance (ft): **141.5**
Structural Grade: **2**
O&M Grade: **0**
Clock Start/From:
Clock To:
1st Value:
2nd Value:
Value Percent: **5.000**
Continuous Index: **F05**
Within 8" of Joint: **NO**
Remarks:

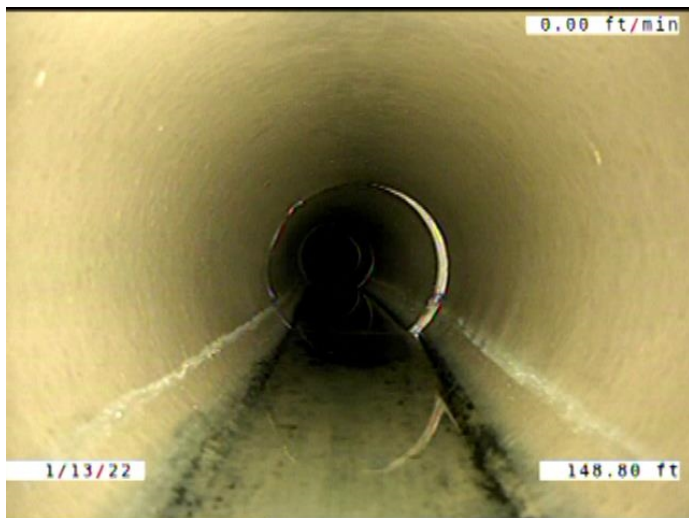
Code: **MWLS**
Description: **Miscellaneous Water Level Sag**

Distance (ft): **148.8**
Structural Grade: **2**
O&M Grade: **0**
Clock Start/From:
Clock To:
1st Value:
2nd Value:
Value Percent: **5.000**
Continuous Index: **S06**
Within 8" of Joint: **NO**
Remarks:

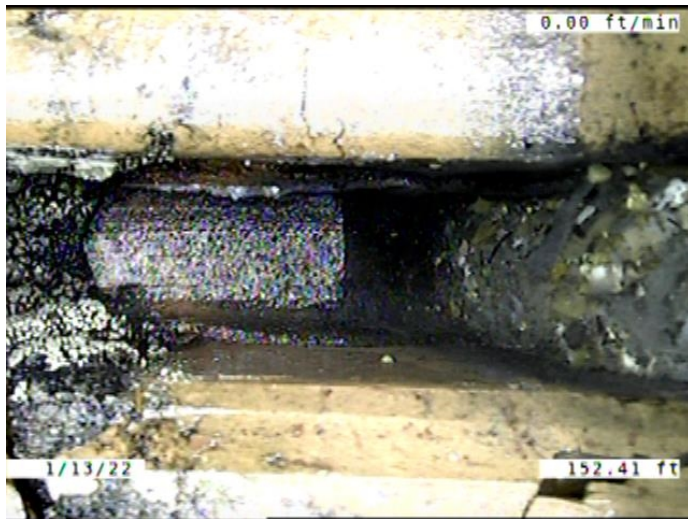
Code: **JAM**
Description: **Joint Angular Medium**

Distance (ft): **152.4**
Structural Grade: **3**
O&M Grade: **0**
Clock Start/From:
Clock To:
1st Value:
2nd Value:
Value Percent:
Continuous Index:
Within 8" of Joint: **NO**
Remarks:

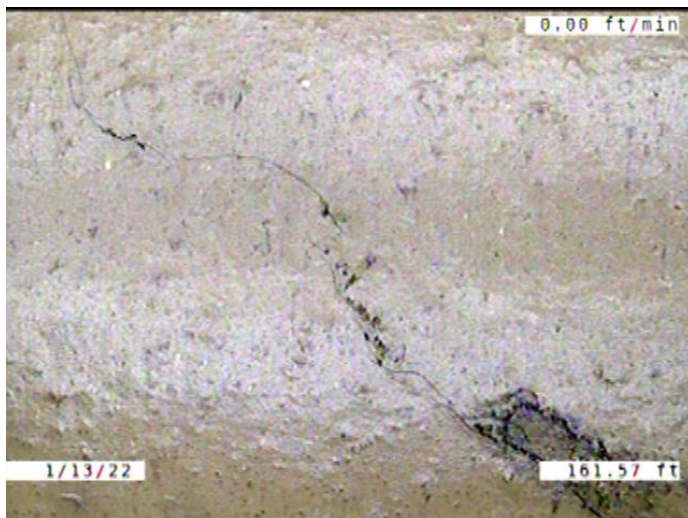
Code: **CS**
Description: **Crack Spiral**

Distance (ft): **161.6**
Structural Grade: **2**
O&M Grade: **0**
Clock Start/From: **2**
Clock To: **6**
1st Value:
2nd Value:
Value Percent:
Continuous Index:
Within 8" of Joint: **YES**
Remarks:

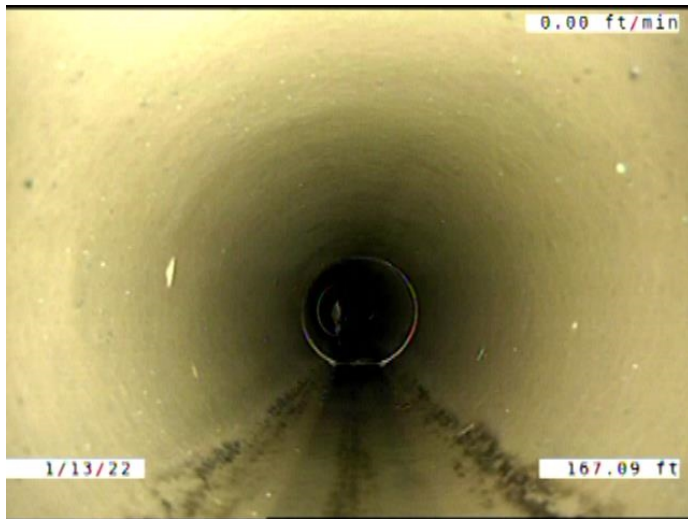
Code: **MWLS**
Description: **Miscellaneous Water Level Sag**

Distance (ft): **167.1**
Structural Grade: **2**
O&M Grade: **0**
Clock Start/From:
Clock To:
1st Value:
2nd Value:
Value Percent: **5.000**
Continuous Index: **F06**
Within 8" of Joint: **NO**
Remarks:

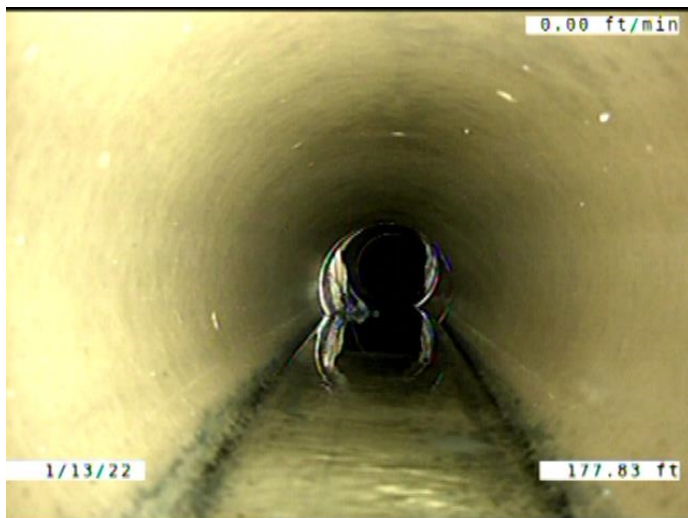
Code: **MWLS**
Description: **Miscellaneous Water Level Sag**

Distance (ft): **177.8**
Structural Grade: **2**
O&M Grade: **0**
Clock Start/From:
Clock To:
1st Value:
2nd Value:
Value Percent: **10.000**
Continuous Index: **S07**
Within 8" of Joint: **NO**
Remarks:

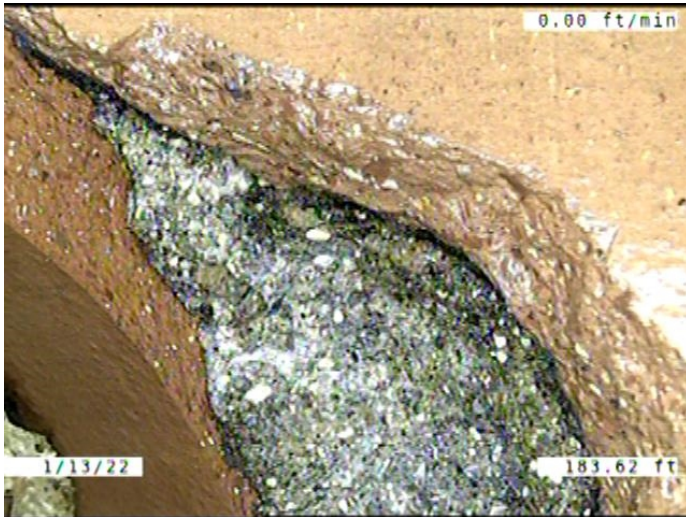
Code: **SSS**
 Description: **Surface Damage Surface Spalling**

Distance (ft): **183.6**
 Structural Grade: **2**
 O&M Grade: **0**
 Clock Start/From: **8**
 Clock To: **12**
 1st Value:
 2nd Value:
 Value Percent:
 Continuous Index:
 Within 8" of Joint: **NO**
 Remarks:

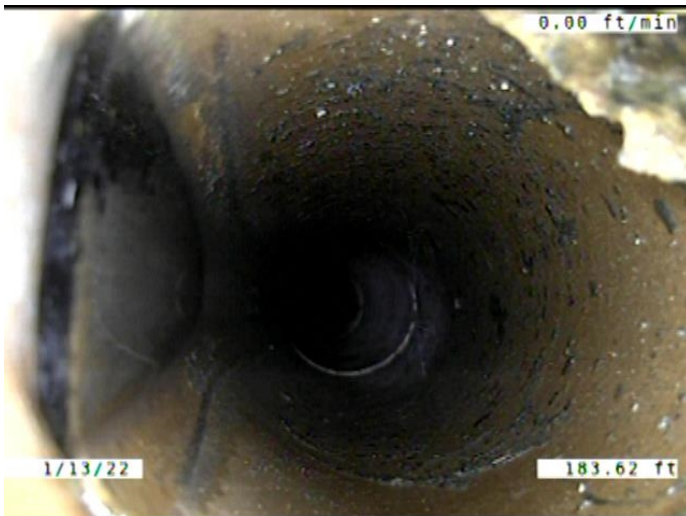
Code: **TBI**
 Description: **Tap Break-in Intruding**

Distance (ft): **183.6**
 Structural Grade: **0**
 O&M Grade: **2**
 Clock Start/From: **9**
 Clock To:
 1st Value: **6.000**
 2nd Value: **1.000**
 Value Percent:
 Continuous Index:
 Within 8" of Joint: **YES**
 Remarks:

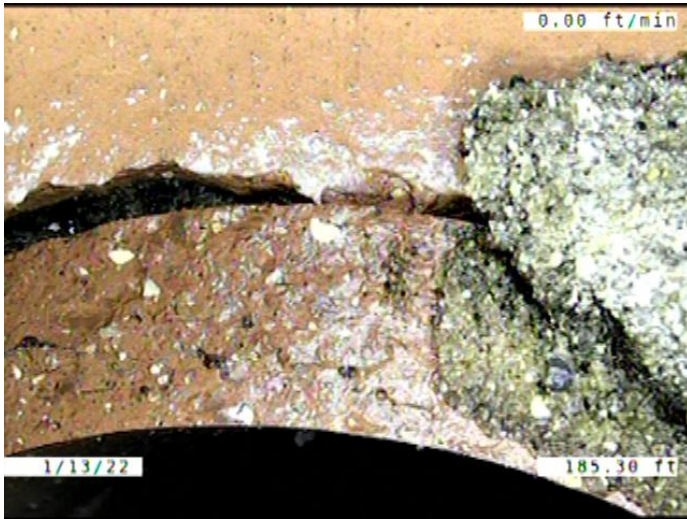
Code:	SSS
Description:	Surface Damage Surface Spalling
Distance (ft):	185.3
Structural Grade:	2
O&M Grade:	0
Clock Start/From:	12
Clock To:	4
1st Value:	
2nd Value:	
Value Percent:	
Continuous Index:	
Within 8" of Joint:	NO
Remarks:

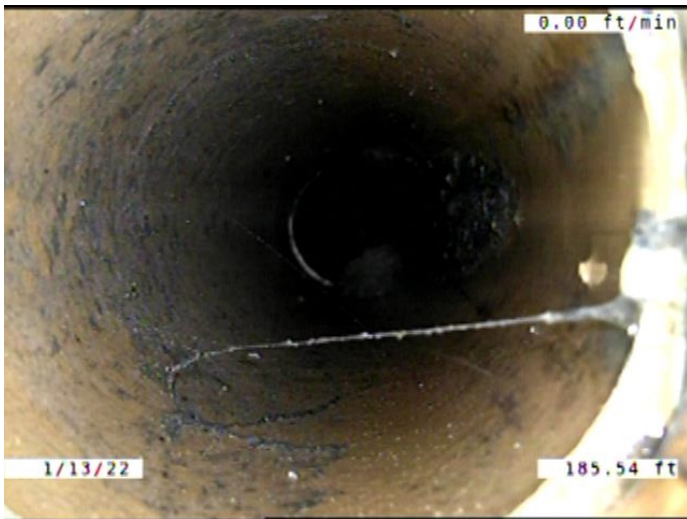
Code:	TBI
Description:	Tap Break-in Intruding
Distance (ft):	185.5
Structural Grade:	0
O&M Grade:	2
Clock Start/From:	3
Clock To:	
1st Value:	6.000
2nd Value:	1.000
Value Percent:	
Continuous Index:	
Within 8" of Joint:	YES
Remarks:

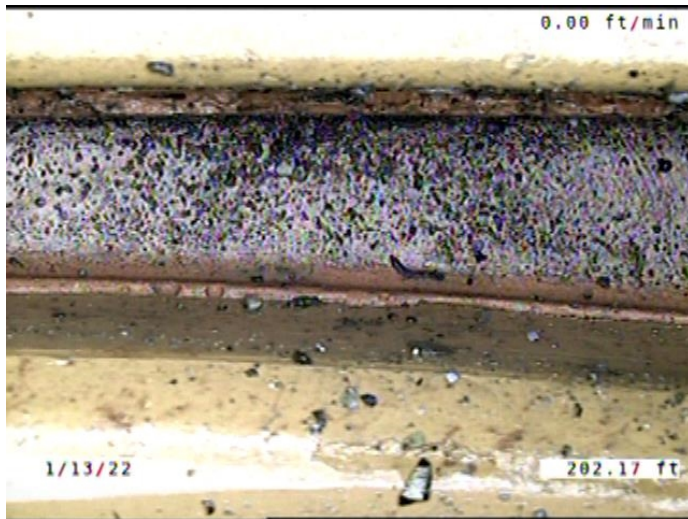
Code: **JAL**
 Description: **Joint Angular Large**

Distance (ft): **202.2**
 Structural Grade: **4**
 O&M Grade: **0**
 Clock Start/From:
 Clock To:
 1st Value:
 2nd Value:
 Value Percent:
 Continuous Index:
 Within 8" of Joint: **NO**
 Remarks:

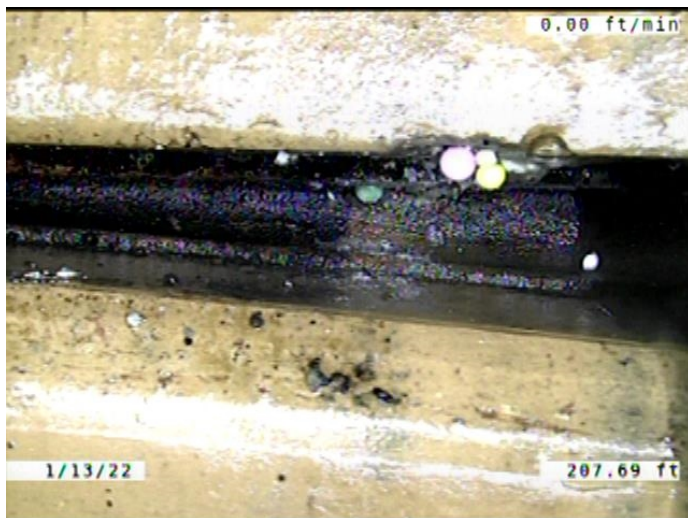
Code: **JAM**
 Description: **Joint Angular Medium**

Distance (ft): **207.7**
 Structural Grade: **3**
 O&M Grade: **0**
 Clock Start/From:
 Clock To:
 1st Value:
 2nd Value:
 Value Percent:
 Continuous Index:
 Within 8" of Joint: **NO**
 Remarks:

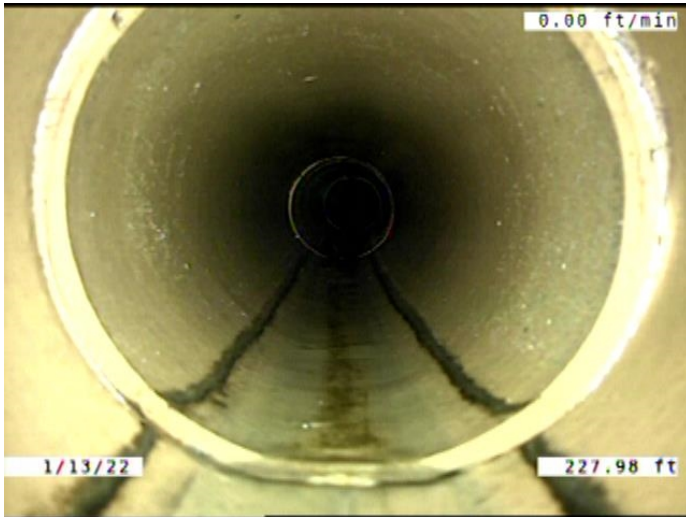
Code: **MWLS**
Description: **Miscellaneous Water Level Sag**

Distance (ft): **228.0**
Structural Grade: **2**
O&M Grade: **0**
Clock Start/From:
Clock To:
1st Value:
2nd Value:
Value Percent: **10.000**
Continuous Index: **F07**
Within 8" of Joint: **NO**
Remarks:

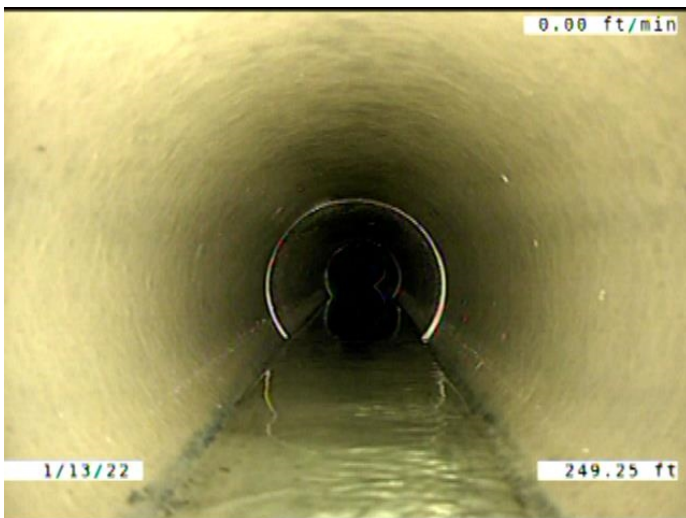
Code: **MWLS**
Description: **Miscellaneous Water Level Sag**

Distance (ft): **249.2**
Structural Grade: **2**
O&M Grade: **0**
Clock Start/From:
Clock To:
1st Value:
2nd Value:
Value Percent: **10.000**
Continuous Index: **S08**
Within 8" of Joint: **NO**
Remarks:

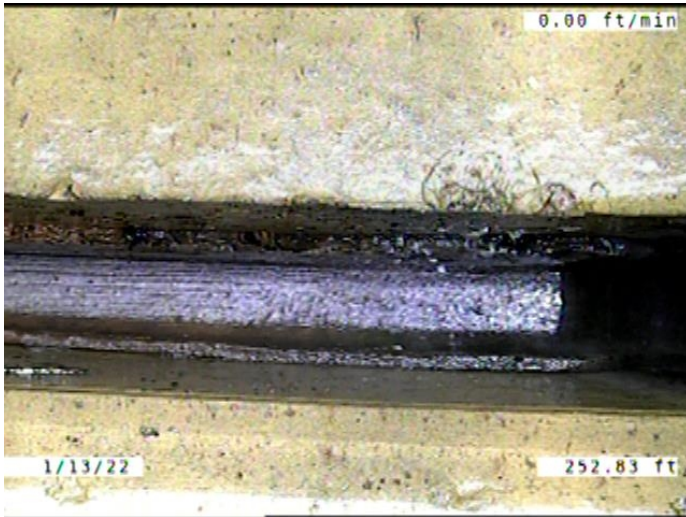
Code: **JAM**
Description: **Joint Angular Medium**

Distance (ft): **252.8**
Structural Grade: **3**
O&M Grade: **0**
Clock Start/From:
Clock To:
1st Value:
2nd Value:
Value Percent:
Continuous Index:
Within 8" of Joint: **NO**
Remarks:

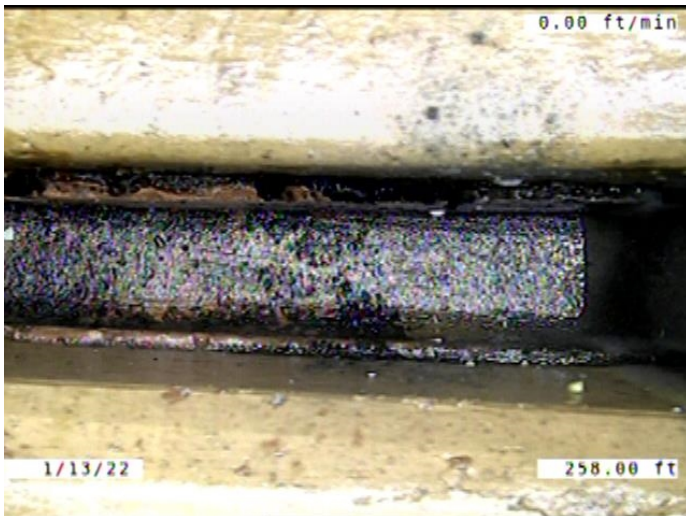
Code: **JAM**
Description: **Joint Angular Medium**

Distance (ft): **258.0**
Structural Grade: **3**
O&M Grade: **0**
Clock Start/From:
Clock To:
1st Value:
2nd Value:
Value Percent:
Continuous Index:
Within 8" of Joint: **NO**
Remarks:

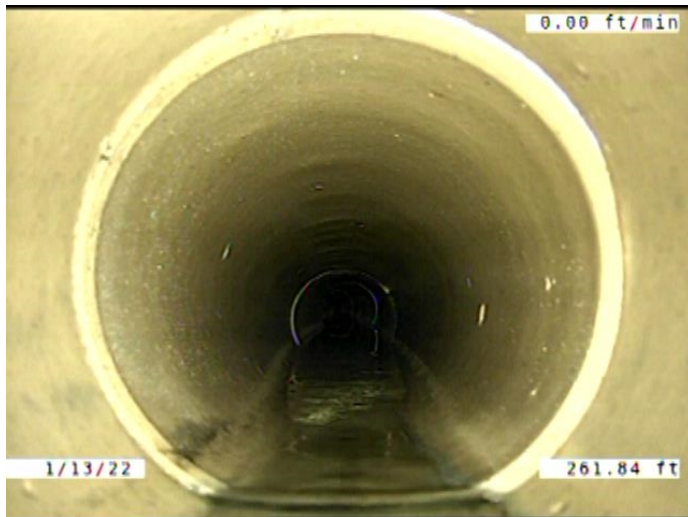
Code: **MWLS**
Description: **Miscellaneous Water Level Sag**

Distance (ft): **261.8**
Structural Grade: **2**
O&M Grade: **0**
Clock Start/From:
Clock To:
1st Value:
2nd Value:
Value Percent: **10.000**
Continuous Index: **F08**
Within 8" of Joint: **NO**
Remarks:

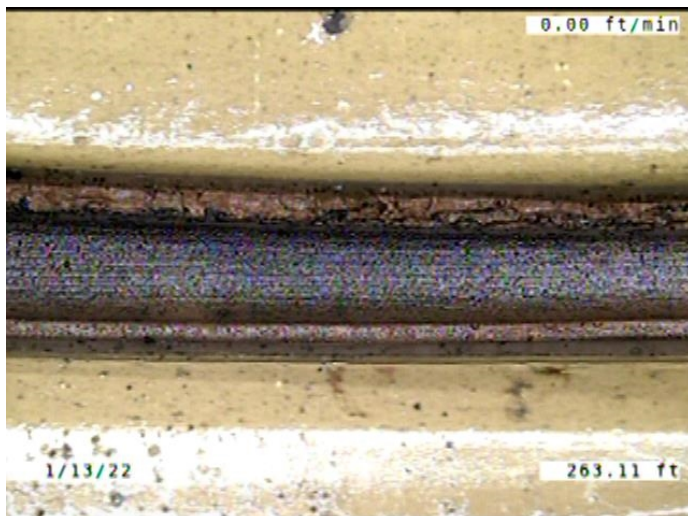
Code: **JAM**
Description: **Joint Angular Medium**

Distance (ft): **263.1**
Structural Grade: **3**
O&M Grade: **0**
Clock Start/From:
Clock To:
1st Value:
2nd Value:
Value Percent:
Continuous Index:
Within 8" of Joint: **NO**
Remarks:

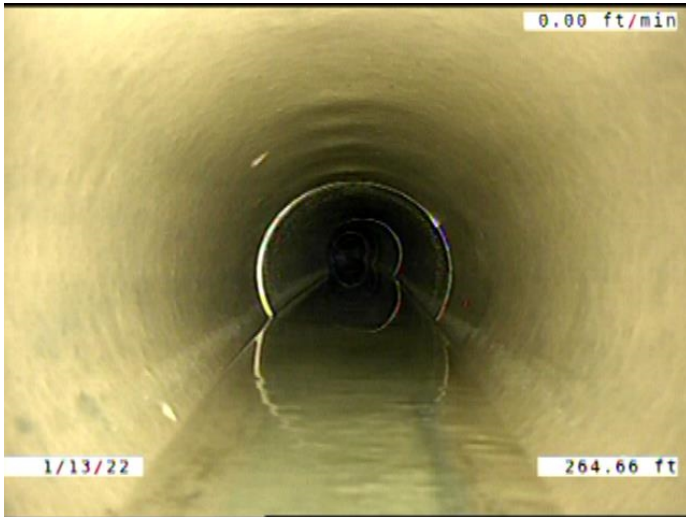
Code: **MWLS**
Description: **Miscellaneous Water Level Sag**

Distance (ft): **264.7**
Structural Grade: **2**
O&M Grade: **0**
Clock Start/From:
Clock To:
1st Value:
2nd Value:
Value Percent: **15.000**
Continuous Index: **S09**
Within 8" of Joint: **NO**
Remarks:

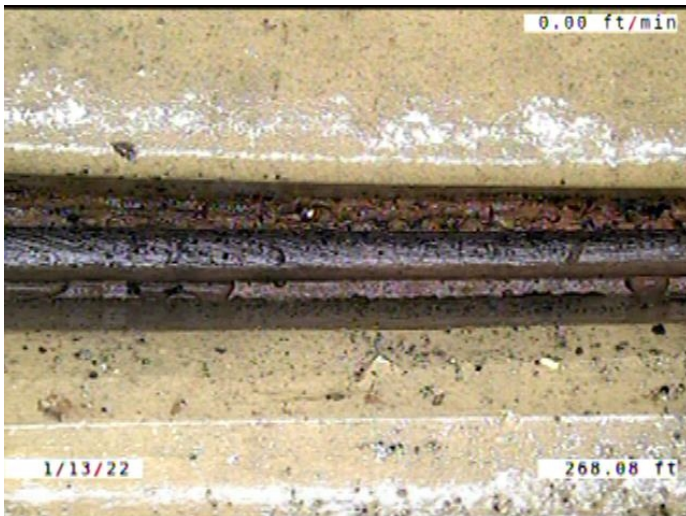
Code: **JAM**
Description: **Joint Angular Medium**

Distance (ft): **268.1**
Structural Grade: **3**
O&M Grade: **0**
Clock Start/From:
Clock To:
1st Value:
2nd Value:
Value Percent:
Continuous Index:
Within 8" of Joint: **NO**
Remarks:

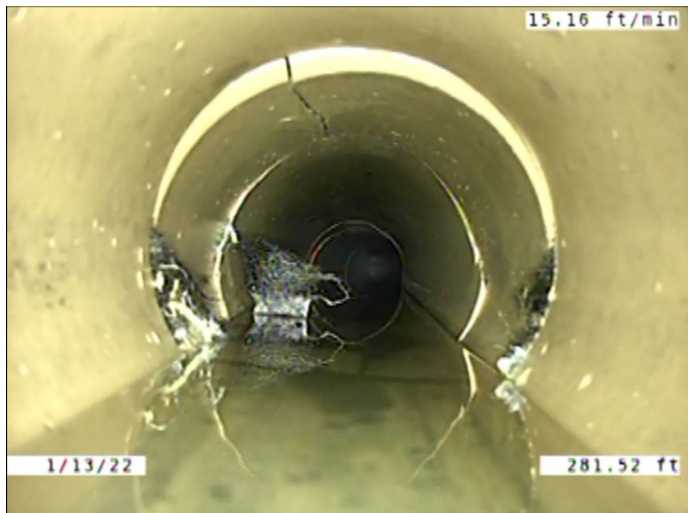
Code: **RFJ**
 Description: **Roots Fine Joint**

Distance (ft): **281.5**
 Structural Grade: **0**
 O&M Grade: **1**
 Clock Start/From: **3**
 Clock To: **4**
 1st Value:
 2nd Value:
 Value Percent:
 Continuous Index:
 Within 8" of Joint: **YES**
 Remarks:

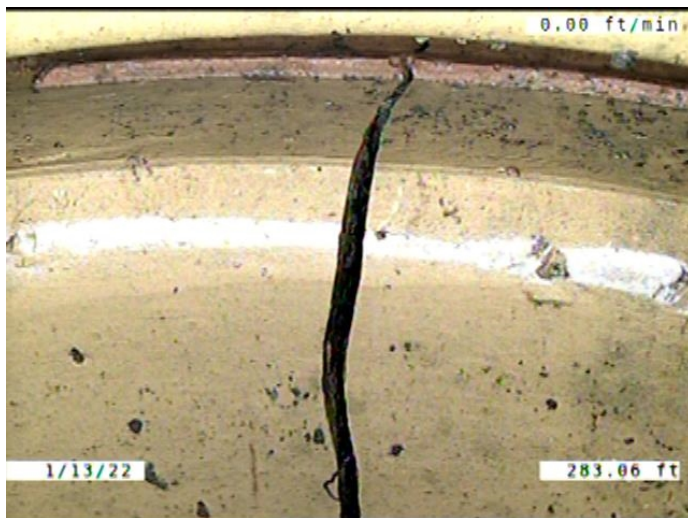
Code: **B**
 Description: **Broken**

Distance (ft): **283.1**
 Structural Grade: **4**
 O&M Grade: **0**
 Clock Start/From: **12**
 Clock To: **12**
 1st Value:
 2nd Value:
 Value Percent:
 Continuous Index: **S10**
 Within 8" of Joint: **YES**
 Remarks:

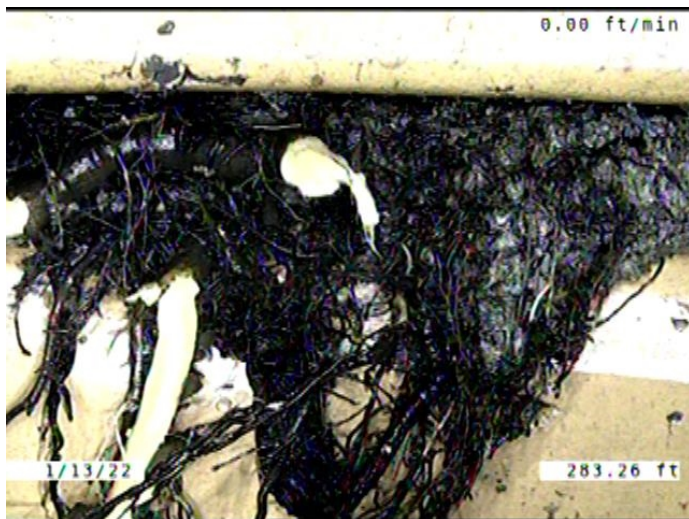
Code: **RFJ**
Description: **Roots Fine Joint**

Distance (ft): **283.3**
Structural Grade: **0**
O&M Grade: **1**
Clock Start/From: **8**
Clock To: **9**
1st Value:
2nd Value:
Value Percent:
Continuous Index:
Within 8" of Joint: **YES**
Remarks:

Code: **RMB**
Description: **Roots Medium Barrel**

Distance (ft): **283.3**
Structural Grade: **0**
O&M Grade: **4**
Clock Start/From: **7**
Clock To: **9**
1st Value:
2nd Value:
Value Percent: **15.000**
Continuous Index:
Within 8" of Joint: **NO**
Remarks:

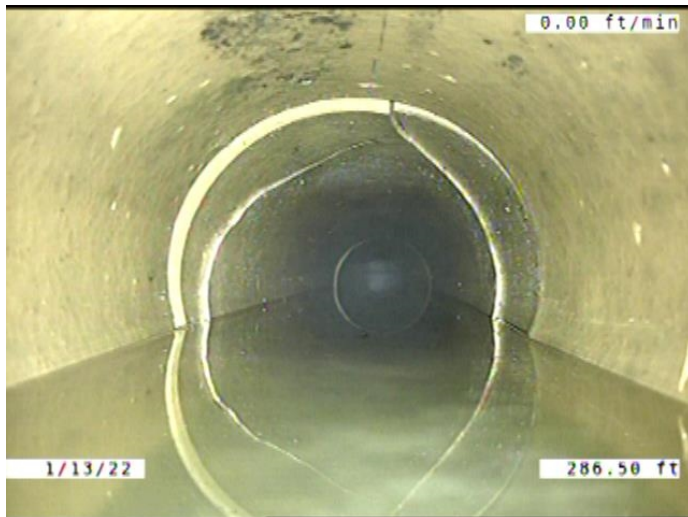
Code: **MWLS**
Description: **Miscellaneous Water Level Sag**

Distance (ft): **286.5**
Structural Grade: **2**
O&M Grade: **0**
Clock Start/From:
Clock To:
1st Value:
2nd Value:
Value Percent: **15.000**
Continuous Index: **F09**
Within 8" of Joint: **NO**
Remarks:

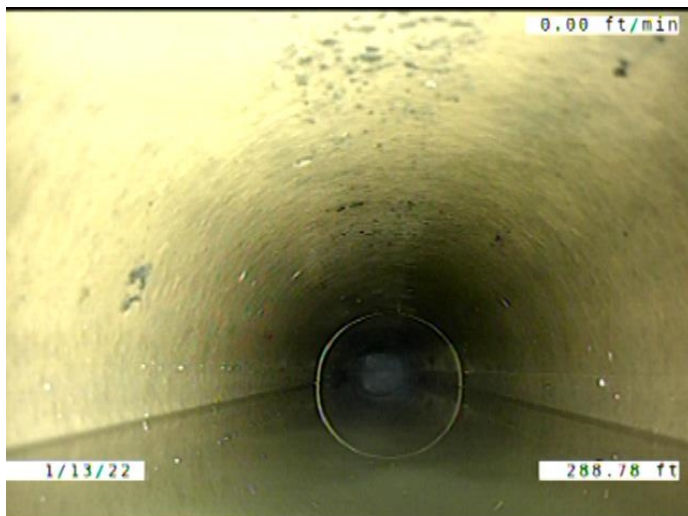
Code: **B**
Description: **Broken**

Distance (ft): **288.8**
Structural Grade: **4**
O&M Grade: **0**
Clock Start/From: **12**
Clock To: **12**
1st Value:
2nd Value:
Value Percent:
Continuous Index: **F10**
Within 8" of Joint: **YES**
Remarks:
