Profile/Photo Observation Report

Date:	01/13/2022	Weather:		Coding:	PACP 7.0
Pipe Length (ft):	305.1	Owner:	City of Hobart	Pre Clean:	Light Cleaning
P.O.#:	YES502259	Surveyor:	S. Bucklin	PSR:	P-505-079-078
Customer:	City of Hobart	Clean Date:	01/12/2021	Shape:	C

Street:	West 4th Street	Flow Control:	Not Controlled
City:	Hobart, IN	Year Renewed:	
Location:	Local rural streets with light traffic, t	Tape/Media #:	
Purpose:	Routine Assessment	Dia/Height:	8"
Use:	Sanitary Sewage Pipe	Material:	VCP
Drain Area:		Lining:	None
Category:	NA		
Comment:			
Location Details:		Direction of Survey:	Downstream
US MH:	M-505-079	DS MH:	M-505-078
		Total Length Surveyed (ft):	305.1

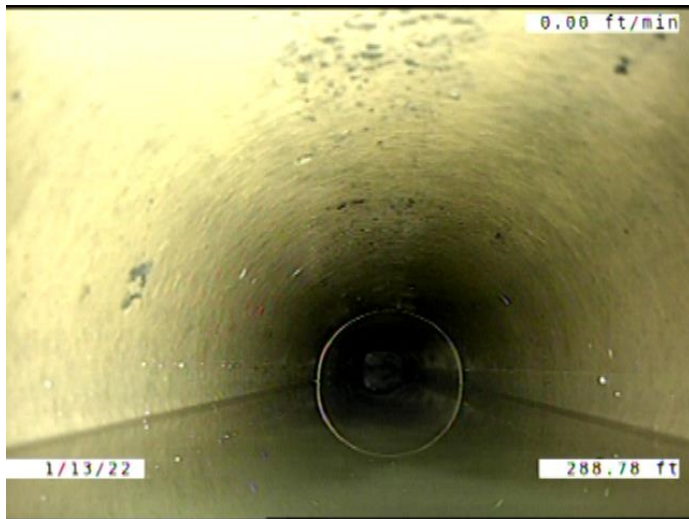
Code: **MWL**
Description: **Miscellaneous Water Level**

Distance (ft): **288.8**
Structural Grade: **0**
O&M Grade: **0**
Clock Start/From:
Clock To:
1st Value:
2nd Value:
Value Percent: **40.000**
Continuous Index:
Within 8" of Joint: **NO**
Remarks:

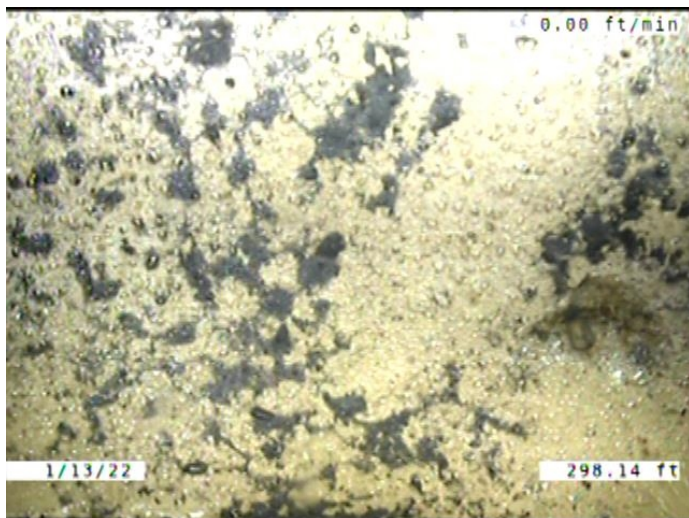
Code: **MWL**
Description: **Miscellaneous Water Level**

Distance (ft): **298.1**
Structural Grade: **0**
O&M Grade: **0**
Clock Start/From:
Clock To:
1st Value:
2nd Value:
Value Percent: **50.000**
Continuous Index:
Within 8" of Joint: **NO**
Remarks:

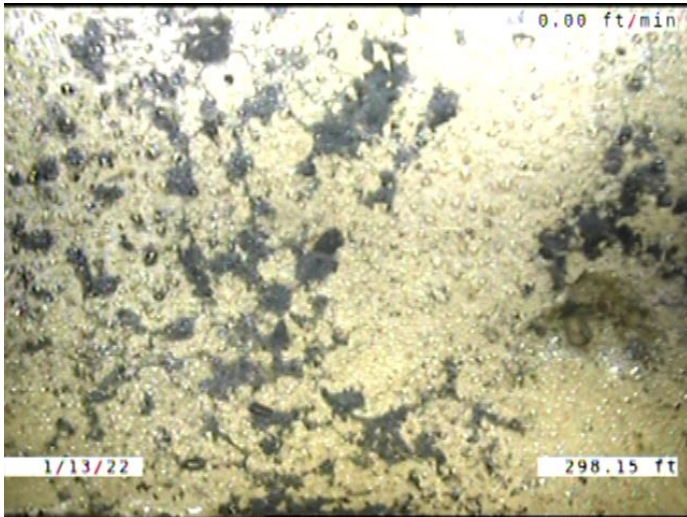
Code:	MCU
Description:	Miscellaneous Camera Underwater
Distance (ft):	298.1
Structural Grade:	0
O&M Grade:	4
Clock Start/From:	
Clock To:	
1st Value:	
2nd Value:	
Value Percent:	
Continuous Index:	
Within 8" of Joint:	NO
Remarks:	WATER IS CLEAR. WILL CONTINUE. Out at 300

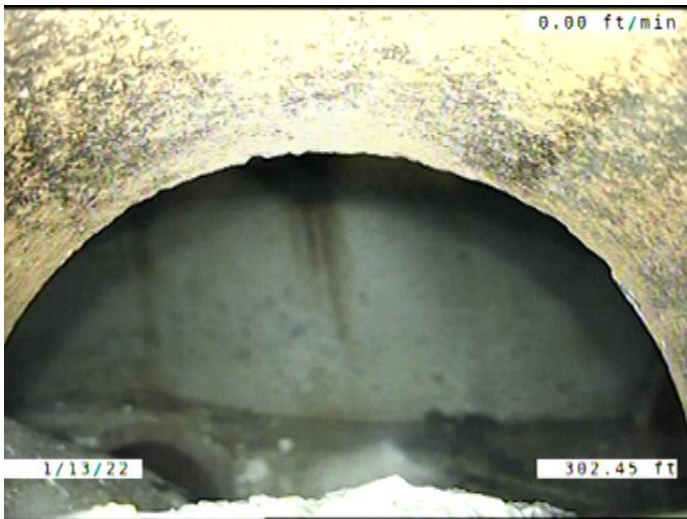
Code:	MWL
Description:	Miscellaneous Water Level
Distance (ft):	302.4
Structural Grade:	0
O&M Grade:	0
Clock Start/From:	
Clock To:	
1st Value:	
2nd Value:	
Value Percent:	40.000
Continuous Index:	
Within 8" of Joint:	NO
Remarks:

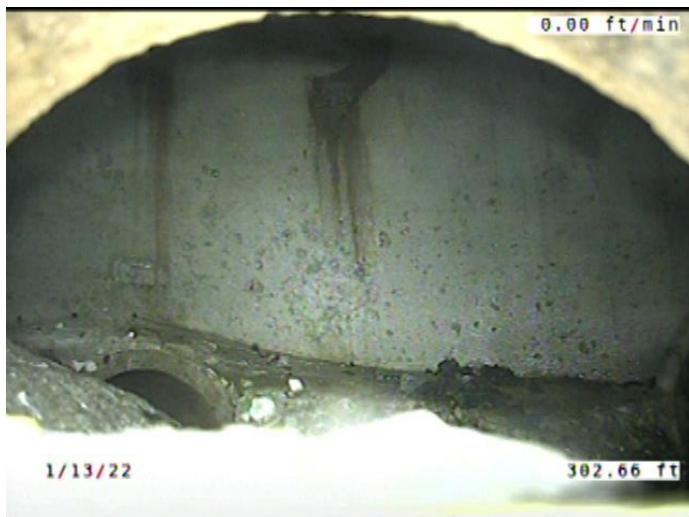
Code: **DSF**
 Description: **Deposits Settled Fine**

Distance (ft): **302.7**
 Structural Grade: **0**
 O&M Grade: **5**
 Clock Start/From: **4**
 Clock To: **8**
 1st Value:
 2nd Value:
 Value Percent: **35.000**
 Continuous Index:
 Within 8" of Joint: **YES**
 Remarks:

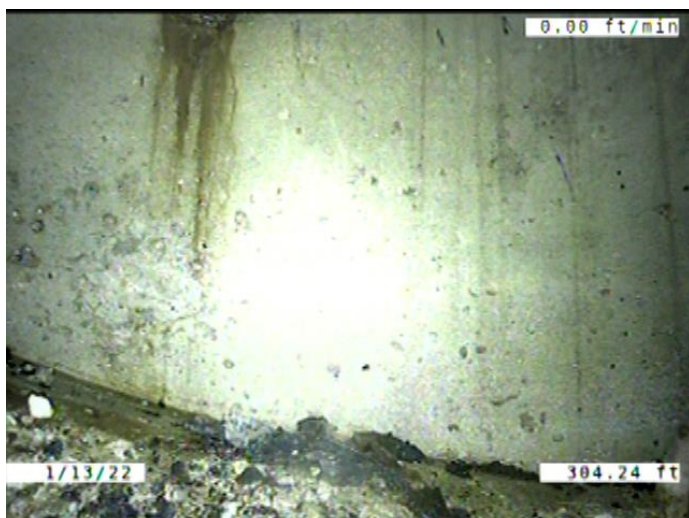
Code: **DAE**
 Description: **Deposits Attached Encrustation**

Distance (ft): **304.2**
 Structural Grade: **0**
 O&M Grade: **2**
 Clock Start/From: **7**
 Clock To: **5**
 1st Value:
 2nd Value:
 Value Percent: **5.000**
 Continuous Index: **F01**
 Within 8" of Joint: **YES**
 Remarks:

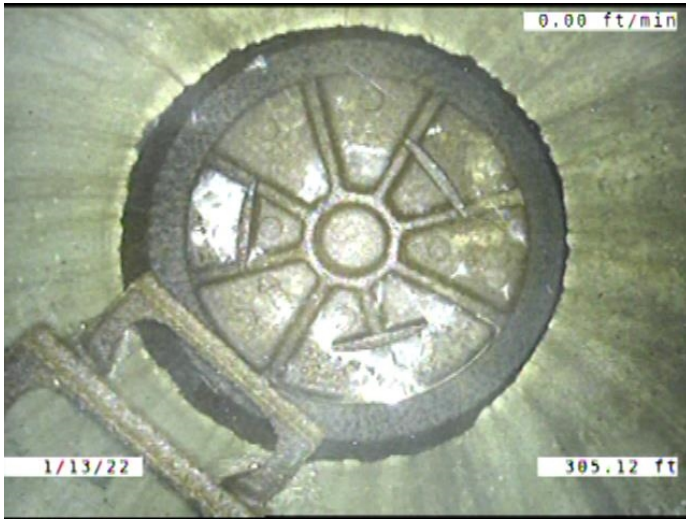
Code:	AMH
Description:	Manhole
Distance (ft):	305.1
Structural Grade:	0
O&M Grade:	0
Clock Start/From:	
Clock To:	
1st Value:	
2nd Value:	
Value Percent:	
Continuous Index:	
Within 8" of Joint:	NO
Remarks:	M-505-078
