Profile/Photo Observation Report

Date:	01/14/2022	Weather:		Coding:	PACP 7.0
Pipe Length (ft):	256.0	Owner:	City of Hobart	Pre Clean:	Heavy Cleaning
P.O.#:	YES502259	Surveyor:	S. Bucklin	PSR:	P-505-080-097
Customer:	City of Hobart	Clean Date:	01/12/2021	Shape:	C

Street:	West 4th Street	Flow Control:	Not Controlled
City:	Hobart, IN	Year Renewed:	
Location:	Local rural streets with light traffic, t	Tape/Media #:	
Purpose:	Routine Assessment	Dia/Height:	8"
Use:	Sanitary Sewage Pipe	Material:	VCP
Drain Area:		Lining:	None
Category:	NA		
Comment:

Location Details:		Direction of Survey:	Upstream
US MH:	M-505-080	DS MH:	M-505-097
		Total Length Surveyed (ft):	150.8

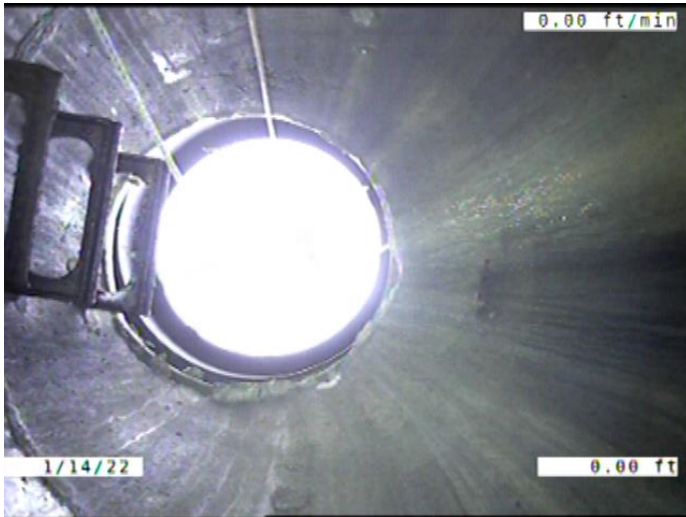
Code: **AMH**
Description: **Manhole**

Distance (ft): **.0**
Structural Grade: **0**
O&M Grade: **0**
Clock Start/From:
Clock To:
1st Value:
2nd Value:
Value Percent:
Continuous Index:
Within 8" of Joint: **NO**
Remarks: **M-505-097**

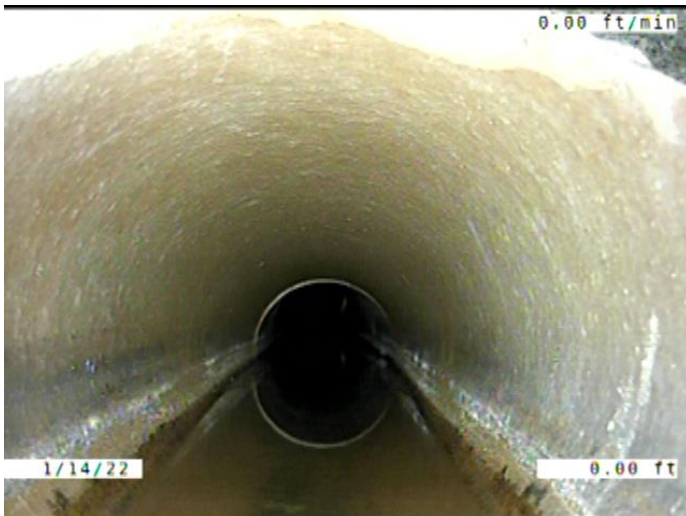
Code: **MWL**
Description: **Miscellaneous Water Level**

Distance (ft): **.0**
Structural Grade: **0**
O&M Grade: **0**
Clock Start/From:
Clock To:
1st Value:
2nd Value:
Value Percent: **5.000**
Continuous Index:
Within 8" of Joint: **NO**
Remarks:

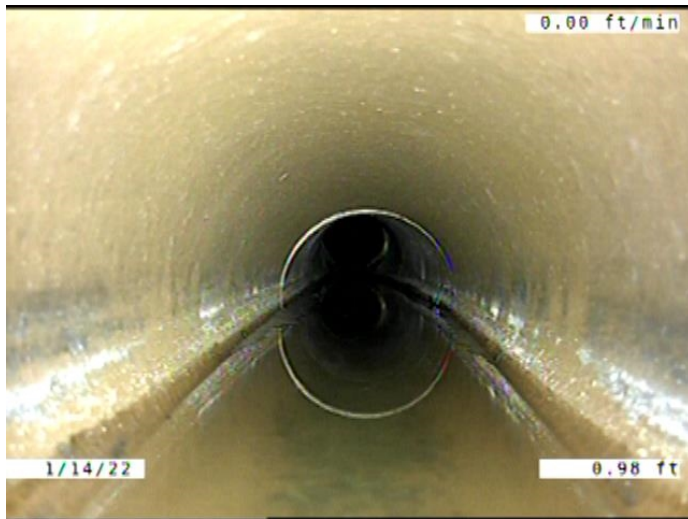
Code: **MWLS**
Description: **Miscellaneous Water Level Sag**

Distance (ft): **1.0**
Structural Grade: **2**
O&M Grade: **0**
Clock Start/From:
Clock To:
1st Value:
2nd Value:
Value Percent: **25.000**
Continuous Index: **S01**
Within 8" of Joint: **NO**
Remarks:

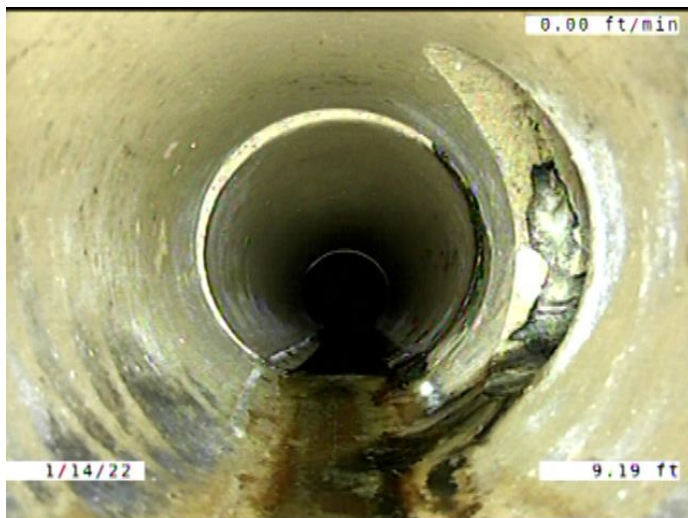
Code: **MWLS**
Description: **Miscellaneous Water Level Sag**

Distance (ft): **9.2**
Structural Grade: **2**
O&M Grade: **0**
Clock Start/From:
Clock To:
1st Value:
2nd Value:
Value Percent: **25.000**
Continuous Index: **F01**
Within 8" of Joint: **NO**
Remarks:

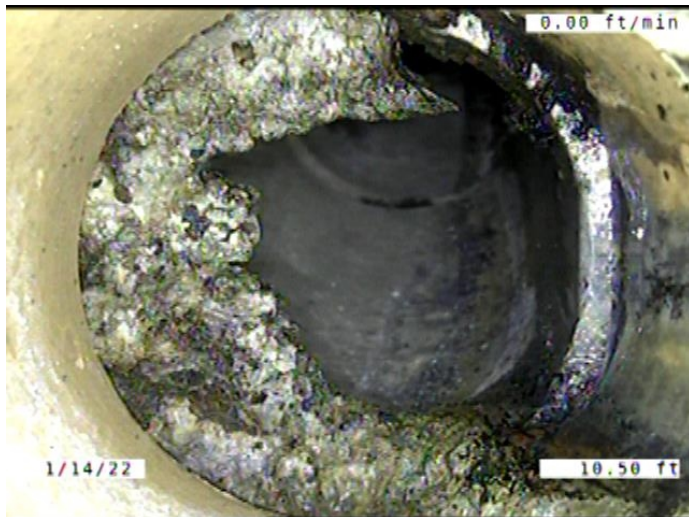
Code: **TF**
 Description: **Tap Factory**

Distance (ft): **10.5**
 Structural Grade: **0**
 O&M Grade: **0**
 Clock Start/From: **3**
 Clock To:
 1st Value: **4.000**

2nd Value:
 Value Percent:
 Continuous Index:
 Within 8" of Joint: **YES**
 Remarks: **ENCrustATION AT THE SERVICE CONNECTION TO THE MAIN**

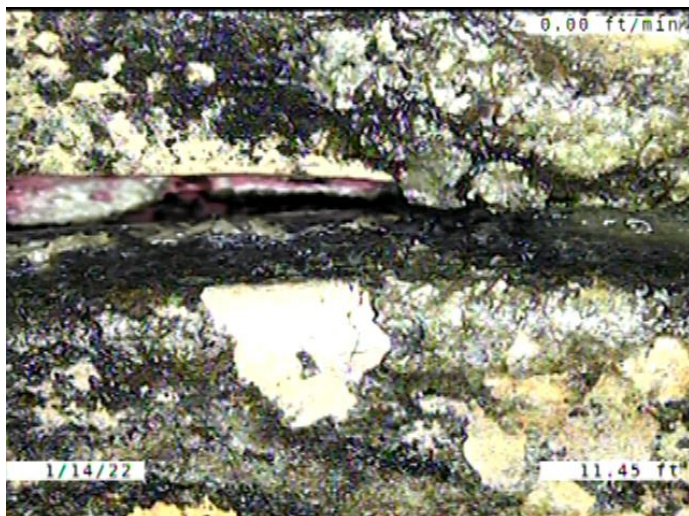
Code: **DAE**
 Description: **Deposits Attached Encrustation**

Distance (ft): **11.4**
 Structural Grade: **0**
 O&M Grade: **2**
 Clock Start/From: **1**
 Clock To: **5**

1st Value:
 2nd Value:
 Value Percent: **5.000**
 Continuous Index:
 Within 8" of Joint: **YES**
 Remarks:

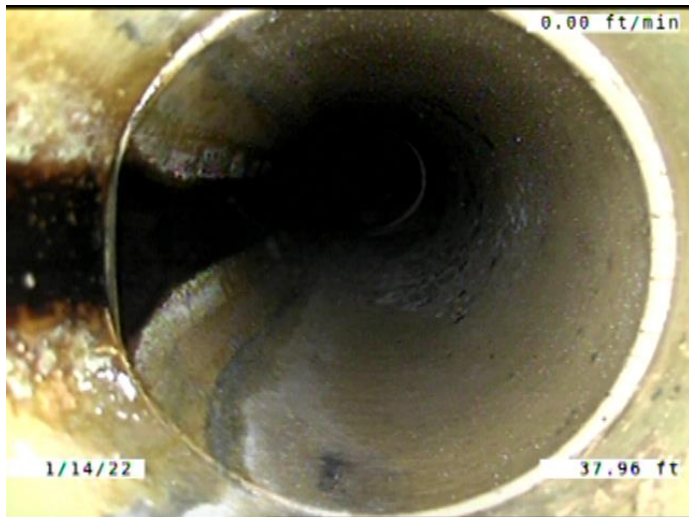
Code: **TF**
 Description: **Tap Factory**

Distance (ft): **38.0**
 Structural Grade: **0**
 O&M Grade: **0**
 Clock Start/From: **9**
 Clock To:
 1st Value: **4.000**
 2nd Value:
 Value Percent:
 Continuous Index:
 Within 8" of Joint: **YES**
 Remarks:

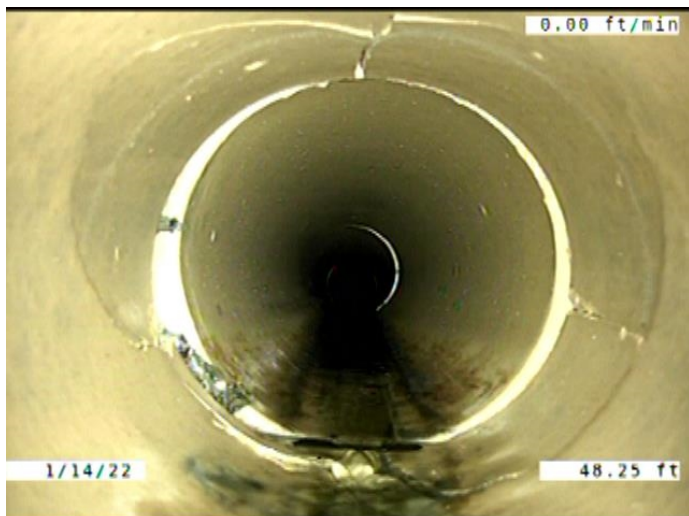
Code: **B**
 Description: **Broken**

Distance (ft): **48.2**
 Structural Grade: **4**
 O&M Grade: **0**
 Clock Start/From: **9**
 Clock To: **6**
 1st Value:
 2nd Value:
 Value Percent:
 Continuous Index:
 Within 8" of Joint: **YES**
 Remarks:

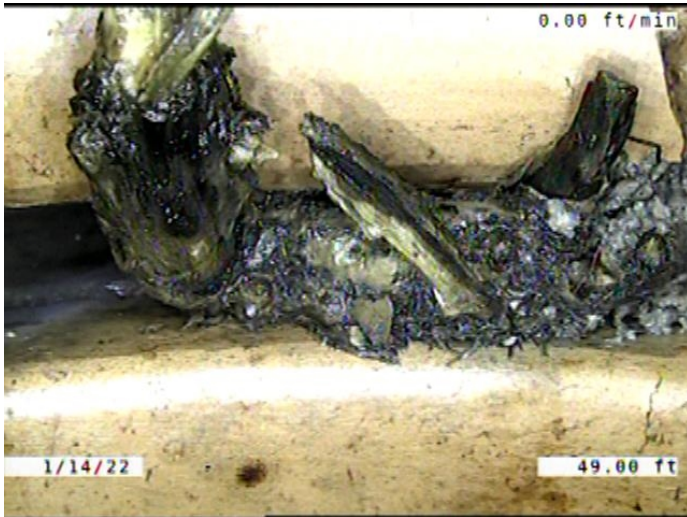
Code: **RTJ**
Description: **Roots Tap Joint**

Distance (ft): **49.0**
Structural Grade: **0**
O&M Grade: **2**
Clock Start/From: **7**
Clock To: **10**
1st Value:
2nd Value:
Value Percent: **5.000**
Continuous Index:
Within 8" of Joint: **YES**
Remarks:

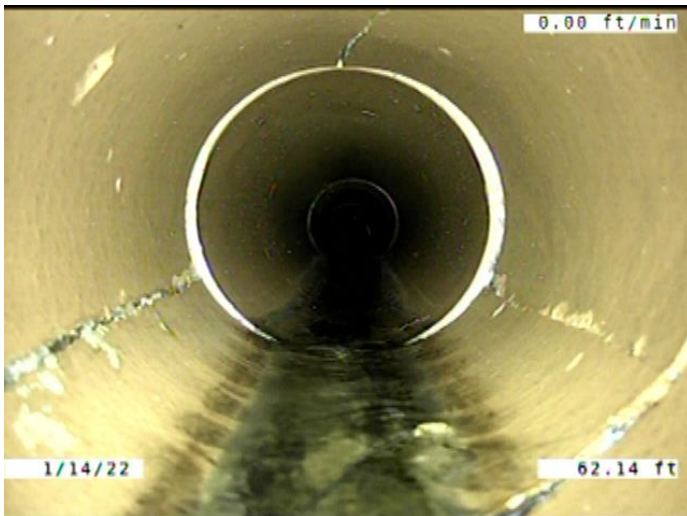
Code: **B**
Description: **Broken**

Distance (ft): **62.1**
Structural Grade: **4**
O&M Grade: **0**
Clock Start/From: **12**
Clock To: **12**
1st Value:
2nd Value:
Value Percent:
Continuous Index:
Within 8" of Joint: **YES**
Remarks:

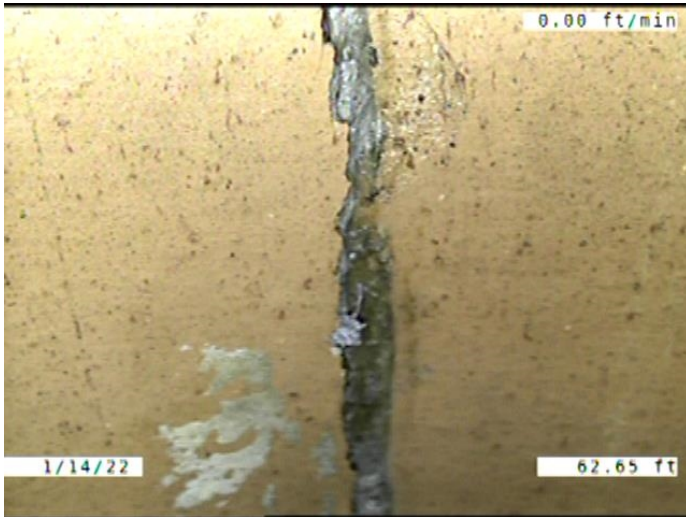
Code: **ISB**
Description: **Infiltration Stain Barrel**

Distance (ft): **62.7**
Structural Grade: **0**
O&M Grade: **1**
Clock Start/From: **7**
Clock To: **8**
1st Value:
2nd Value:
Value Percent:
Continuous Index:
Within 8" of Joint: **YES**
Remarks:

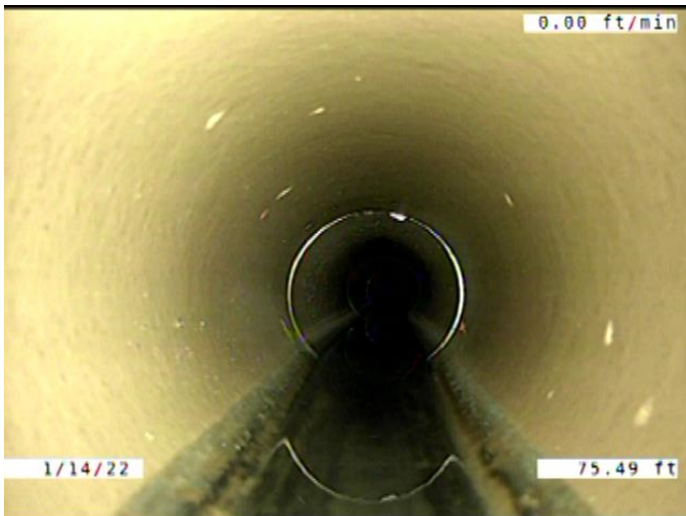
Code: **MWLS**
Description: **Miscellaneous Water Level Sag**

Distance (ft): **75.5**
Structural Grade: **2**
O&M Grade: **0**
Clock Start/From:
Clock To:
1st Value:
2nd Value:
Value Percent: **5.000**
Continuous Index: **S02**
Within 8" of Joint: **NO**
Remarks:

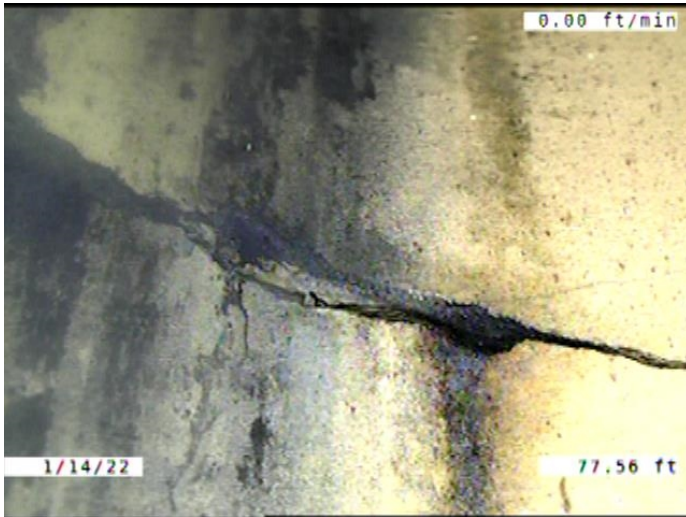
Code: **FM**
 Description: **Fracture Multiple**

Distance (ft): **77.6**
 Structural Grade: **4**
 O&M Grade: **0**
 Clock Start/From: **1**
 Clock To: **9**
 1st Value:
 2nd Value:
 Value Percent:
 Continuous Index:
 Within 8" of Joint: **YES**
 Remarks:

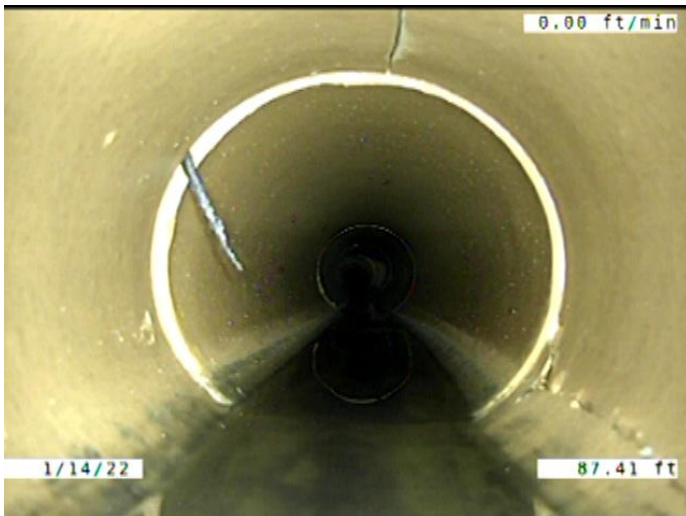
Code: **FM**
 Description: **Fracture Multiple**

Distance (ft): **87.4**
 Structural Grade: **4**
 O&M Grade: **0**
 Clock Start/From: **12**
 Clock To: **12**
 1st Value:
 2nd Value:
 Value Percent:
 Continuous Index:
 Within 8" of Joint: **YES**
 Remarks:

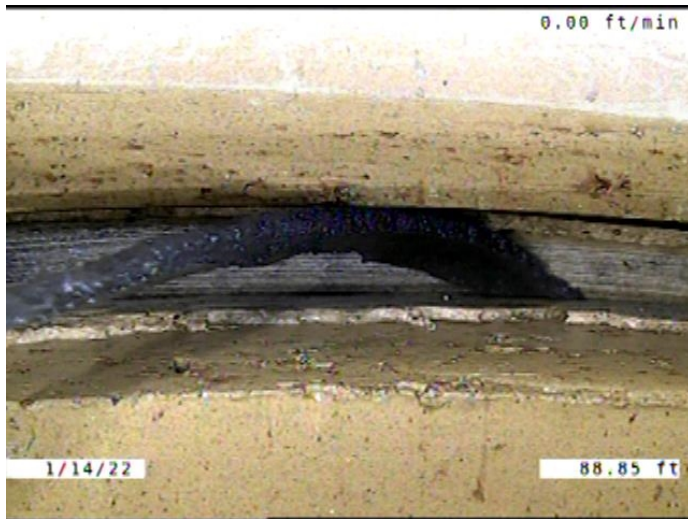
Code: **ISSRH**
Description: **Intruding Sealing Material Sealing Ring Hanging**

Distance (ft): **88.9**
Structural Grade: **0**
O&M Grade: **2**
Clock Start/From: **9**
Clock To: **11**
1st Value:
2nd Value:
Value Percent: **5.000**
Continuous Index:
Within 8" of Joint: **NO**
Remarks:

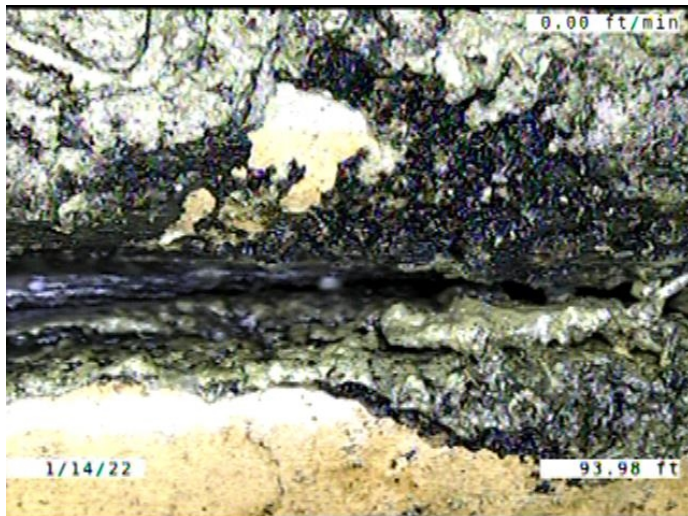
Code: **DAE**
Description: **Deposits Attached Encrustation**

Distance (ft): **94.0**
Structural Grade: **0**
O&M Grade: **2**
Clock Start/From: **7**
Clock To: **12**
1st Value:
2nd Value:
Value Percent: **5.000**
Continuous Index:
Within 8" of Joint: **YES**
Remarks:

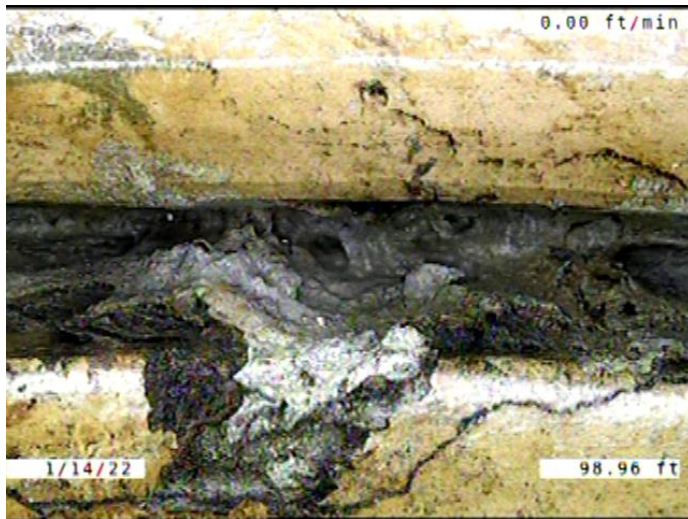
Code: **DAE**
 Description: **Deposits Attached Encrustation**

Distance (ft): **99.0**
 Structural Grade: **0**
 O&M Grade: **2**
 Clock Start/From: **7**
 Clock To: **5**
 1st Value:
 2nd Value:
 Value Percent: **5.000**
 Continuous Index:
 Within 8" of Joint: **YES**
 Remarks:

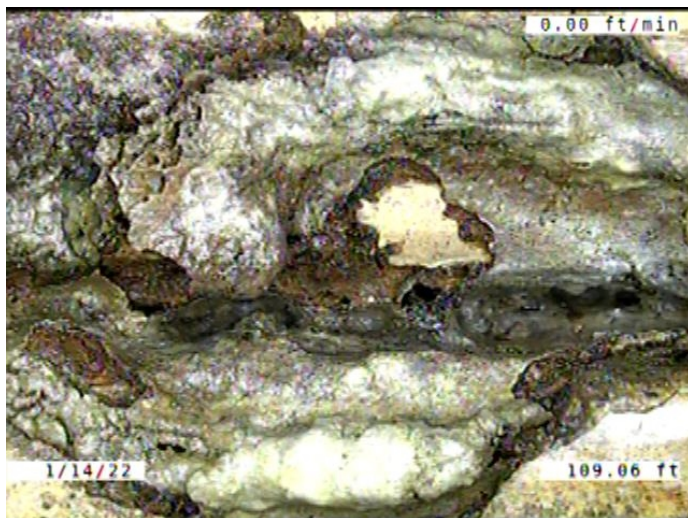
Code: **DAE**
 Description: **Deposits Attached Encrustation**

Distance (ft): **109.1**
 Structural Grade: **0**
 O&M Grade: **2**
 Clock Start/From: **7**
 Clock To: **5**
 1st Value:
 2nd Value:
 Value Percent: **5.000**
 Continuous Index: **S03**
 Within 8" of Joint: **YES**
 Remarks:

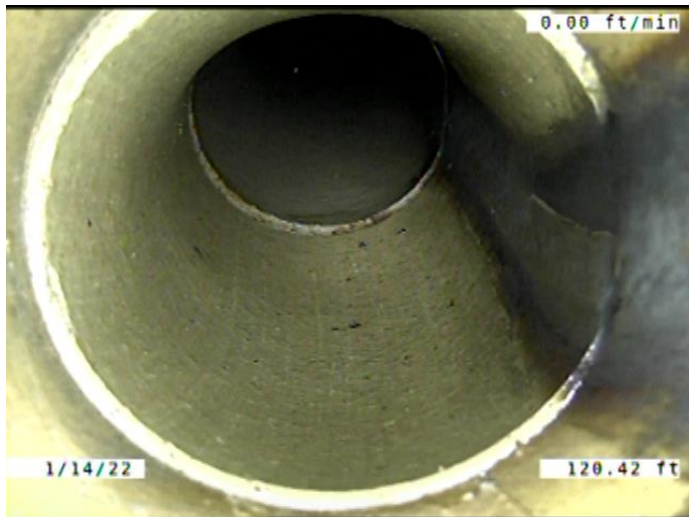
Code: **TF**
 Description: **Tap Factory**

Distance (ft): **120.4**
 Structural Grade: **0**
 O&M Grade: **0**
 Clock Start/From: **3**
 Clock To:
 1st Value: **4.000**
 2nd Value:
 Value Percent:
 Continuous Index:
 Within 8" of Joint: **YES**
 Remarks:

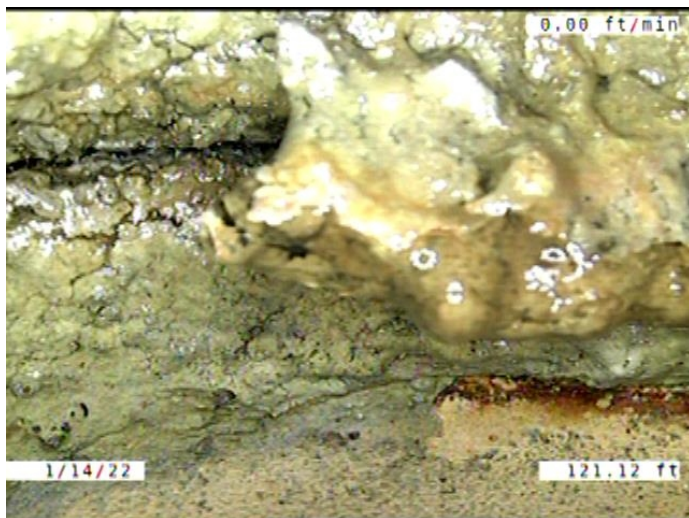
Code: **IDJ**
 Description: **Infiltration Dripper Joint**

Distance (ft): **121.1**
 Structural Grade: **0**
 O&M Grade: **3**
 Clock Start/From: **10**
 Clock To:
 1st Value:
 2nd Value:
 Value Percent:
 Continuous Index:
 Within 8" of Joint: **YES**
 Remarks:

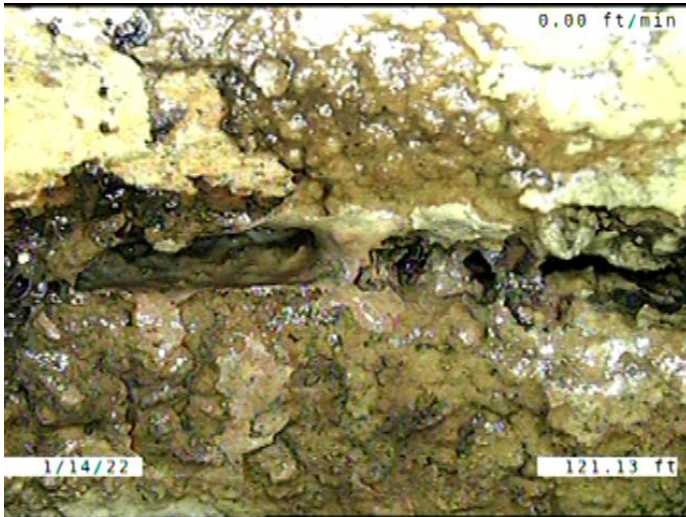
Code: **DAE**
 Description: **Deposits Attached Encrustation**

Distance (ft): **121.1**
 Structural Grade: **0**
 O&M Grade: **2**
 Clock Start/From: **8**
 Clock To: **4**
 1st Value:
 2nd Value:
 Value Percent: **5.000**
 Continuous Index:
 Within 8" of Joint: **YES**
 Remarks:

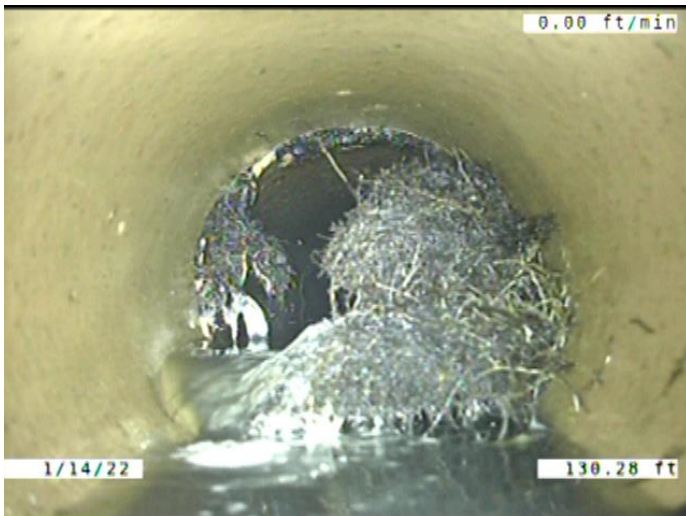
Code: **MWLS**
 Description: **Miscellaneous Water Level Sag**

Distance (ft): **130.3**
 Structural Grade: **2**
 O&M Grade: **0**
 Clock Start/From:
 Clock To:
 1st Value:
 2nd Value:
 Value Percent: **5.000**
 Continuous Index: **F02**
 Within 8" of Joint: **NO**
 Remarks:

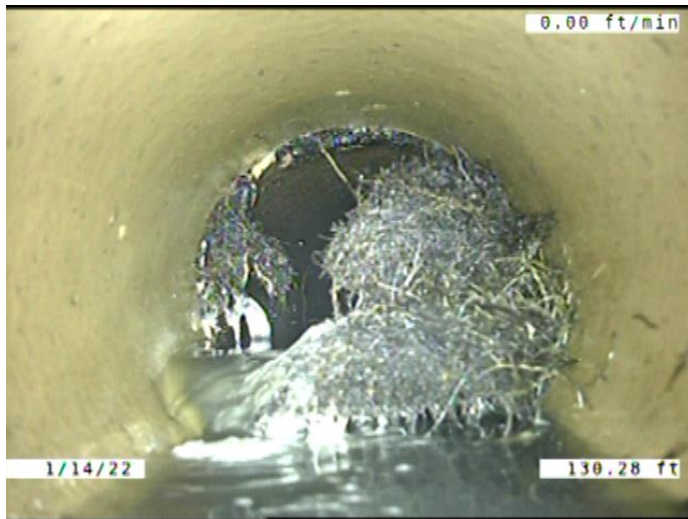
Code: **RBJ**
 Description: **Roots Ball Joint**

Distance (ft): **130.3**
 Structural Grade: **0**
 O&M Grade: **4**
 Clock Start/From: **12**
 Clock To: **12**
 1st Value:
 2nd Value:
 Value Percent: **65.000**
 Continuous Index:
 Within 8" of Joint: **YES**
 Remarks:

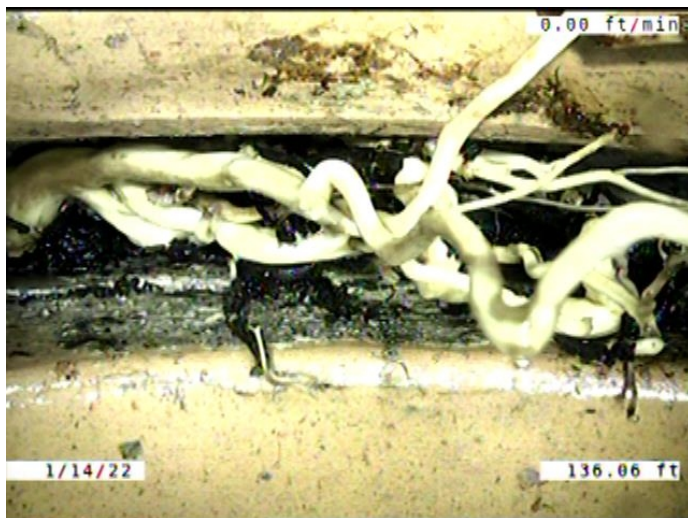
Code: **RMJ**
 Description: **Roots Medium Joint**

Distance (ft): **136.1**
 Structural Grade: **0**
 O&M Grade: **3**
 Clock Start/From: **10**
 Clock To: **11**
 1st Value:
 2nd Value:
 Value Percent: **5.000**
 Continuous Index:
 Within 8" of Joint: **YES**
 Remarks:

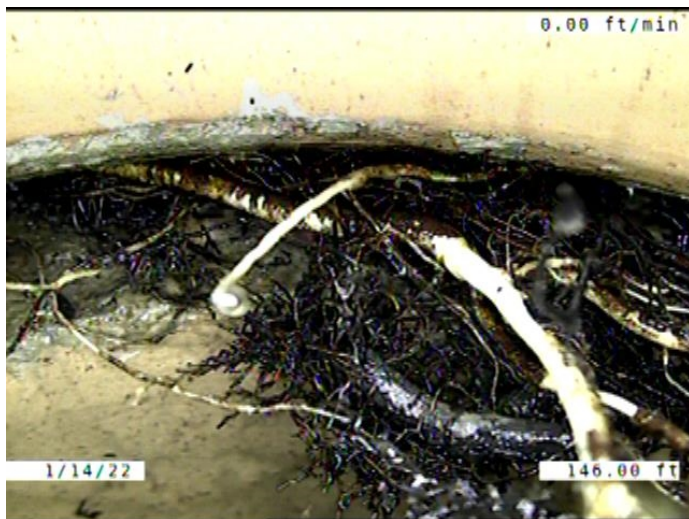
Code: **RMJ**
 Description: **Roots Medium Joint**

Distance (ft): **146.0**
 Structural Grade: **0**
 O&M Grade: **3**
 Clock Start/From: **9**
 Clock To: **3**
 1st Value:
 2nd Value:
 Value Percent: **5.000**
 Continuous Index:
 Within 8" of Joint: **YES**
 Remarks:

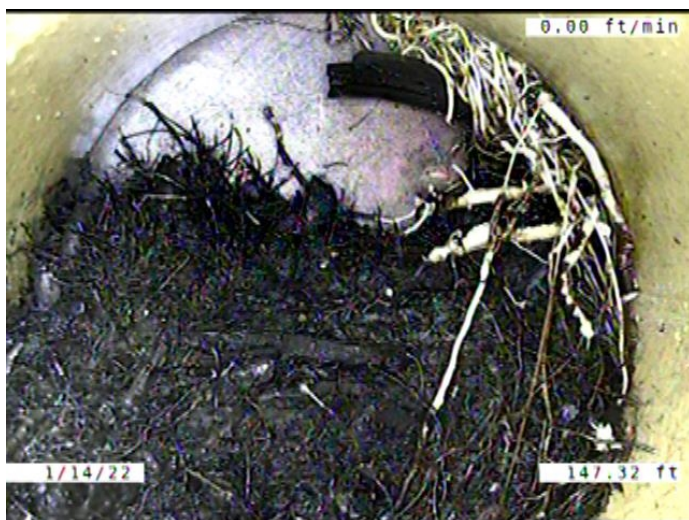
Code: **TFC**
 Description: **Tap Factory Capped**

Distance (ft): **147.3**
 Structural Grade: **0**
 O&M Grade: **0**
 Clock Start/From: **9**
 Clock To:
 1st Value: **4.000**
 2nd Value:
 Value Percent:
 Continuous Index:
 Within 8" of Joint: **YES**
 Remarks: **ROOTS GROWING AROUND THE CAP**

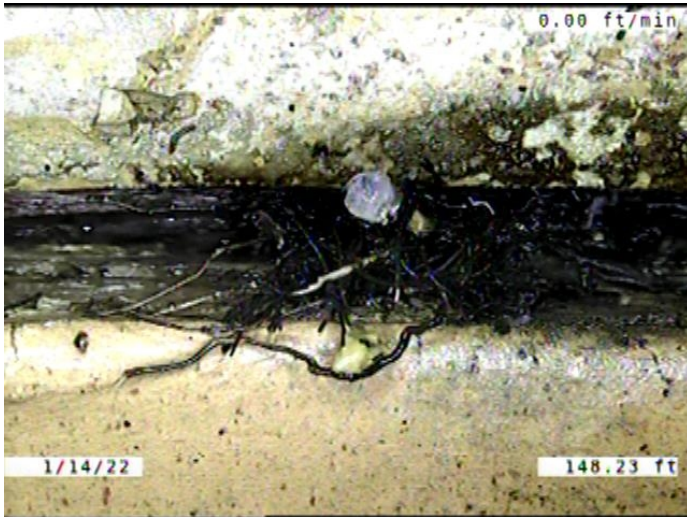
Code: **RFJ**
 Description: **Roots Fine Joint**

Distance (ft): **148.2**
 Structural Grade: **0**
 O&M Grade: **1**
 Clock Start/From: **9**
 Clock To: **11**
 1st Value:
 2nd Value:
 Value Percent:
 Continuous Index:
 Within 8" of Joint: **YES**
 Remarks:

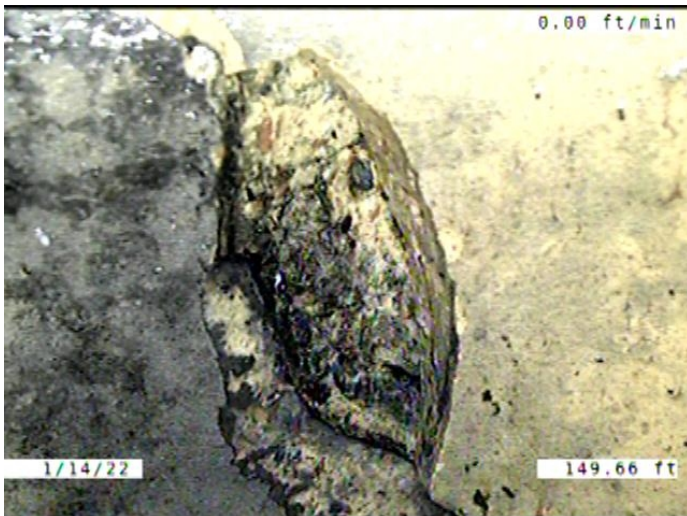
Code: **SMW**
 Description: **Surface Damage Missing Wall**

Distance (ft): **149.7**
 Structural Grade: **5**
 O&M Grade: **0**
 Clock Start/From: **8**
 Clock To: **12**
 1st Value:
 2nd Value:
 Value Percent:
 Continuous Index:
 Within 8" of Joint: **YES**
 Remarks:

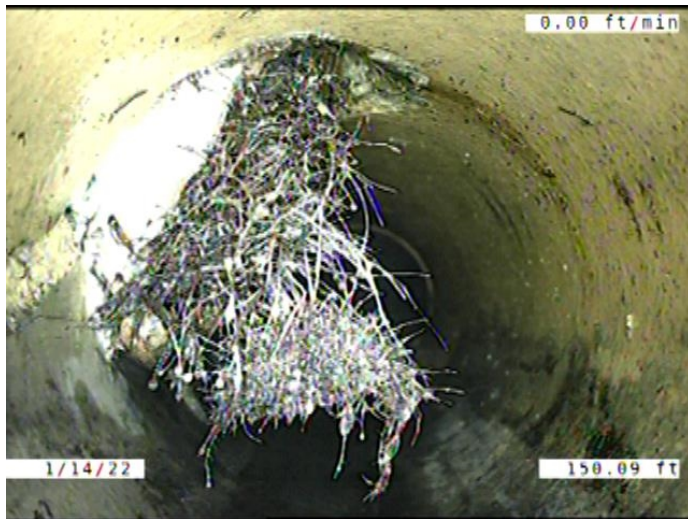
Code: **RML**
 Description: **Roots Medium Lateral**

Distance (ft): **150.1**
 Structural Grade: **0**
 O&M Grade: **3**
 Clock Start/From: **8**
 Clock To: **12**
 1st Value:
 2nd Value:
 Value Percent: **10.000**
 Continuous Index:
 Within 8" of Joint: **NO**
 Remarks:

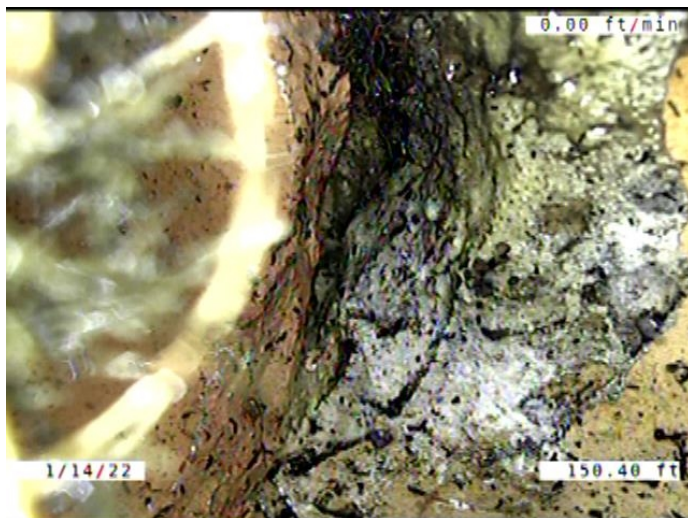
Code: **TBI**
 Description: **Tap Break-in Intruding**

Distance (ft): **150.4**
 Structural Grade: **0**
 O&M Grade: **2**
 Clock Start/From: **10**
 Clock To:
 1st Value: **4.000**
 2nd Value: **2.000**
 Value Percent:
 Continuous Index:
 Within 8" of Joint: **NO**
 Remarks:

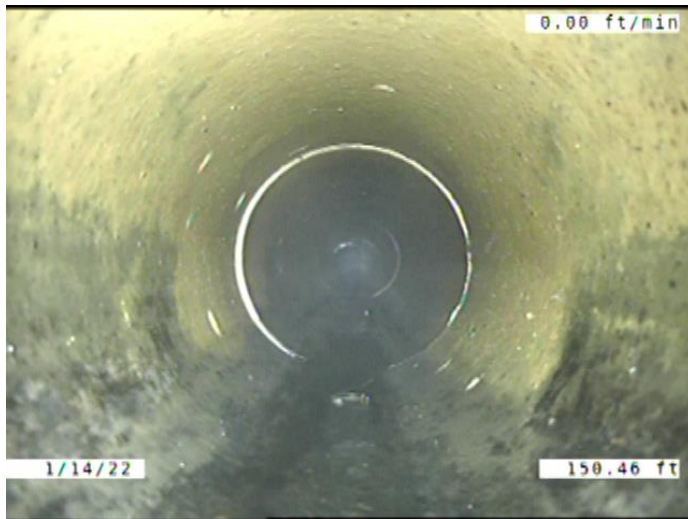
Code: **DAE**
 Description: **Deposits Attached Encrustation**

Distance (ft): **150.5**
 Structural Grade: **0**
 O&M Grade: **2**
 Clock Start/From: **7**
 Clock To: **5**
 1st Value:
 2nd Value:
 Value Percent: **5.000**
 Continuous Index: **F03**
 Within 8" of Joint: **YES**
 Remarks:

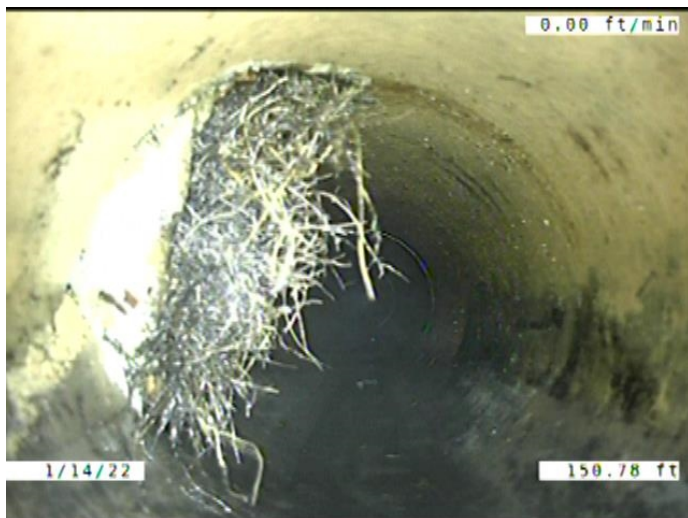
Code: **MSA**
 Description: **Miscellaneous Survey Abandoned**

Distance (ft): **150.8**
 Structural Grade: **0**
 O&M Grade: **0**
 Clock Start/From:
 Clock To:
 1st Value:
 2nd Value:
 Value Percent:
 Continuous Index:
 Within 8" of Joint: **NO**
 Remarks: **CAMERA CANT MAKE IT PAST PROTRUDING TAP.**
