## Profile/Photo Observation Report

Date:	<b>04/14/2018</b>	Weather:		Coding:	<b>PACP 6.0</b>
Pipe Length (ft):	<b>151.6</b>	Owner:	<b>NA</b>	Pre Clean:	<b>No Pre-Cleaning</b>
P.O.#:		Surveyor:	<b>Jen Costello</b>	PSR:	<b>P-505-081-082</b>
Customer:		Clean Date:	<b>01/01/1900</b>	Shape:	<b>C</b>

Street:	<b>W 4TH PL</b>	Flow Control:	<b>Not Controlled</b>
City:	<b>Hobart, IN</b>	Year Renewed:	
Location:	<b>Yard</b>	Tape/Media #:	
Purpose:	<b>Routine Assessment</b>	Dia/Height:	<b>10"</b>
Use:	<b>Sanitary</b>	Material:	<b>VCP</b>
Drain Area:	<b>NA</b>	Lining:	
Category:	<b>NA</b>		
Comment:	<b>Flow direction is marked wrong.</b>		
Location Details:		Direction of Survey:	<b>Downstream</b>
US MH:	<b>M-505-082</b>	DS MH:	<b>M-505-081</b>
		Total Length Surveyed (ft):	<b>20.9</b>

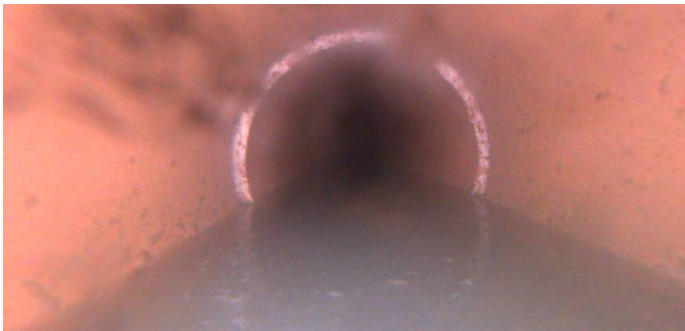
Code: **AMH**  
Description: **Manhole**

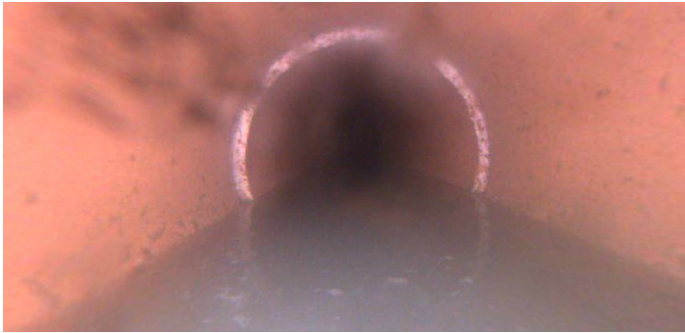
Code:	<b>MWL</b>
Description:	<b>Water Level</b>

Distance (ft):	<b>.0</b>
Structural Grade:	<b>0</b>
O&M Grade:	<b>0</b>
Clock Start/From:	
Clock To:	
1st Value:	
2nd Value:	
Value Percent:	<b>30.000</b>
Continuous Index:	
Within 8" of Joint:	<b>NO</b>
Remarks:

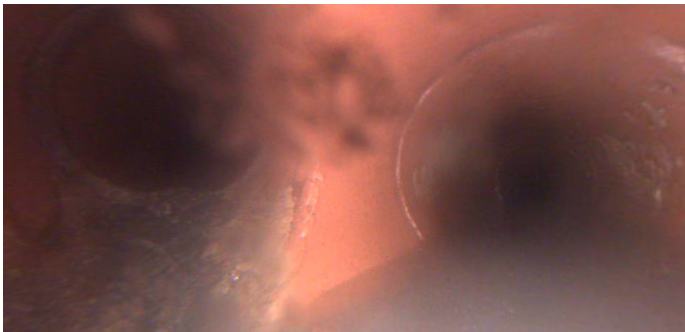
Code:	<b>TF</b>
Description:	<b>Tap Factory</b>

Distance (ft):	<b>3.2</b>
Structural Grade:	<b>0</b>
O&M Grade:	<b>0</b>
Clock Start/From:	<b>9</b>
Clock To:	
1st Value:	<b>4.000</b>
2nd Value:	
Value Percent:	
Continuous Index:	
Within 8" of Joint:	
Remarks:

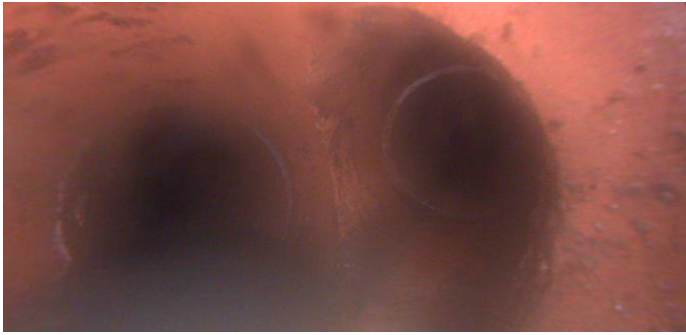
Code: **TF**  
Description: **Tap Factory**

Distance (ft): **5.0**  
Structural Grade: **0**  
O&M Grade: **0**  
Clock Start/From: **3**  
Clock To:  
1st Value: **4.000**  
2nd Value:  
Value Percent:  
Continuous Index:  
Within 8" of Joint:  
Remarks:

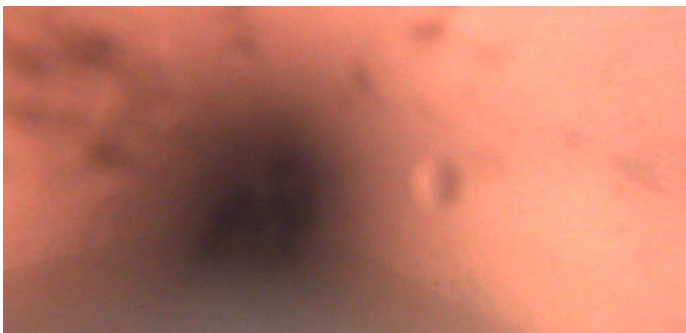
Code: **MSA**  
Description: **Abandoned Survey**

Distance (ft): **20.9**  
Structural Grade: **0**  
O&M Grade: **0**  
Clock Start/From:  
Clock To:  
1st Value:  
2nd Value:  
Value Percent:  
Continuous Index:  
Within 8" of Joint: **NO**  
Remarks: **high water**
