Profile/Photo Observation Report

Date:	01/15/2022	Weather:		Coding:	PACP 7.0
Pipe Length (ft):	146.9	Owner:	City of Hobart	Pre Clean:	Heavy Cleaning
P.O.#:	YES502259	Surveyor:	S. Bucklin	PSR:	P-505-081-082
Customer:	City of Hobart	Clean Date:	01/13/2021	Shape:	C

Street:	West 4th Street	Flow Control:	Not Controlled
City:	Hobart, IN	Year Renewed:	
Location:	Local rural streets with light traffic, t	Tape/Media #:	
Purpose:	Routine Assessment	Dia/Height:	8"
Use:	Sanitary Sewage Pipe	Material:	VCP
Drain Area:		Lining:	None
Category:	NA		
Comment:			
Location Details:		Direction of Survey:	Upstream
US MH:	M-505-082	DS MH:	M-505-081
		Total Length Surveyed (ft):	146.9

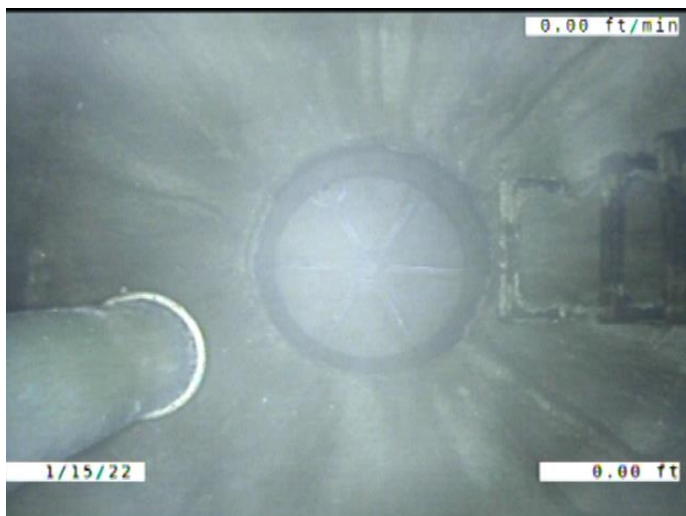
Code: **AMH**
 Description: **Manhole**

Distance (ft): **.0**
 Structural Grade: **0**
 O&M Grade: **0**
 Clock Start/From:
 Clock To:
 1st Value:
 2nd Value:
 Value Percent:
 Continuous Index:
 Within 8" of Joint: **NO**
 Remarks: **M-505-081**

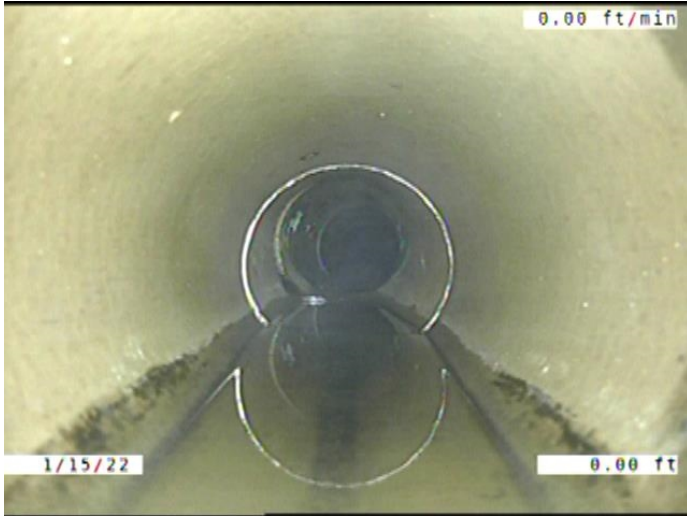
Code: **MWL**
Description: **Miscellaneous Water Level**

Distance (ft): **.0**
Structural Grade: **0**
O&M Grade: **0**
Clock Start/From:
Clock To:
1st Value:
2nd Value:
Value Percent: **5.000**
Continuous Index:
Within 8" of Joint: **NO**
Remarks:

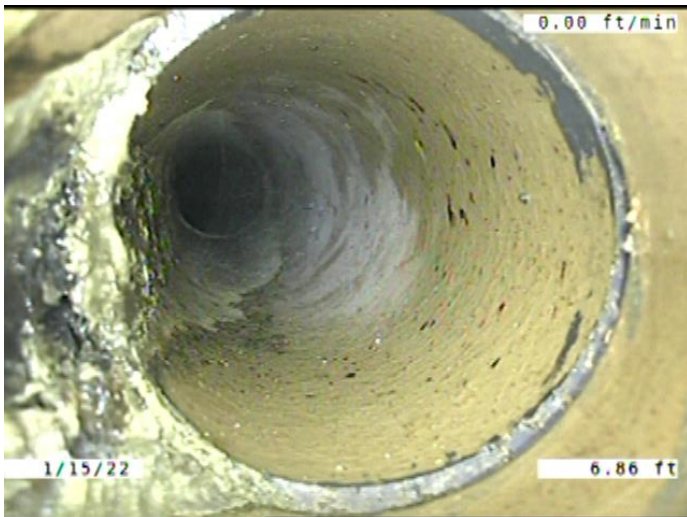
Code: **TF**
Description: **Tap Factory**

Distance (ft): **6.9**
Structural Grade: **0**
O&M Grade: **0**
Clock Start/From: **10**
Clock To:
1st Value: **4.000**
2nd Value:
Value Percent:
Continuous Index:
Within 8" of Joint: **YES**
Remarks: **ENCrustation COMING DOWN THE SERVICE INTO THE MAIN.**

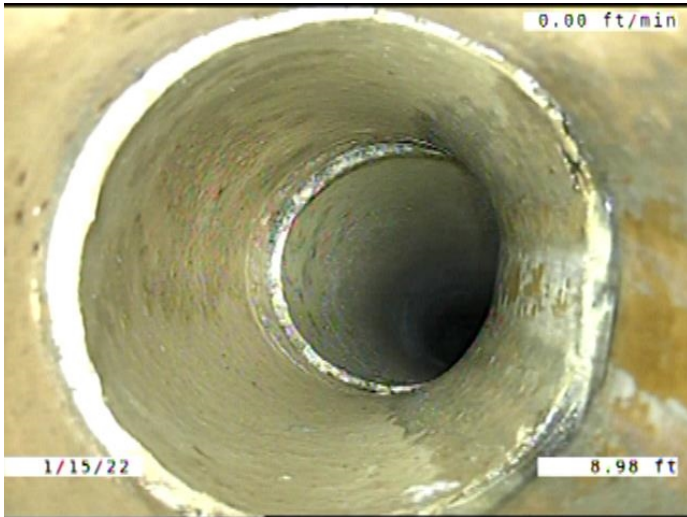
Code: **TF**
 Description: **Tap Factory**

Distance (ft): **9.0**
 Structural Grade: **0**
 O&M Grade: **0**
 Clock Start/From: **2**
 Clock To:
 1st Value: **4.000**
 2nd Value:
 Value Percent:
 Continuous Index:
 Within 8" of Joint: **YES**
 Remarks:

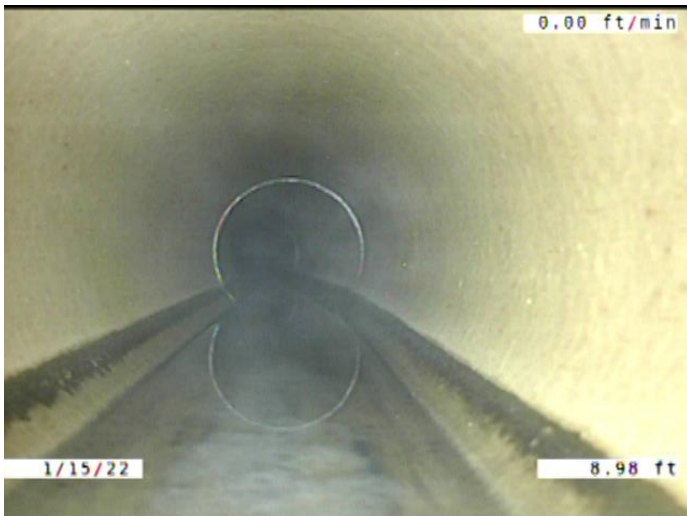
Code: **MWLS**
 Description: **Miscellaneous Water Level Sag**

Distance (ft): **9.0**
 Structural Grade: **2**
 O&M Grade: **0**
 Clock Start/From:
 Clock To:
 1st Value:
 2nd Value:
 Value Percent: **5.000**
 Continuous Index: **S01**
 Within 8" of Joint: **NO**
 Remarks:

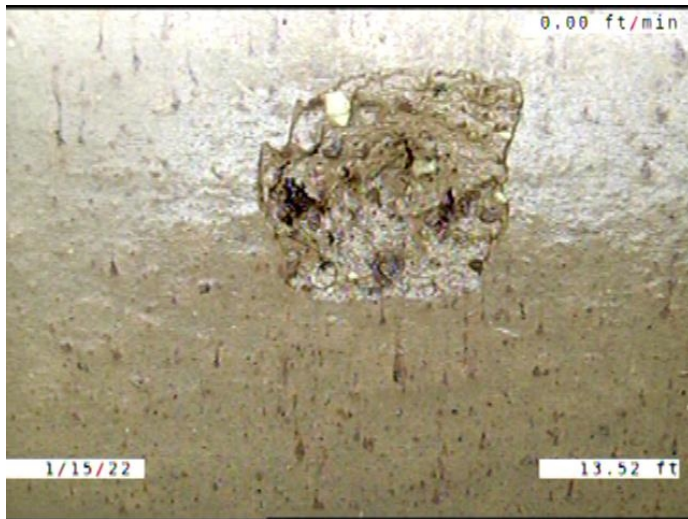
Code: **SSS**
 Description: **Surface Damage Surface Spalling**

Distance (ft): **13.5**
 Structural Grade: **2**
 O&M Grade: **0**
 Clock Start/From: **11**
 Clock To:
 1st Value:
 2nd Value:
 Value Percent:
 Continuous Index:
 Within 8" of Joint: **NO**
 Remarks:

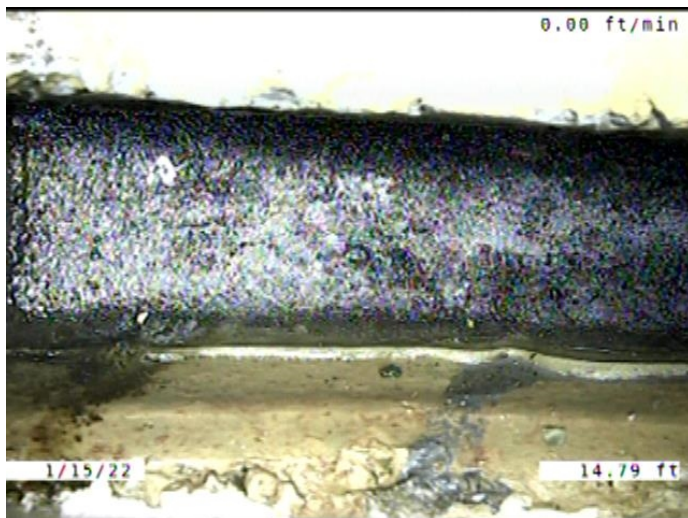
Code: **JSL**
 Description: **Joint Separated Large**

Distance (ft): **14.8**
 Structural Grade: **4**
 O&M Grade: **0**
 Clock Start/From:
 Clock To:
 1st Value:
 2nd Value:
 Value Percent:
 Continuous Index:
 Within 8" of Joint: **NO**
 Remarks:

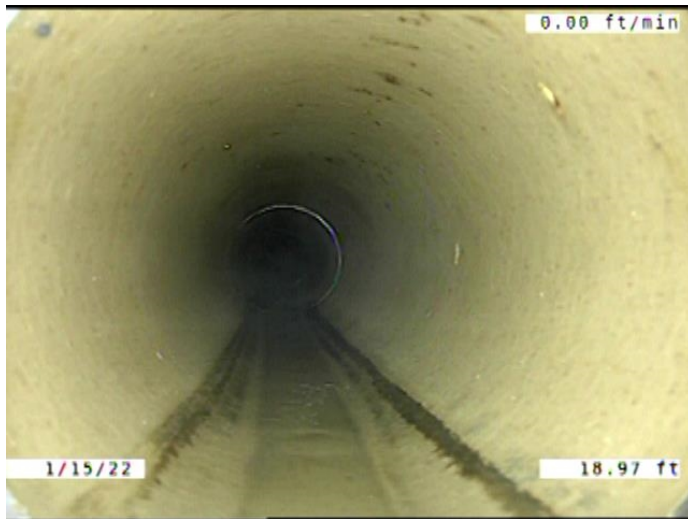
Code: **MWLS**
 Description: **Miscellaneous Water Level Sag**

Distance (ft): **19.0**
 Structural Grade: **2**
 O&M Grade: **0**
 Clock Start/From:
 Clock To:
 1st Value:
 2nd Value:
 Value Percent: **5.000**
 Continuous Index: **F01**
 Within 8" of Joint: **NO**
 Remarks:

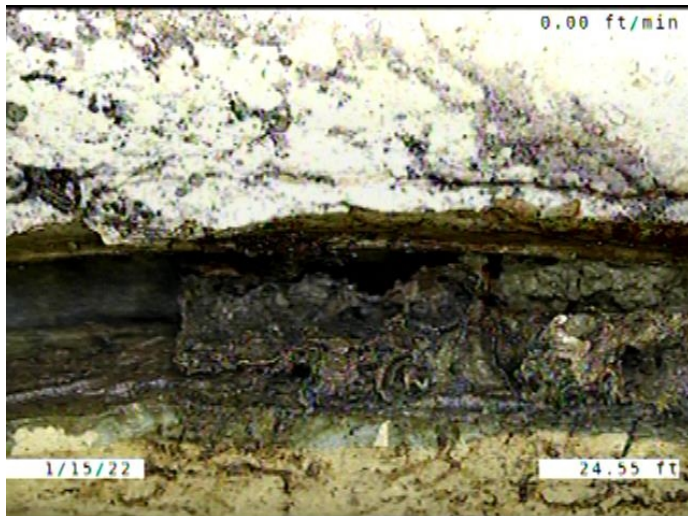
Code: **DAE**
 Description: **Deposits Attached Encrustation**

Distance (ft): **24.5**
 Structural Grade: **0**
 O&M Grade: **2**
 Clock Start/From: **7**
 Clock To: **11**
 1st Value:
 2nd Value:
 Value Percent: **5.000**
 Continuous Index:
 Within 8" of Joint: **YES**
 Remarks:

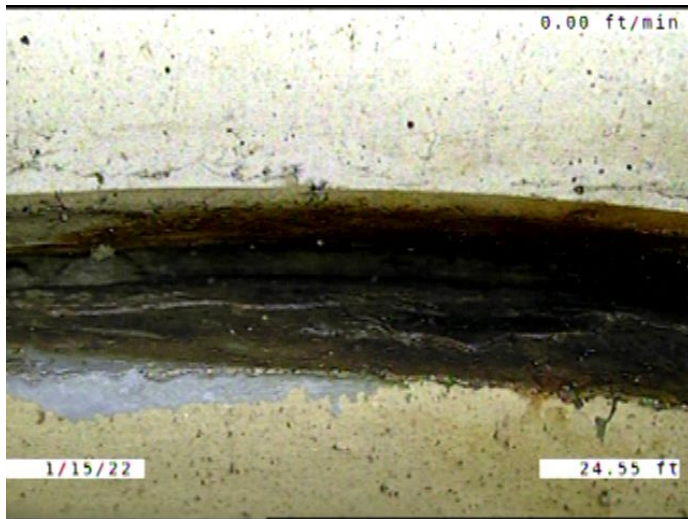
Code: **ISJ**
 Description: **Infiltration Stain Joint**

Distance (ft): **24.5**
 Structural Grade: **0**
 O&M Grade: **1**
 Clock Start/From: **2**
 Clock To: **5**
 1st Value:
 2nd Value:
 Value Percent:
 Continuous Index:
 Within 8" of Joint: **YES**
 Remarks:

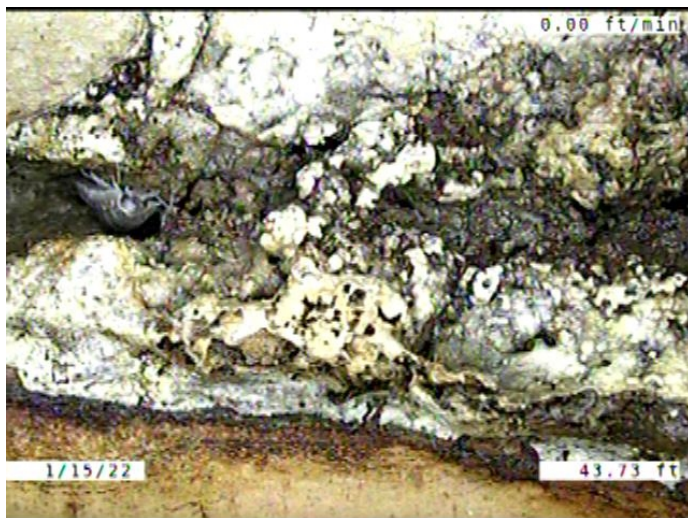
Code: **DAE**
 Description: **Deposits Attached Encrustation**

Distance (ft): **43.7**
 Structural Grade: **0**
 O&M Grade: **2**
 Clock Start/From: **8**
 Clock To: **5**
 1st Value:
 2nd Value:
 Value Percent: **5.000**
 Continuous Index: **S02**
 Within 8" of Joint: **YES**
 Remarks:

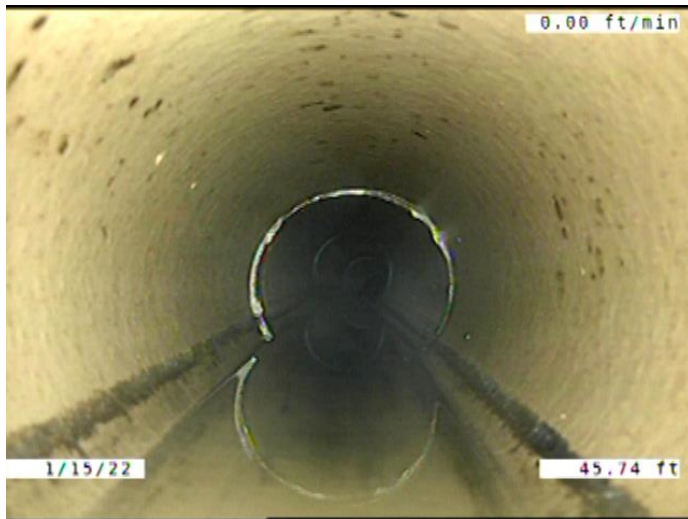
Code: **MWLS**
Description: **Miscellaneous Water Level Sag**

Distance (ft): **45.7**
Structural Grade: **2**
O&M Grade: **0**
Clock Start/From:
Clock To:
1st Value:
2nd Value:
Value Percent: **30.000**
Continuous Index:
Within 8" of Joint: **NO**
Remarks:

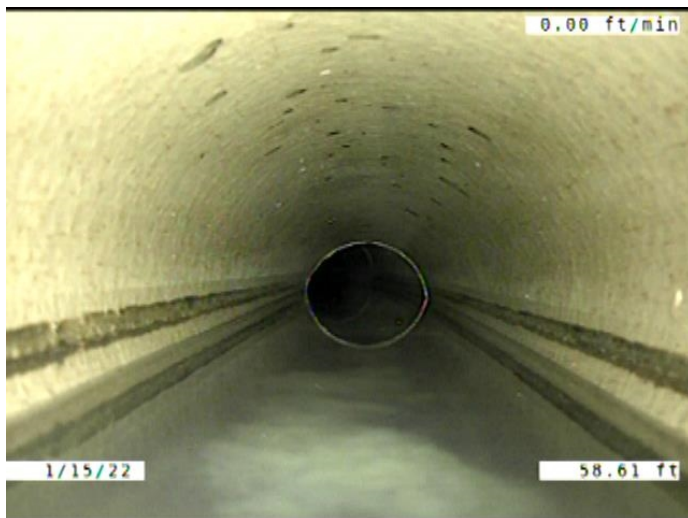
Code: **MWLS**
Description: **Miscellaneous Water Level Sag**

Distance (ft): **58.6**
Structural Grade: **2**
O&M Grade: **0**
Clock Start/From:
Clock To:
1st Value:
2nd Value:
Value Percent: **5.000**
Continuous Index: **S04**
Within 8" of Joint: **NO**
Remarks:

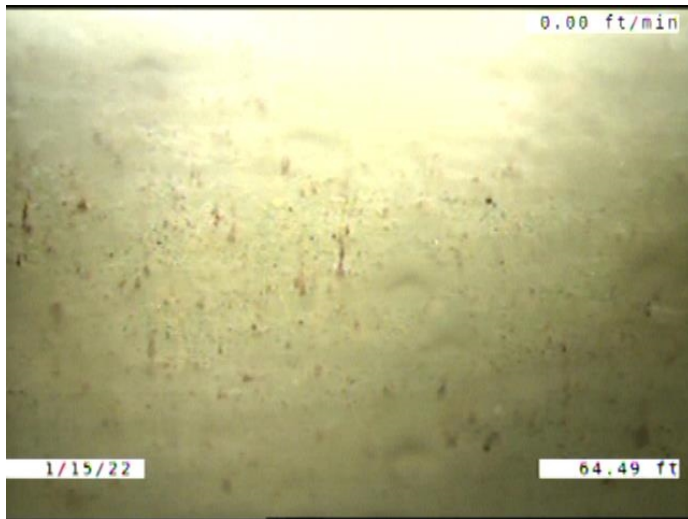
Code: **MWLS**
Description: **Miscellaneous Water Level Sag**

Distance (ft): **64.5**
Structural Grade: **3**
O&M Grade: **0**
Clock Start/From:
Clock To:
1st Value:
2nd Value:
Value Percent: **45.000**
Continuous Index:
Within 8" of Joint: **NO**
Remarks:

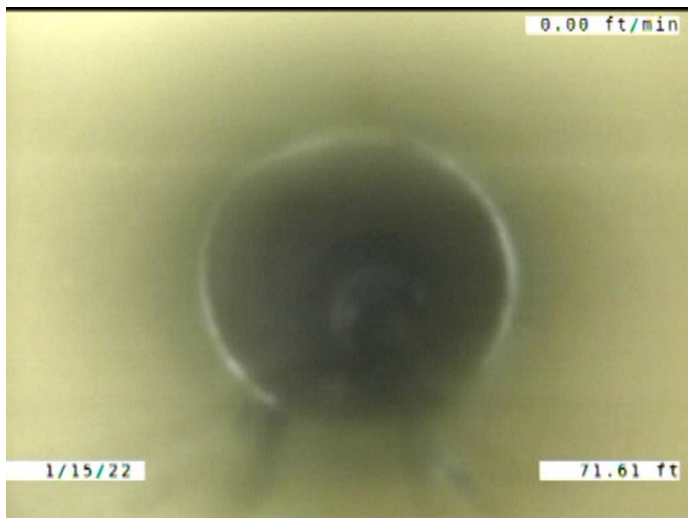
Code: **MWLS**
Description: **Miscellaneous Water Level Sag**

Distance (ft): **71.6**
Structural Grade: **2**
O&M Grade: **0**
Clock Start/From:
Clock To:
1st Value:
2nd Value:
Value Percent: **5.000**
Continuous Index: **F04**
Within 8" of Joint: **NO**
Remarks:

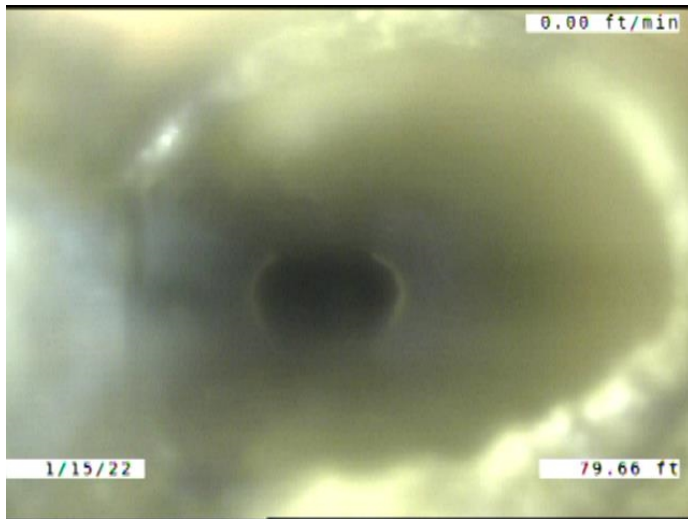
Code:	TF
Description:	Tap Factory
Distance (ft):	79.7
Structural Grade:	0
O&M Grade:	0
Clock Start/From:	9
Clock To:	
1st Value:	4.000
2nd Value:	
Value Percent:	
Continuous Index:	
Within 8" of Joint:	YES
Remarks:	SERVICE CONNECTION TO MAIN HAS ENCRUSTATION

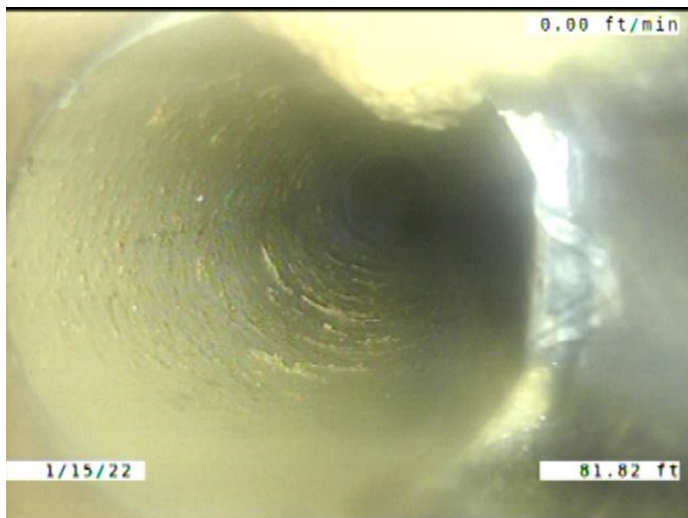
Code:	TF
Description:	Tap Factory
Distance (ft):	81.8
Structural Grade:	0
O&M Grade:	0
Clock Start/From:	3
Clock To:	
1st Value:	4.000
2nd Value:	
Value Percent:	
Continuous Index:	
Within 8" of Joint:	YES
Remarks:	SERVICE CONNECTION TO THE MAIN HAS ENCRUSTATION

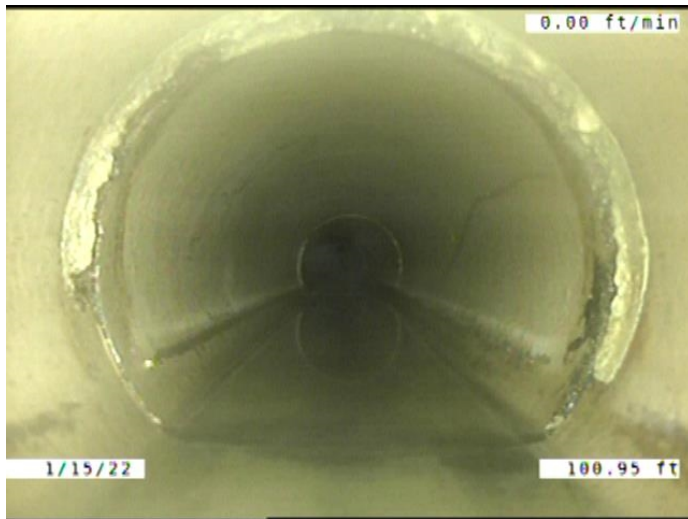
Code: **MWLS**
Description: **Miscellaneous Water Level Sag**

Distance (ft): **101.0**
Structural Grade: **2**
O&M Grade: **0**
Clock Start/From:
Clock To:
1st Value:
2nd Value:
Value Percent: **10.000**
Continuous Index: **S05**
Within 8" of Joint: **NO**
Remarks:

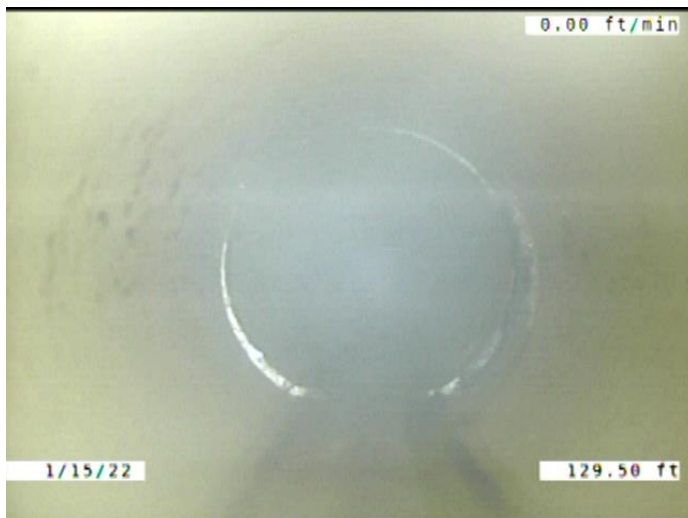
Code: **MWLS**
Description: **Miscellaneous Water Level Sag**

Distance (ft): **129.5**
Structural Grade: **2**
O&M Grade: **0**
Clock Start/From:
Clock To:
1st Value:
2nd Value:
Value Percent: **10.000**
Continuous Index: **F05**
Within 8" of Joint: **NO**
Remarks:

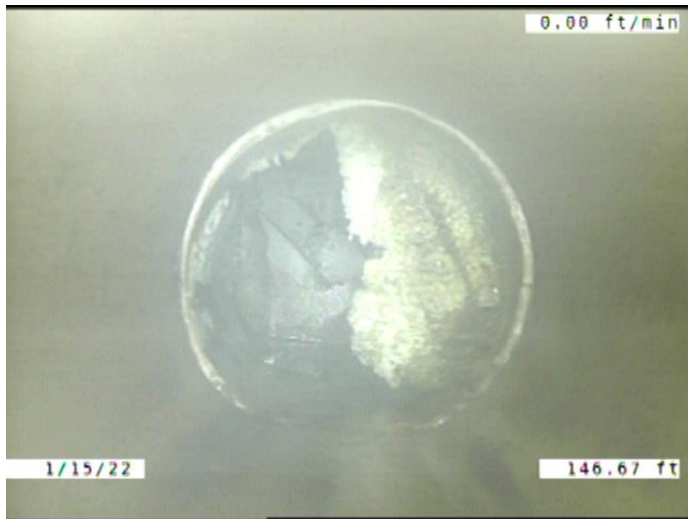
Code: **DAE**
Description: **Deposits Attached Encrustation**

Distance (ft): **146.7**
Structural Grade: **0**
O&M Grade: **5**
Clock Start/From: **8**
Clock To: **6**
1st Value:
2nd Value:
Value Percent: **45.000**
Continuous Index:
Within 8" of Joint: **YES**
Remarks:

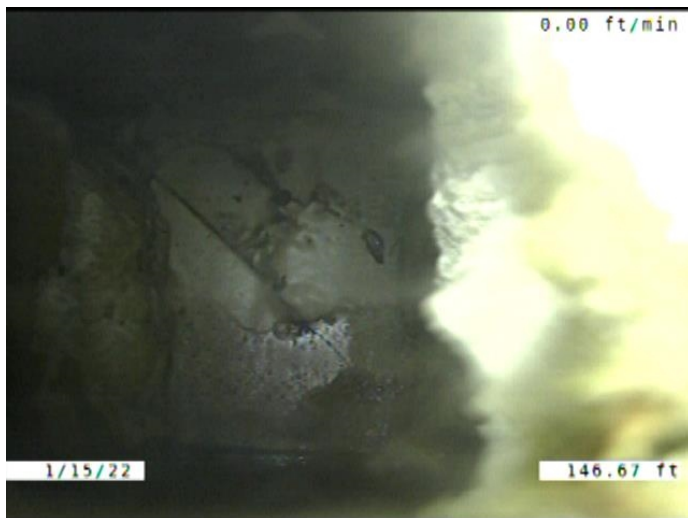
Code: **DAE**
Description: **Deposits Attached Encrustation**

Distance (ft): **146.7**
Structural Grade: **0**
O&M Grade: **2**
Clock Start/From: **8**
Clock To: **5**
1st Value:
2nd Value:
Value Percent: **5.000**
Continuous Index: **F02**
Within 8" of Joint: **YES**
Remarks:

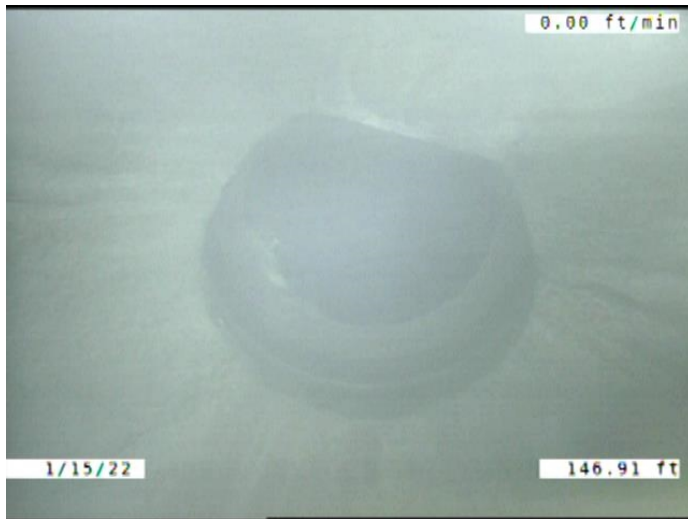
Code:	AMH
Description:	Manhole
Distance (ft):	146.9
Structural Grade:	0
O&M Grade:	0
Clock Start/From:	
Clock To:	
1st Value:	
2nd Value:	
Value Percent:	
Continuous Index:	
Within 8" of Joint:	NO
Remarks:	M-505-082
