Profile/Photo Observation Report

Date:	04/14/2018	Weather:		Coding:	PACP 6.0
Pipe Length (ft):	299.7	Owner:	NA	Pre Clean:	No Pre-Cleaning
P.O.#:		Surveyor:	Jen Costello	PSR:	P-505-084-085
Customer:		Clean Date:	01/01/1900	Shape:	C

Street:	W 4TH PL	Flow Control:	Not Controlled
City:	Hobart, IN	Year Renewed:	
Location:	Yard	Tape/Media #:	
Purpose:	Routine Assessment	Dia/Height:	10"
Use:	Sanitary	Material:	VCP
Drain Area:	NA	Lining:	
Category:	NA		
Comment:			
Location Details:		Direction of Survey:	Upstream
US MH:	M-505-084	DS MH:	M-505-085
		Total Length Surveyed (ft):	58.8

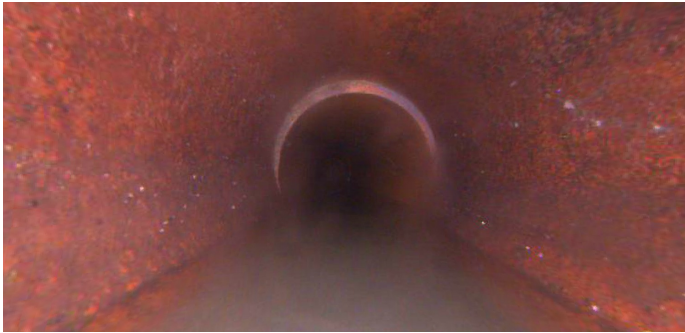
Code:	MWL
Description:	Water Level

Distance (ft):	.0
Structural Grade:	0
O&M Grade:	0
Clock Start/From:	
Clock To:	
1st Value:	
2nd Value:	
Value Percent:	20.000
Continuous Index:	
Within 8" of Joint:	NO
Remarks:

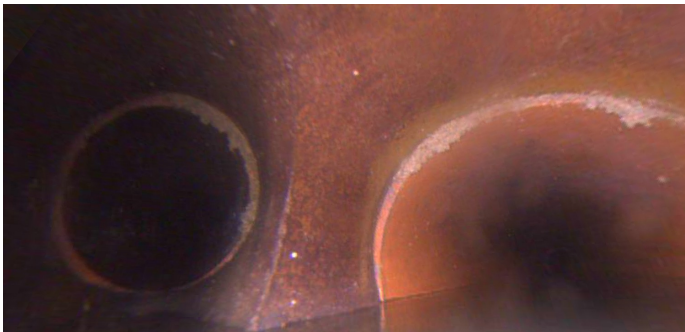
Code:	TFA
Description:	Tap Factory Active

Distance (ft):	9.0
Structural Grade:	0
O&M Grade:	0
Clock Start/From:	9
Clock To:	
1st Value:	4.000
2nd Value:	
Value Percent:	
Continuous Index:	
Within 8" of Joint:	
Remarks:

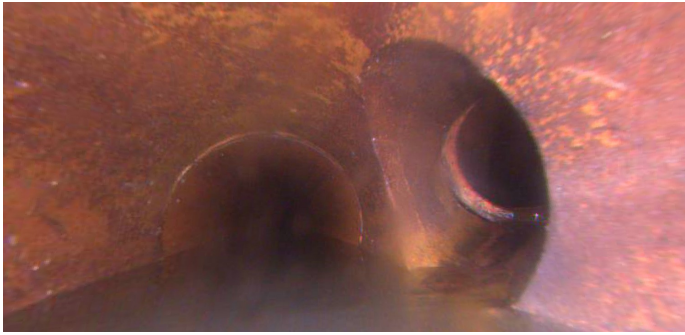
Code: **TFA**
Description: **Tap Factory Active**

Distance (ft): **20.5**
Structural Grade: **0**
O&M Grade: **0**
Clock Start/From: **3**
Clock To:
1st Value: **4.000**
2nd Value:
Value Percent:
Continuous Index:
Within 8" of Joint:
Remarks:

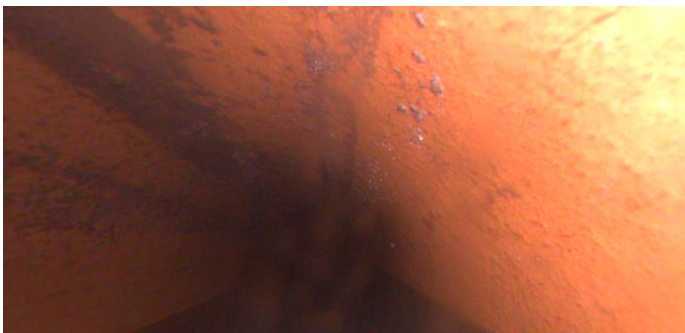
Code: **MSA**
Description: **Abandoned Survey**

Distance (ft): **58.8**
Structural Grade: **0**
O&M Grade: **0**
Clock Start/From:
Clock To:
1st Value:
2nd Value:
Value Percent:
Continuous Index:
Within 8" of Joint: **NO**
Remarks: **debris under water**
