Profile/Pho	oto Observation I	Report				RedZone
Date: Pipe Length (ft) P.O.#: Customer:	04/14/2018 : 299.7	Weather: Owner: Surveyor: Clean Date:	NA Jen Coste 01/01/19	-	Coding: Pre Clean: PSR: Shape:	PACP 6.0 No Pre-Cleaning P-505-084-085 C
Street:	FOXCROFT STREET		Flow Contro	ol:	Not Controlled	
City:	Hobart, IN		Year Renew	ved:		
Location:	Yard		Tape/Medi	a #:		
Purpose:	Routine Assessment	:	Dia/Height:	:	10"	
Use:	Sanitary		Material:		VCP	
Drain Area:	NA		Lining:			
Category:	NA					
Comment:						
Location Details	s:		Direction o	f Survey:	Upstream	
US MH:	M-505-084	DS MH:	M-505-085		Total Length Surveyed (ft):	58.8
D&M Index:	0.00	O&M Quick:		0000	O&M Rating:	0.00
Structural Index:	0.00		uick:	0000	Structural Rating:	0.00
Overall Index:	0.00	Overall Quick	<:	0000	Overall Rating:	0.00

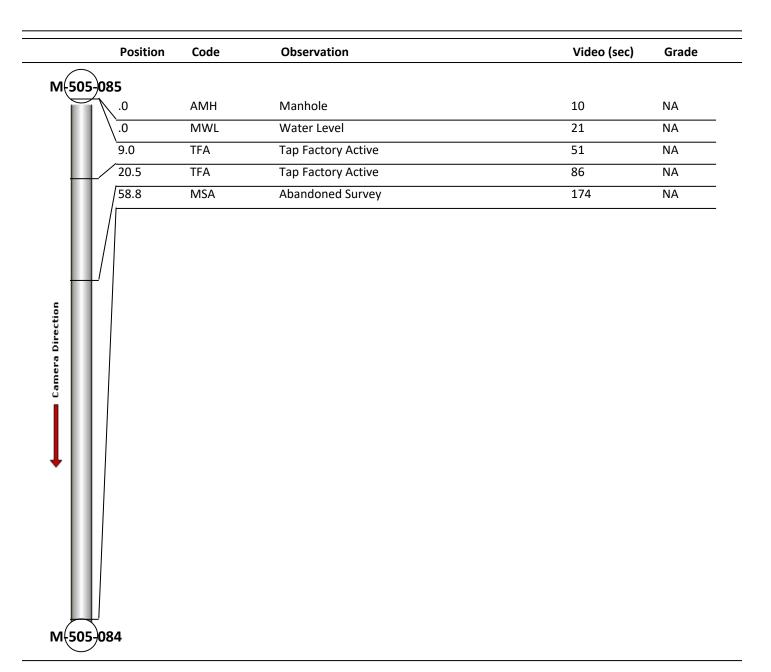
Code: Description:	AMH Manhole
	_
Distance (ft):	.0
Structural Grade:	0
O&M Grade:	0
Clock Start/From:	
Clock To:	
1st Value:	
2nd Value:	
Value Percent:	
Continuous Index:	
Within 8" of Joint:	NO
Remarks:	M-505-085
