Profile/Photo Observation Report

Date:	04/14/2018	Weather:		Coding:	PACP 6.0
Pipe Length (ft):	145.8	Owner:	NA	Pre Clean:	No Pre-Cleaning
P.O.#:		Surveyor:	Jen Costello	PSR:	P-505-085-086
Customer:		Clean Date:	01/01/1900	Shape:	C

Street:	W 4TH PL	Flow Control:	Not Controlled
City:	Hobart, IN	Year Renewed:	
Location:	Yard	Tape/Media #:	
Purpose:	Routine Assessment	Dia/Height:	10"
Use:	Sanitary	Material:	VCP
Drain Area:	NA	Lining:	
Category:	NA		
Comment:			
Location Details:		Direction of Survey:	Downstream
US MH:	M-505-085	DS MH:	M-505-086
		Total Length Surveyed (ft):	68.6

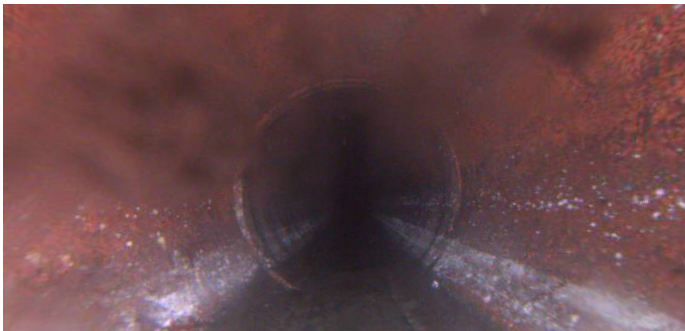
Code: **AMH**
Description: **Manhole**

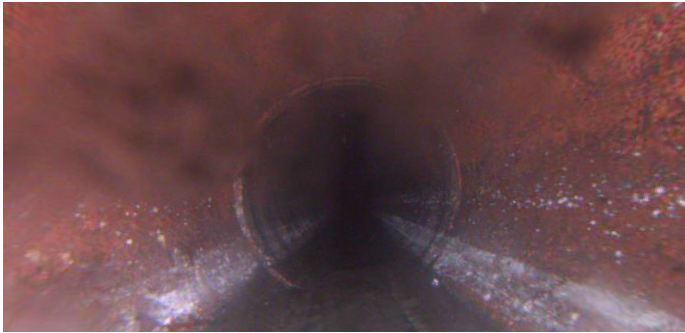
Code:	MWL
Description:	Water Level

Distance (ft):	.0
Structural Grade:	0
O&M Grade:	0
Clock Start/From:	
Clock To:	
1st Value:	
2nd Value:	
Value Percent:	5.000
Continuous Index:	
Within 8" of Joint:	NO
Remarks:

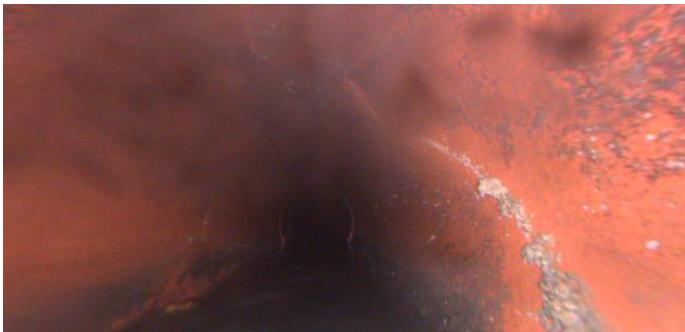
Code:	FM
Description:	Fracture Multiple

Distance (ft):	9.1
Structural Grade:	4
O&M Grade:	0
Clock Start/From:	8
Clock To:	4
1st Value:	
2nd Value:	
Value Percent:	
Continuous Index:	
Within 8" of Joint:	
Remarks:

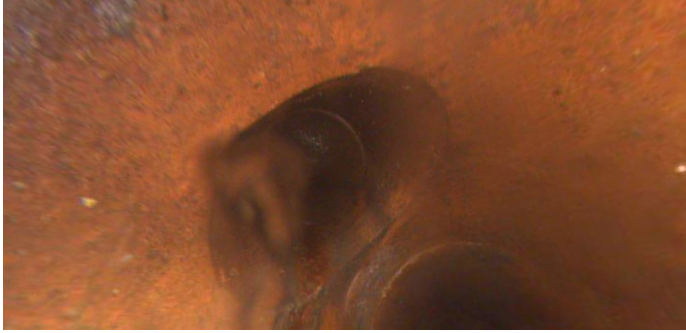
Code: **TF**
Description: **Tap Factory**

Distance (ft): **13.7**
Structural Grade: **0**
O&M Grade: **0**
Clock Start/From: **2**
Clock To:
1st Value: **4.000**
2nd Value:
Value Percent:
Continuous Index:
Within 8" of Joint:
Remarks:

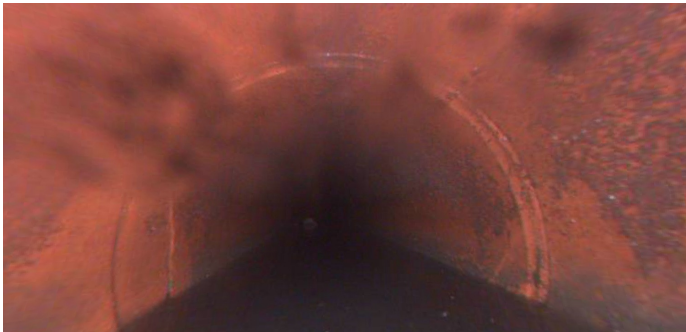
Code: **FM**
Description: **Fracture Multiple**

Distance (ft): **24.2**
Structural Grade: **4**
O&M Grade: **0**
Clock Start/From: **8**
Clock To: **4**
1st Value:
2nd Value:
Value Percent:
Continuous Index:
Within 8" of Joint: **YES**
Remarks:

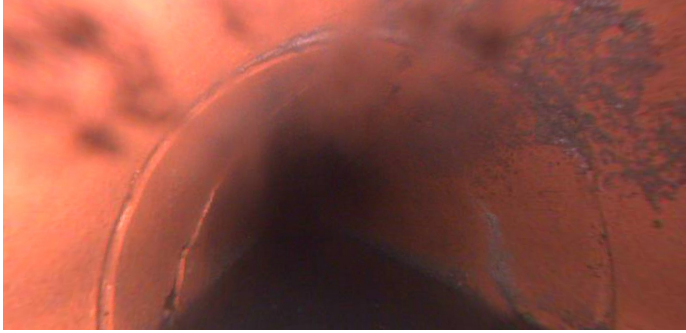
Code: **FC**
Description: **Fracture Circumferential**

Distance (ft): **34.6**
Structural Grade: **2**
O&M Grade: **0**
Clock Start/From: **8**
Clock To: **4**
1st Value:
2nd Value:
Value Percent:
Continuous Index:
Within 8" of Joint:
Remarks:

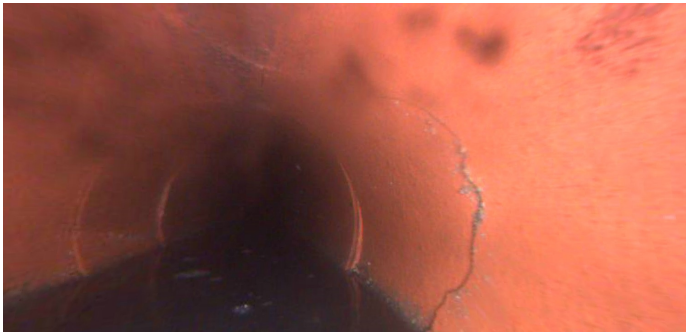
Code: **FM**
Description: **Fracture Multiple**

Distance (ft): **49.4**
Structural Grade: **4**
O&M Grade: **0**
Clock Start/From: **8**
Clock To: **4**
1st Value:
2nd Value:
Value Percent:
Continuous Index:
Within 8" of Joint: **YES**
Remarks:

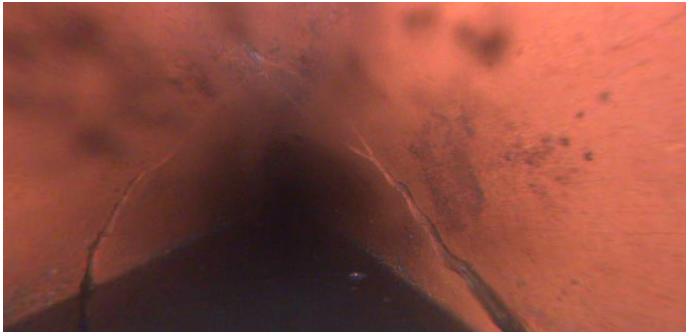
Code: **FM**
Description: **Fracture Multiple**

Distance (ft): **60.6**
Structural Grade: **4**
O&M Grade: **0**
Clock Start/From: **8**
Clock To: **4**
1st Value:
2nd Value:
Value Percent:
Continuous Index:
Within 8" of Joint:
Remarks:

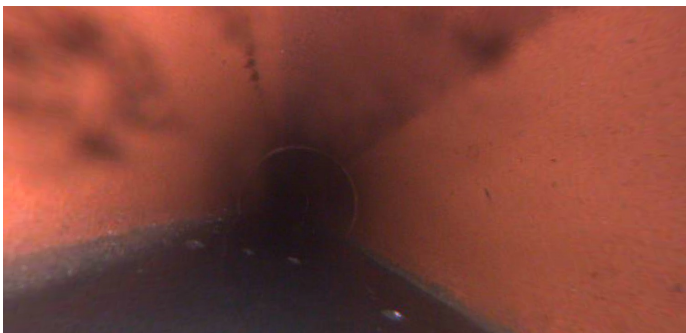
Code: **MSA**
Description: **Abandoned Survey**

Distance (ft): **68.6**
Structural Grade: **0**
O&M Grade: **0**
Clock Start/From:
Clock To:
1st Value:
2nd Value:
Value Percent:
Continuous Index:
Within 8" of Joint: **NO**
Remarks: **debris under water**
