Profile/Photo Observation Report

Street:	FOXCROFT STREET	Flow Control:	Not Controlled
City:	Hobart, IN	Year Renewed:	
Location:	Yard	Tape/Media #:	
Purpose:	Routine Assessment	Dia/Height:	10"
Use:	Sanitary	Material:	VCP
Drain Area:	NA	Lining:	
Category:	NA		
Comment:

Location Details:		Direction of Survey:	Downstream
US MH:	M-505-085	DS MH:	M-505-086
		Total Length Surveyed (ft):	68.6

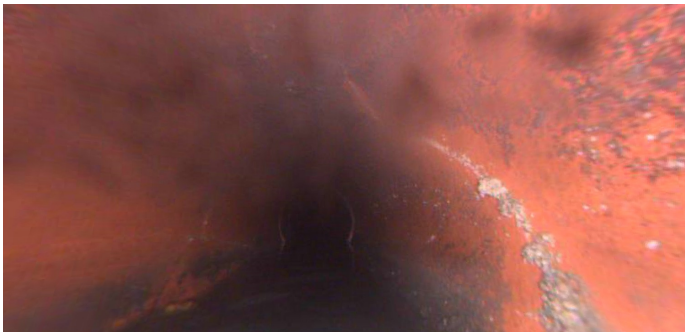
Code:	FM
Description:	Fracture Multiple

Distance (ft):	9.1
Structural Grade:	4
O&M Grade:	0
Clock Start/From:	8
Clock To:	4
1st Value:	
2nd Value:	
Value Percent:	
Continuous Index:	
Within 8" of Joint:	
Remarks:

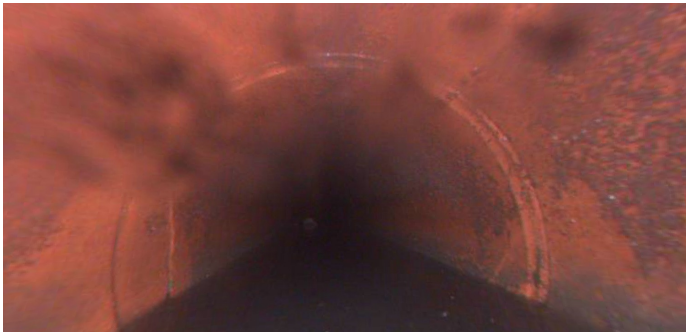
Code: **FM**
Description: **Fracture Multiple**

Distance (ft): **24.2**
Structural Grade: **4**
O&M Grade: **0**
Clock Start/From: **8**
Clock To: **4**
1st Value:
2nd Value:
Value Percent:
Continuous Index:
Within 8" of Joint: **YES**
Remarks:

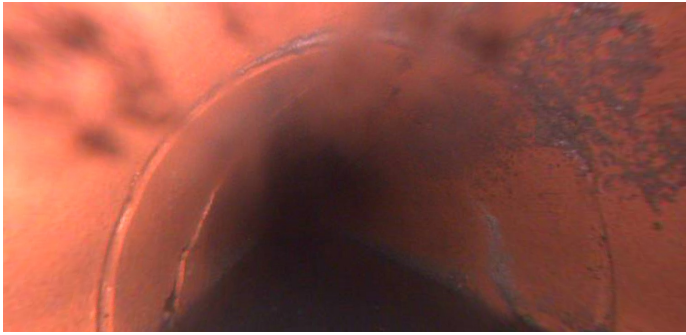
Code: **FC**
Description: **Fracture Circumferential**

Distance (ft): **34.6**
Structural Grade: **2**
O&M Grade: **0**
Clock Start/From: **8**
Clock To: **4**
1st Value:
2nd Value:
Value Percent:
Continuous Index:
Within 8" of Joint:
Remarks:

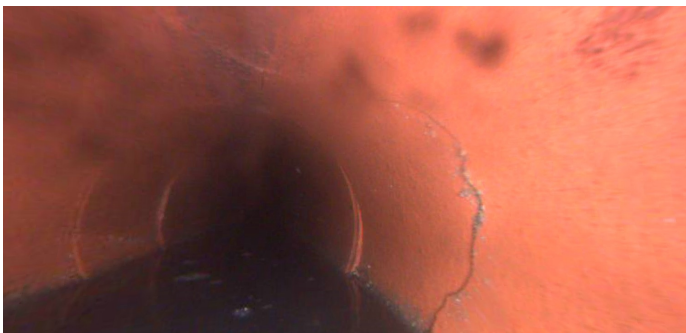
Code: **FM**
Description: **Fracture Multiple**

Distance (ft): **49.4**
Structural Grade: **4**
O&M Grade: **0**
Clock Start/From: **8**
Clock To: **4**
1st Value:
2nd Value:
Value Percent:
Continuous Index:
Within 8" of Joint: **YES**
Remarks:

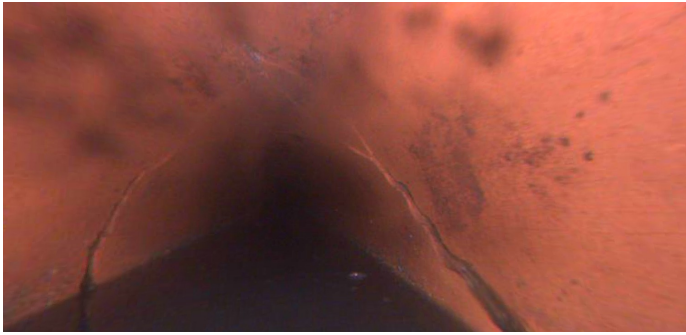
Code: **FM**
Description: **Fracture Multiple**

Distance (ft): **60.6**
Structural Grade: **4**
O&M Grade: **0**
Clock Start/From: **8**
Clock To: **4**
1st Value:
2nd Value:
Value Percent:
Continuous Index:
Within 8" of Joint:
Remarks:

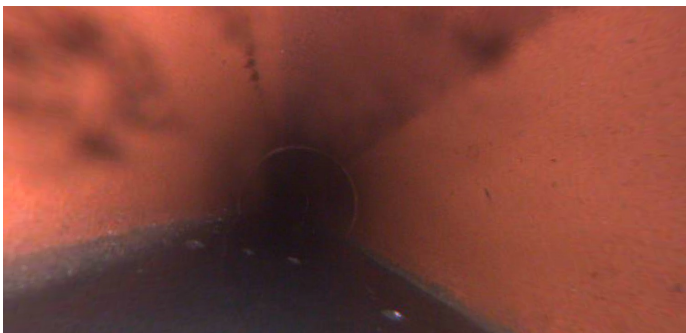
Code: **MSA**
Description: **Abandoned Survey**

Distance (ft): **68.6**
Structural Grade: **0**
O&M Grade: **0**
Clock Start/From:
Clock To:
1st Value:
2nd Value:
Value Percent:
Continuous Index:
Within 8" of Joint: **NO**
Remarks: **debris under water**
