Profile/Photo Observation Report

Street:	W 4TH PL	Flow Control:	Not Controlled
City:	Hobart, IN	Year Renewed:	
Location:	Yard	Tape/Media #:	
Purpose:	Routine Assessment	Dia/Height:	10"
Use:	Sanitary	Material:	VCP
Drain Area:	NA	Lining:	
Category:	NA		
Comment:

Location Details:		Direction of Survey:	Downstream
US MH:	M-505-086	DS MH:	M-505-087
		Total Length Surveyed (ft):	242.3

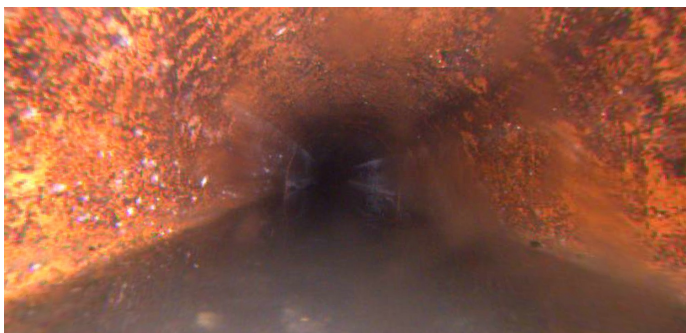
Code: **AMH**
Description: **Manhole**

Distance (ft): **.0**
Structural Grade: **0**
O&M Grade: **0**
Clock Start/From:
Clock To:
1st Value:
2nd Value:
Value Percent:
Continuous Index:
Within 8" of Joint: **NO**
Remarks: **M-505-086**

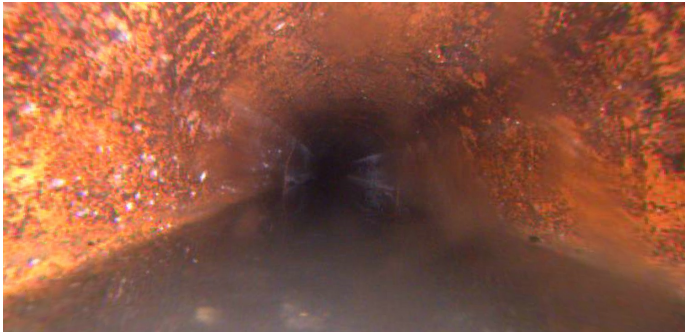
Code:	MWL
Description:	Water Level

Distance (ft):	.0
Structural Grade:	0
O&M Grade:	0
Clock Start/From:	
Clock To:	
1st Value:	
2nd Value:	
Value Percent:	30.000
Continuous Index:	
Within 8" of Joint:	NO
Remarks:

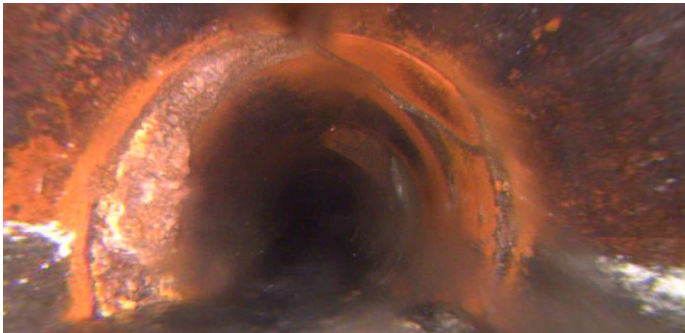
Code:	FS
Description:	Fracture Spiral

Distance (ft):	7.6
Structural Grade:	3
O&M Grade:	0
Clock Start/From:	12
Clock To:	2
1st Value:	
2nd Value:	
Value Percent:	
Continuous Index:	
Within 8" of Joint:	YES
Remarks:

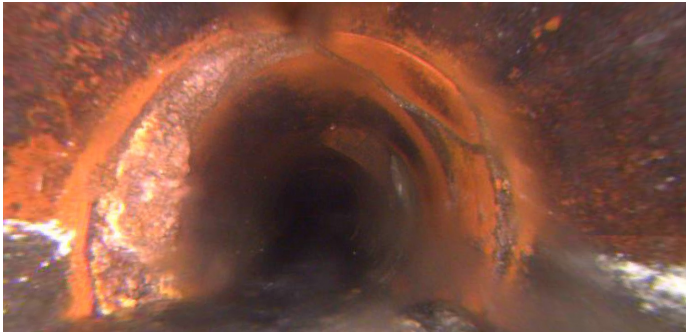
Code: **DAE**
Description: **Deposits Attached Encrustation**

Distance (ft): **7.6**
Structural Grade: **0**
O&M Grade: **2**
Clock Start/From: **8**
Clock To: **12**
1st Value:
2nd Value:
Value Percent: **10.000**
Continuous Index:
Within 8" of Joint: **YES**
Remarks:

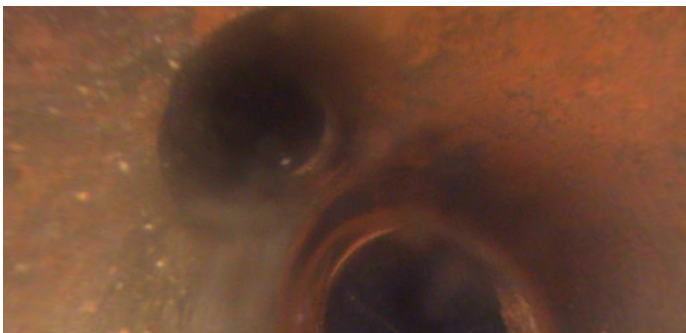
Code: **TF**
Description: **Tap Factory**

Distance (ft): **9.6**
Structural Grade: **0**
O&M Grade: **0**
Clock Start/From: **1**
Clock To:
1st Value: **4.000**
2nd Value:
Value Percent:
Continuous Index:
Within 8" of Joint:
Remarks:

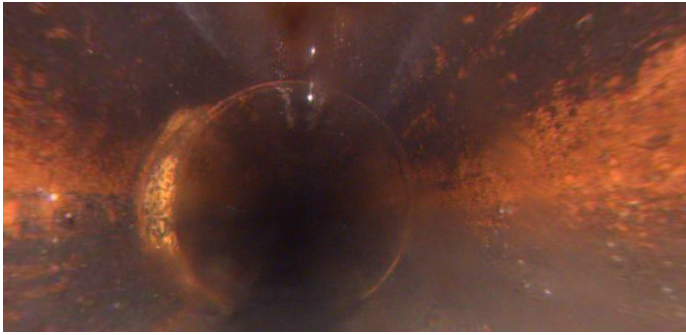
Code: **DAE**
Description: **Deposits Attached Encrustation**

Distance (ft): **24.0**
Structural Grade: **0**
O&M Grade: **2**
Clock Start/From: **8**
Clock To: **9**
1st Value:
2nd Value:
Value Percent: **5.000**
Continuous Index:
Within 8" of Joint: **YES**
Remarks:

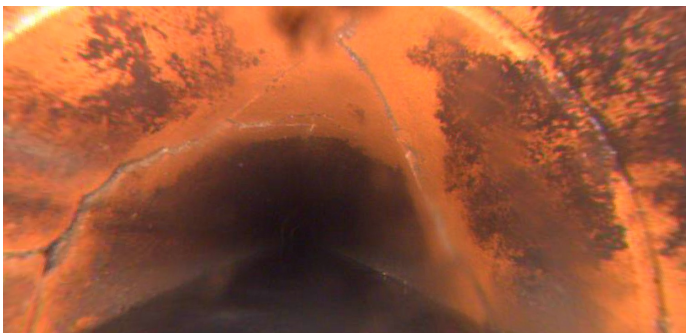
Code: **FM**
Description: **Fracture Multiple**

Distance (ft): **34.5**
Structural Grade: **4**
O&M Grade: **0**
Clock Start/From: **8**
Clock To: **4**
1st Value:
2nd Value:
Value Percent:
Continuous Index: **S01**
Within 8" of Joint: **YES**
Remarks:

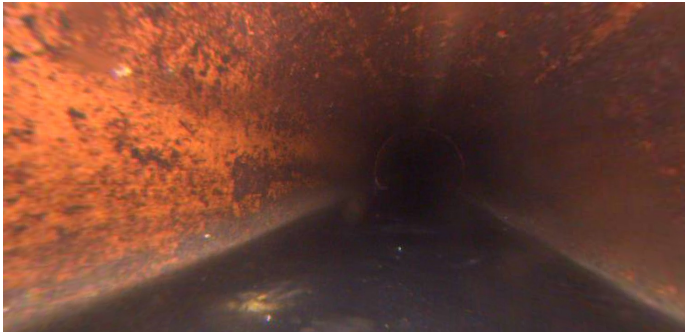
Code: **FM**
Description: **Fracture Multiple**

Distance (ft): **46.8**
Structural Grade: **4**
O&M Grade: **0**
Clock Start/From: **8**
Clock To: **4**
1st Value:
2nd Value:
Value Percent:
Continuous Index: **F01**
Within 8" of Joint: **YES**
Remarks:

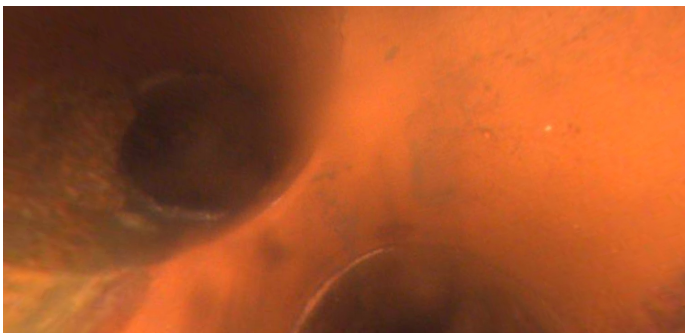
Code: **TF**
Description: **Tap Factory**

Distance (ft): **75.4**
Structural Grade: **0**
O&M Grade: **0**
Clock Start/From: **2**
Clock To:
1st Value: **4.000**
2nd Value:
Value Percent:
Continuous Index:
Within 8" of Joint:
Remarks:

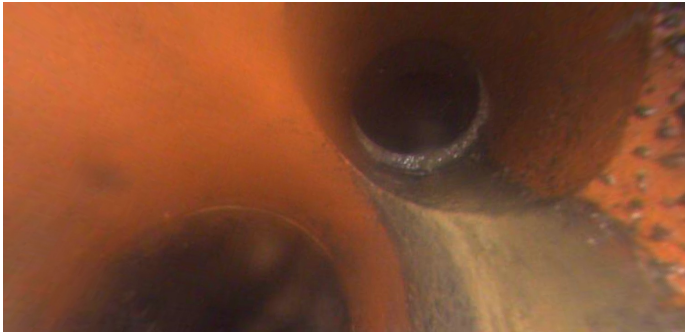
Code: **TF**
Description: **Tap Factory**

Distance (ft): **82.4**
Structural Grade: **0**
O&M Grade: **0**
Clock Start/From: **11**
Clock To:
1st Value: **4.000**
2nd Value:
Value Percent:
Continuous Index:
Within 8" of Joint:
Remarks:

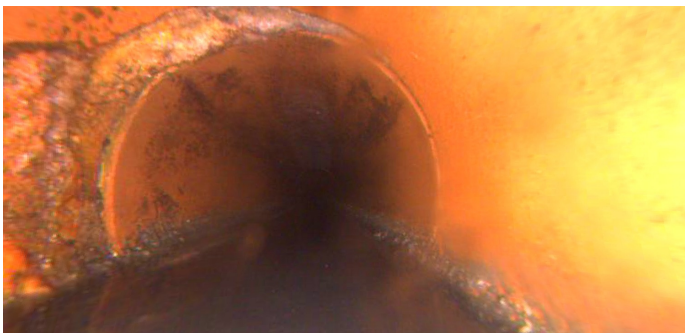
Code: **DAE**
Description: **Deposits Attached Encrustation**

Distance (ft): **87.5**
Structural Grade: **0**
O&M Grade: **2**
Clock Start/From: **8**
Clock To: **12**
1st Value:
2nd Value:
Value Percent: **5.000**
Continuous Index:
Within 8" of Joint: **YES**
Remarks:

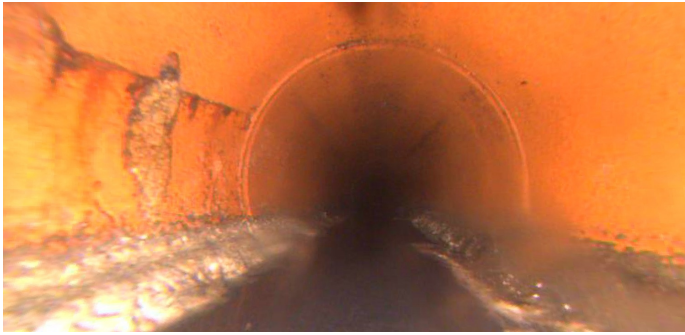
Code: **FL**
Description: **Fracture Longitudinal**

Distance (ft): **102.4**
Structural Grade: **3**
O&M Grade: **0**
Clock Start/From: **10**
Clock To:
1st Value:
2nd Value:
Value Percent:
Continuous Index:
Within 8" of Joint: **YES**
Remarks:

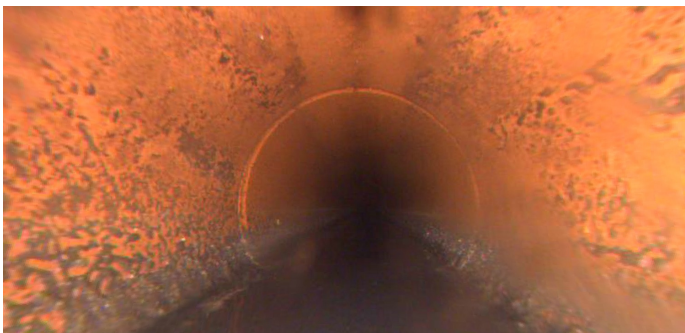
Code: **DAGS**
Description: **Deposits Attached Grease**

Distance (ft): **141.4**
Structural Grade: **0**
O&M Grade: **2**
Clock Start/From: **8**
Clock To: **4**
1st Value:
2nd Value:
Value Percent: **5.000**
Continuous Index: **S02**
Within 8" of Joint: **NO**
Remarks:

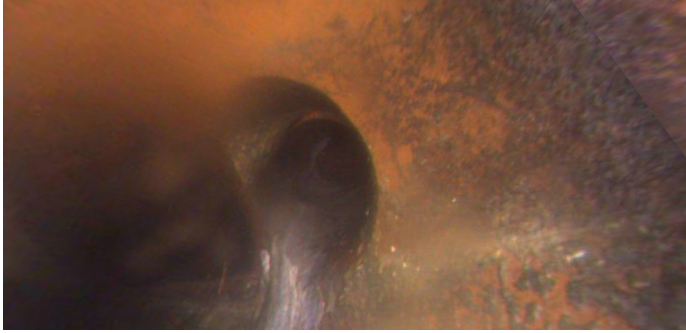
Code: **TFA**
Description: **Tap Factory Active**

Distance (ft): **193.2**
Structural Grade: **0**
O&M Grade: **0**
Clock Start/From: **10**
Clock To:
1st Value: **4.000**
2nd Value:
Value Percent:
Continuous Index:
Within 8" of Joint:
Remarks:

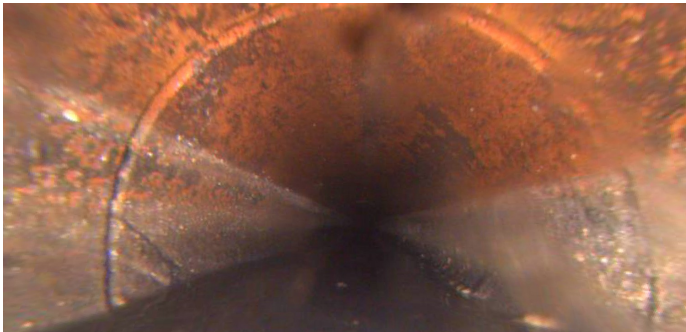
Code: **FS**
Description: **Fracture Spiral**

Distance (ft): **193.2**
Structural Grade: **3**
O&M Grade: **0**
Clock Start/From: **8**
Clock To: **9**
1st Value:
2nd Value:
Value Percent:
Continuous Index:
Within 8" of Joint:
Remarks:

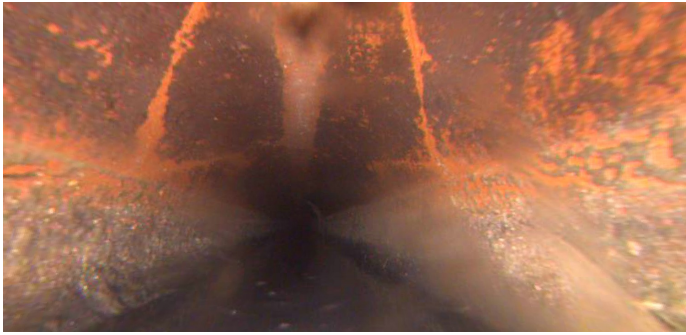
Code: **FM**
Description: **Fracture Multiple**

Distance (ft): **199.1**
Structural Grade: **4**
O&M Grade: **0**
Clock Start/From: **8**
Clock To: **4**
1st Value:
2nd Value:
Value Percent:
Continuous Index:
Within 8" of Joint:
Remarks:

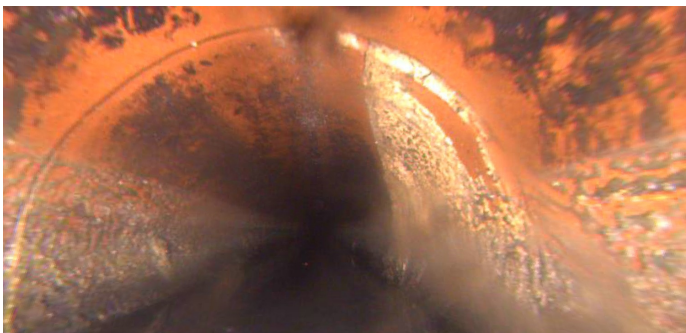
Code: **FS**
Description: **Fracture Spiral**

Distance (ft): **203.1**
Structural Grade: **3**
O&M Grade: **0**
Clock Start/From: **1**
Clock To: **4**
1st Value:
2nd Value:
Value Percent:
Continuous Index:
Within 8" of Joint: **YES**
Remarks:

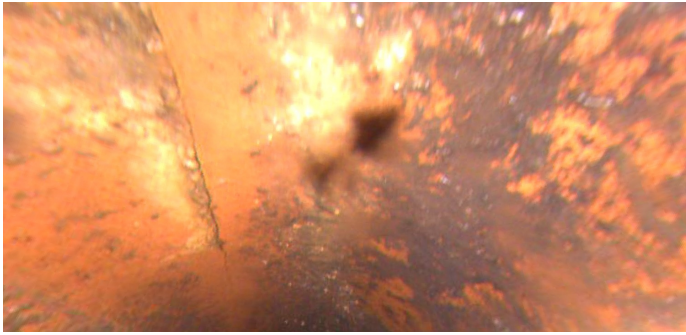
Code: **FL**
Description: **Fracture Longitudinal**

Distance (ft): **218.9**
Structural Grade: **3**
O&M Grade: **0**
Clock Start/From: **11**
Clock To:
1st Value:
2nd Value:
Value Percent:
Continuous Index:
Within 8" of Joint:
Remarks:

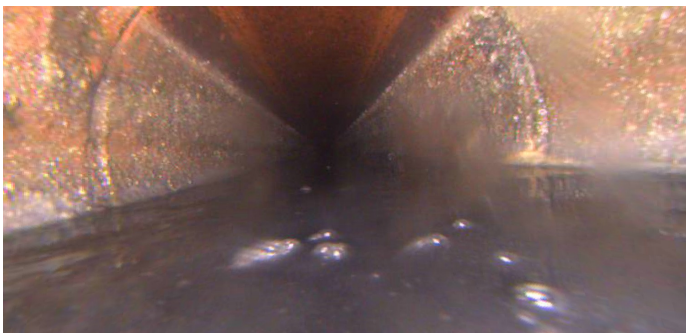
Code: **DAGS**
Description: **Deposits Attached Grease**

Distance (ft): **242.3**
Structural Grade: **0**
O&M Grade: **2**
Clock Start/From: **8**
Clock To: **4**
1st Value:
2nd Value:
Value Percent: **5.000**
Continuous Index: **F02**
Within 8" of Joint: **NO**
Remarks:

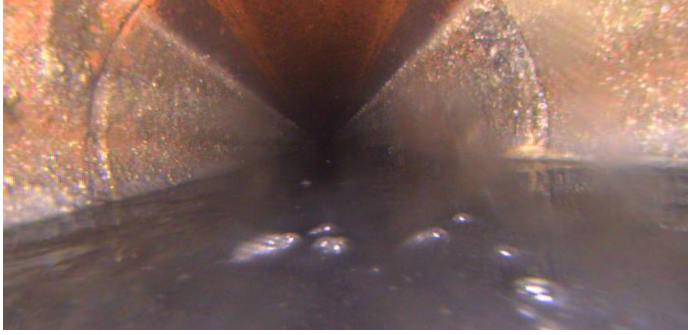
Code:	MSA
Description:	Abandoned Survey
Distance (ft):	242.3
Structural Grade:	0
O&M Grade:	0
Clock Start/From:	
Clock To:	
1st Value:	
2nd Value:	
Value Percent:	
Continuous Index:	
Within 8" of Joint:	NO
Remarks:	debris under water
