Profile/Photo Observation Report

Street:	FOXCROFT STREET	Flow Control:	Not Controlled
City:	Hobart, IN	Year Renewed:	
Location:	Yard	Tape/Media #:	
Purpose:	Routine Assessment	Dia/Height:	10"
Use:	Sanitary	Material:	VCP
Drain Area:	NA	Lining:	
Category:	NA		
Comment:

Location Details:		Direction of Survey:	Downstream
US MH:	M-505-086	DS MH:	M-505-087
		Total Length Surveyed (ft):	242.3

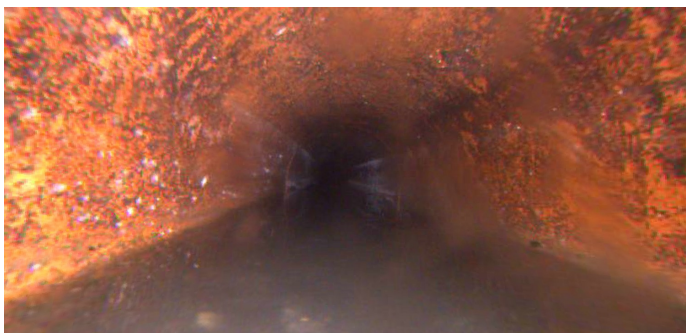
Code: **AMH**
Description: **Manhole**

Distance (ft): **.0**
Structural Grade: **0**
O&M Grade: **0**
Clock Start/From:
Clock To:
1st Value:
2nd Value:
Value Percent:
Continuous Index:
Within 8" of Joint: **NO**
Remarks: **M-505-086**

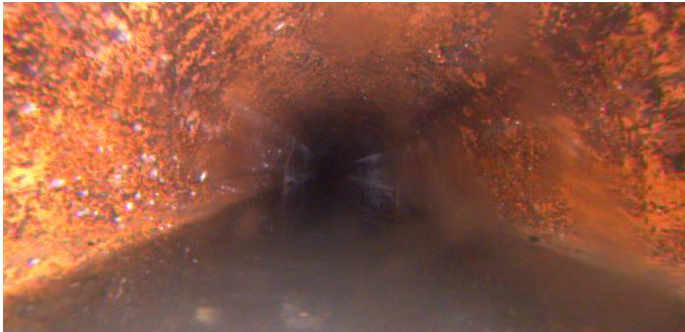
Code:	MWL
Description:	Water Level

Distance (ft):	.0
Structural Grade:	0
O&M Grade:	0
Clock Start/From:	
Clock To:	
1st Value:	
2nd Value:	
Value Percent:	30.000
Continuous Index:	
Within 8" of Joint:	NO
Remarks:

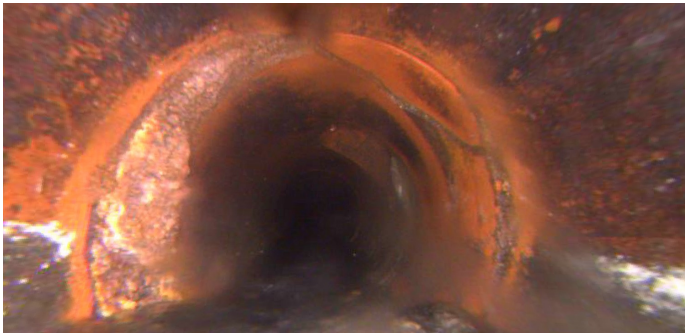
Code:	FS
Description:	Fracture Spiral

Distance (ft):	7.6
Structural Grade:	3
O&M Grade:	0
Clock Start/From:	12
Clock To:	2
1st Value:	
2nd Value:	
Value Percent:	
Continuous Index:	
Within 8" of Joint:	YES
Remarks:

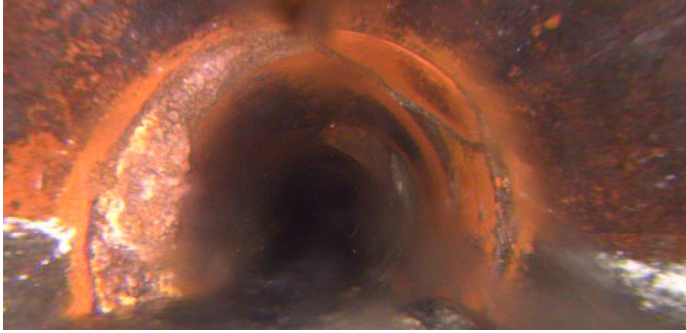
Code: **DAE**
Description: **Deposits Attached Encrustation**

Distance (ft): **7.6**
Structural Grade: **0**
O&M Grade: **2**
Clock Start/From: **8**
Clock To: **12**
1st Value:
2nd Value:
Value Percent: **10.000**
Continuous Index:
Within 8" of Joint: **YES**
Remarks:

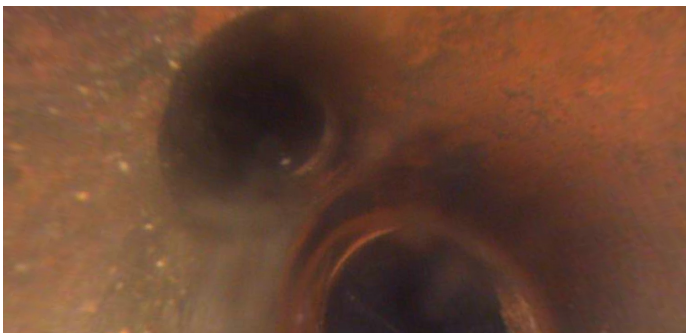
Code: **TF**
Description: **Tap Factory**

Distance (ft): **9.6**
Structural Grade: **0**
O&M Grade: **0**
Clock Start/From: **1**
Clock To:
1st Value: **4.000**
2nd Value:
Value Percent:
Continuous Index:
Within 8" of Joint:
Remarks:

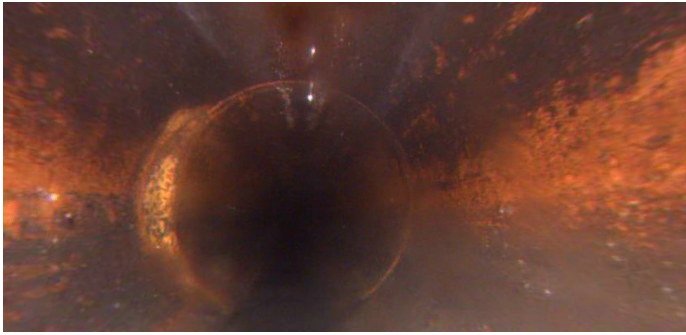
Code: **DAE**
Description: **Deposits Attached Encrustation**

Distance (ft): **24.0**
Structural Grade: **0**
O&M Grade: **2**
Clock Start/From: **8**
Clock To: **9**
1st Value:
2nd Value:
Value Percent: **5.000**
Continuous Index:
Within 8" of Joint: **YES**
Remarks:

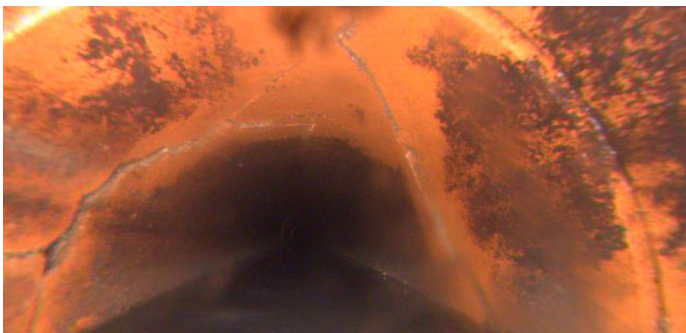
Code: **FM**
Description: **Fracture Multiple**

Distance (ft): **34.5**
Structural Grade: **4**
O&M Grade: **0**
Clock Start/From: **8**
Clock To: **4**
1st Value:
2nd Value:
Value Percent:
Continuous Index: **S01**
Within 8" of Joint: **YES**
Remarks:

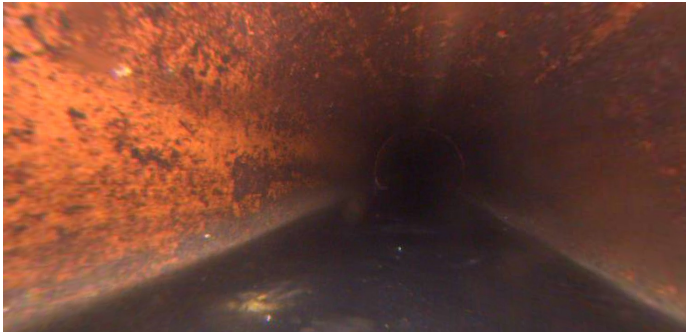
Code: **FM**
Description: **Fracture Multiple**

Distance (ft): **46.8**
Structural Grade: **4**
O&M Grade: **0**
Clock Start/From: **8**
Clock To: **4**
1st Value:
2nd Value:
Value Percent:
Continuous Index: **F01**
Within 8" of Joint: **YES**
Remarks:

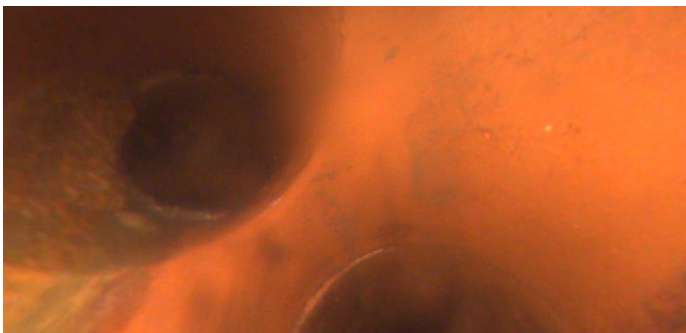
Code: **TF**
Description: **Tap Factory**

Distance (ft): **75.4**
Structural Grade: **0**
O&M Grade: **0**
Clock Start/From: **2**
Clock To:
1st Value: **4.000**
2nd Value:
Value Percent:
Continuous Index:
Within 8" of Joint:
Remarks:

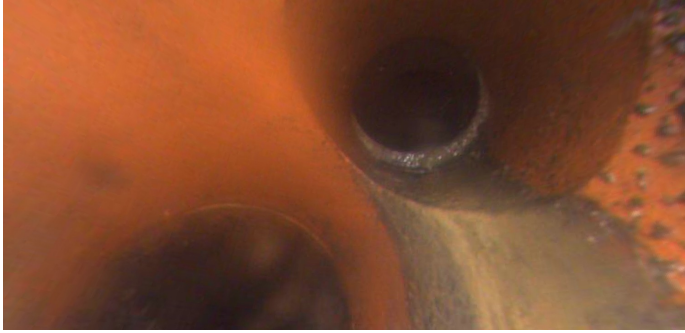
Code: **TF**
Description: **Tap Factory**

Distance (ft): **82.4**
Structural Grade: **0**
O&M Grade: **0**
Clock Start/From: **11**
Clock To:
1st Value: **4.000**
2nd Value:
Value Percent:
Continuous Index:
Within 8" of Joint:
Remarks:

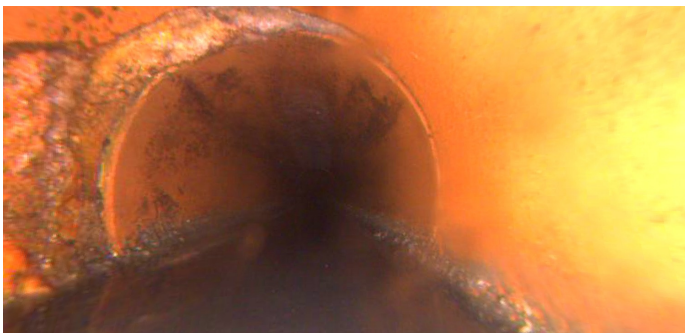
Code: **DAE**
Description: **Deposits Attached Encrustation**

Distance (ft): **87.5**
Structural Grade: **0**
O&M Grade: **2**
Clock Start/From: **8**
Clock To: **12**
1st Value:
2nd Value:
Value Percent: **5.000**
Continuous Index:
Within 8" of Joint: **YES**
Remarks:

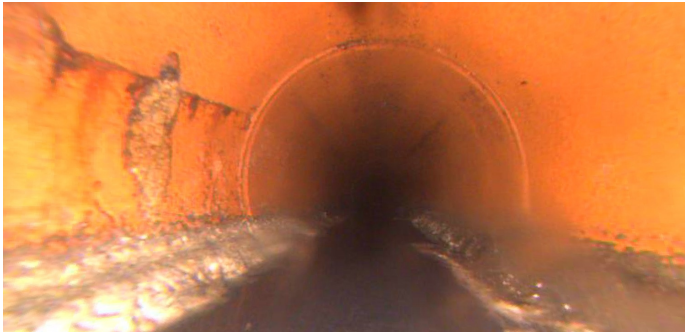
Code: **FL**
Description: **Fracture Longitudinal**

Distance (ft): **102.4**
Structural Grade: **3**
O&M Grade: **0**
Clock Start/From: **10**
Clock To:
1st Value:
2nd Value:
Value Percent:
Continuous Index:
Within 8" of Joint: **YES**
Remarks:

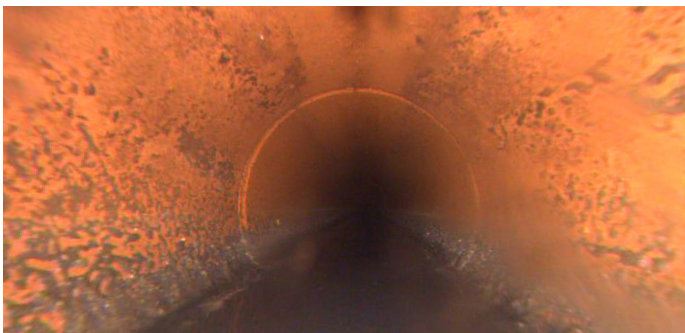
Code: **DAGS**
Description: **Deposits Attached Grease**

Distance (ft): **141.4**
Structural Grade: **0**
O&M Grade: **2**
Clock Start/From: **8**
Clock To: **4**
1st Value:
2nd Value:
Value Percent: **5.000**
Continuous Index: **S02**
Within 8" of Joint: **NO**
Remarks:

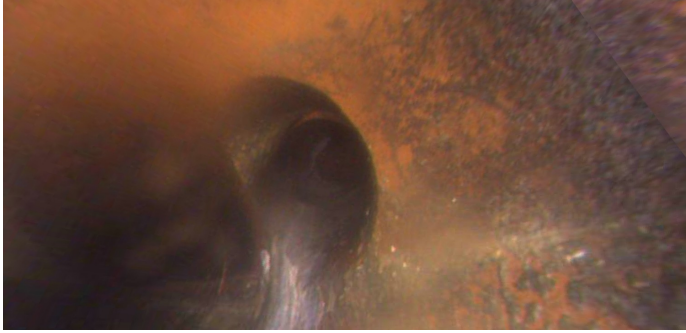
Code: **TFA**
Description: **Tap Factory Active**

Distance (ft): **193.2**
Structural Grade: **0**
O&M Grade: **0**
Clock Start/From: **10**
Clock To:
1st Value: **4.000**
2nd Value:
Value Percent:
Continuous Index:
Within 8" of Joint:
Remarks:

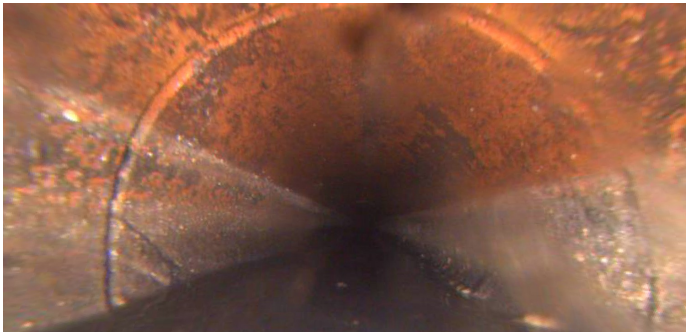
Code: **FS**
Description: **Fracture Spiral**

Distance (ft): **193.2**
Structural Grade: **3**
O&M Grade: **0**
Clock Start/From: **8**
Clock To: **9**
1st Value:
2nd Value:
Value Percent:
Continuous Index:
Within 8" of Joint:
Remarks:

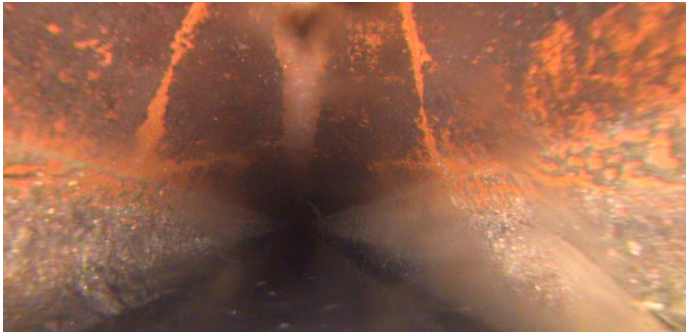
Code: **FM**
Description: **Fracture Multiple**

Distance (ft): **199.1**
Structural Grade: **4**
O&M Grade: **0**
Clock Start/From: **8**
Clock To: **4**
1st Value:
2nd Value:
Value Percent:
Continuous Index:
Within 8" of Joint:
Remarks:

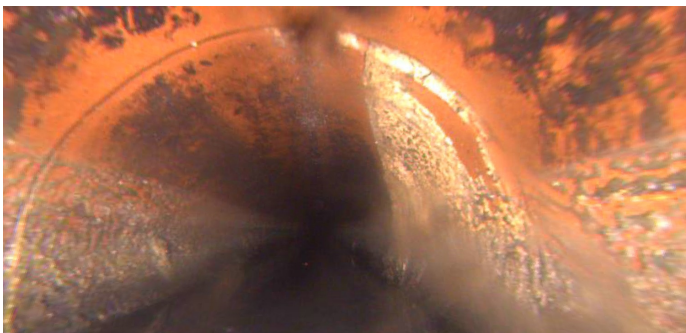
Code: **FS**
Description: **Fracture Spiral**

Distance (ft): **203.1**
Structural Grade: **3**
O&M Grade: **0**
Clock Start/From: **1**
Clock To: **4**
1st Value:
2nd Value:
Value Percent:
Continuous Index:
Within 8" of Joint: **YES**
Remarks:

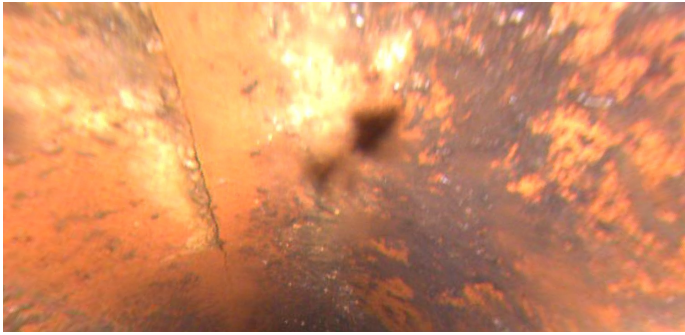
Code: **FL**
Description: **Fracture Longitudinal**

Distance (ft): **218.9**
Structural Grade: **3**
O&M Grade: **0**
Clock Start/From: **11**
Clock To:
1st Value:
2nd Value:
Value Percent:
Continuous Index:
Within 8" of Joint:
Remarks:

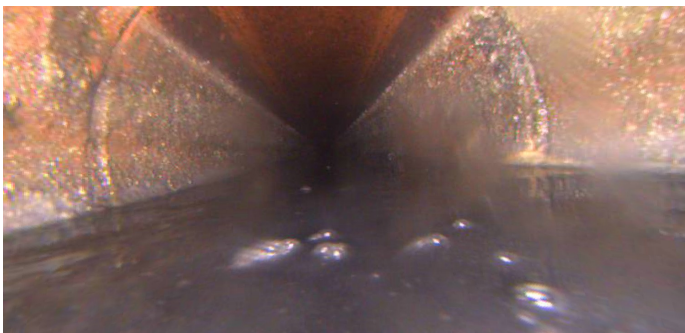
Code: **DAGS**
Description: **Deposits Attached Grease**

Distance (ft): **242.3**
Structural Grade: **0**
O&M Grade: **2**
Clock Start/From: **8**
Clock To: **4**
1st Value:
2nd Value:
Value Percent: **5.000**
Continuous Index: **F02**
Within 8" of Joint: **NO**
Remarks:

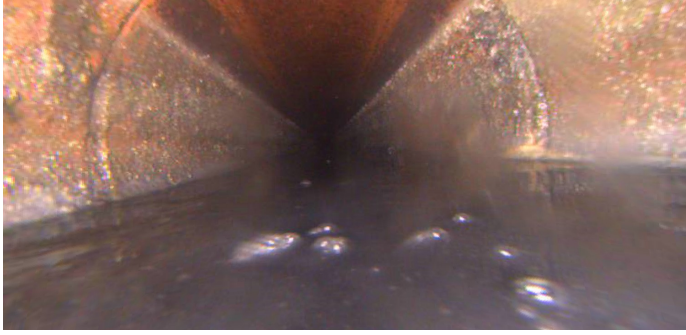
Code:	MSA
Description:	Abandoned Survey
Distance (ft):	242.3
Structural Grade:	0
O&M Grade:	0
Clock Start/From:	
Clock To:	
1st Value:	
2nd Value:	
Value Percent:	
Continuous Index:	
Within 8" of Joint:	NO
Remarks:	debris under water
