Profile/Photo Observation Report

Date:	01/14/2022	Weather:		Coding:	PACP 7.0
Pipe Length (ft):	285.1	Owner:	City of Hobart	Pre Clean:	Heavy Cleaning
P.O.#:	YES502259	Surveyor:	S. Bucklin	PSR:	P-505-086-087
Customer:	City of Hobart	Clean Date:	01/12/2021	Shape:	C

Street:	West 4th Place	Flow Control:	Not Controlled
City:	Hobart, IN	Year Renewed:	
Location:	Local rural streets with light traffic, t	Tape/Media #:	
Purpose:	Routine Assessment	Dia/Height:	10"
Use:	Sanitary Sewage Pipe	Material:	VCP
Drain Area:		Lining:	None
Category:	NA		
Comment:			
Location Details:		Direction of Survey:	Downstream
US MH:	M-505-086	DS MH:	M-505-087
		Total Length Surveyed (ft):	285.0

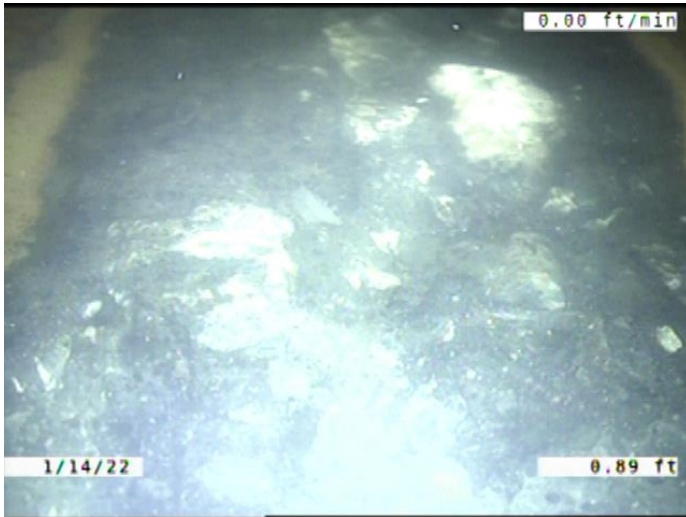
Code:	DSC
Description:	Deposits Settled Hard/Compacted
Distance (ft):	.9
Structural Grade:	0
O&M Grade:	2
Clock Start/From:	5
Clock To:	7
1st Value:	
2nd Value:	
Value Percent:	5.000
Continuous Index:	
Within 8" of Joint:	YES
Remarks:

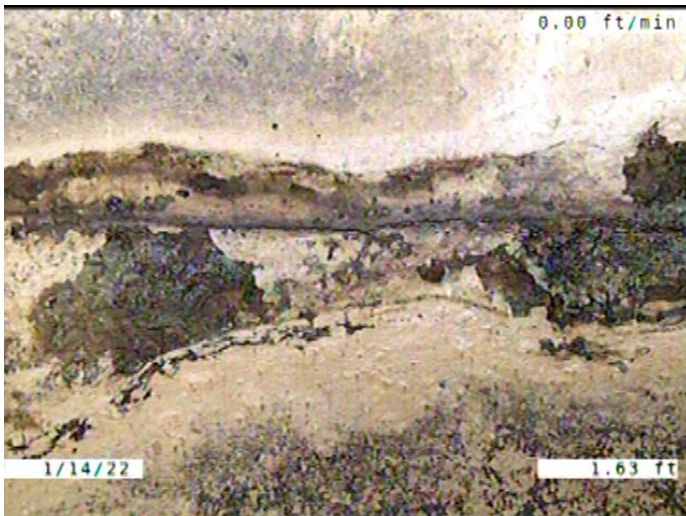
Code:	CS
Description:	Crack Spiral
Distance (ft):	1.6
Structural Grade:	2
O&M Grade:	0
Clock Start/From:	8
Clock To:	2
1st Value:	
2nd Value:	
Value Percent:	
Continuous Index:	
Within 8" of Joint:	YES
Remarks:

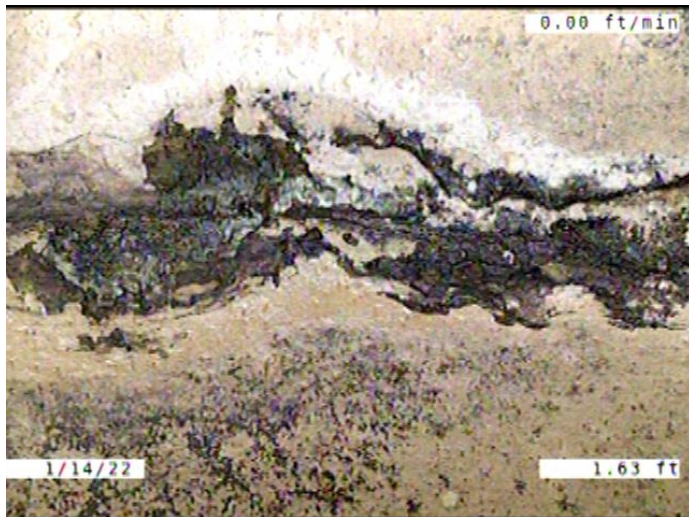
Code: **DAE**
 Description: **Deposits Attached Encrustation**

Distance (ft): **1.6**
 Structural Grade: **0**
 O&M Grade: **2**
 Clock Start/From: **8**
 Clock To: **4**
 1st Value:
 2nd Value:
 Value Percent: **5.000**
 Continuous Index:
 Within 8" of Joint: **YES**
 Remarks:

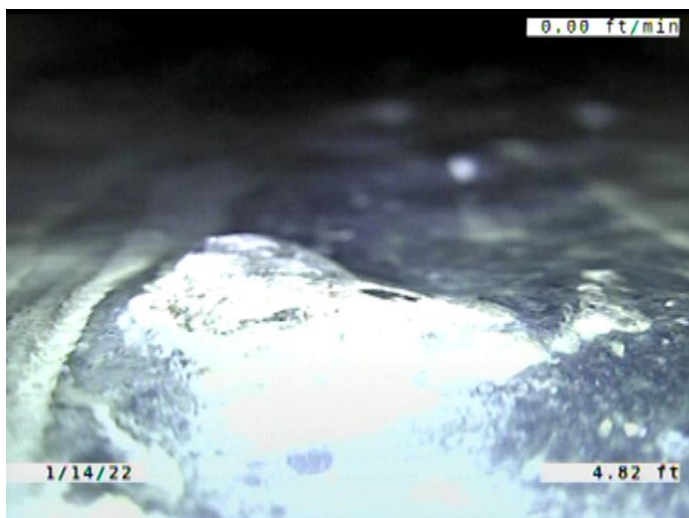
Code: **DSC**
 Description: **Deposits Settled Hard/Compacted**

Distance (ft): **4.8**
 Structural Grade: **0**
 O&M Grade: **2**
 Clock Start/From: **5**
 Clock To: **7**
 1st Value:
 2nd Value:
 Value Percent: **10.000**
 Continuous Index:
 Within 8" of Joint: **YES**
 Remarks:

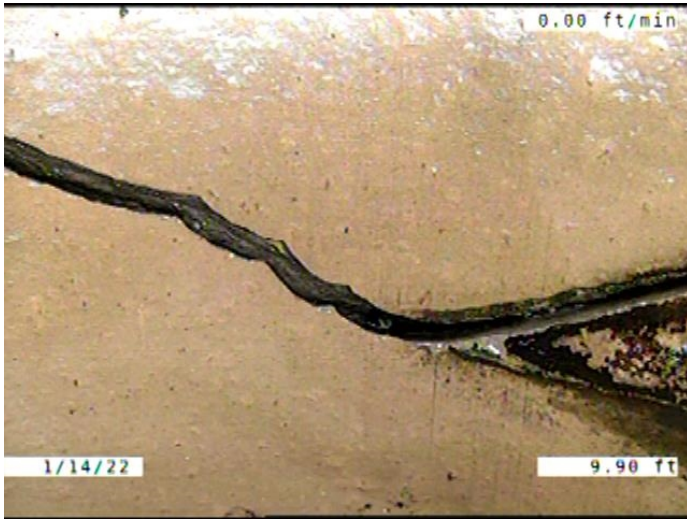
Code: **B**
Description: **Broken**

Distance (ft): **9.9**
Structural Grade: **4**
O&M Grade: **0**
Clock Start/From: **12**
Clock To: **2**
1st Value:
2nd Value:
Value Percent:
Continuous Index:
Within 8" of Joint: **YES**
Remarks:

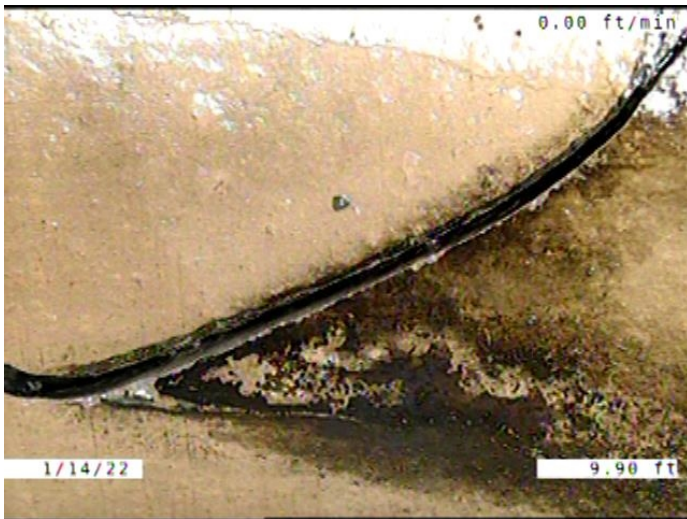
Code: **IDB**
Description: **Infiltration Dripper Barrel**

Distance (ft): **9.9**
Structural Grade: **0**
O&M Grade: **3**
Clock Start/From: **1**
Clock To: **2**
1st Value:
2nd Value:
Value Percent:
Continuous Index:
Within 8" of Joint: **YES**
Remarks:

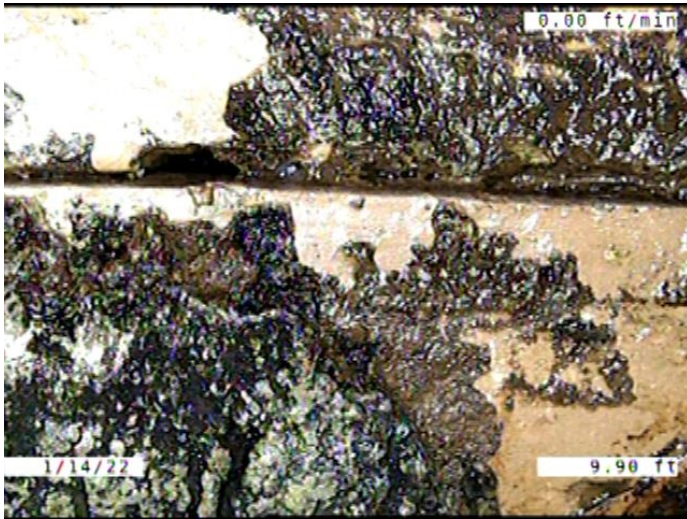
Code: **DAE**
 Description: **Deposits Attached Encrustation**

Distance (ft): **9.9**
 Structural Grade: **0**
 O&M Grade: **2**
 Clock Start/From: **7**
 Clock To: **5**
 1st Value:
 2nd Value:
 Value Percent: **5.000**
 Continuous Index:
 Within 8" of Joint: **YES**
 Remarks:

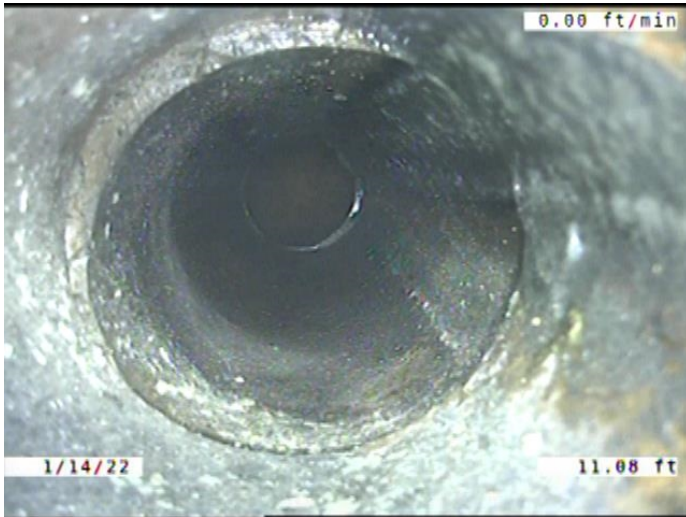
Code: **TF**
Description: **Tap Factory**

Distance (ft): **11.1**
Structural Grade: **0**
O&M Grade: **0**
Clock Start/From: **1**
Clock To:
1st Value: **4.000**
2nd Value:
Value Percent:
Continuous Index:
Within 8" of Joint: **YES**
Remarks: **CONSTANTLY RUNNING WATER.**

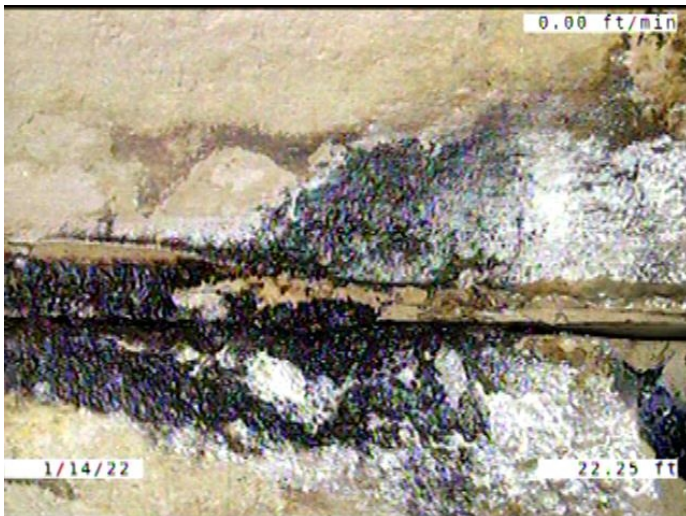
Code: **ISJ**
Description: **Infiltration Stain Joint**

Distance (ft): **22.3**
Structural Grade: **0**
O&M Grade: **1**
Clock Start/From: **7**
Clock To: **9**
1st Value:
2nd Value:
Value Percent:
Continuous Index:
Within 8" of Joint: **YES**
Remarks:

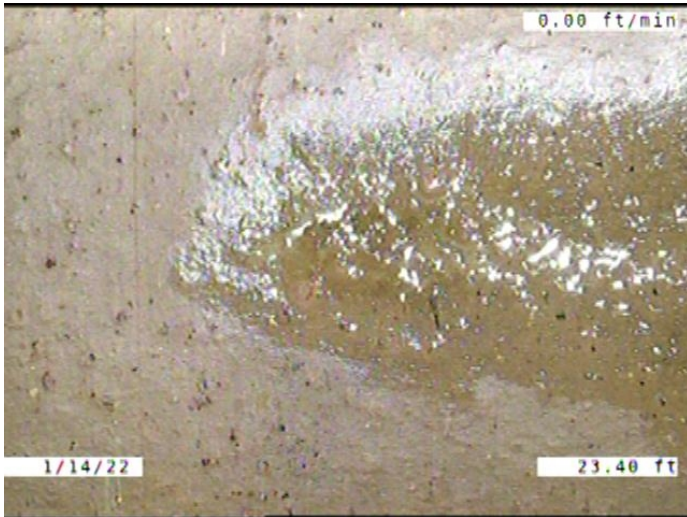
Code: **IWB**
Description: **Infiltration Weeper Barrel**

Distance (ft): **23.4**
Structural Grade: **0**
O&M Grade: **2**
Clock Start/From: **9**
Clock To:
1st Value:
2nd Value:
Value Percent:
Continuous Index:
Within 8" of Joint: **NO**
Remarks:

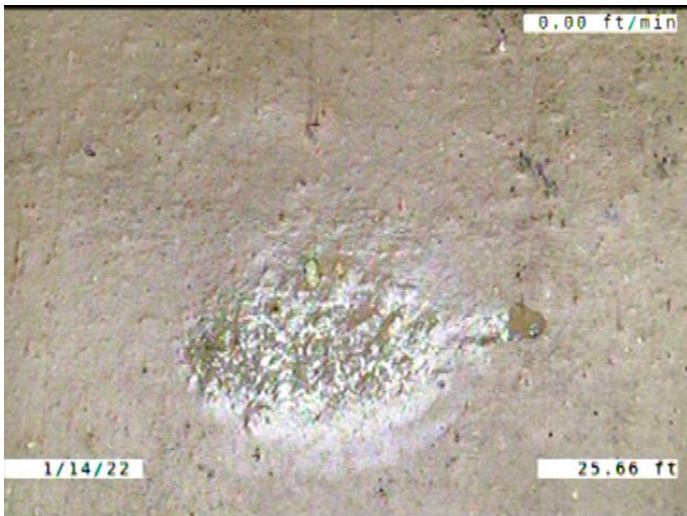
Code: **IWB**
Description: **Infiltration Weeper Barrel**

Distance (ft): **25.7**
Structural Grade: **0**
O&M Grade: **2**
Clock Start/From: **9**
Clock To:
1st Value:
2nd Value:
Value Percent:
Continuous Index:
Within 8" of Joint: **NO**
Remarks:

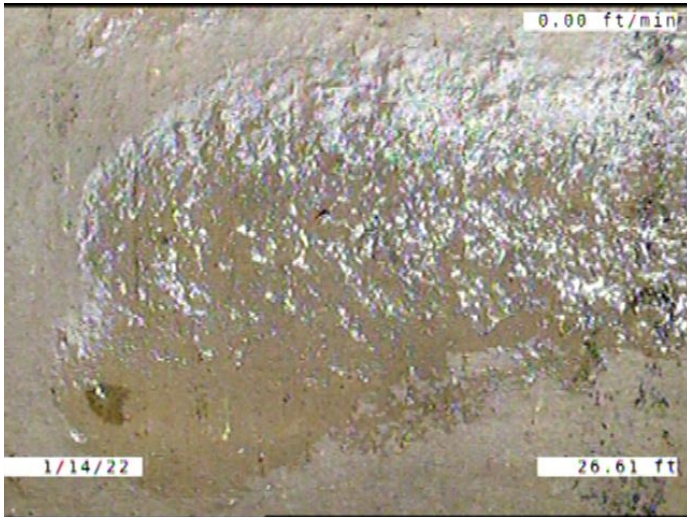
Code: **IWB**
 Description: **Infiltration Weeper Barrel**

Distance (ft): **26.6**
 Structural Grade: **0**
 O&M Grade: **2**
 Clock Start/From: **9**
 Clock To:
 1st Value:
 2nd Value:
 Value Percent:
 Continuous Index:
 Within 8" of Joint: **YES**
 Remarks:

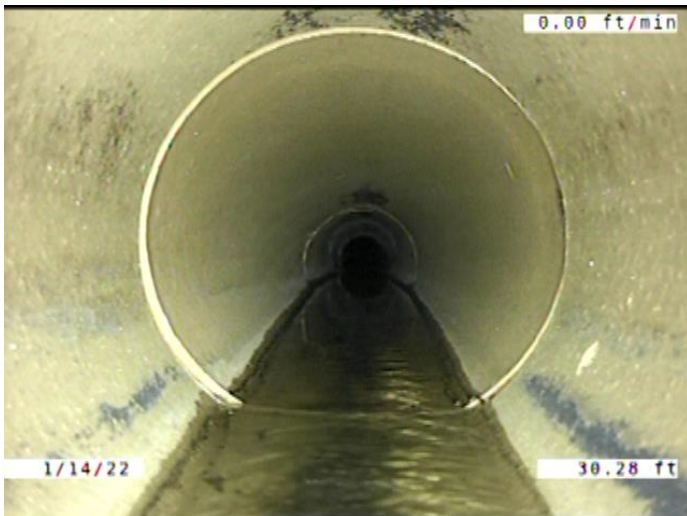
Code: **MWLS**
 Description: **Miscellaneous Water Level Sag**

Distance (ft): **30.3**
 Structural Grade: **2**
 O&M Grade: **0**
 Clock Start/From:
 Clock To:
 1st Value:
 2nd Value:
 Value Percent: **10.000**
 Continuous Index: **S01**
 Within 8" of Joint: **NO**
 Remarks:

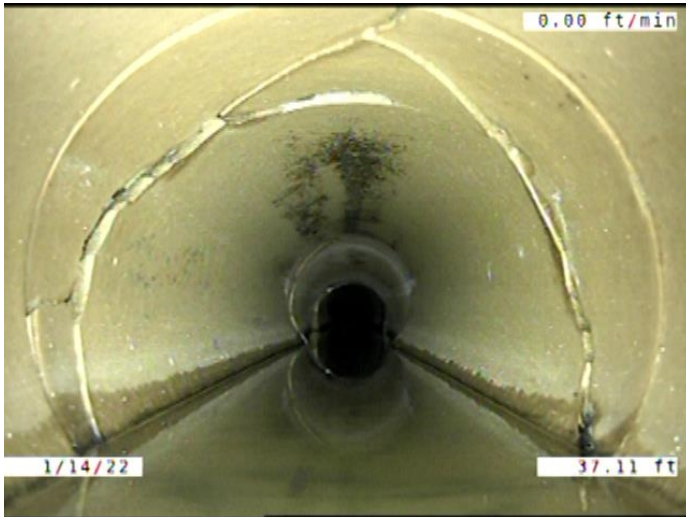
Code: **BSV**
 Description: **Broken Soil Visible**

Distance (ft): **37.1**
 Structural Grade: **5**
 O&M Grade: **0**
 Clock Start/From: **12**
 Clock To: **12**
 1st Value:
 2nd Value:
 Value Percent:
 Continuous Index:
 Within 8" of Joint: **YES**
 Remarks:

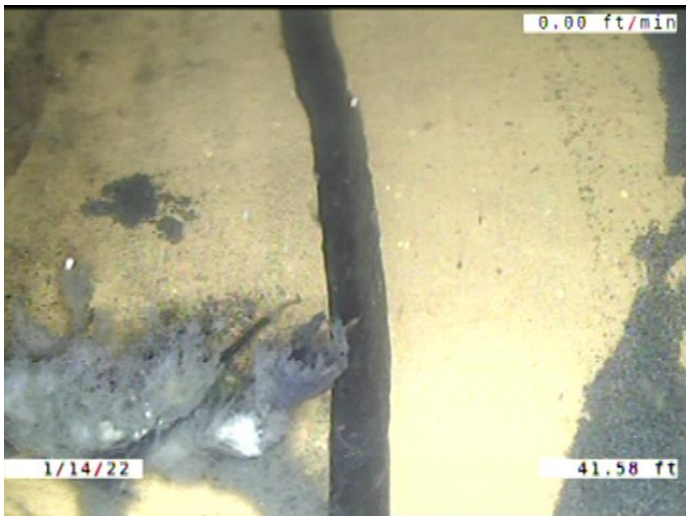
Code: **BSV**
 Description: **Broken Soil Visible**

Distance (ft): **41.6**
 Structural Grade: **5**
 O&M Grade: **0**
 Clock Start/From: **6**
 Clock To: **12**
 1st Value:
 2nd Value:
 Value Percent:
 Continuous Index:
 Within 8" of Joint: **YES**
 Remarks:

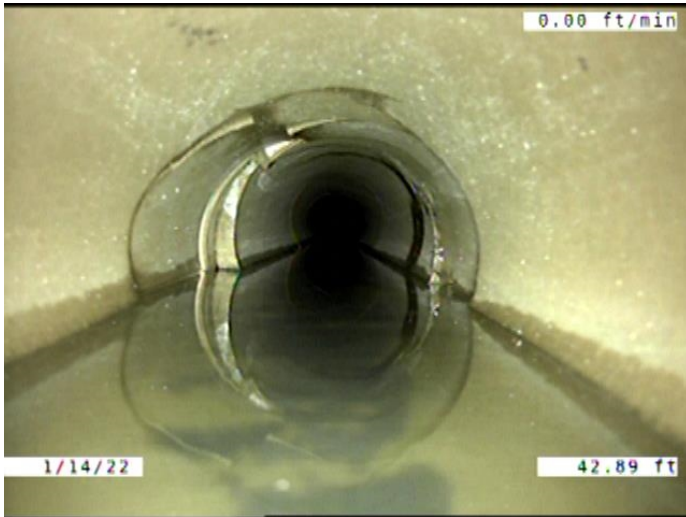
Code: **DSF**
 Description: **Deposits Settled Fine**

Distance (ft): **42.9**
 Structural Grade: **0**
 O&M Grade: **2**
 Clock Start/From: **5**
 Clock To: **7**
 1st Value:
 2nd Value:
 Value Percent: **5.000**
 Continuous Index: **S02**
 Within 8" of Joint: **YES**
 Remarks:

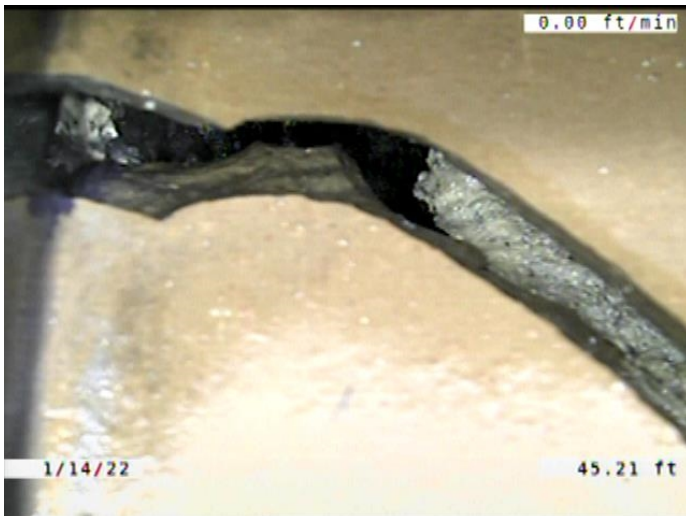
Code: **BSV**
 Description: **Broken Soil Visible**

Distance (ft): **45.2**
 Structural Grade: **5**
 O&M Grade: **0**
 Clock Start/From: **12**
 Clock To: **12**
 1st Value:
 2nd Value:
 Value Percent:
 Continuous Index: **S03**
 Within 8" of Joint: **YES**
 Remarks:

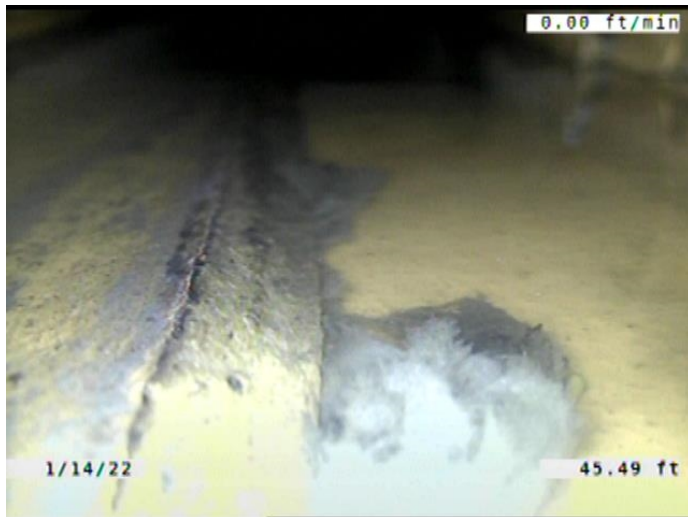
Code: **DR**
 Description: **Deformed Rigid**

Distance (ft): **45.5**
 Structural Grade: **5**
 O&M Grade: **0**
 Clock Start/From:
 Clock To:
 1st Value:
 2nd Value:
 Value Percent: **10.000**
 Continuous Index:
 Within 8" of Joint: **NO**
 Remarks:

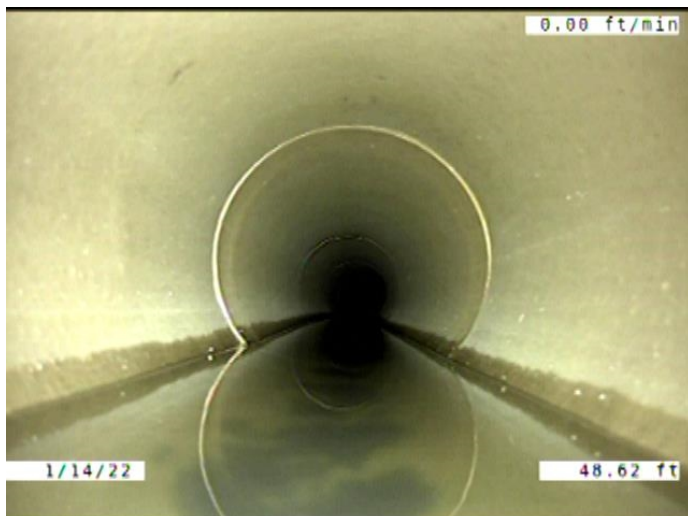
Code: **BSV**
 Description: **Broken Soil Visible**

Distance (ft): **48.6**
 Structural Grade: **5**
 O&M Grade: **0**
 Clock Start/From: **12**
 Clock To: **12**
 1st Value:
 2nd Value:
 Value Percent:
 Continuous Index: **F03**
 Within 8" of Joint: **YES**
 Remarks:

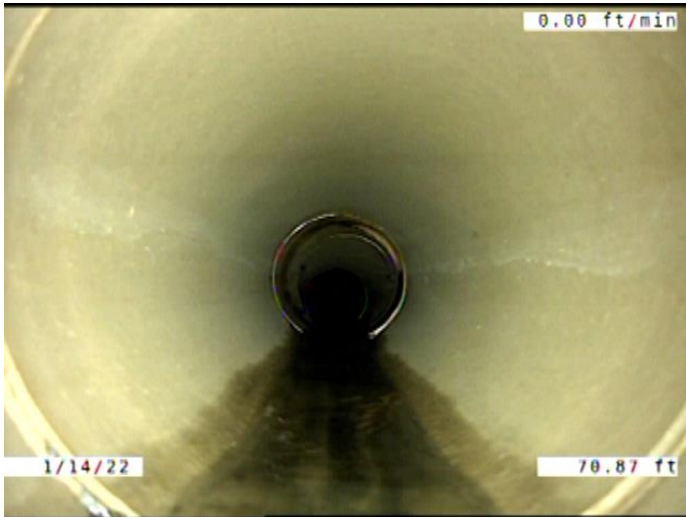
Code: **MWLS**
 Description: **Miscellaneous Water Level Sag**

Distance (ft): **70.9**
 Structural Grade: **2**
 O&M Grade: **0**
 Clock Start/From:
 Clock To:
 1st Value:
 2nd Value:
 Value Percent: **10.000**
 Continuous Index: **F01**
 Within 8" of Joint: **NO**
 Remarks:

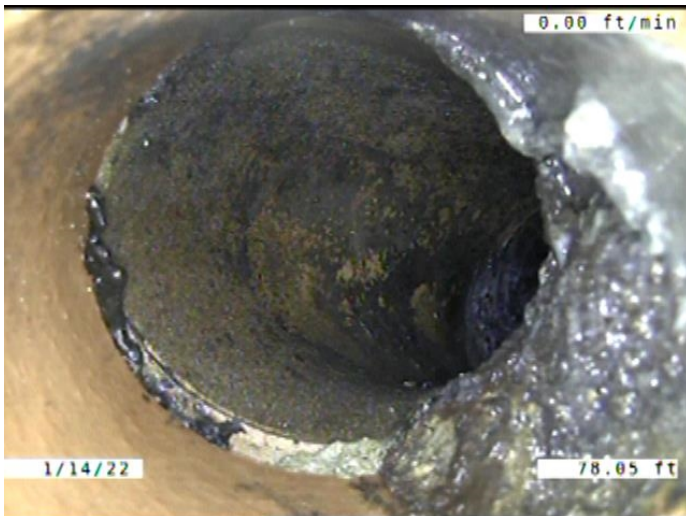
Code: **TF**
 Description: **Tap Factory**

Distance (ft): **78.0**
 Structural Grade: **0**
 O&M Grade: **0**
 Clock Start/From: **1**
 Clock To:
 1st Value: **4.000**
 2nd Value:
 Value Percent:
 Continuous Index:
 Within 8" of Joint: **YES**
 Remarks: **CONSTANTLY RUNNING WATER.**

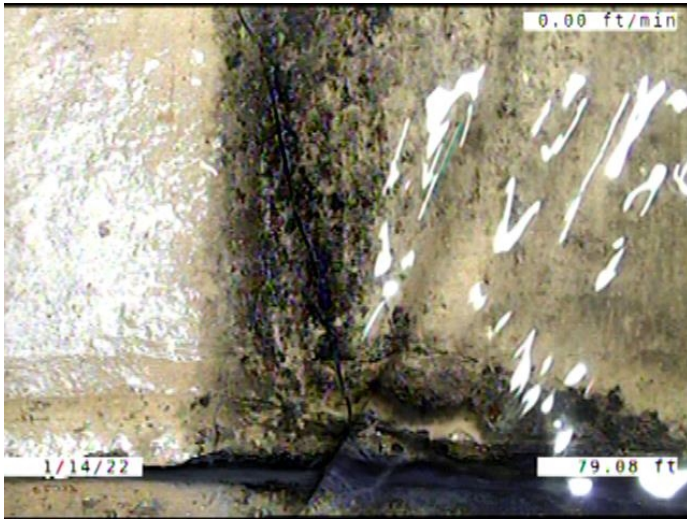
Code: **CM**
Description: **Crack Multiple**

Distance (ft): **79.1**
Structural Grade: **3**
O&M Grade: **0**
Clock Start/From: **7**
Clock To: **8**
1st Value:
2nd Value:
Value Percent:
Continuous Index:
Within 8" of Joint: **YES**
Remarks:

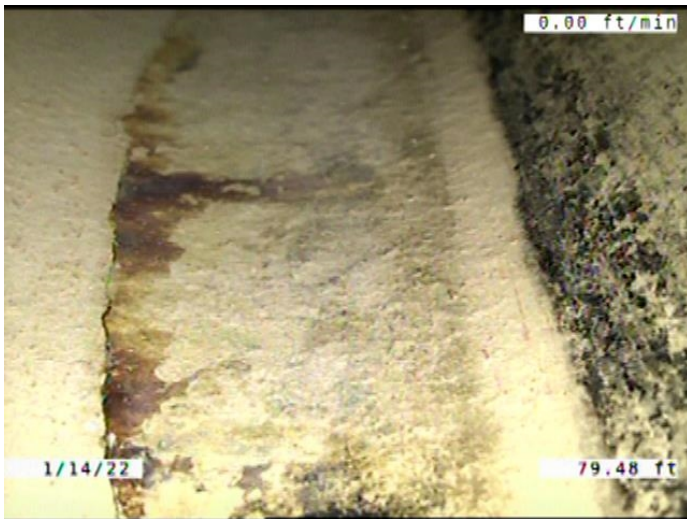
Code: **ISB**
Description: **Infiltration Stain Barrel**

Distance (ft): **79.5**
Structural Grade: **0**
O&M Grade: **1**
Clock Start/From: **7**
Clock To: **8**
1st Value:
2nd Value:
Value Percent:
Continuous Index:
Within 8" of Joint: **YES**
Remarks:

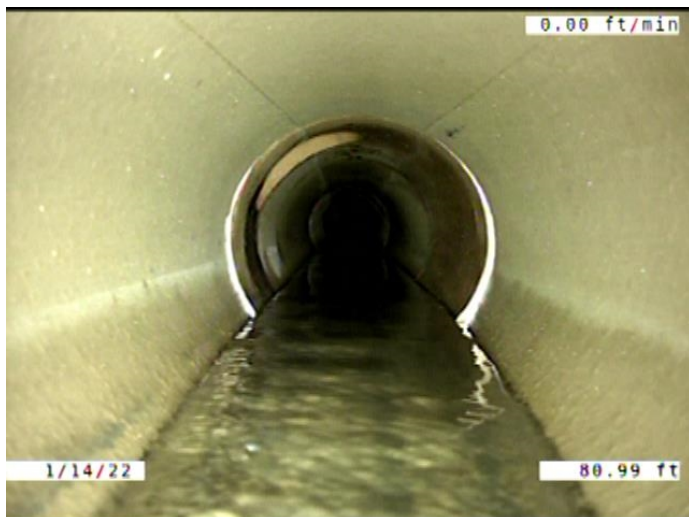
Code: **MWLS**
 Description: **Miscellaneous Water Level Sag**

Distance (ft): **81.0**
 Structural Grade: **2**
 O&M Grade: **0**
 Clock Start/From:
 Clock To:
 1st Value:
 2nd Value:
 Value Percent: **10.000**
 Continuous Index: **S04**
 Within 8" of Joint: **NO**
 Remarks:

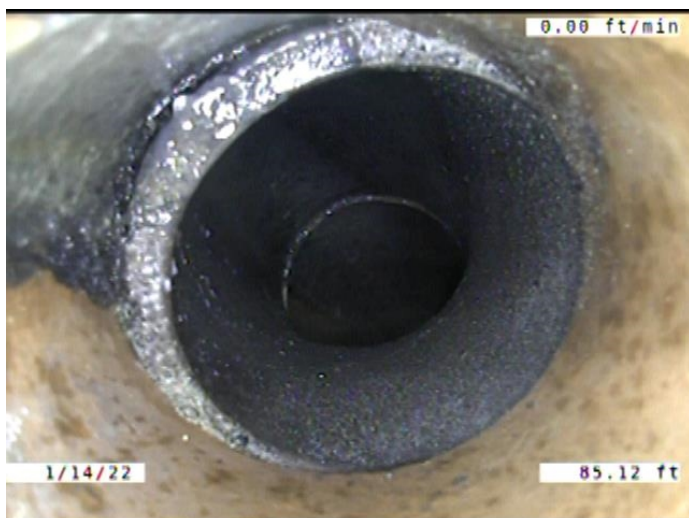
Code: **TF**
 Description: **Tap Factory**

Distance (ft): **85.1**
 Structural Grade: **0**
 O&M Grade: **0**
 Clock Start/From: **11**
 Clock To:
 1st Value: **4.000**
 2nd Value:
 Value Percent:
 Continuous Index:
 Within 8" of Joint: **YES**
 Remarks: **CONSTANTLY DRIPPING WATER.**

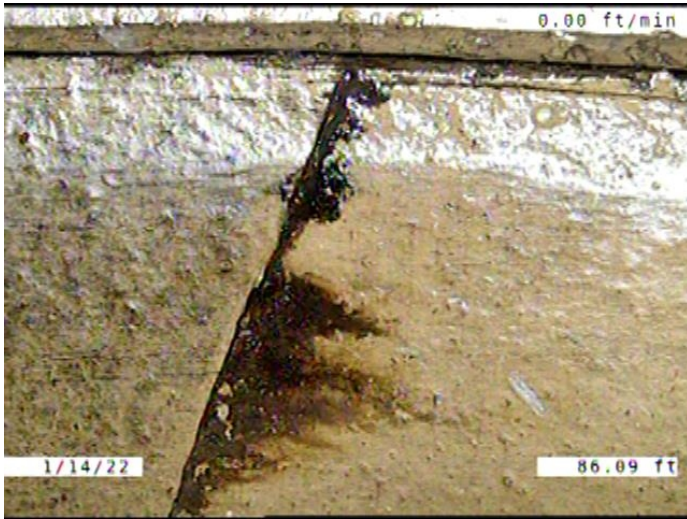
Code: **CS**
Description: **Crack Spiral**

Distance (ft): **86.1**
Structural Grade: **2**
O&M Grade: **0**
Clock Start/From: **1**
Clock To: **3**
1st Value:
2nd Value:
Value Percent:
Continuous Index:
Within 8" of Joint: **YES**
Remarks:

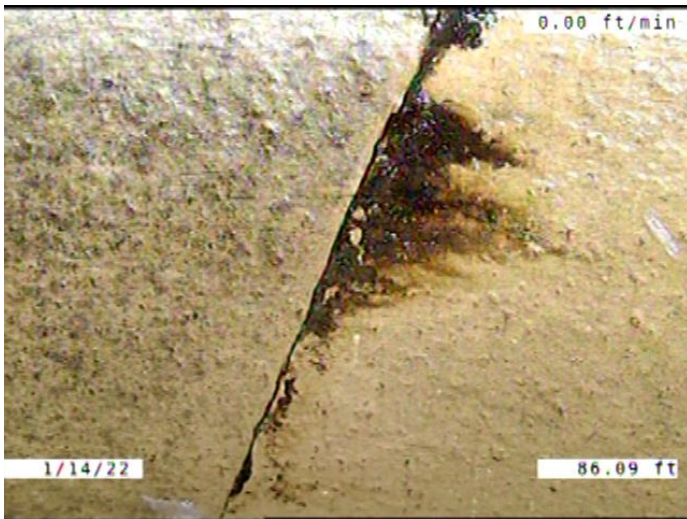
Code: **ISB**
Description: **Infiltration Stain Barrel**

Distance (ft): **86.1**
Structural Grade: **0**
O&M Grade: **1**
Clock Start/From: **1**
Clock To: **3**
1st Value:
2nd Value:
Value Percent:
Continuous Index:
Within 8" of Joint: **YES**
Remarks:

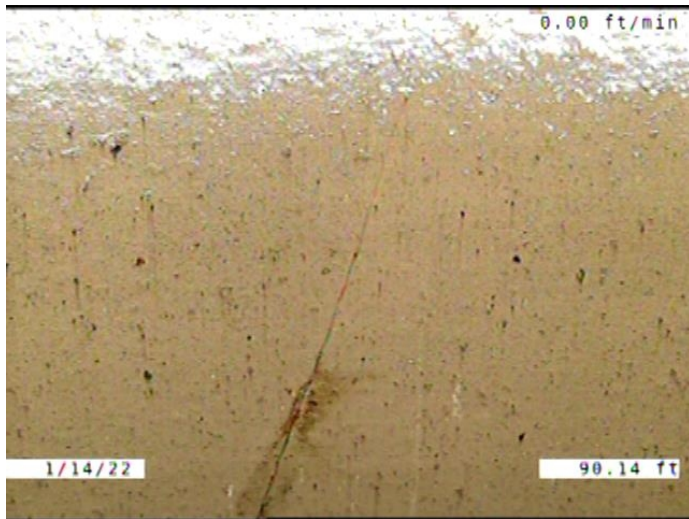
Code: **CS**
 Description: **Crack Spiral**

Distance (ft): **90.1**
 Structural Grade: **2**
 O&M Grade: **0**
 Clock Start/From: **12**
 Clock To: **1**
 1st Value:
 2nd Value:
 Value Percent:
 Continuous Index:
 Within 8" of Joint: **YES**
 Remarks:

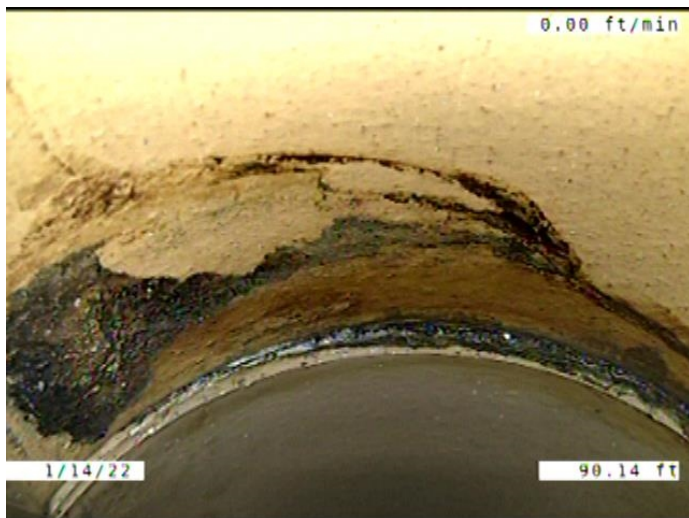
Code: **DAE**
 Description: **Deposits Attached Encrustation**

Distance (ft): **90.1**
 Structural Grade: **0**
 O&M Grade: **2**
 Clock Start/From: **8**
 Clock To: **1**
 1st Value:
 2nd Value:
 Value Percent: **5.000**
 Continuous Index:
 Within 8" of Joint: **YES**
 Remarks:

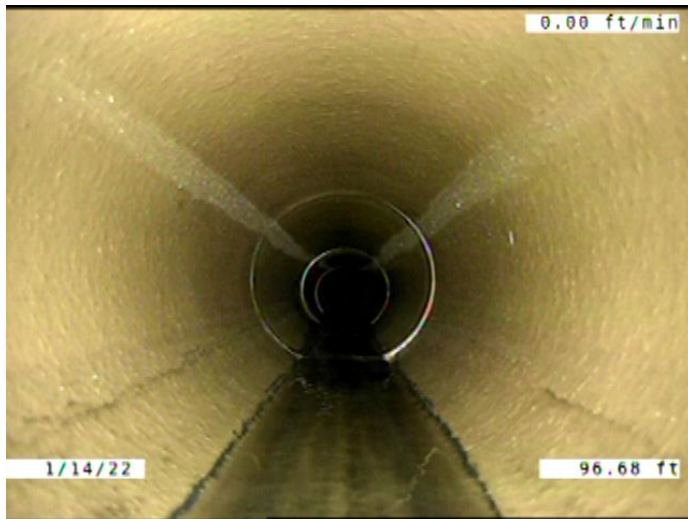
Code: **MWLS**
Description: **Miscellaneous Water Level Sag**

Distance (ft): **96.7**
Structural Grade: **2**
O&M Grade: **0**
Clock Start/From:
Clock To:
1st Value:
2nd Value:
Value Percent: **10.000**
Continuous Index: **F04**
Within 8" of Joint: **NO**
Remarks:

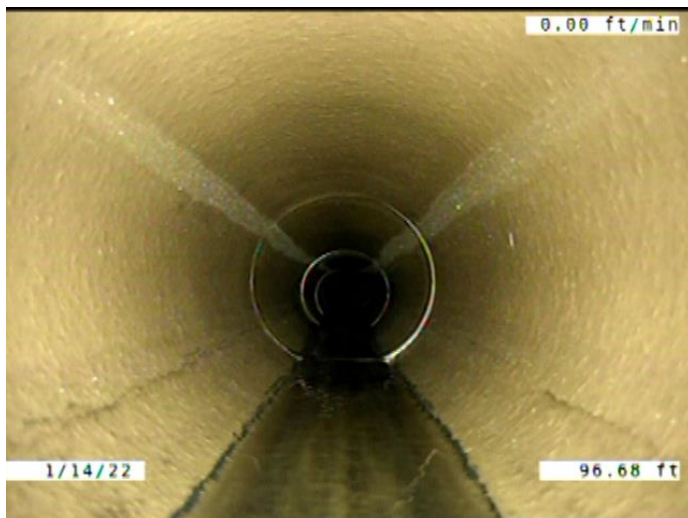
Code: **DSF**
Description: **Deposits Settled Fine**

Distance (ft): **96.7**
Structural Grade: **0**
O&M Grade: **2**
Clock Start/From: **5**
Clock To: **7**
1st Value:
2nd Value:
Value Percent: **5.000**
Continuous Index: **F02**
Within 8" of Joint: **YES**
Remarks:

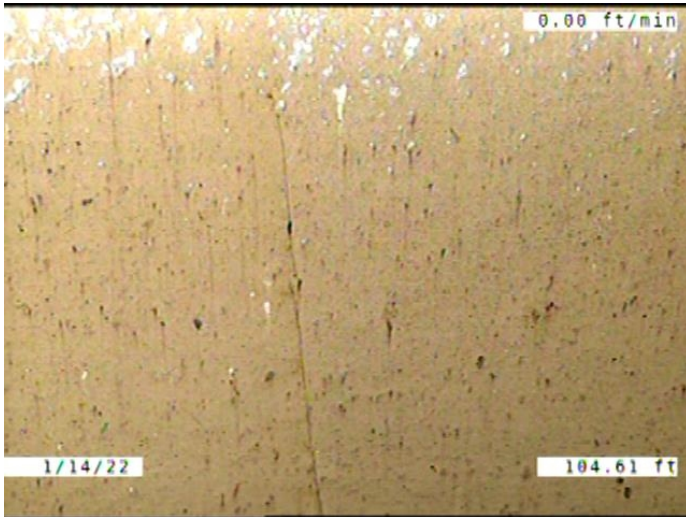
Code: **CS**
Description: **Crack Spiral**

Distance (ft): **104.6**
Structural Grade: **2**
O&M Grade: **0**
Clock Start/From: **9**
Clock To: **10**
1st Value:
2nd Value:
Value Percent:
Continuous Index:
Within 8" of Joint: **YES**
Remarks:

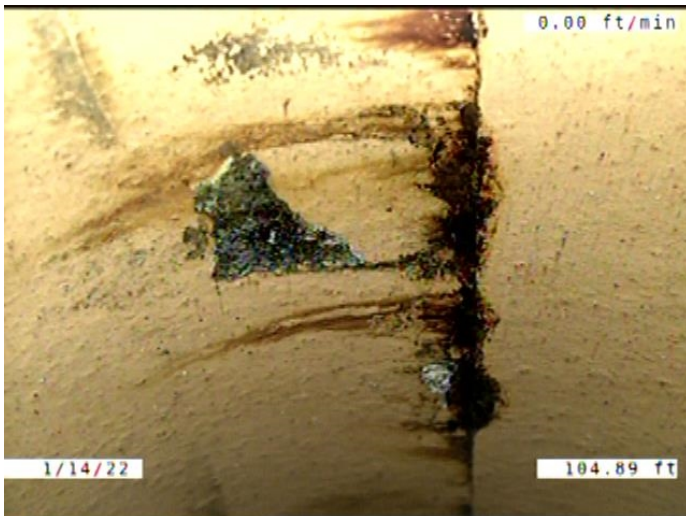
Code: **ISB**
Description: **Infiltration Stain Barrel**

Distance (ft): **104.9**
Structural Grade: **0**
O&M Grade: **1**
Clock Start/From: **8**
Clock To: **10**
1st Value:
2nd Value:
Value Percent:
Continuous Index:
Within 8" of Joint: **YES**
Remarks:

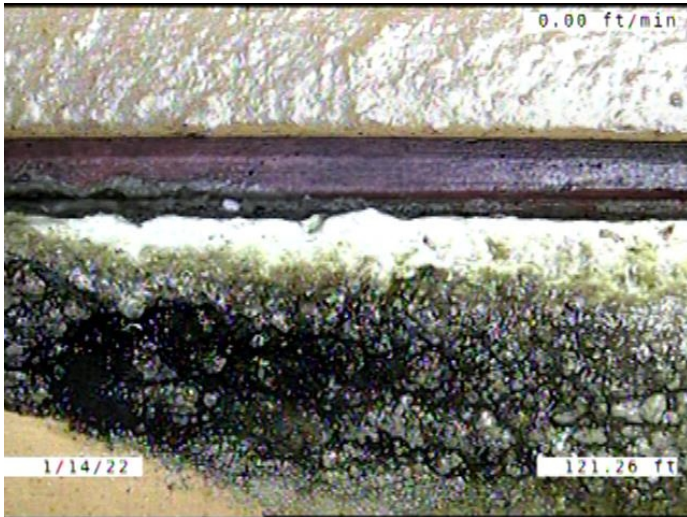
Code: **DAE**
 Description: **Deposits Attached Encrustation**

Distance (ft): **121.3**
 Structural Grade: **0**
 O&M Grade: **2**
 Clock Start/From: **1**
 Clock To: **3**
 1st Value:
 2nd Value:
 Value Percent: **5.000**
 Continuous Index:
 Within 8" of Joint: **YES**
 Remarks:

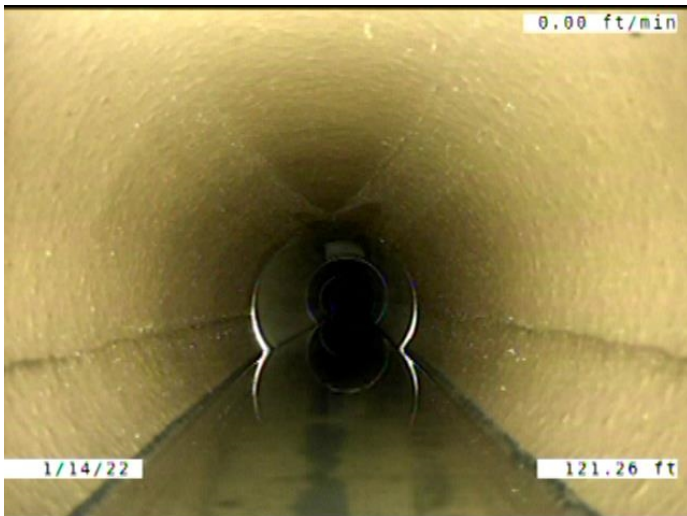
Code: **MWLS**
 Description: **Miscellaneous Water Level Sag**

Distance (ft): **121.3**
 Structural Grade: **2**
 O&M Grade: **0**
 Clock Start/From:
 Clock To:
 1st Value:
 2nd Value:
 Value Percent: **10.000**
 Continuous Index: **S05**
 Within 8" of Joint: **NO**
 Remarks:

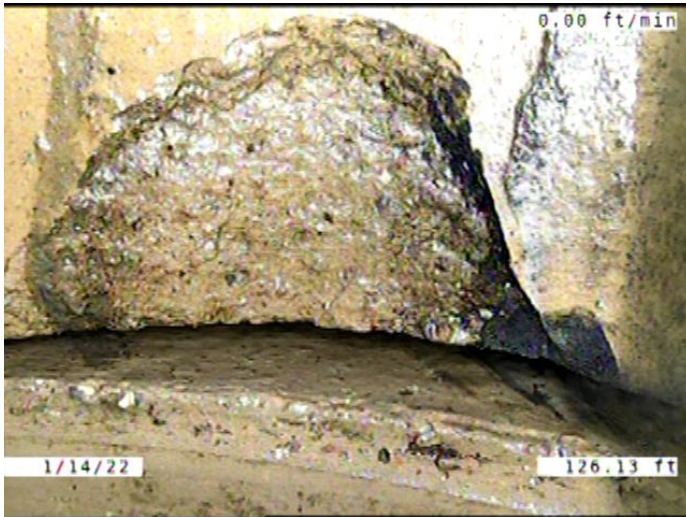
Code: **SZ**
 Description: **Surface Damage Other**

Distance (ft): **126.1**
 Structural Grade: **0**
 O&M Grade: **0**
 Clock Start/From: **2**
 Clock To: **4**
 1st Value:
 2nd Value:
 Value Percent:
 Continuous Index:
 Within 8" of Joint: **YES**
 Remarks: **A PIECE CHIPPED AWAY FROM THE JOINT**

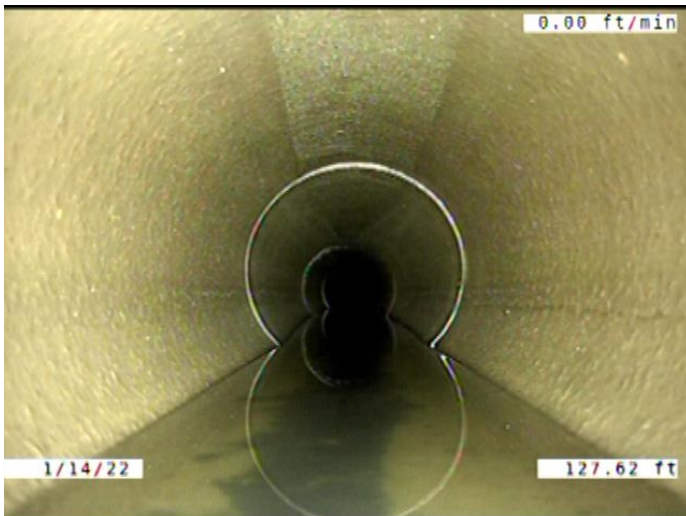
Code: **DSF**
 Description: **Deposits Settled Fine**

Distance (ft): **127.6**
 Structural Grade: **0**
 O&M Grade: **2**
 Clock Start/From: **5**
 Clock To: **7**
 1st Value:
 2nd Value:
 Value Percent: **5.000**
 Continuous Index: **S06**
 Within 8" of Joint: **YES**
 Remarks:

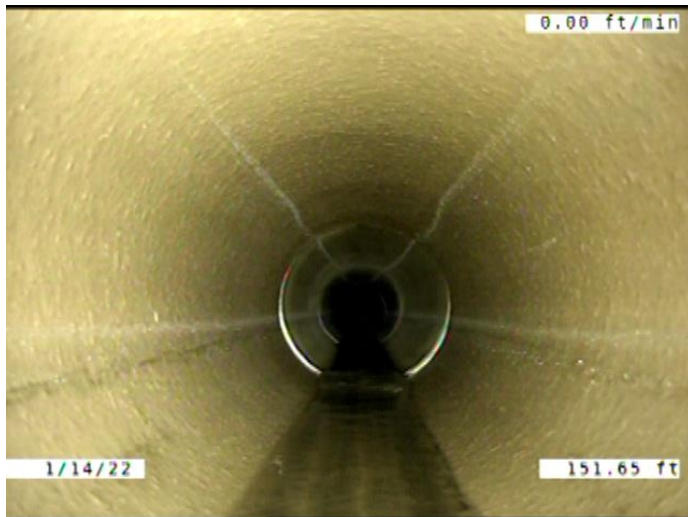
Code: **MWLS**
Description: **Miscellaneous Water Level Sag**

Distance (ft): **151.6**
Structural Grade: **2**
O&M Grade: **0**
Clock Start/From:
Clock To:
1st Value:
2nd Value:
Value Percent: **10.000**
Continuous Index: **F05**
Within 8" of Joint: **NO**
Remarks:

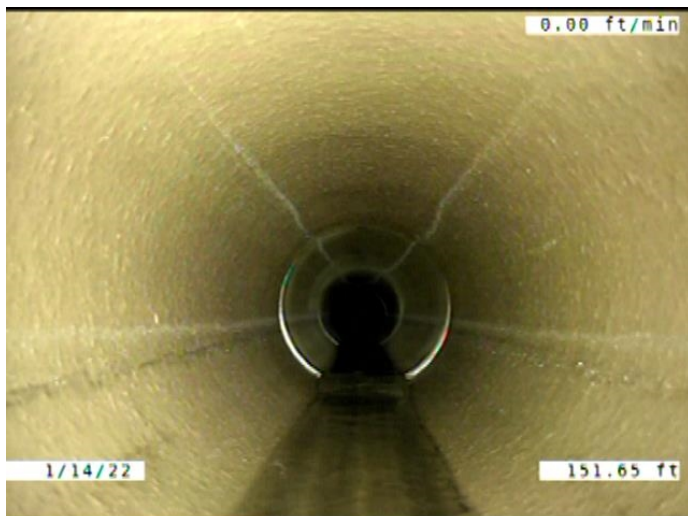
Code: **DSF**
Description: **Deposits Settled Fine**

Distance (ft): **151.6**
Structural Grade: **0**
O&M Grade: **2**
Clock Start/From: **5**
Clock To: **7**
1st Value:
2nd Value:
Value Percent: **5.000**
Continuous Index: **F06**
Within 8" of Joint: **YES**
Remarks:

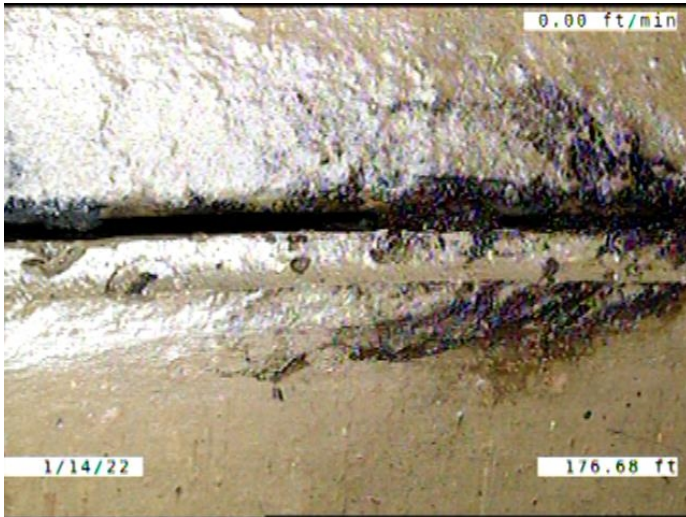
Code: **ISJ**
 Description: **Infiltration Stain Joint**

Distance (ft): **176.7**
 Structural Grade: **0**
 O&M Grade: **1**
 Clock Start/From: **8**
 Clock To: **9**
 1st Value:
 2nd Value:
 Value Percent:
 Continuous Index:
 Within 8" of Joint: **YES**
 Remarks:

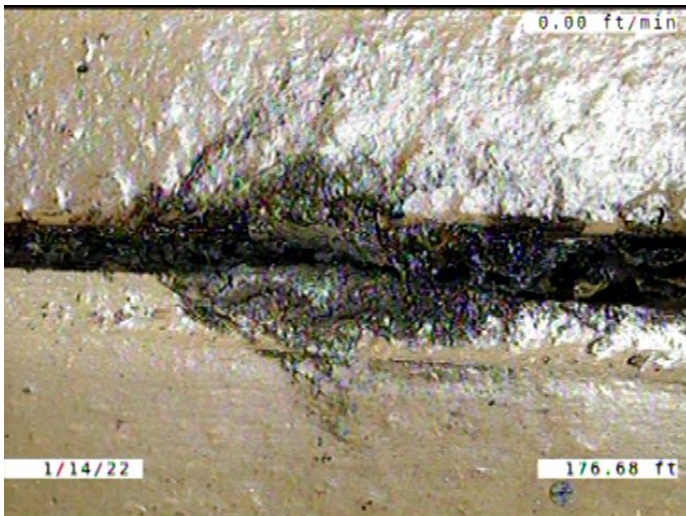
Code: **DAE**
 Description: **Deposits Attached Encrustation**

Distance (ft): **176.7**
 Structural Grade: **0**
 O&M Grade: **2**
 Clock Start/From: **2**
 Clock To: **4**
 1st Value:
 2nd Value:
 Value Percent: **5.000**
 Continuous Index:
 Within 8" of Joint: **YES**
 Remarks:

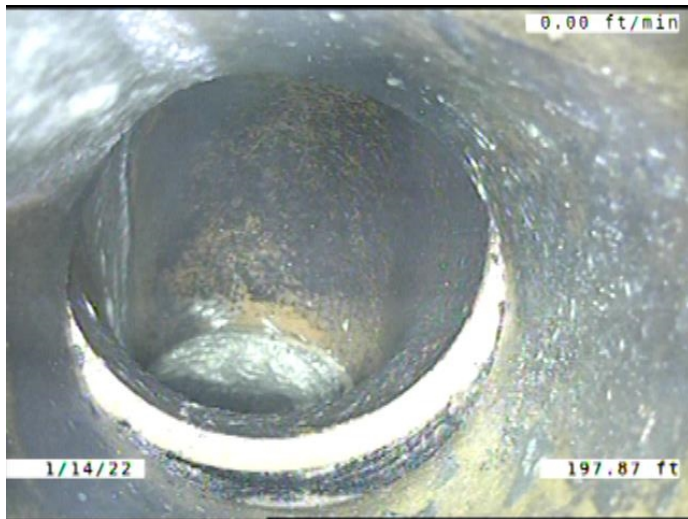
Code:	TF
Description:	Tap Factory
Distance (ft):	197.9
Structural Grade:	0
O&M Grade:	0
Clock Start/From:	11
Clock To:	
1st Value:	4.000
2nd Value:	
Value Percent:	
Continuous Index:	
Within 8" of Joint:	YES
Remarks:	LARGE OFFSET ON THE FIRST JOINT BACK

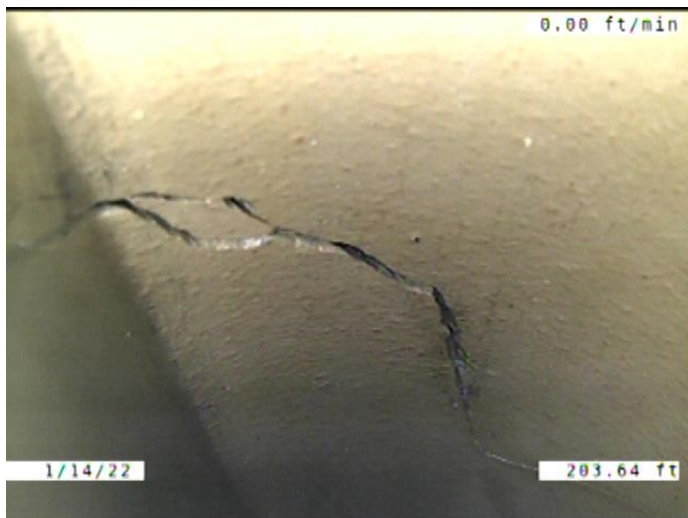
Code:	B
Description:	Broken
Distance (ft):	203.6
Structural Grade:	4
O&M Grade:	0
Clock Start/From:	12
Clock To:	12
1st Value:	
2nd Value:	
Value Percent:	
Continuous Index:	
Within 8" of Joint:	YES
Remarks:

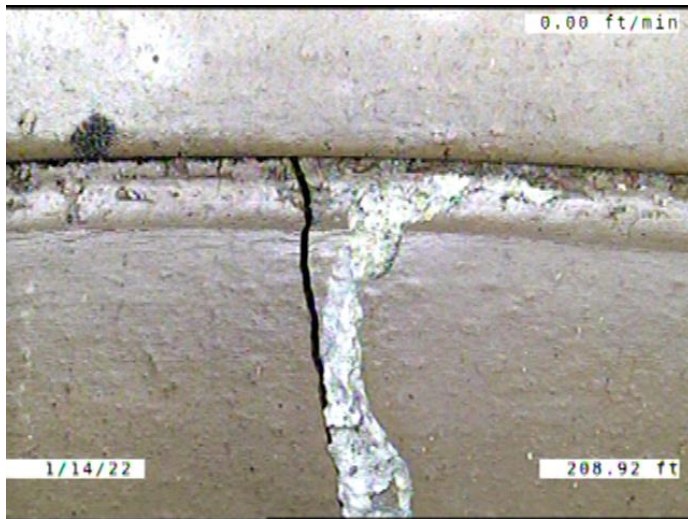
Code: **FS**
 Description: **Fracture Spiral**

Distance (ft): **208.9**
 Structural Grade: **3**
 O&M Grade: **0**
 Clock Start/From: **12**
 Clock To: **3**
 1st Value:
 2nd Value:
 Value Percent:
 Continuous Index:
 Within 8" of Joint: **YES**
 Remarks:

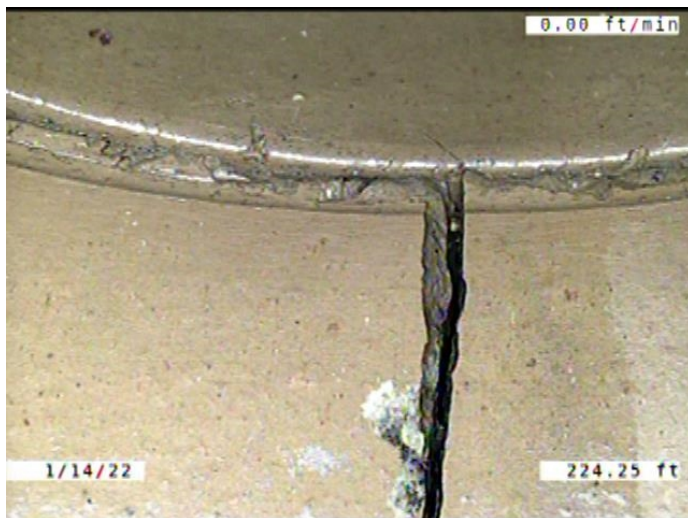
Code: **B**
 Description: **Broken**

Distance (ft): **224.0**
 Structural Grade: **4**
 O&M Grade: **0**
 Clock Start/From: **12**
 Clock To: **12**
 1st Value:
 2nd Value:
 Value Percent:
 Continuous Index:
 Within 8" of Joint: **YES**
 Remarks:

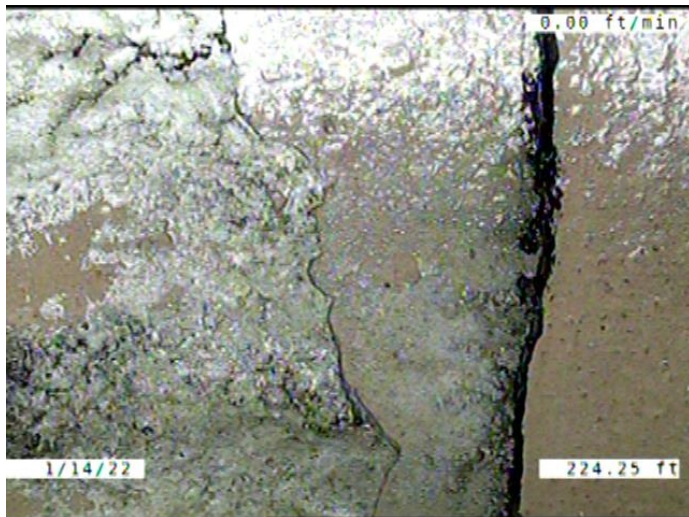
Code: **DAE**
 Description: **Deposits Attached Encrustation**

Distance (ft): **224.2**
 Structural Grade: **0**
 O&M Grade: **2**
 Clock Start/From: **9**
 Clock To: **12**
 1st Value:
 2nd Value:
 Value Percent: **5.000**
 Continuous Index:
 Within 8" of Joint: **YES**
 Remarks:

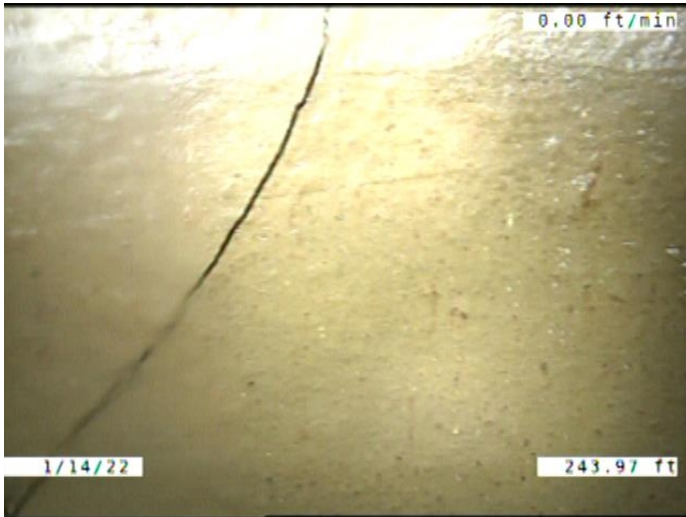
Code: **FS**
 Description: **Fracture Spiral**

Distance (ft): **244.0**
 Structural Grade: **3**
 O&M Grade: **0**
 Clock Start/From: **9**
 Clock To: **10**
 1st Value:
 2nd Value:
 Value Percent:
 Continuous Index:
 Within 8" of Joint: **YES**
 Remarks:

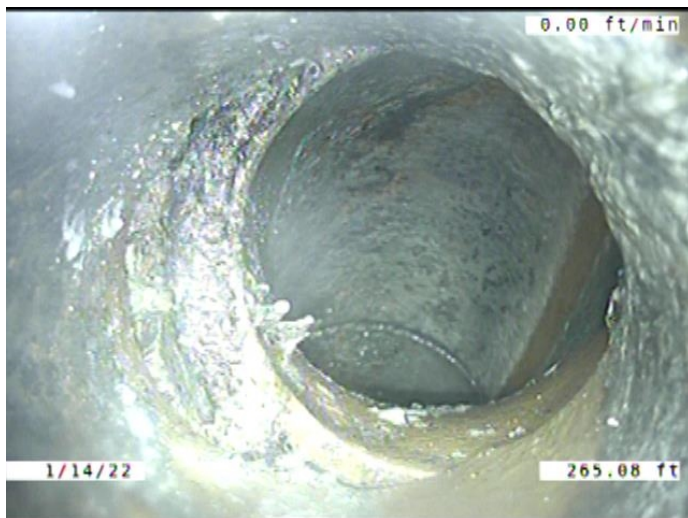
Code: **TFD**
 Description: **Tap Factory Defective**

Distance (ft): **265.1**
 Structural Grade: **0**
 O&M Grade: **3**
 Clock Start/From: **2**
 Clock To:
 1st Value: **4.000**
 2nd Value:
 Value Percent:
 Continuous Index:
 Within 8" of Joint: **YES**
 Remarks: **CONSTANTLY RUNNING WATER.
 MAIN TO SERVICE CONNECTION BR**

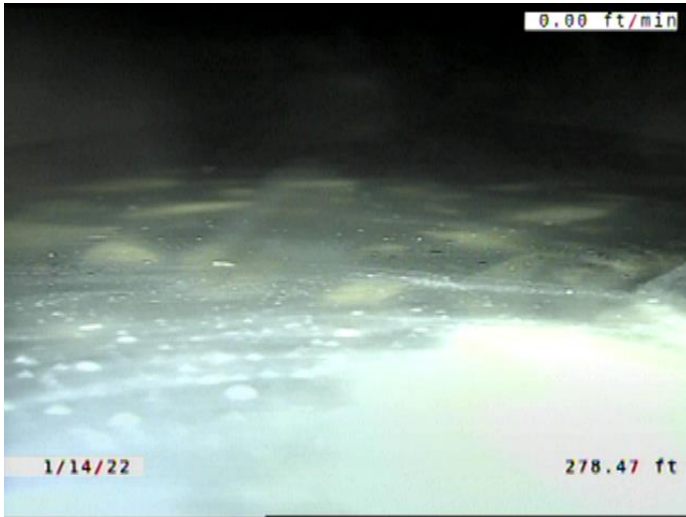
Code: **DSC**
 Description: **Deposits Settled Hard/Compacted**

Distance (ft): **278.5**
 Structural Grade: **0**
 O&M Grade: **2**
 Clock Start/From: **5**
 Clock To: **7**
 1st Value:
 2nd Value:
 Value Percent: **10.000**
 Continuous Index:
 Within 8" of Joint: **NO**
 Remarks:
