Profile/Photo Observation Report

Date:	04/24/2018	Weather:		Coding:	PACP 6.0
Pipe Length (ft):	119.0	Owner:	NA	Pre Clean:	No Pre-Cleaning
P.O.#:		Surveyor:	Jen Costello	PSR:	P-505-088-089
Customer:		Clean Date:	01/01/1900	Shape:	C

Street:	W 4TH PL	Flow Control:	Not Controlled
City:	Hobart, IN	Year Renewed:	
Location:	Yard	Tape/Media #:	
Purpose:	Routine Assessment	Dia/Height:	12"
Use:	Sanitary	Material:	VCP
Drain Area:	NA	Lining:	
Category:	NA		
Comment:	false MH_F at 32 ft Build on the pipe . looks like an off set joint		
Location Details:		Direction of Survey:	Downstream
US MH:	M-505-088	DS MH:	M-505-089
		Total Length Surveyed (ft):	33.4

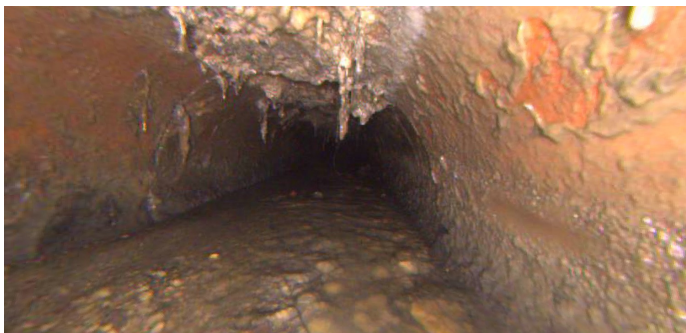
Code: **AMH**
Description: **Manhole**

Distance (ft): **.0**
Structural Grade: **0**
O&M Grade: **0**
Clock Start/From:
Clock To:
1st Value:
2nd Value:
Value Percent:
Continuous Index:
Within 8" of Joint: **NO**
Remarks: **M-505-088**

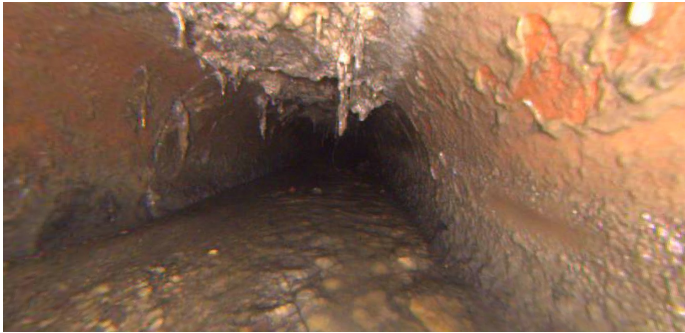
Code:	MWL
Description:	Water Level

Distance (ft):	.0
Structural Grade:	0
O&M Grade:	0
Clock Start/From:	
Clock To:	
1st Value:	
2nd Value:	
Value Percent:	30.000
Continuous Index:	
Within 8" of Joint:	NO
Remarks:

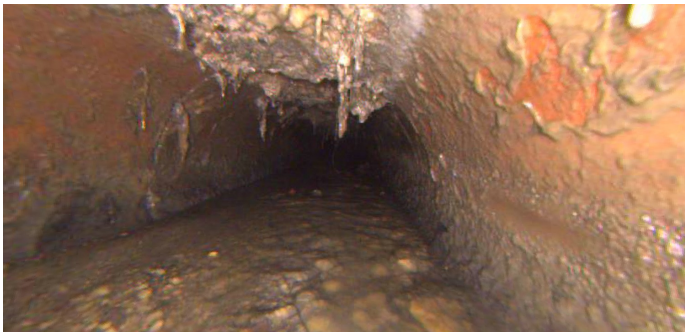
Code:	DAGS
Description:	Deposits Attached Grease

Distance (ft):	.0
Structural Grade:	0
O&M Grade:	2
Clock Start/From:	8
Clock To:	4
1st Value:	
2nd Value:	
Value Percent:	10.000
Continuous Index:	S01
Within 8" of Joint:	NO
Remarks:

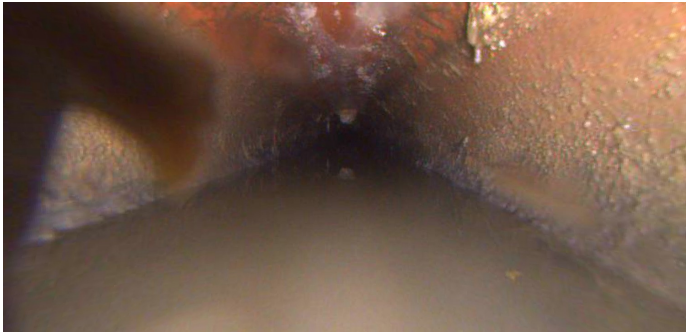
Code: **DAGS**
Description: **Deposits Attached Grease**

Distance (ft): **33.4**
Structural Grade: **0**
O&M Grade: **2**
Clock Start/From: **8**
Clock To: **4**
1st Value:
2nd Value:
Value Percent: **10.000**
Continuous Index: **F01**
Within 8" of Joint: **NO**
Remarks:

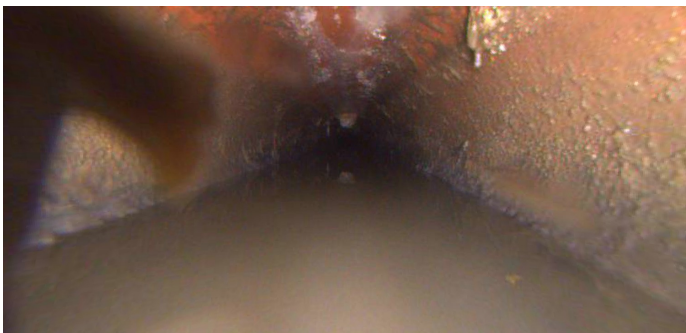
Code: **MSA**
Description: **Abandoned Survey**

Distance (ft): **33.4**
Structural Grade: **0**
O&M Grade: **0**
Clock Start/From:
Clock To:
1st Value:
2nd Value:
Value Percent:
Continuous Index:
Within 8" of Joint: **NO**
Remarks: **debris under water**
