## Profile/Photo Observation Report

Date:	<b>04/24/2018</b>	Weather:		Coding:	<b>PACP 6.0</b>
Pipe Length (ft):	<b>119.0</b>	Owner:	<b>NA</b>	Pre Clean:	<b>No Pre-Cleaning</b>
P.O.#:		Surveyor:	<b>Jen Costello</b>	PSR:	<b>P-505-088-089</b>
Customer:		Clean Date:	<b>01/01/1900</b>	Shape:	<b>C</b>

Street:	<b>FOXCROFT STREET</b>	Flow Control:	<b>Not Controlled</b>
City:	<b>Hobart, IN</b>	Year Renewed:	
Location:	<b>Yard</b>	Tape/Media #:	
Purpose:	<b>Routine Assessment</b>	Dia/Height:	<b>12"</b>
Use:	<b>Sanitary</b>	Material:	<b>VCP</b>
Drain Area:	<b>NA</b>	Lining:	
Category:	<b>NA</b>		
Comment:	<b>false MH_F at 32 ft Build on the pipe . looks like an off set joint</b>		
Location Details:		Direction of Survey:	<b>Downstream</b>
US MH:	<b>M-505-088</b>	DS MH:	<b>M-505-089</b>
		Total Length Surveyed (ft):	<b>33.4</b>

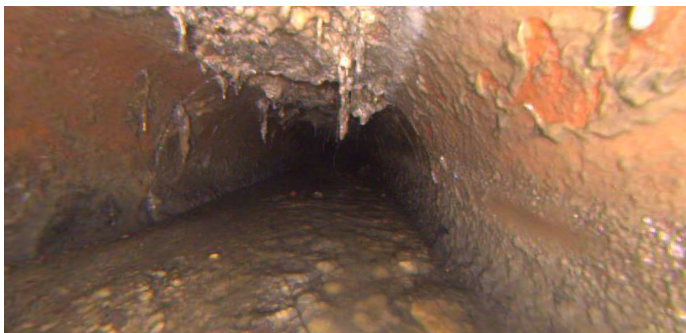
Code: **AMH**  
Description: **Manhole**

Distance (ft): **.0**  
Structural Grade: **0**  
O&M Grade: **0**  
Clock Start/From:  
Clock To:  
1st Value:  
2nd Value:  
Value Percent:  
Continuous Index:  
Within 8" of Joint: **NO**  
Remarks: **M-505-088**

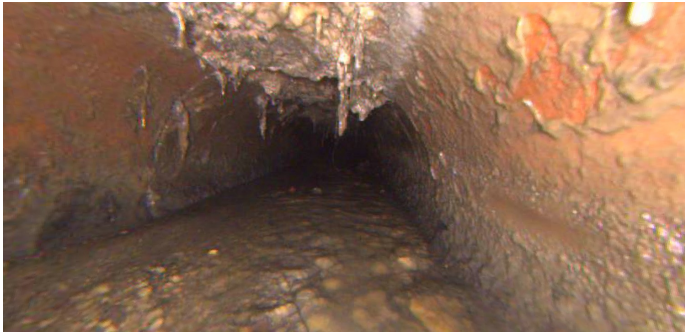
Code:	<b>MWL</b>
Description:	<b>Water Level</b>

Distance (ft):	<b>.0</b>
Structural Grade:	<b>0</b>
O&M Grade:	<b>0</b>
Clock Start/From:	
Clock To:	
1st Value:	
2nd Value:	
Value Percent:	<b>30.000</b>
Continuous Index:	
Within 8" of Joint:	<b>NO</b>
Remarks:

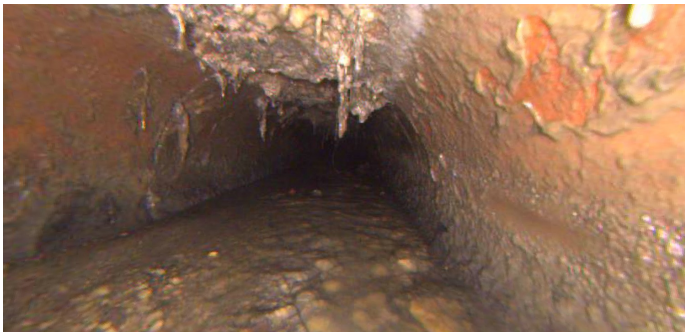
Code:	<b>DAGS</b>
Description:	<b>Deposits Attached Grease</b>

Distance (ft):	<b>.0</b>
Structural Grade:	<b>0</b>
O&M Grade:	<b>2</b>
Clock Start/From:	<b>8</b>
Clock To:	<b>4</b>
1st Value:	
2nd Value:	
Value Percent:	<b>10.000</b>
Continuous Index:	<b>S01</b>
Within 8" of Joint:	<b>NO</b>
Remarks:

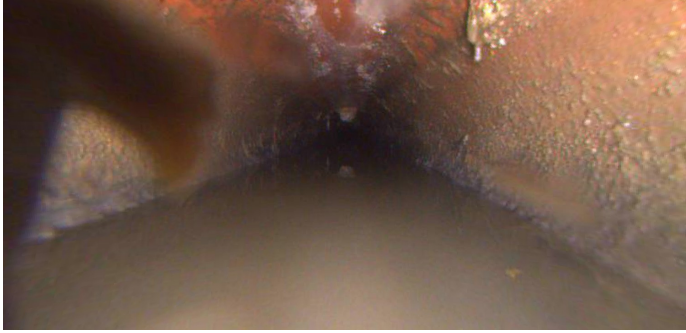
Code: **DAGS**  
Description: **Deposits Attached Grease**

Distance (ft): **33.4**  
Structural Grade: **0**  
O&M Grade: **2**  
Clock Start/From: **8**  
Clock To: **4**  
1st Value:  
2nd Value:  
Value Percent: **10.000**  
Continuous Index: **F01**  
Within 8" of Joint: **NO**  
Remarks:

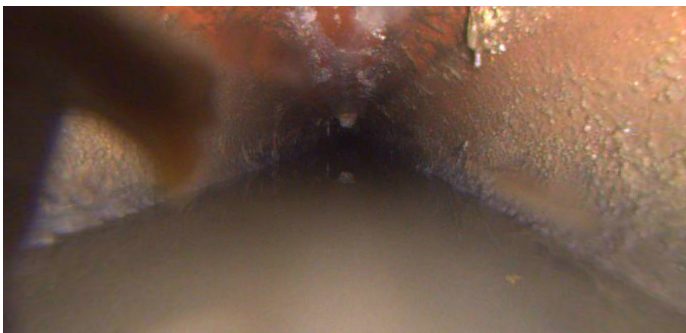
Code: **MSA**  
Description: **Abandoned Survey**

Distance (ft): **33.4**  
Structural Grade: **0**  
O&M Grade: **0**  
Clock Start/From:  
Clock To:  
1st Value:  
2nd Value:  
Value Percent:  
Continuous Index:  
Within 8" of Joint: **NO**  
Remarks: **debris under water**
