Profile/Photo Observation Report

Date:	10/19/2021	Weather:		Coding:	PACP 6.0
Pipe Length (ft):		Owner:	Hobart, IN	Pre Clean:	Not Known
P.O.#:	895_1	Surveyor:	M. Pielacha	PSR:	P-505-090-088
Customer:	Hobart, IN	Clean Date:		Shape:	C

Street:	Off Wabash Street	Flow Control:	
City:	Hobart, IN	Year Renewed:	
Location:	Yard	Tape/Media #:	895
Purpose:	Routine Assessment	Dia/Height:	8"
Use:	Sanitary	Material:	PVC
Drain Area:		Lining:	
Category:	NA		
Comment:

Location Details:		Direction of Survey:	Upstream
US MH:	M-505-88	DS MH:	M-505-90
		Total Length Surveyed (ft):	14.0

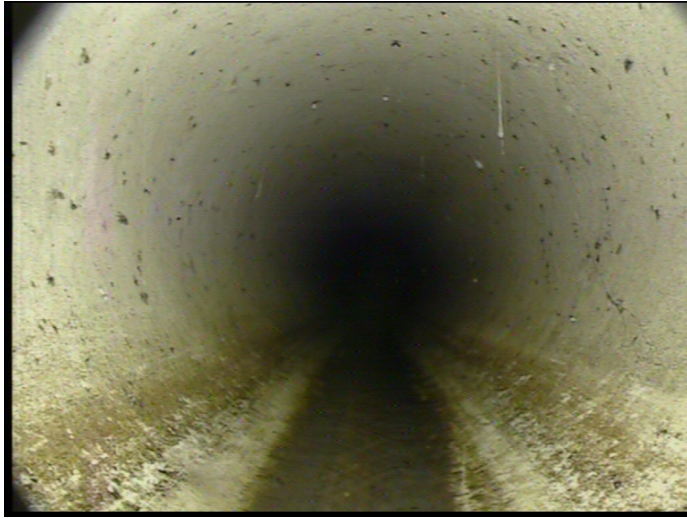
Code: **MWL**
Description: **Water Level**

Distance (ft): **.0**
Structural Grade: **0**
O&M Grade: **0**
Clock Start/From:
Clock To:
1st Value:
2nd Value:
Value Percent: **5.000**
Continuous Index:
Within 8" of Joint: **NO**
Remarks:

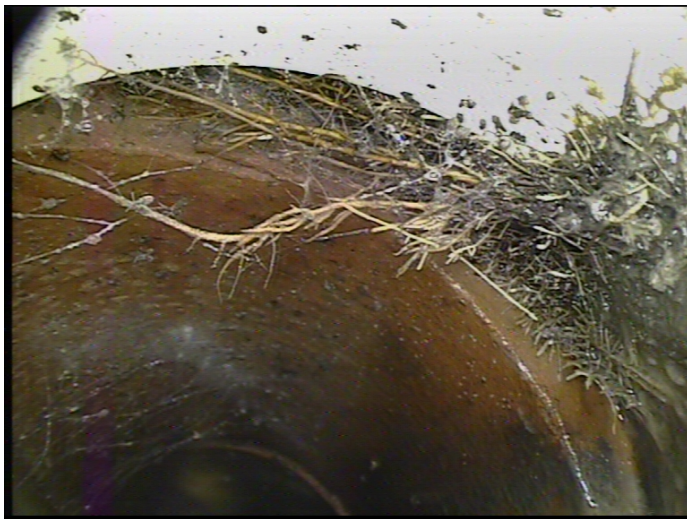
Code: **RFJ**
Description: **Roots Fine Joint**

Distance (ft): **9.6**
Structural Grade: **0**
O&M Grade: **1**
Clock Start/From: **1**
Clock To: **5**
1st Value:
2nd Value:
Value Percent:
Continuous Index:
Within 8" of Joint: **YES**
Remarks:

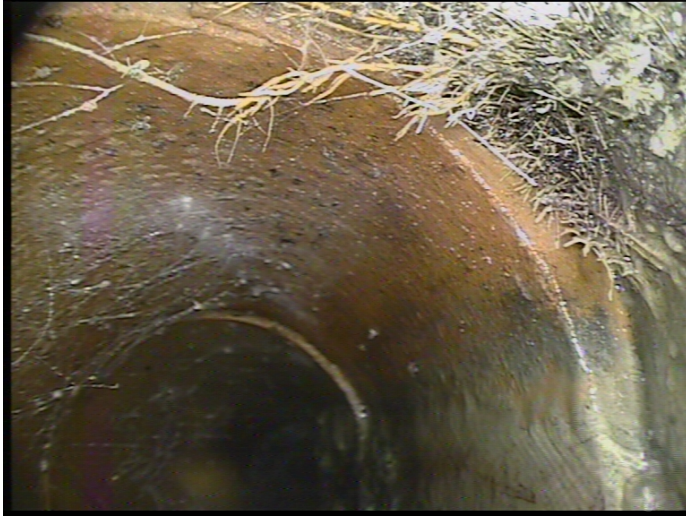
Code:	MMC
Description:	Material Change
Distance (ft):	9.6
Structural Grade:	0
O&M Grade:	0
Clock Start/From:	
Clock To:	
1st Value:	
2nd Value:	
Value Percent:	
Continuous Index:	
Within 8" of Joint:	NO
Remarks:	vcp

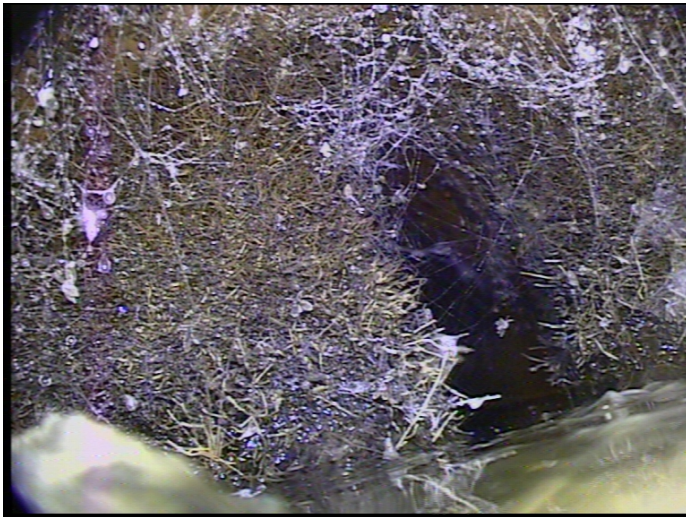
Code:	RMJ
Description:	Roots Medium Joint
Distance (ft):	13.5
Structural Grade:	0
O&M Grade:	3
Clock Start/From:	8
Clock To:	4
1st Value:	
2nd Value:	
Value Percent:	40.000
Continuous Index:	
Within 8" of Joint:	YES
Remarks:

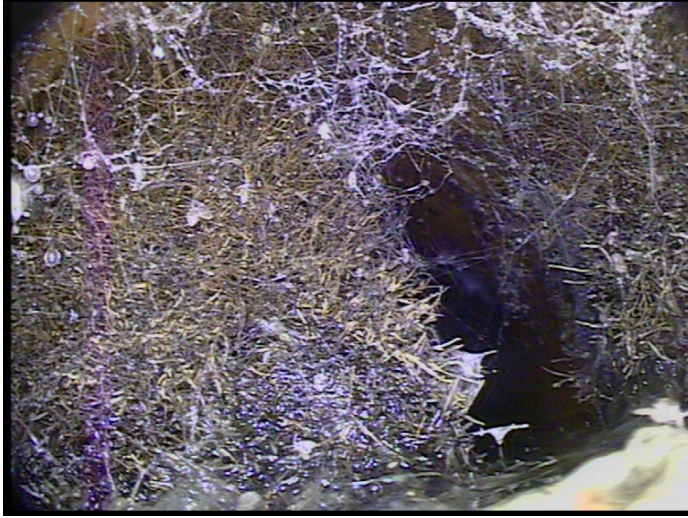
Code:	MSA
Description:	Abandoned Survey
Distance (ft):	14.0
Structural Grade:	0
O&M Grade:	0
Clock Start/From:	
Clock To:	
1st Value:	
2nd Value:	
Value Percent:	
Continuous Index:	
Within 8" of Joint:	NO
Remarks:	roots
