## Profile/Photo Observation Report

Street:	<b>Wabash Street</b>	Flow Control:	
City:	<b>Hobart, IN</b>	Year Renewed:	
Location:	<b>Light Highway</b>	Tape/Media #:	<b>894</b>
Purpose:	<b>Routine Assessment</b>	Dia/Height:	<b>6"</b>
Use:	<b>Sanitary</b>	Material:	<b>VCP</b>
Drain Area:		Lining:	
Category:	<b>NA</b>		
Comment:

Location Details:		Direction of Survey:	<b>Downstream</b>
US MH:	<b>M-505-88</b>	DS MH:	<b>M-505-90</b>
		Total Length Surveyed (ft):	<b>40.5</b>

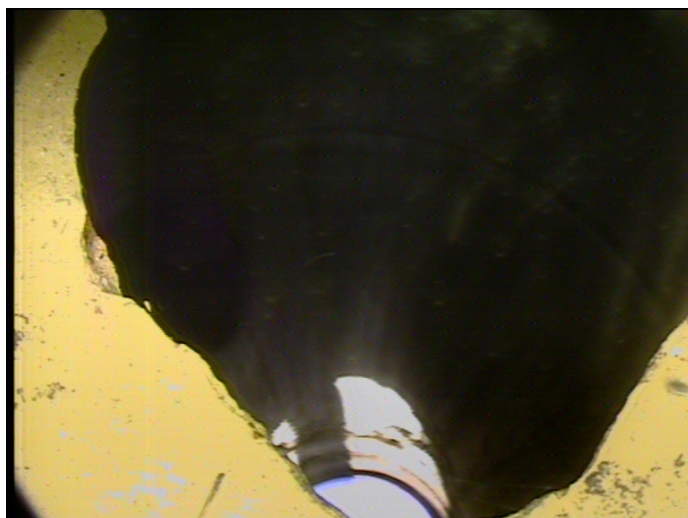
Code: **AMH**  
Description: **Manhole**

Distance (ft): **.0**  
Structural Grade: **0**  
O&M Grade: **0**  
Clock Start/From:  
Clock To:  
1st Value:  
2nd Value:  
Value Percent:  
Continuous Index:  
Within 8" of Joint: **NO**  
Remarks: **M-505-88**

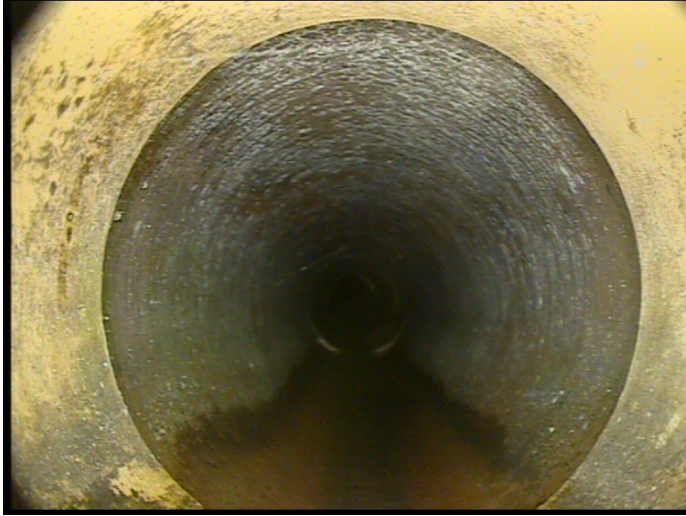
Code: **MWL**  
Description: **Water Level**

Distance (ft): **.0**  
Structural Grade: **0**  
O&M Grade: **0**  
Clock Start/From:  
Clock To:  
1st Value:  
2nd Value:  
Value Percent: **5.000**  
Continuous Index:  
Within 8" of Joint: **NO**  
Remarks:

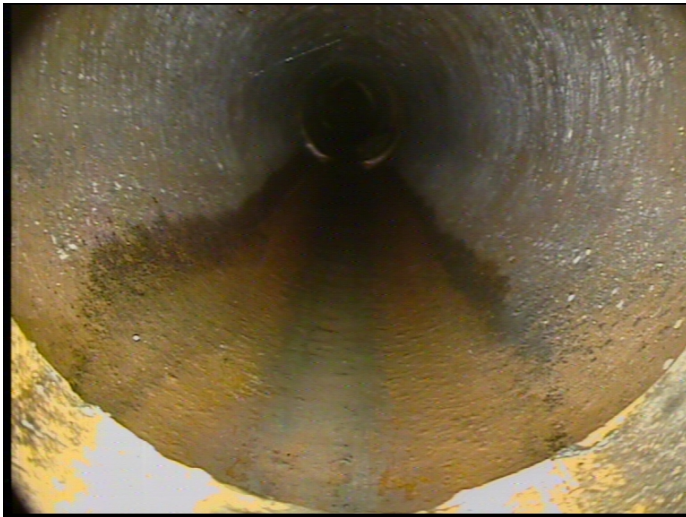
Code: **JOM**  
Description: **Joint Offset Medium**

Distance (ft): **2.0**  
Structural Grade: **1**  
O&M Grade: **0**  
Clock Start/From:  
Clock To:  
1st Value:  
2nd Value:  
Value Percent:  
Continuous Index:  
Within 8" of Joint: **NO**  
Remarks:

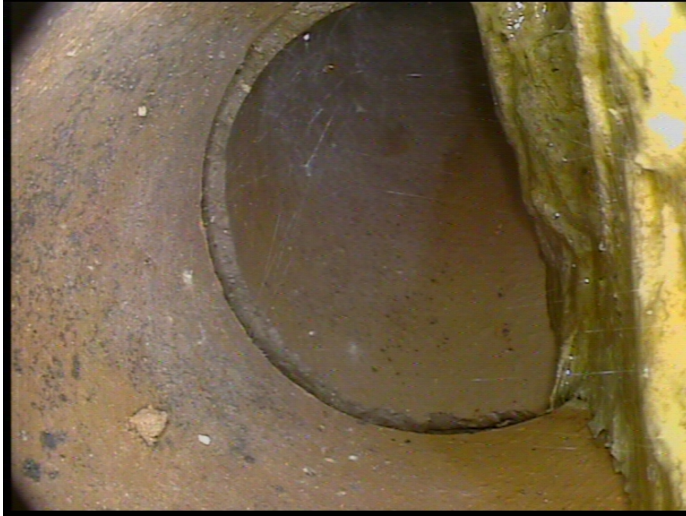
Code:	<b>TFD</b>
Description:	<b>Tap Factory Defective</b>
Distance (ft):	<b>7.0</b>
Structural Grade:	<b>0</b>
O&M Grade:	<b>2</b>
Clock Start/From:	<b>3</b>
Clock To:	
1st Value:	<b>4.000</b>
2nd Value:	
Value Percent:	
Continuous Index:	
Within 8" of Joint:	<b>NO</b>
Remarks:	<b>Defective</b>

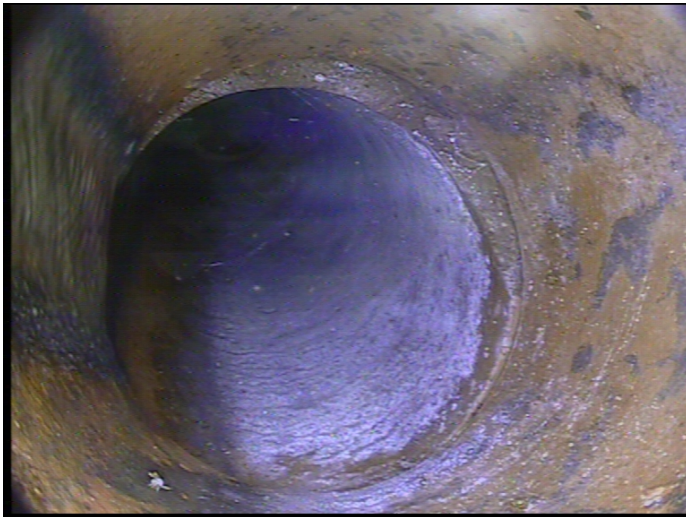
Code:	<b>TFA</b>
Description:	<b>Tap Factory Active</b>
Distance (ft):	<b>10.4</b>
Structural Grade:	<b>0</b>
O&M Grade:	<b>0</b>
Clock Start/From:	<b>9</b>
Clock To:	
1st Value:	<b>4.000</b>
2nd Value:	
Value Percent:	
Continuous Index:	
Within 8" of Joint:	<b>NO</b>
Remarks:

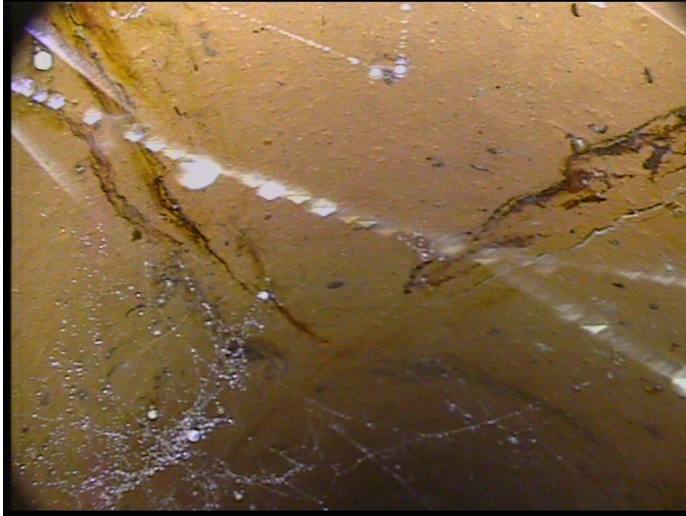
Code:	<b>CM</b>
Description:	<b>Crack Multiple</b>
Distance (ft):	<b>26.3</b>
Structural Grade:	<b>3</b>
O&M Grade:	<b>0</b>
Clock Start/From:	<b>7</b>
Clock To:	<b>5</b>
1st Value:	
2nd Value:	
Value Percent:	
Continuous Index:	
Within 8" of Joint:	<b>YES</b>
Remarks:

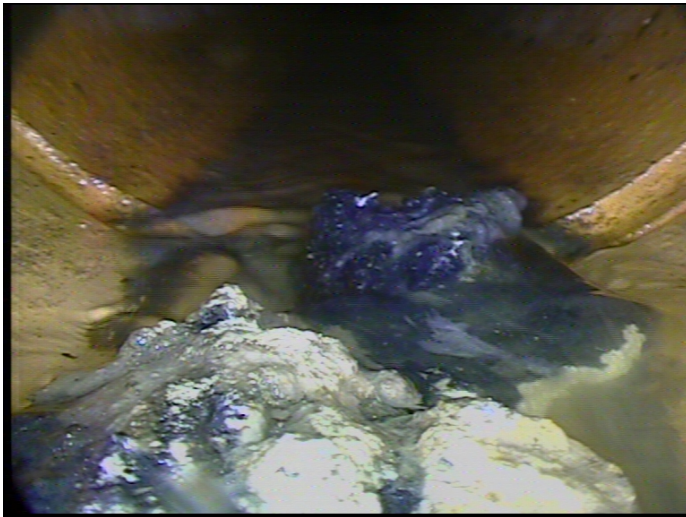
Code:	<b>OBR</b>
Description:	<b>Obstacle Rocks</b>
Distance (ft):	<b>39.2</b>
Structural Grade:	<b>0</b>
O&M Grade:	<b>2</b>
Clock Start/From:	<b>5</b>
Clock To:	<b>7</b>
1st Value:	
2nd Value:	
Value Percent:	<b>10.000</b>
Continuous Index:	
Within 8" of Joint:	<b>NO</b>
Remarks:

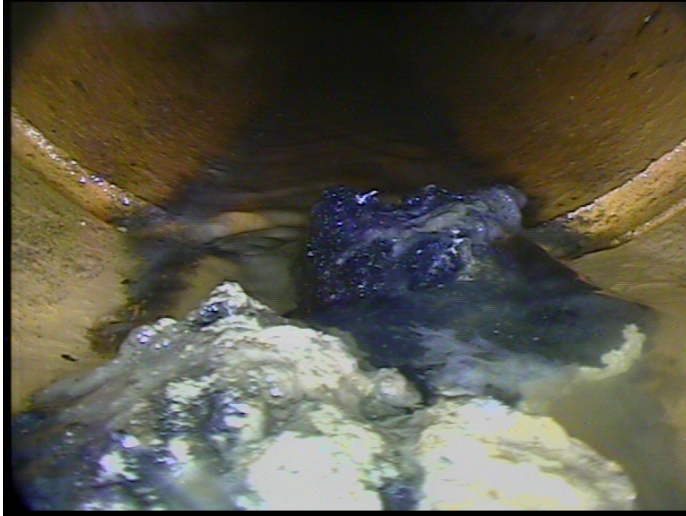
Code:	<b>MSA</b>
Description:	<b>Abandoned Survey</b>
Distance (ft):	<b>39.2</b>
Structural Grade:	<b>0</b>
O&M Grade:	<b>0</b>
Clock Start/From:	
Clock To:	
1st Value:	
2nd Value:	
Value Percent:	
Continuous Index:	
Within 8" of Joint:	<b>NO</b>
Remarks:	<b>Can not pass rocks</b>
