## **Profile/Photo Observation Report**

**West 3rd Street** Flow Control: **Not Controlled** Street:

Total Length Surveyed (ft): US MH: M-505-093 DS MH: M-505-092 276.6

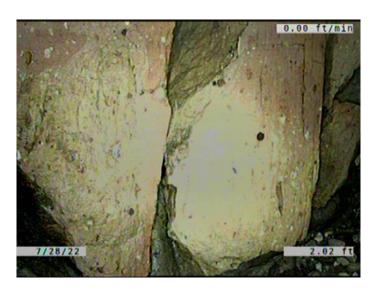
Code: TBD

Description: Tap Break-in/Hammer Defective

Distance (ft): 2.0
Structural Grade: 0
O&M Grade: 3
Clock Start/From: 10

Remarks: BRICKED OFF. BRICKS ARE BREAKING

DOWN.

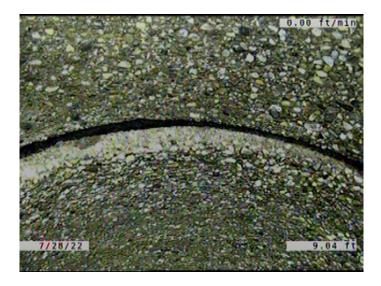
Code: **JOM**

Description: Joint Offset Medium

Distance (ft): 9.0
Structural Grade: 3
O&M Grade: 0

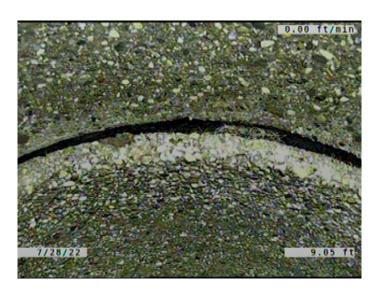
Code: RFJ

Description: Roots Fine Joint

Distance (ft): 9.0
Structural Grade: 0
O&M Grade: 1
Clock Start/From: 9
Clock To: 3
1st Value:
2nd Value:
Value Percent:
Continuous Index:

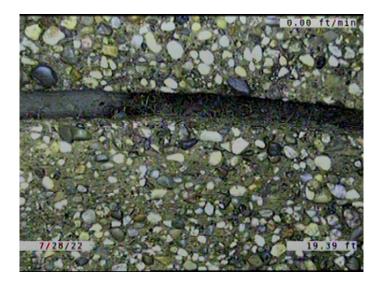
Code: RFJ

Description: Roots Fine Joint

Distance (ft): 19.4
Structural Grade: 0

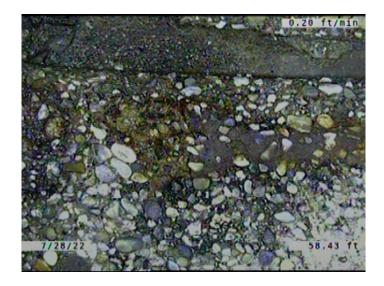
Code: ISB

Description: Infiltration Stain Barrel

Distance (ft): 58.4
Structural Grade: 0

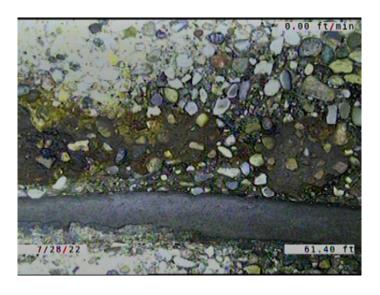
Code: ISB

Description: Infiltration Stain Barrel

Distance (ft): 61.4
Structural Grade: 0

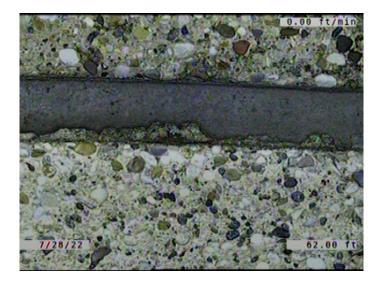
Code: JAM

Description: Joint Angular Medium

Distance (ft): 62.0
Structural Grade: 3
O&M Grade: 0

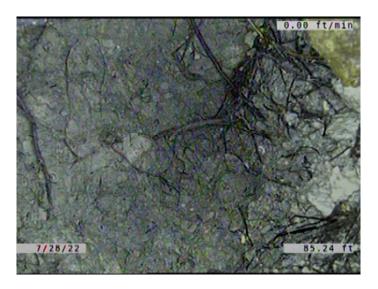
Code: **TBD**

Description: Tap Break-in/Hammer Defective

Distance (ft): 85.2
Structural Grade: 0
O&M Grade: 3
Clock Start/From: 3

Remarks: Filled with soil, possibly collapsed

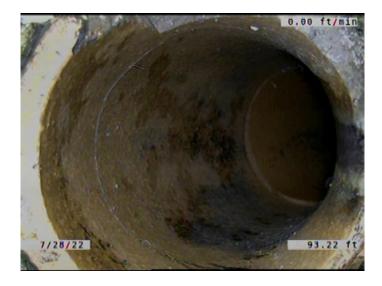
Code: **TBI**

Description: Tap Break-in Intruding

Distance (ft): 93.2
Structural Grade: 0
O&M Grade: 2
Clock Start/From: 1

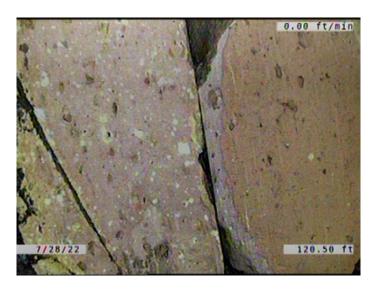
Code: TBD

Description: Tap Break-in/Hammer Defective

Distance (ft): 120.5
Structural Grade: 0
O&M Grade: 3
Clock Start/From: 9

Remarks: BRICKED OFF. BRICKS BREAKING

DOWN.

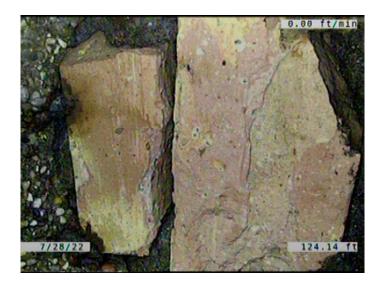
Code: TBD

Description: Tap Break-in/Hammer Defective

Distance (ft): 124.1 Structural Grade: 0 3 O&M Grade: Clock Start/From: 3

Remarks: **BRICKED OFF. BRICKS BREAKING**

DOWN.

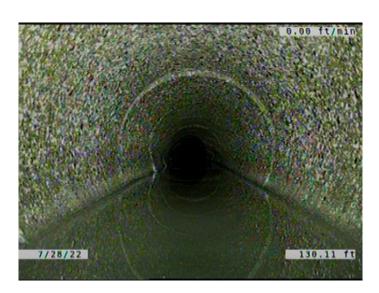
Code: **MWLS**

Description: **Miscellaneous Water Level Sag**

Distance (ft): 130.1 Structural Grade: 2 O&M Grade: 0

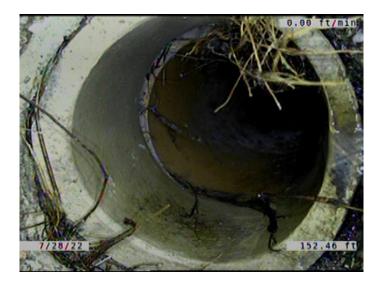
Code: TBA

Description: Tap Break-in Activity

Remarks: ROOTS GROWING AROUND THE TAP.

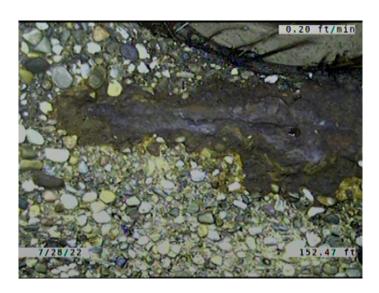
Code: SRP

Description: Surface Damage Reinforcement

**Projecting**

Distance (ft): 152.5
Structural Grade: 5
O&M Grade: 0
Clock Start/From: 1
Clock To: 2

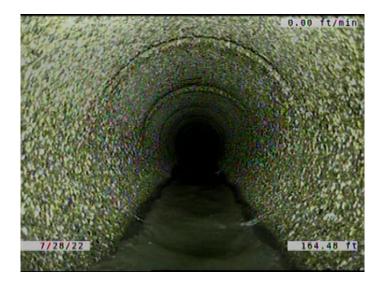
Code: MWLS

Description: Miscellaneous Water Level Sag

Distance (ft): 164.5
Structural Grade: 2
O&M Grade: 0

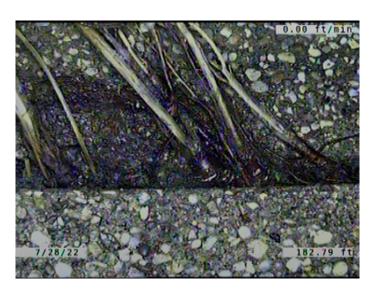
Code: RMJ

Description: Roots Medium Joint

Distance (ft): 182.8
Structural Grade: 0
O&M Grade: 3
Clock Start/From: 8
Clock To: 4
1st Value:

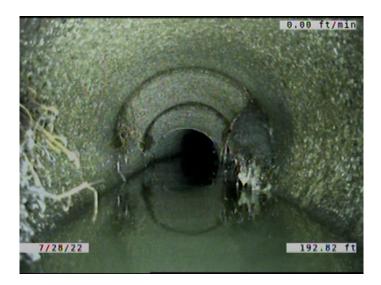
Code: MWLS

Description: Miscellaneous Water Level Sag

Distance (ft): 192.8
Structural Grade: 3
O&M Grade: 0

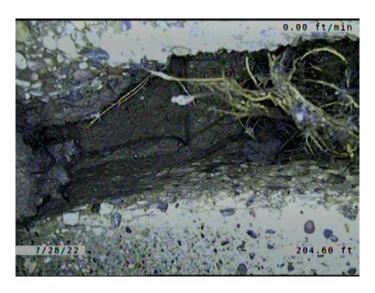
Code: JAL

Description: Joint Angular Large

Distance (ft): 204.6
Structural Grade: 4
O&M Grade: 0

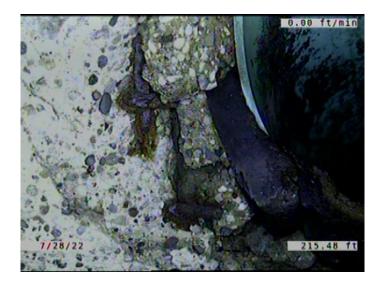
Code: SRP

Description: Surface Damage Reinforcement

**Projecting**

Distance (ft): 215.5
Structural Grade: 5
O&M Grade: 0
Clock Start/From: 2
Clock To: 3

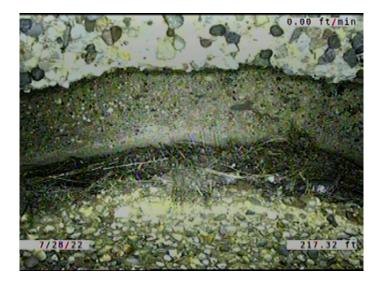
Code: JSL

Description: Joint Separated Large

Distance (ft): 217.3
Structural Grade: 4
O&M Grade: 0

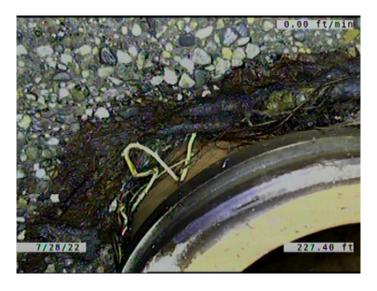
Code: SRP

Description: Surface Damage Reinforcement

**Projecting**

Distance (ft): 227.4
Structural Grade: 5
O&M Grade: 0
Clock Start/From: 9
Clock To: 11

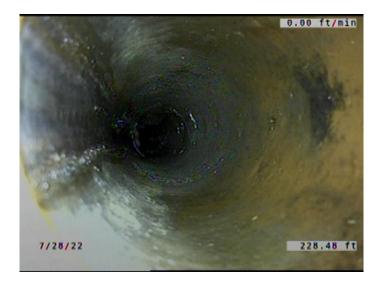
Code: TBI

Description: Tap Break-in Intruding

Distance (ft): 228.5
Structural Grade: 0
O&M Grade: 2
Clock Start/From: 10

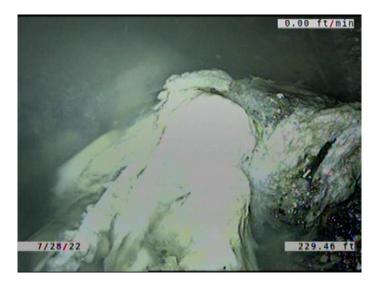
Code: DAR

Description: Deposits Attached Ragging

Distance (ft): 229.5
Structural Grade: 0
O&M Grade: 2
Clock Start/From: 4
Clock To: 5
1st Value:
2nd Value:

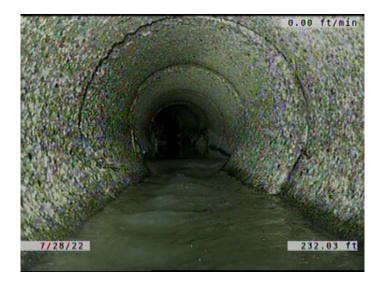
Code: MWLS

Description: Miscellaneous Water Level Sag

Distance (ft): 232.0
Structural Grade: 3
O&M Grade: 0

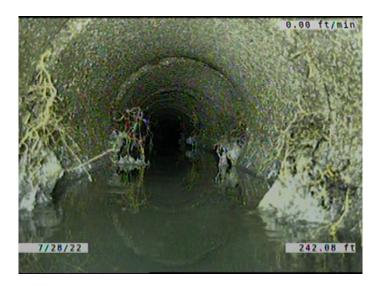
Code: MWLS

Description: Miscellaneous Water Level Sag

Distance (ft): 242.1
Structural Grade: 2
O&M Grade: 0

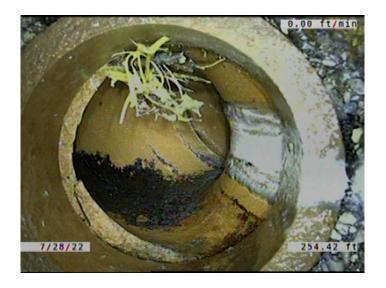
Code: TBD

Description: Tap Break-in/Hammer Defective

Distance (ft): 254.4
Structural Grade: 0
O&M Grade: 3
Clock Start/From: 2

Remarks: SERVICE BROKEN. CONSTANTLY
RUNNING WATER. ROOTS GROWING

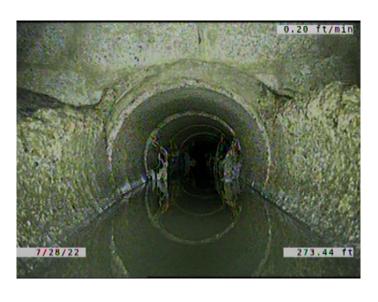
Code: RFJ

Description: Roots Fine Joint

Distance (ft): 273.3

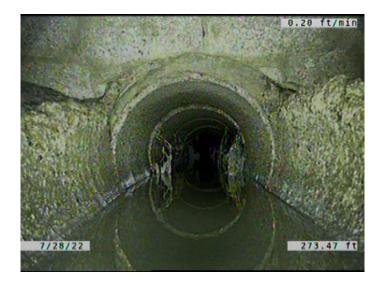
Code: RMJ

Description: **Roots Medium Joint**

Distance (ft): 273.4 Structural Grade: 0 3 O&M Grade: Clock Start/From: 8 Clock To: 4

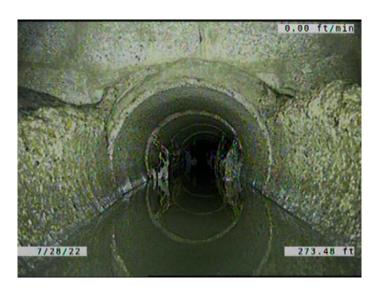
Code: **MWLS**

Description: **Miscellaneous Water Level Sag**

Distance (ft): 273.5 Structural Grade: 2 O&M Grade: 0
