M-505-095

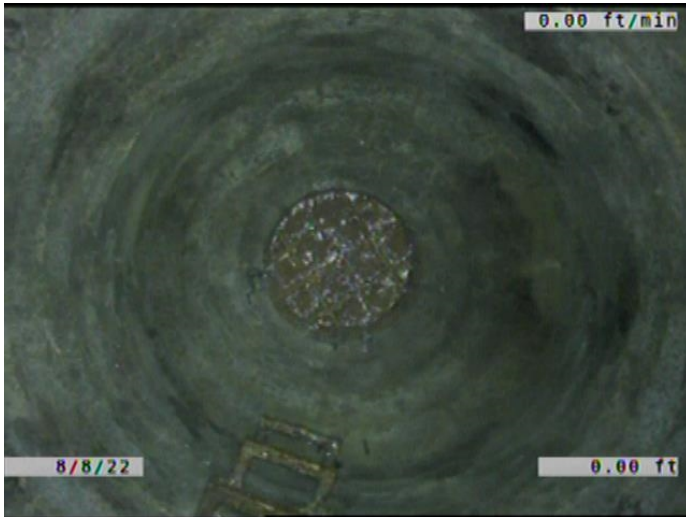
Code: **AMH**
 Description: **Manhole**

Distance (ft): **.0**
 Structural Grade: **0**
 O&M Grade: **0**
 Clock Start/From:
 Clock To:
 1st Value:
 2nd Value:
 Value Percent:
 Continuous Index:
 Within 8" of Joint: **NO**
 Remarks: **M-505-094**

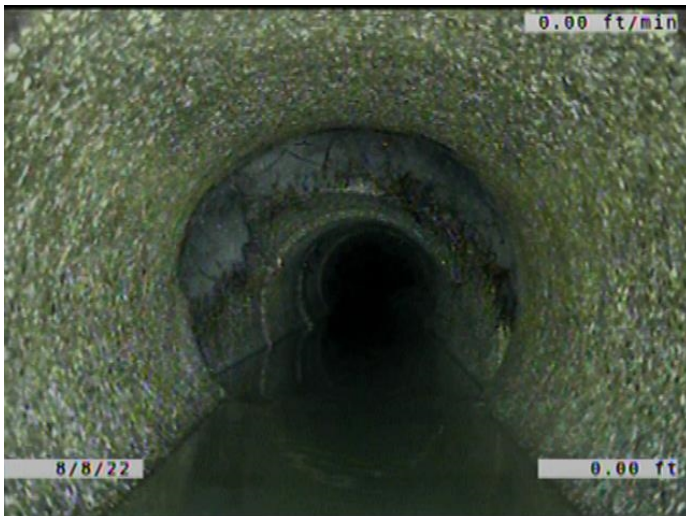
Code: **MWL**
 Description: **Miscellaneous Water Level**

Distance (ft): **.0**
 Structural Grade: **0**
 O&M Grade: **0**
 Clock Start/From:
 Clock To:
 1st Value:
 2nd Value:
 Value Percent: **15.000**
 Continuous Index:
 Within 8" of Joint: **NO**
 Remarks:

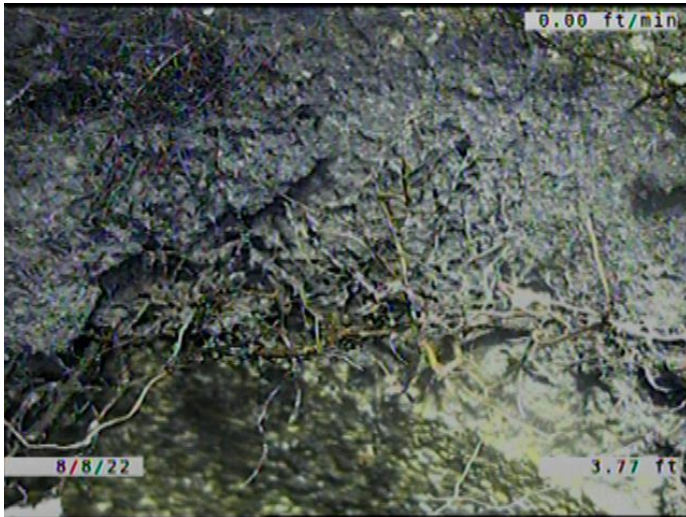
Code: **RMJ**
 Description: **Roots Medium Joint**

Distance (ft): **3.8**
 Structural Grade: **0**
 O&M Grade: **3**
 Clock Start/From: **8**
 Clock To: **4**
 1st Value:
 2nd Value:
 Value Percent: **5.000**
 Continuous Index: **S01**
 Within 8" of Joint: **YES**
 Remarks:

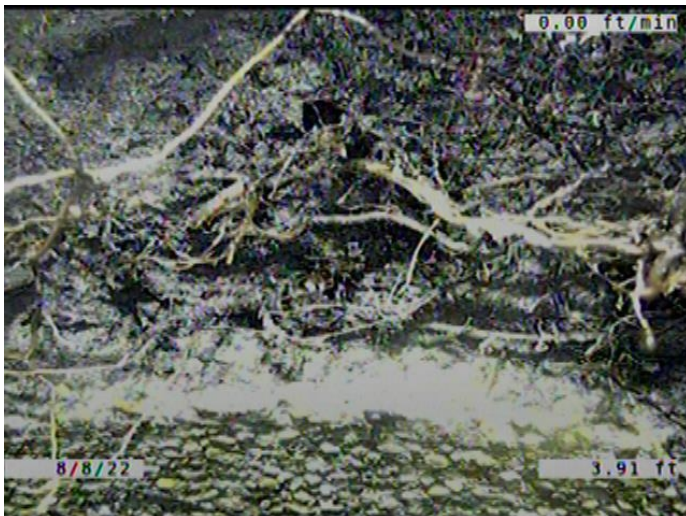
Code: **JOLD**
 Description: **Joint Offset Large Defective**

Distance (ft): **3.9**
 Structural Grade: **4**
 O&M Grade: **0**
 Clock Start/From:
 Clock To:
 1st Value:
 2nd Value:
 Value Percent:
 Continuous Index:
 Within 8" of Joint: **NO**
 Remarks:

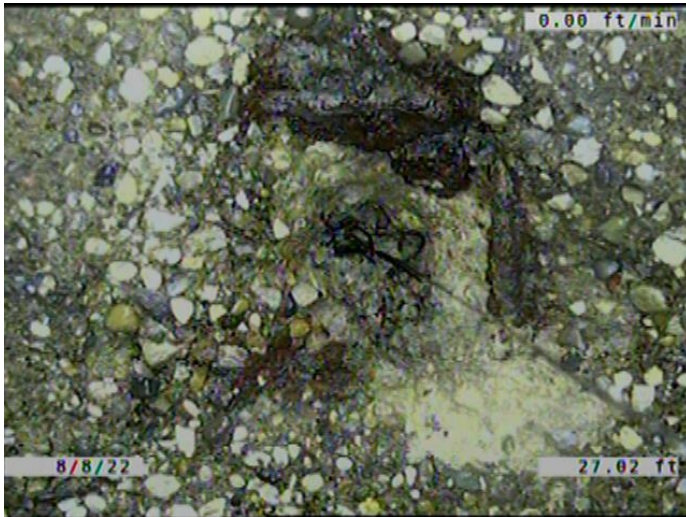
Code: **SRP**
 Description: **Surface Damage Reinforcement Projecting**

Distance (ft): **27.0**
 Structural Grade: **5**
 O&M Grade: **0**
 Clock Start/From: **12**
 Clock To: **1**
 1st Value:
 2nd Value:
 Value Percent:
 Continuous Index:
 Within 8" of Joint: **YES**
 Remarks:

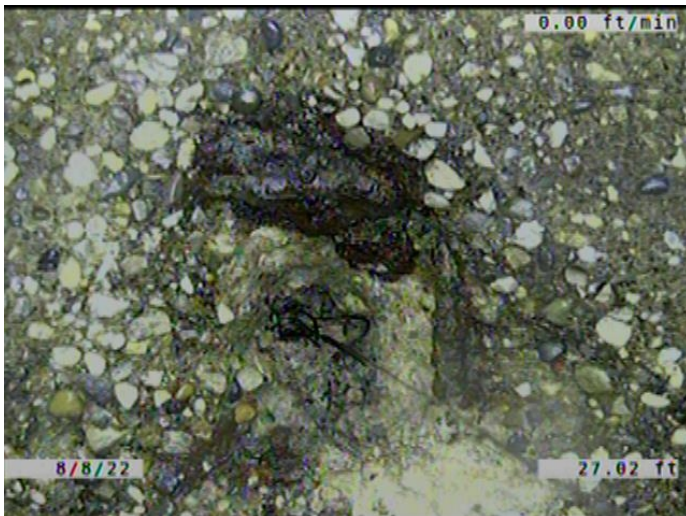
Code: **SRV**
 Description: **Surface Damage Reinforcement Visible**

Distance (ft): **27.0**
 Structural Grade: **4**
 O&M Grade: **0**
 Clock Start/From: **12**
 Clock To: **1**
 1st Value:
 2nd Value:
 Value Percent:
 Continuous Index:
 Within 8" of Joint: **YES**
 Remarks:

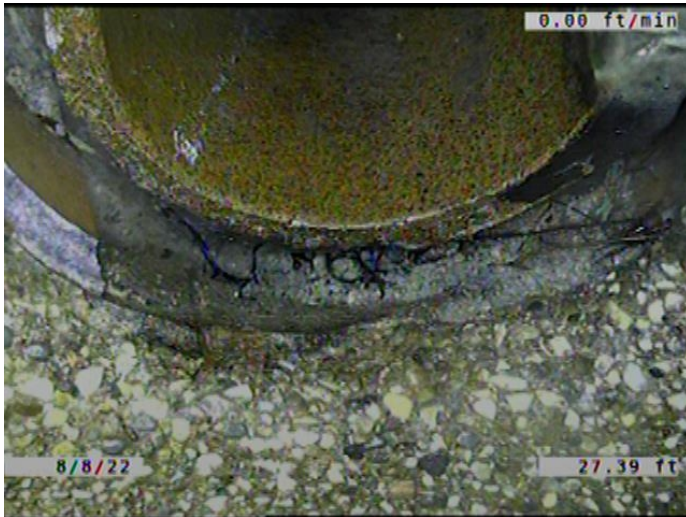
Code: **BSV**
Description: **Broken Soil Visible**

Distance (ft): **27.4**
Structural Grade: **5**
O&M Grade: **0**
Clock Start/From: **2**
Clock To: **4**
1st Value:
2nd Value:
Value Percent:
Continuous Index:
Within 8" of Joint: **YES**
Remarks:

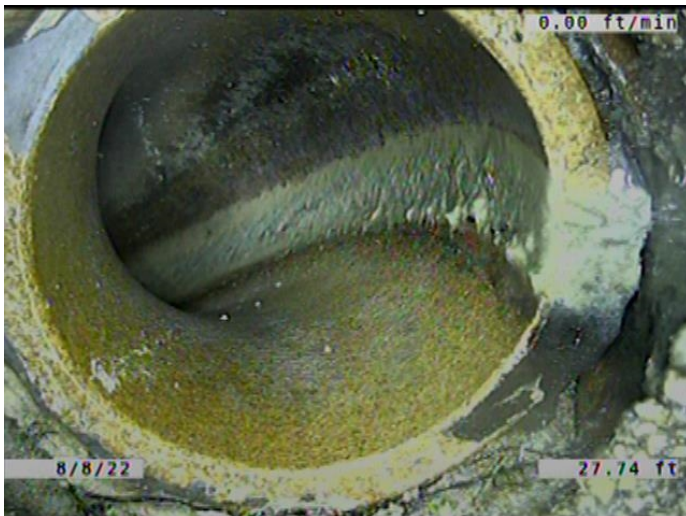
Code: **TBD**
Description: **Tap Break-in/Hammer Defective**

Distance (ft): **27.7**
Structural Grade: **0**
O&M Grade: **3**
Clock Start/From: **3**
Clock To:
1st Value: **6.000**
2nd Value:
Value Percent:
Continuous Index:
Within 8" of Joint: **YES**
Remarks: **CONSTANTLY RUNNING WATER.**

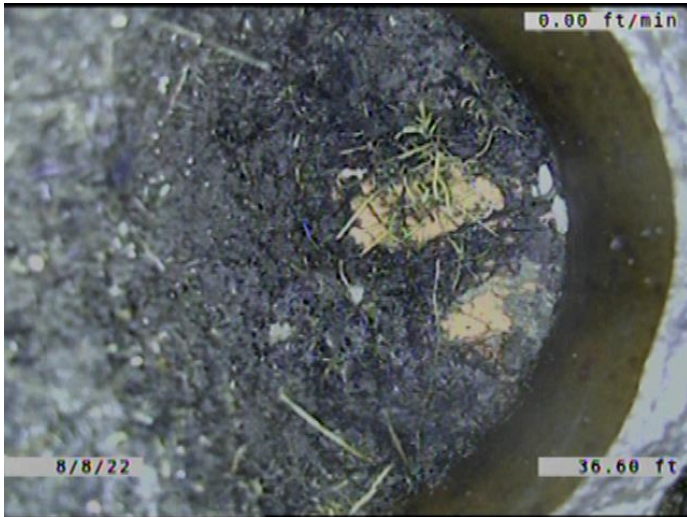
Code:	TBI
Description:	Tap Break-in Intruding
Distance (ft):	36.6
Structural Grade:	0
O&M Grade:	2
Clock Start/From:	9
Clock To:	
1st Value:	6.000
2nd Value:	2.000
Value Percent:	
Continuous Index:	
Within 8" of Joint:	YES
Remarks:	COULD BE CAPPED. CANT TELL FOR SURE. 95% PLUGGED WITH ROOTS.

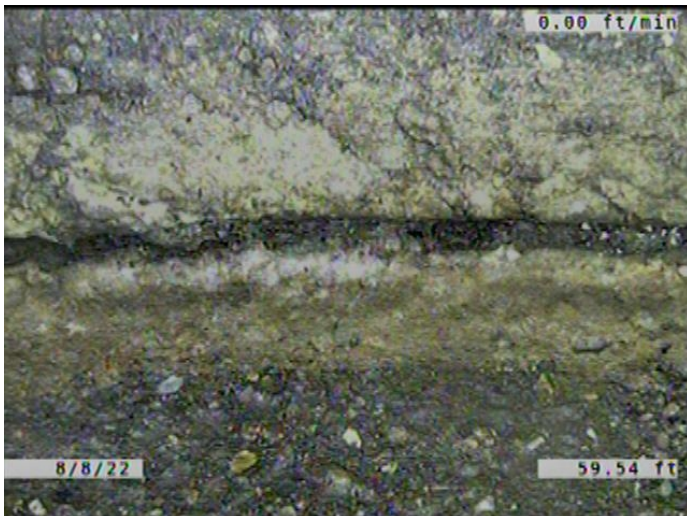
Code:	DAE
Description:	Deposits Attached Encrustation
Distance (ft):	59.5
Structural Grade:	0
O&M Grade:	2
Clock Start/From:	9
Clock To:	3
1st Value:	
2nd Value:	
Value Percent:	5.000
Continuous Index:	
Within 8" of Joint:	YES
Remarks:

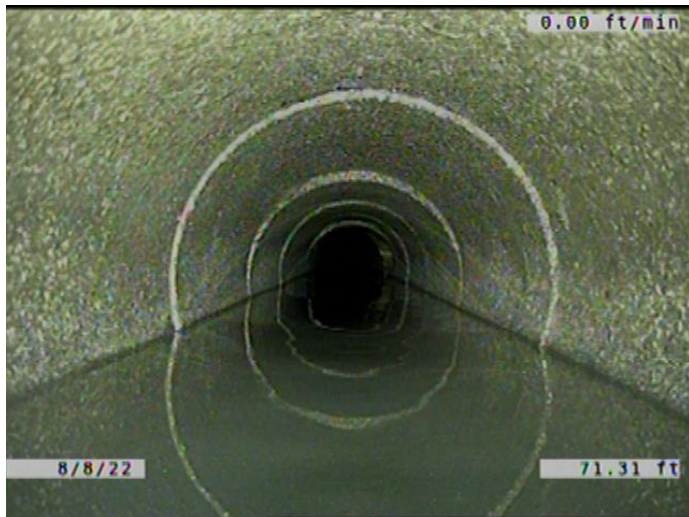
Code: **MWL**
 Description: **Miscellaneous Water Level**

Distance (ft): **71.3**
 Structural Grade: **0**
 O&M Grade: **0**
 Clock Start/From:
 Clock To:
 1st Value:
 2nd Value:
 Value Percent: **30.000**
 Continuous Index:
 Within 8" of Joint: **NO**
 Remarks:

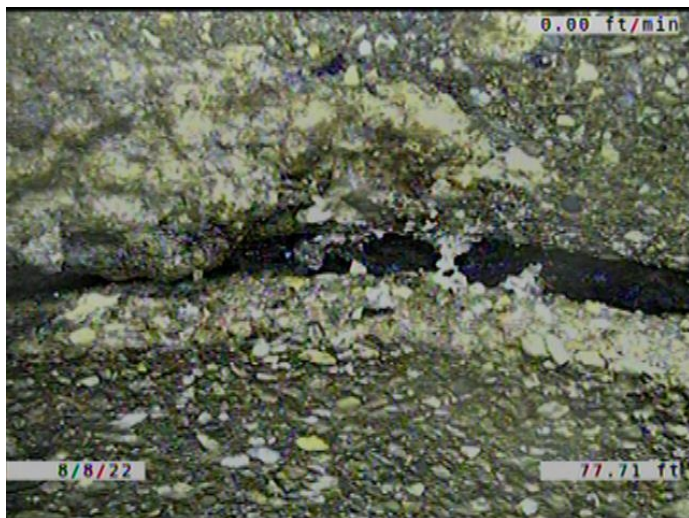
Code: **DAE**
 Description: **Deposits Attached Encrustation**

Distance (ft): **77.7**
 Structural Grade: **0**
 O&M Grade: **2**
 Clock Start/From: **9**
 Clock To: **3**
 1st Value:
 2nd Value:
 Value Percent: **5.000**
 Continuous Index:
 Within 8" of Joint: **YES**
 Remarks:

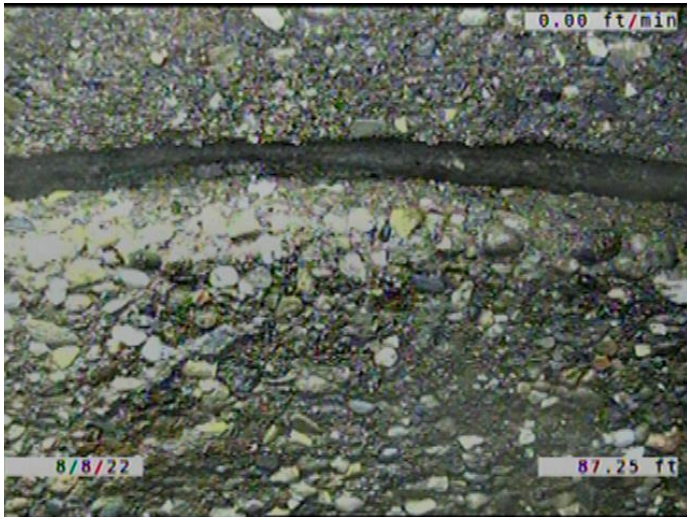
Code: **JOMD**
 Description: **Joint Offset Medium Defective**

Distance (ft): **87.3**
 Structural Grade: **3**
 O&M Grade: **0**
 Clock Start/From:
 Clock To:
 1st Value:
 2nd Value:
 Value Percent:
 Continuous Index:
 Within 8" of Joint: **NO**
 Remarks:

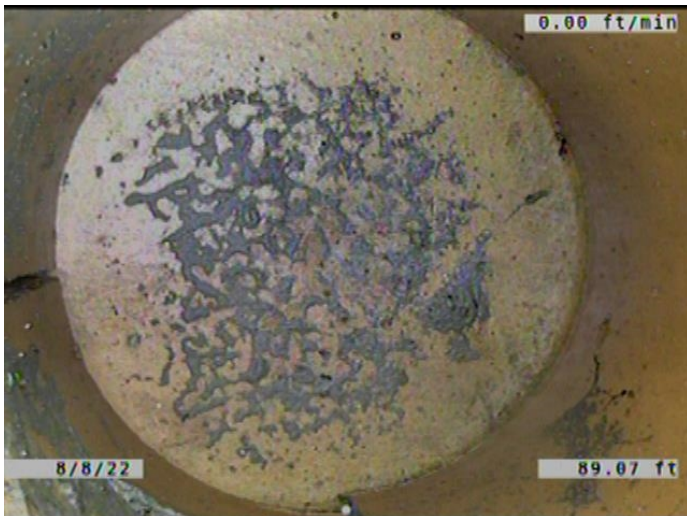
Code: **TBI**
 Description: **Tap Break-in Intruding**

Distance (ft): **89.1**
 Structural Grade: **0**
 O&M Grade: **2**
 Clock Start/From: **3**
 Clock To:
 1st Value: **6.000**
 2nd Value: **2.000**
 Value Percent:
 Continuous Index:
 Within 8" of Joint: **YES**
 Remarks: **TAP BROKEN. CAPPED.**

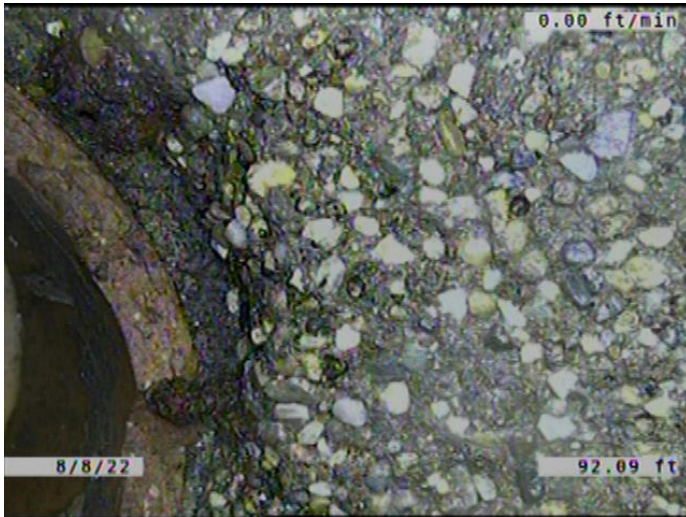
Code: **B**
 Description: **Broken**

Distance (ft): **92.1**
 Structural Grade: **4**
 O&M Grade: **0**
 Clock Start/From: **8**
 Clock To: **10**
 1st Value:
 2nd Value:
 Value Percent:
 Continuous Index:
 Within 8" of Joint: **YES**
 Remarks:

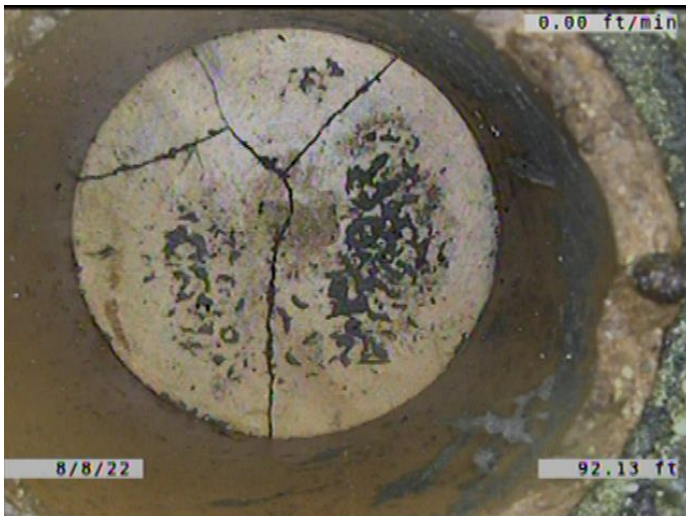
Code: **TBI**
 Description: **Tap Break-in Intruding**

Distance (ft): **92.1**
 Structural Grade: **0**
 O&M Grade: **2**
 Clock Start/From: **9**
 Clock To:
 1st Value: **6.000**
 2nd Value: **1.000**
 Value Percent:
 Continuous Index:
 Within 8" of Joint: **YES**
 Remarks: **CAPPED. CAP BROKEN.**

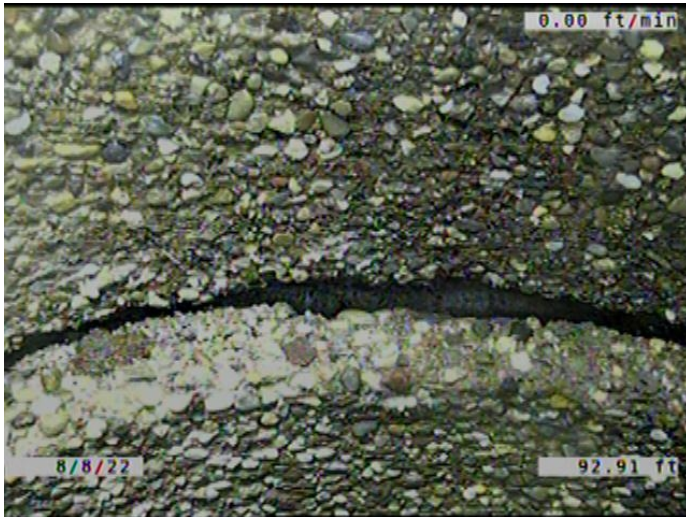
Code: **JOMD**
 Description: **Joint Offset Medium Defective**

Distance (ft): **92.9**
 Structural Grade: **3**
 O&M Grade: **0**
 Clock Start/From:
 Clock To:
 1st Value:
 2nd Value:
 Value Percent:
 Continuous Index:
 Within 8" of Joint: **NO**
 Remarks:

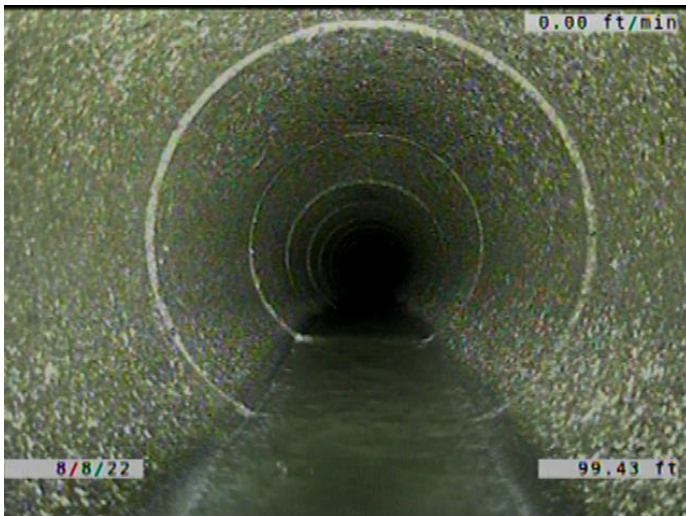
Code: **MWL**
 Description: **Miscellaneous Water Level**

Distance (ft): **99.4**
 Structural Grade: **0**
 O&M Grade: **0**
 Clock Start/From:
 Clock To:
 1st Value:
 2nd Value:
 Value Percent: **5.000**
 Continuous Index:
 Within 8" of Joint: **NO**
 Remarks:

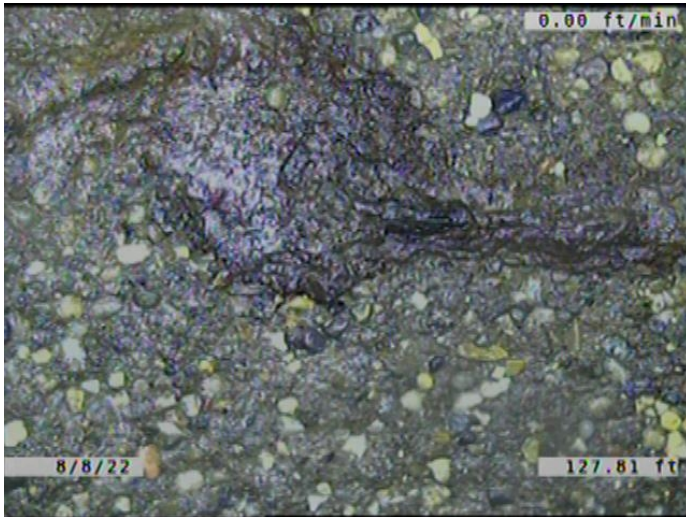
Code: **DAE**
Description: **Deposits Attached Encrustation**

Distance (ft): **127.8**
Structural Grade: **0**
O&M Grade: **2**
Clock Start/From: **10**
Clock To: **11**
1st Value:
2nd Value:
Value Percent: **5.000**
Continuous Index:
Within 8" of Joint: **YES**
Remarks:

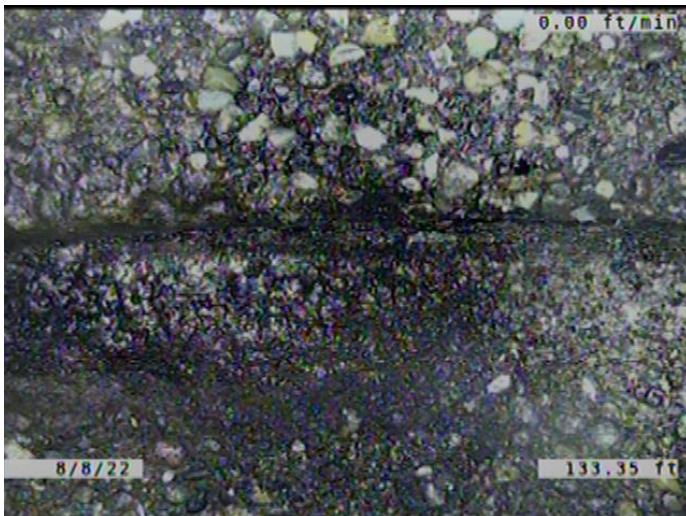
Code: **DAE**
Description: **Deposits Attached Encrustation**

Distance (ft): **133.3**
Structural Grade: **0**
O&M Grade: **2**
Clock Start/From: **7**
Clock To: **9**
1st Value:
2nd Value:
Value Percent: **5.000**
Continuous Index:
Within 8" of Joint: **YES**
Remarks:

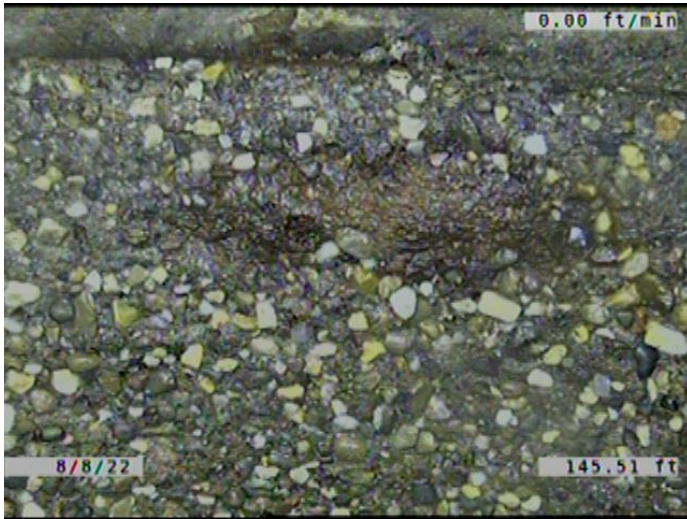
Code: **DAE**
 Description: **Deposits Attached Encrustation**

Distance (ft): **145.5**
 Structural Grade: **0**
 O&M Grade: **2**
 Clock Start/From: **1**
 Clock To: **2**
 1st Value:
 2nd Value:
 Value Percent: **5.000**
 Continuous Index:
 Within 8" of Joint: **YES**
 Remarks:

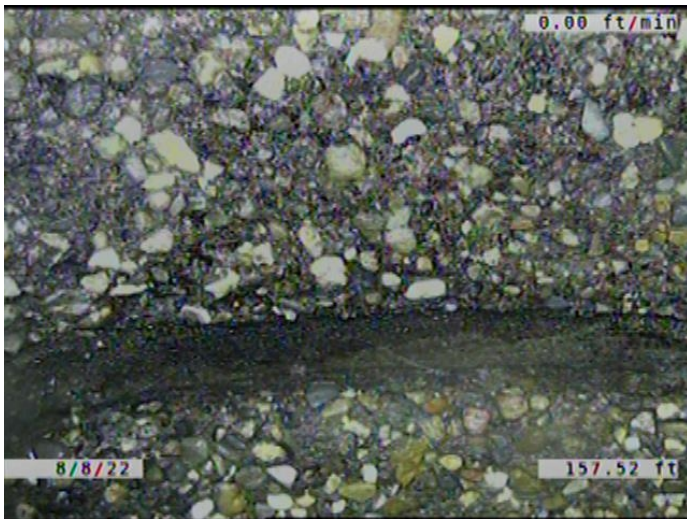
Code: **JSM**
 Description: **Joint Separated Medium**

Distance (ft): **157.5**
 Structural Grade: **3**
 O&M Grade: **0**
 Clock Start/From:
 Clock To:
 1st Value:
 2nd Value:
 Value Percent:
 Continuous Index:
 Within 8" of Joint: **NO**
 Remarks:

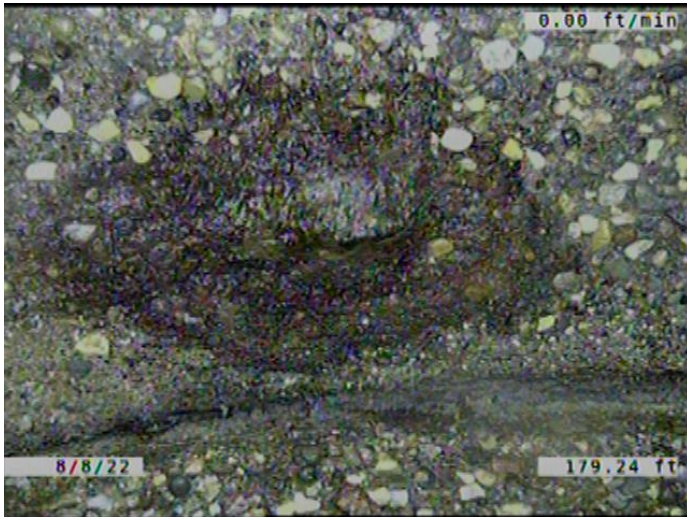
Code: **DAE**
 Description: **Deposits Attached Encrustation**

Distance (ft): **179.2**
 Structural Grade: **0**
 O&M Grade: **2**
 Clock Start/From: **9**
 Clock To: **10**
 1st Value:
 2nd Value:
 Value Percent: **5.000**
 Continuous Index:
 Within 8" of Joint: **YES**
 Remarks:

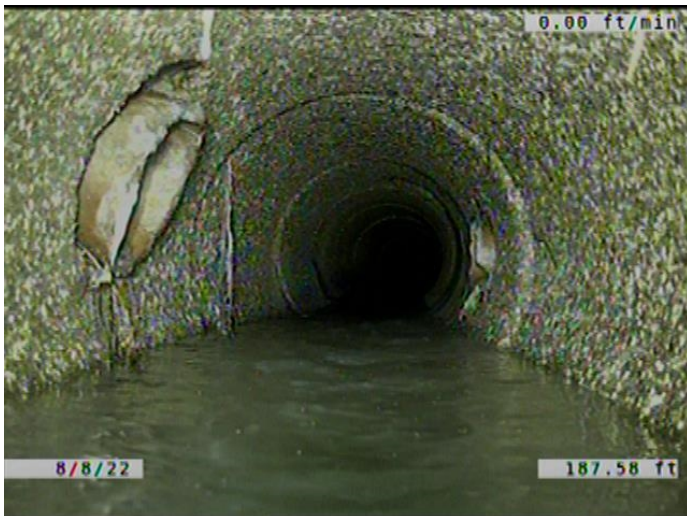
Code: **MWLS**
 Description: **Miscellaneous Water Level Sag**

Distance (ft): **187.6**
 Structural Grade: **2**
 O&M Grade: **0**
 Clock Start/From:
 Clock To:
 1st Value:
 2nd Value:
 Value Percent: **15.000**
 Continuous Index:
 Within 8" of Joint: **NO**
 Remarks:

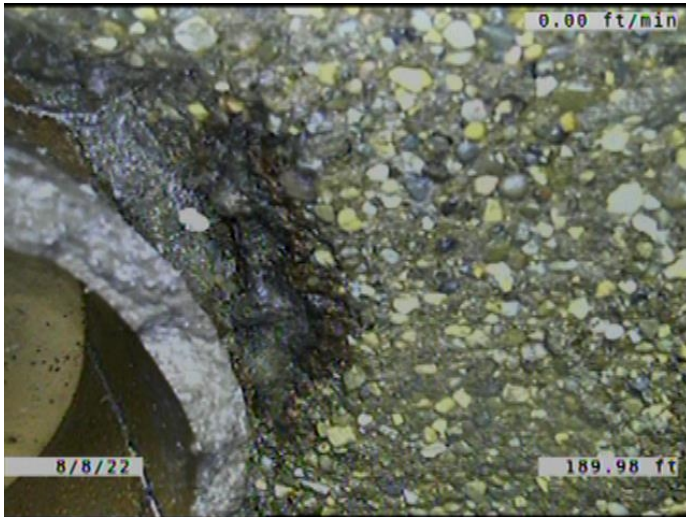
Code: **B**
Description: **Broken**

Distance (ft): **190.0**
Structural Grade: **4**
O&M Grade: **0**
Clock Start/From: **9**
Clock To: **11**
1st Value:
2nd Value:
Value Percent:
Continuous Index:
Within 8" of Joint: **YES**
Remarks:

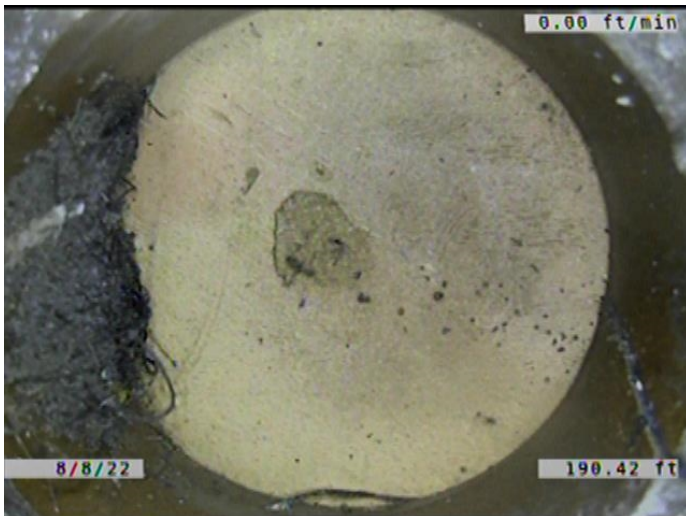
Code: **TBI**
Description: **Tap Break-in Intruding**

Distance (ft): **190.4**
Structural Grade: **0**
O&M Grade: **2**
Clock Start/From: **10**
Clock To:
1st Value: **6.000**
2nd Value: **1.000**
Value Percent:
Continuous Index:
Within 8" of Joint: **YES**
Remarks: **CAPPED.**

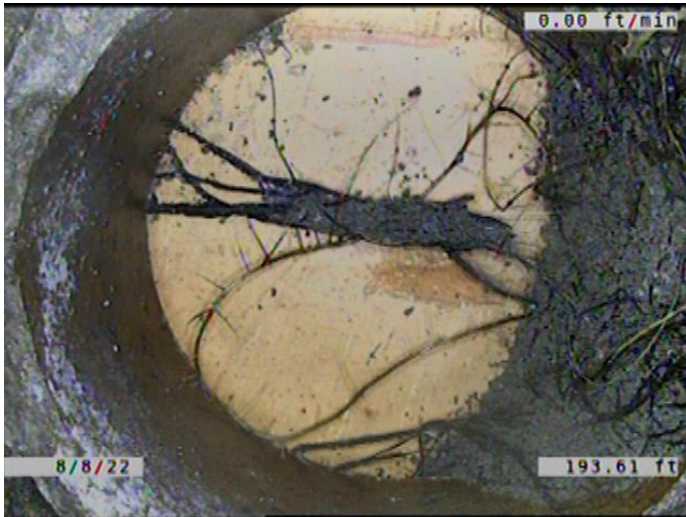
Code: **TBI**
 Description: **Tap Break-in Intruding**

Distance (ft): **193.6**
 Structural Grade: **0**
 O&M Grade: **2**
 Clock Start/From: **2**
 Clock To:
 1st Value: **6.000**
 2nd Value: **1.000**
 Value Percent:
 Continuous Index:
 Within 8" of Joint: **YES**
 Remarks: **CAPPED. ROOTS GROWING AROUND THE CAP.**

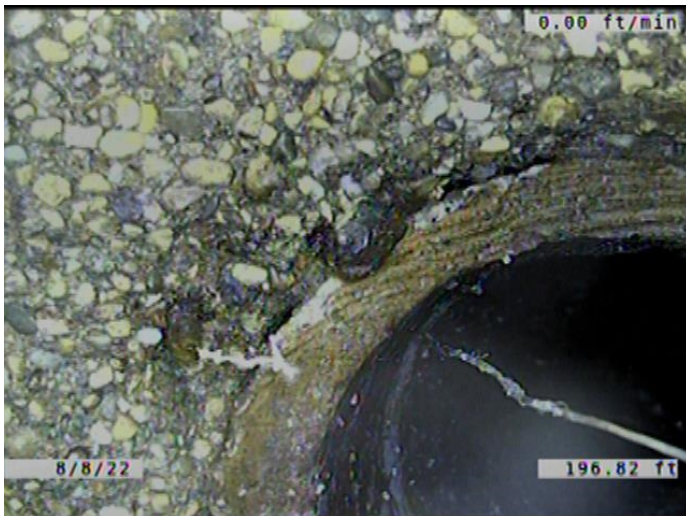
Code: **SRP**
 Description: **Surface Damage Reinforcement Projecting**

Distance (ft): **196.8**
 Structural Grade: **5**
 O&M Grade: **0**
 Clock Start/From: **12**
 Clock To: **1**
 1st Value:
 2nd Value:
 Value Percent:
 Continuous Index:
 Within 8" of Joint: **YES**
 Remarks:

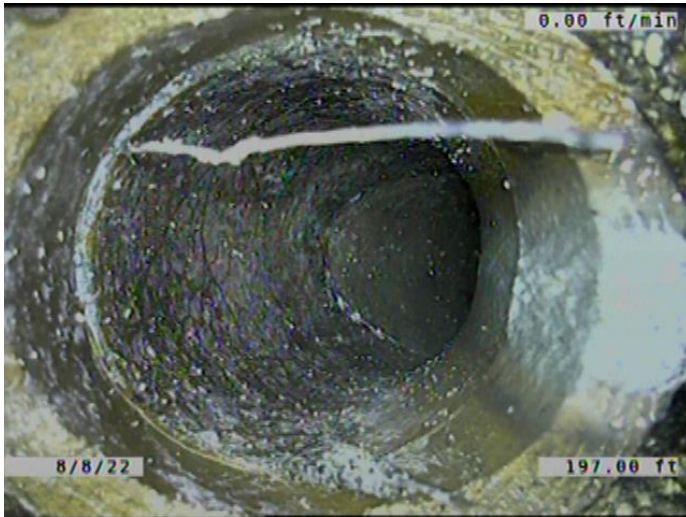
Code: **TBD**
Description: **Tap Break-in/Hammer Defective**

Distance (ft): **197.0**
Structural Grade: **0**
O&M Grade: **3**
Clock Start/From: **1**
Clock To:
1st Value: **6.000**
2nd Value:
Value Percent:
Continuous Index:
Within 8" of Joint: **YES**
Remarks: **CONSTANTLY RUNNING WATER.**

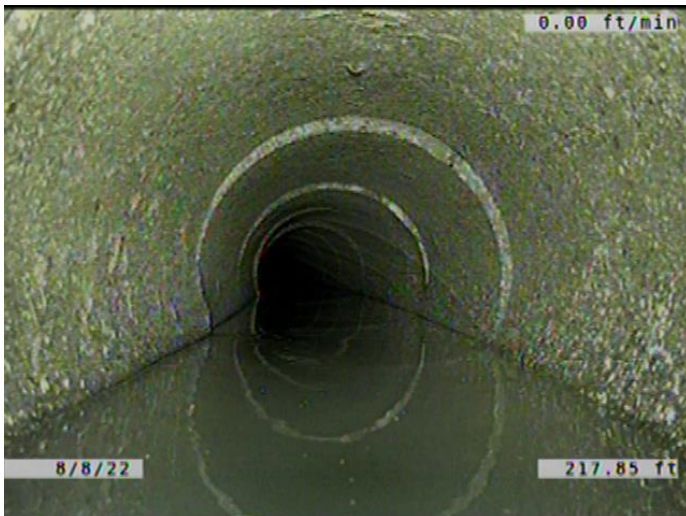
Code: **MWL**
Description: **Miscellaneous Water Level**

Distance (ft): **217.9**
Structural Grade: **0**
O&M Grade: **0**
Clock Start/From:
Clock To:
1st Value:
2nd Value:
Value Percent: **25.000**
Continuous Index:
Within 8" of Joint: **NO**
Remarks:

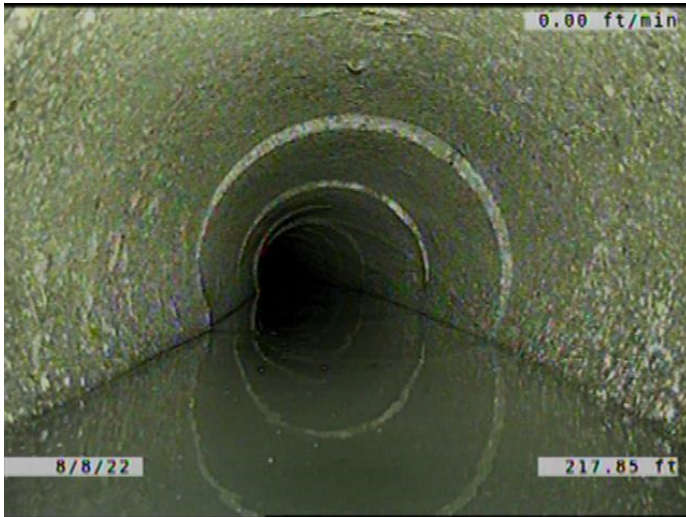
Code: **LL**
 Description: **Line Left**

Distance (ft): **217.9**
 Structural Grade: **0**
 O&M Grade: **1**
 Clock Start/From:
 Clock To:
 1st Value:
 2nd Value:
 Value Percent: **10.000**
 Continuous Index:
 Within 8" of Joint: **NO**
 Remarks:

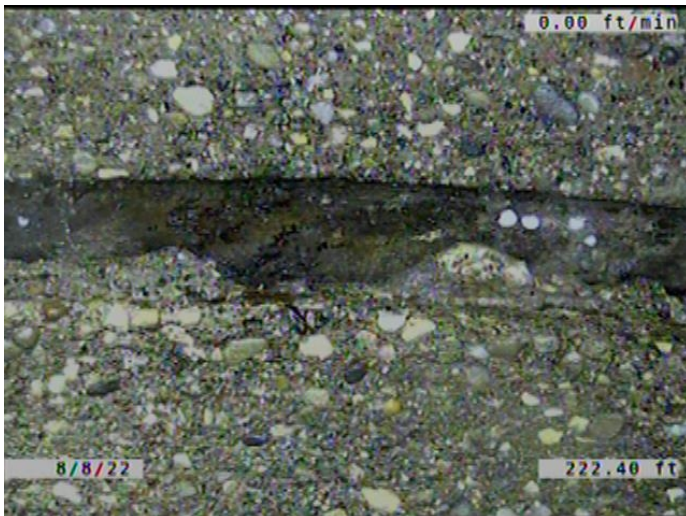
Code: **JAM**
 Description: **Joint Angular Medium**

Distance (ft): **222.4**
 Structural Grade: **3**
 O&M Grade: **0**
 Clock Start/From:
 Clock To:
 1st Value:
 2nd Value:
 Value Percent:
 Continuous Index:
 Within 8" of Joint: **NO**
 Remarks:

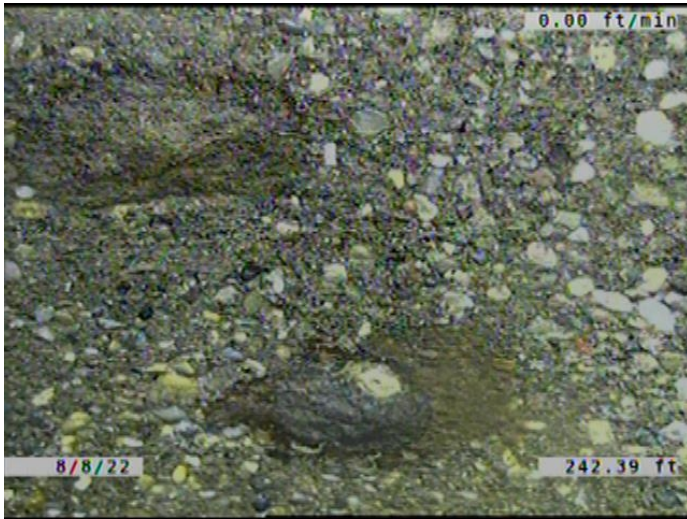
Code: **DAE**
Description: **Deposits Attached Encrustation**

Distance (ft): **242.4**
Structural Grade: **0**
O&M Grade: **2**
Clock Start/From: **11**
Clock To:
1st Value:
2nd Value:
Value Percent: **5.000**
Continuous Index:
Within 8" of Joint: **YES**
Remarks:

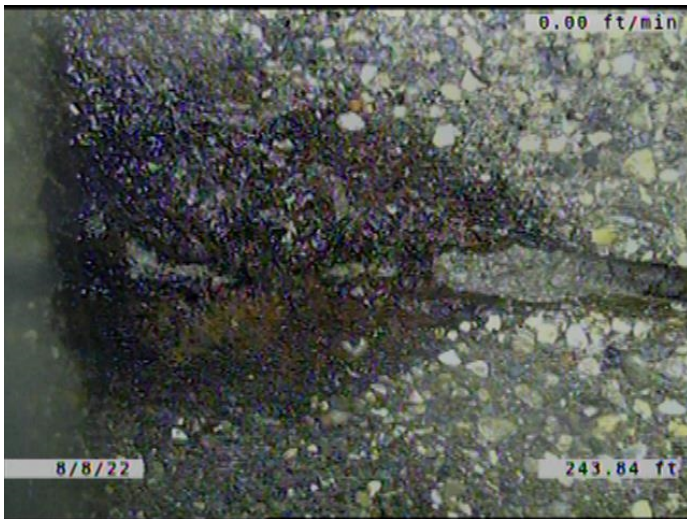
Code: **DAE**
Description: **Deposits Attached Encrustation**

Distance (ft): **243.8**
Structural Grade: **0**
O&M Grade: **2**
Clock Start/From: **8**
Clock To: **4**
1st Value:
2nd Value:
Value Percent: **5.000**
Continuous Index:
Within 8" of Joint: **YES**
Remarks:

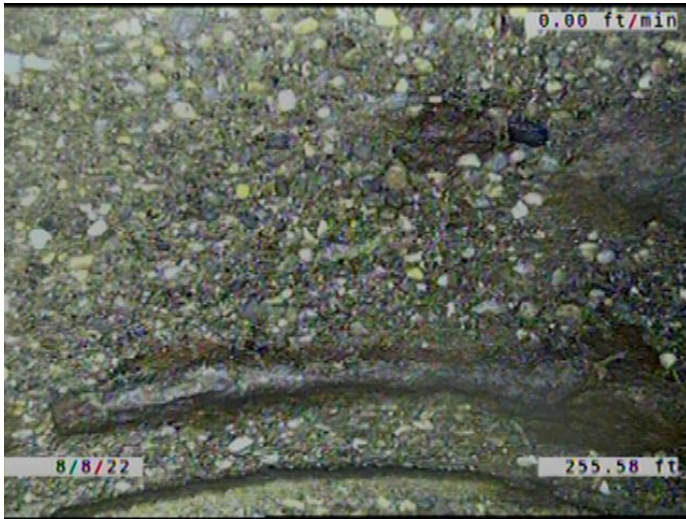
Code: **SRP**
 Description: **Surface Damage Reinforcement Projecting**

Distance (ft): **255.6**
 Structural Grade: **5**
 O&M Grade: **0**
 Clock Start/From: **2**
 Clock To: **4**
 1st Value:
 2nd Value:
 Value Percent:
 Continuous Index:
 Within 8" of Joint: **YES**
 Remarks:

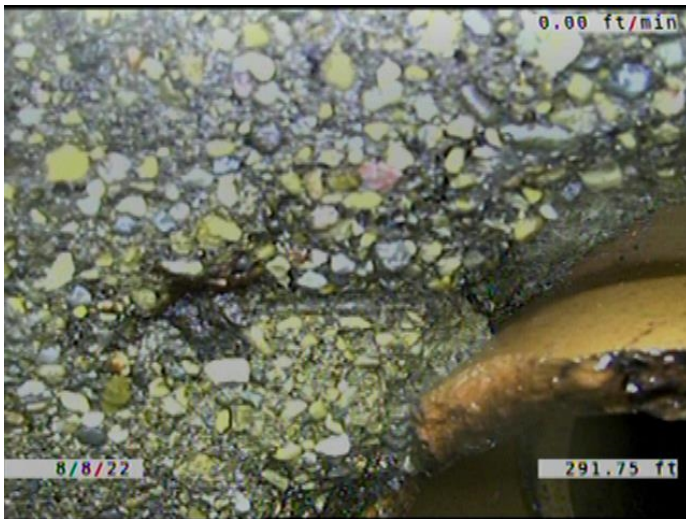
Code: **B**
 Description: **Broken**

Distance (ft): **291.7**
 Structural Grade: **4**
 O&M Grade: **0**
 Clock Start/From: **11**
 Clock To: **3**
 1st Value:
 2nd Value:
 Value Percent:
 Continuous Index:
 Within 8" of Joint: **YES**
 Remarks:

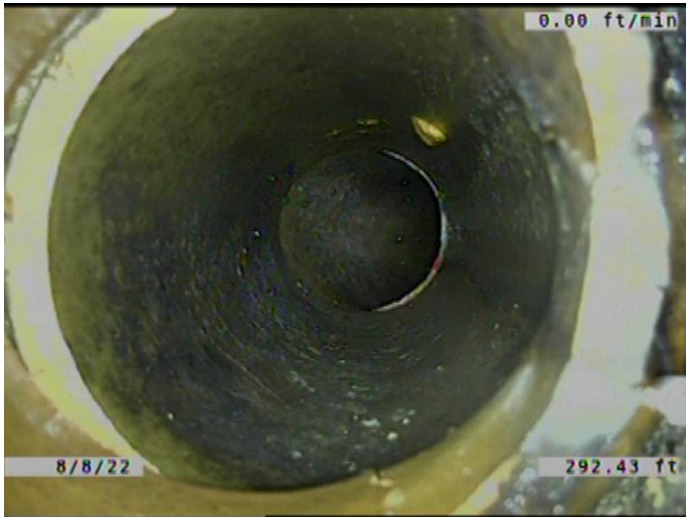
Code: **TBI**
Description: **Tap Break-in Intruding**

Distance (ft): **292.4**
Structural Grade: **0**
O&M Grade: **2**
Clock Start/From: **1**
Clock To:
1st Value: **6.000**
2nd Value: **2.000**
Value Percent:
Continuous Index:
Within 8" of Joint: **YES**
Remarks: **TAP BROKEN. CONSTANTLY DRIPPING WATER.**

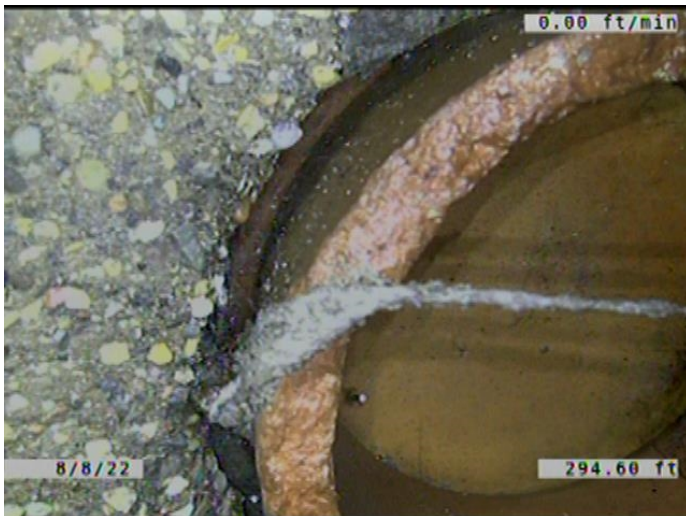
Code: **B**
Description: **Broken**

Distance (ft): **294.6**
Structural Grade: **4**
O&M Grade: **0**
Clock Start/From: **2**
Clock To: **4**
1st Value:
2nd Value:
Value Percent:
Continuous Index:
Within 8" of Joint: **YES**
Remarks:

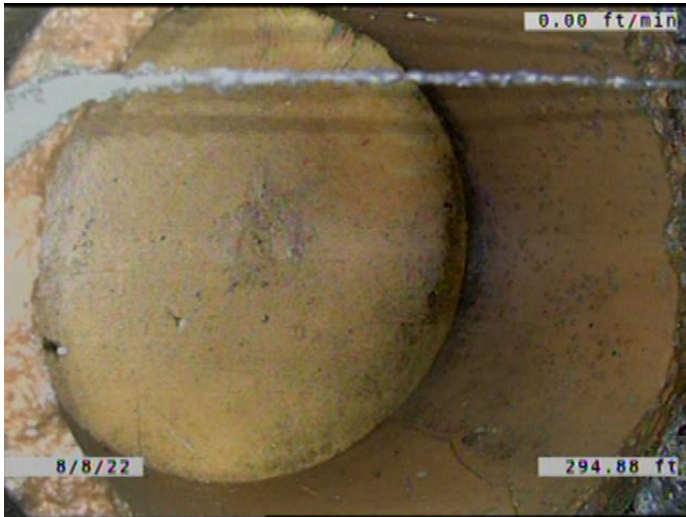
Code: **TBI**
 Description: **Tap Break-in Intruding**

Distance (ft): **294.9**
 Structural Grade: **0**
 O&M Grade: **2**
 Clock Start/From: **3**
 Clock To:
 1st Value: **6.000**
 2nd Value: **1.000**
 Value Percent:
 Continuous Index:
 Within 8" of Joint: **YES**
 Remarks: **TAP CRACKED. CAPPED.**

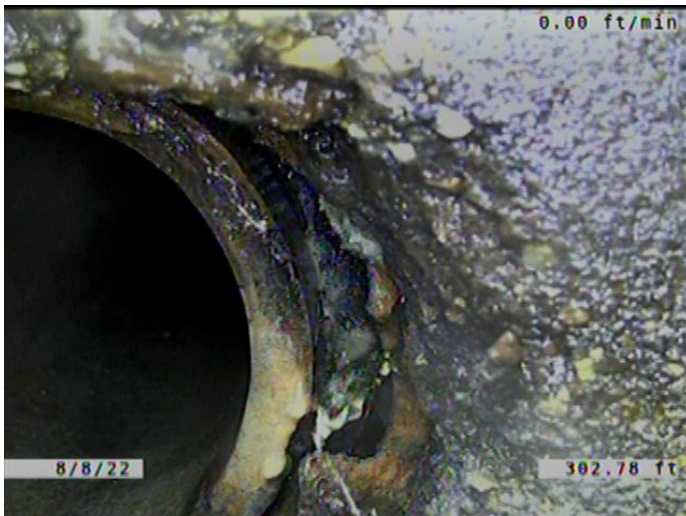
Code: **BVV**
 Description: **Broken Void Visible**

Distance (ft): **302.8**
 Structural Grade: **5**
 O&M Grade: **0**
 Clock Start/From: **1**
 Clock To:
 1st Value:
 2nd Value:
 Value Percent:
 Continuous Index:
 Within 8" of Joint: **YES**
 Remarks:

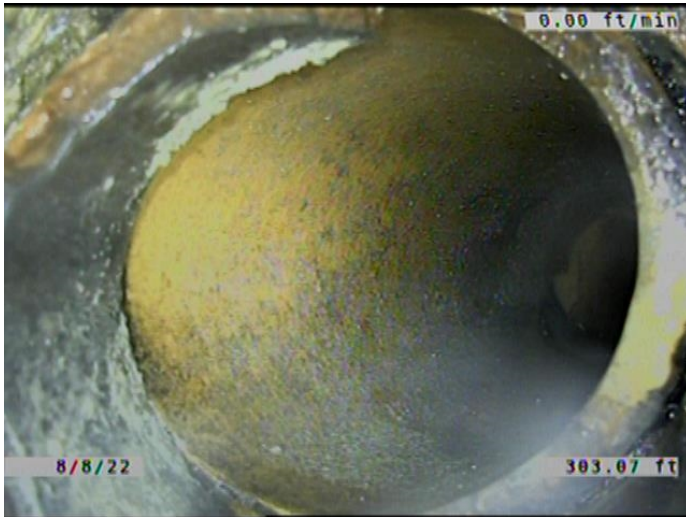
Code: **TBD**
 Description: **Tap Break-in/Hammer Defective**

Distance (ft): **303.1**
 Structural Grade: **0**
 O&M Grade: **3**
 Clock Start/From: **12**
 Clock To:
 1st Value: **6.000**
 2nd Value:
 Value Percent:
 Continuous Index:
 Within 8" of Joint: **YES**
 Remarks: **TAP BROKEN. AND MISSING PART OF IT.**

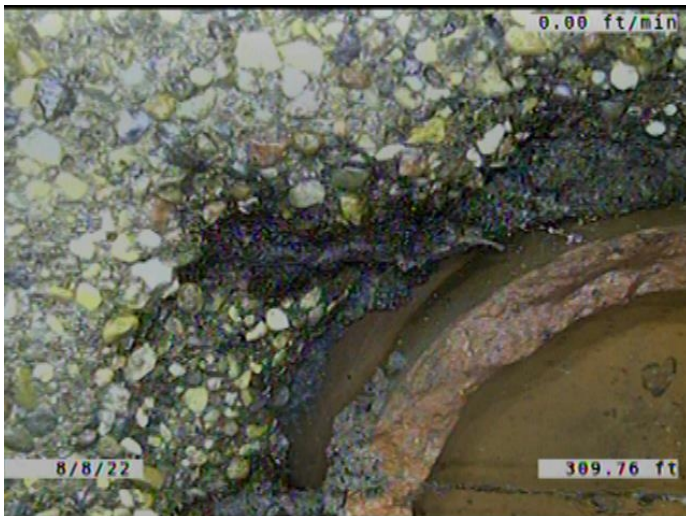
Code: **SSS**
 Description: **Surface Damage Surface Spalling**

Distance (ft): **309.8**
 Structural Grade: **2**
 O&M Grade: **0**
 Clock Start/From: **2**
 Clock To: **4**
 1st Value:
 2nd Value:
 Value Percent:
 Continuous Index:
 Within 8" of Joint: **YES**
 Remarks:

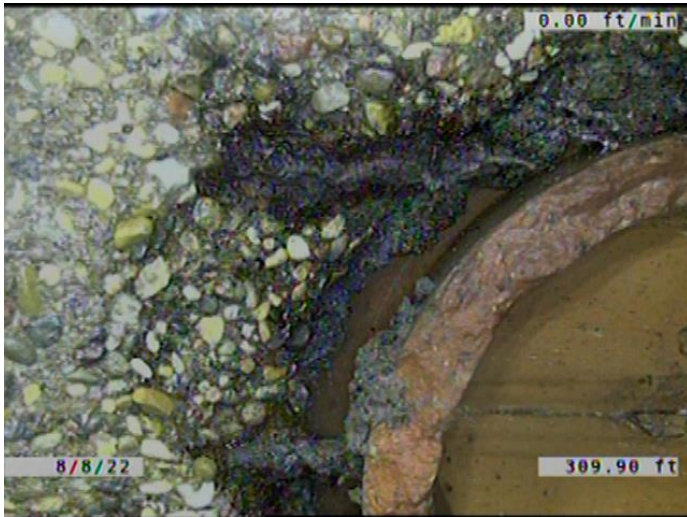
Code: **SRP**
 Description: **Surface Damage Reinforcement Projecting**

Distance (ft): **309.9**
 Structural Grade: **5**
 O&M Grade: **0**
 Clock Start/From: **2**
 Clock To: **3**
 1st Value:
 2nd Value:
 Value Percent:
 Continuous Index:
 Within 8" of Joint: **YES**
 Remarks:

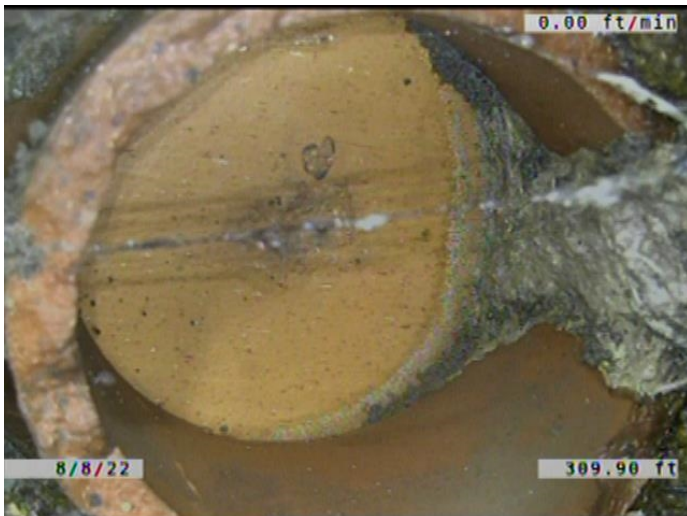
Code: **TBD**
 Description: **Tap Break-in/Hammer Defective**

Distance (ft): **309.9**
 Structural Grade: **0**
 O&M Grade: **3**
 Clock Start/From: **3**
 Clock To:
 1st Value: **6.000**
 2nd Value:
 Value Percent:
 Continuous Index:
 Within 8" of Joint: **YES**
 Remarks: **CAPPED. ENCRUSTATION COMING AROUND THE CAP INTO THE MAIN.**

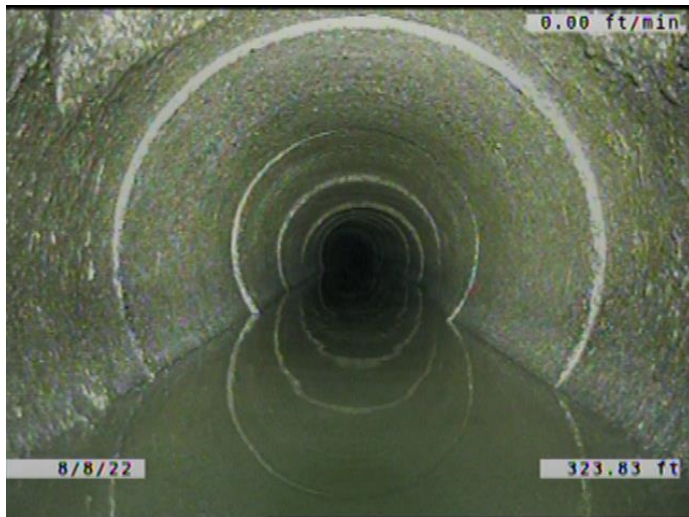
Code: **RMJ**
 Description: **Roots Medium Joint**

Distance (ft): **323.8**
 Structural Grade: **0**
 O&M Grade: **3**
 Clock Start/From: **8**
 Clock To: **4**
 1st Value:
 2nd Value:
 Value Percent: **5.000**
 Continuous Index: **F01**
 Within 8" of Joint: **YES**
 Remarks:

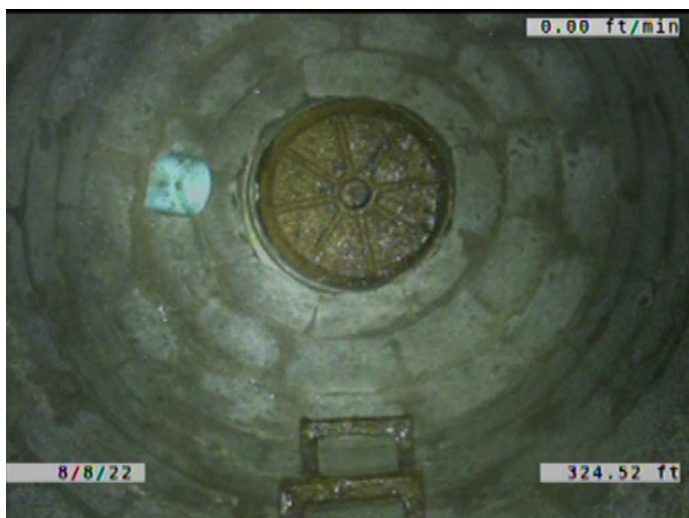
Code: **AMH**
 Description: **Manhole**

Distance (ft): **324.5**
 Structural Grade: **0**
 O&M Grade: **0**
 Clock Start/From:
 Clock To:
 1st Value:
 2nd Value:
 Value Percent:
 Continuous Index:
 Within 8" of Joint: **NO**
 Remarks: **M-505-095**
