## Profile/Photo Observation Report

Street:	<b>W 4TH PL</b>	Flow Control:	<b>Not Controlled</b>
City:	<b>Hobart, IN</b>	Year Renewed:	
Location:	<b>Yard</b>	Tape/Media #:	
Purpose:	<b>Routine Assessment</b>	Dia/Height:	<b>10"</b>
Use:	<b>Sanitary</b>	Material:	<b>VCP</b>
Drain Area:	<b>NA</b>	Lining:	
Category:	<b>NA</b>		
Comment:

Location Details:		Direction of Survey:	<b>Upstream</b>
US MH:	<b>M-505-097</b>	DS MH:	<b>M-505-079</b>
		Total Length Surveyed (ft):	<b>93.9</b>

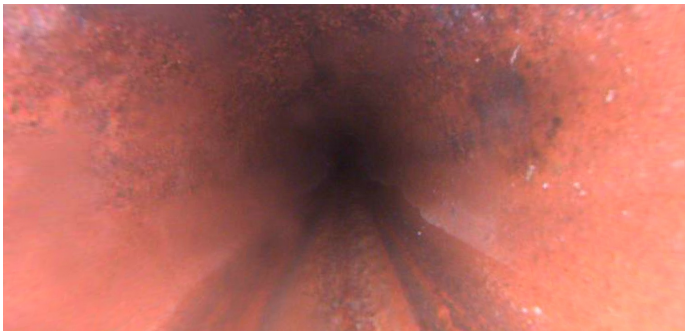
Code: **AMH**  
Description: **Manhole**

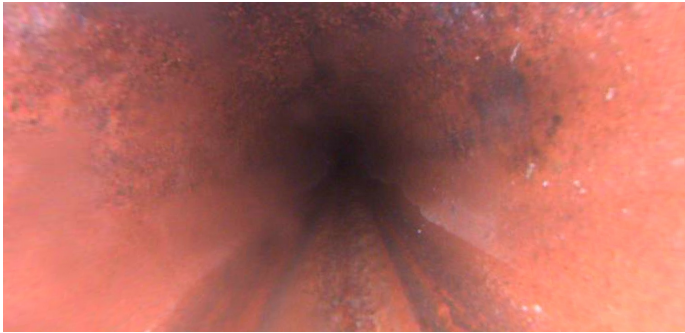
Code:	<b>MWL</b>
Description:	<b>Water Level</b>

Distance (ft):	<b>.0</b>
Structural Grade:	<b>0</b>
O&M Grade:	<b>0</b>
Clock Start/From:	
Clock To:	
1st Value:	
2nd Value:	
Value Percent:	<b>5.000</b>
Continuous Index:	
Within 8" of Joint:	<b>NO</b>
Remarks:

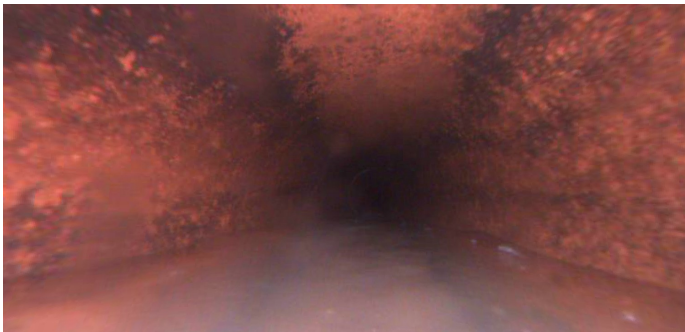
Code:	<b>MWL</b>
Description:	<b>Water Level</b>

Distance (ft):	<b>21.0</b>
Structural Grade:	<b>0</b>
O&M Grade:	<b>0</b>
Clock Start/From:	
Clock To:	
1st Value:	
2nd Value:	
Value Percent:	<b>40.000</b>
Continuous Index:	
Within 8" of Joint:	<b>NO</b>
Remarks:

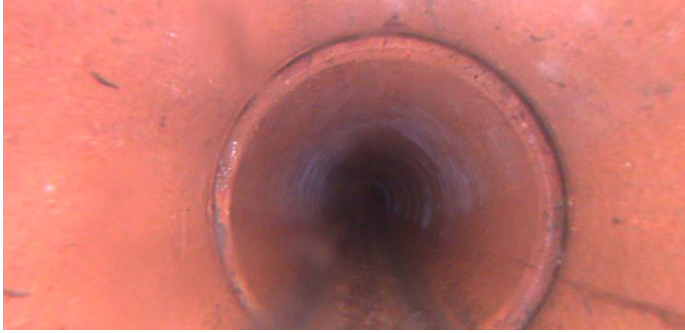
Code: **MWL**  
Description: **Water Level**

Distance (ft): **33.9**  
Structural Grade: **0**  
O&M Grade: **0**  
Clock Start/From:  
Clock To:  
1st Value:  
2nd Value:  
Value Percent: **5.000**  
Continuous Index:  
Within 8" of Joint: **NO**  
Remarks:

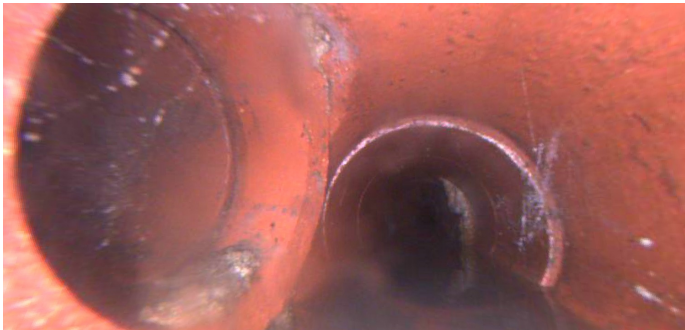
Code: **TBI**  
Description: **Tap Break-in Intruding**

Distance (ft): **45.5**  
Structural Grade: **0**  
O&M Grade: **2**  
Clock Start/From: **9**  
Clock To:  
1st Value: **4.000**  
2nd Value: **1.000**  
Value Percent:  
Continuous Index:  
Within 8" of Joint:  
Remarks:

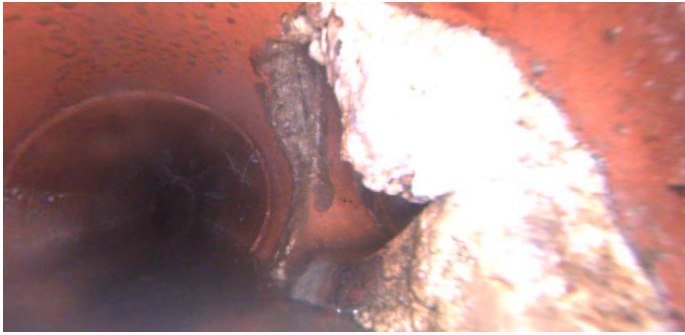
Code: **TFD**  
Description: **Tap Factory Defective**

Distance (ft): **47.4**  
Structural Grade: **0**  
O&M Grade: **2**  
Clock Start/From: **3**  
Clock To:  
1st Value: **4.000**  
2nd Value:  
Value Percent:  
Continuous Index:  
Within 8" of Joint:  
Remarks: **dae**

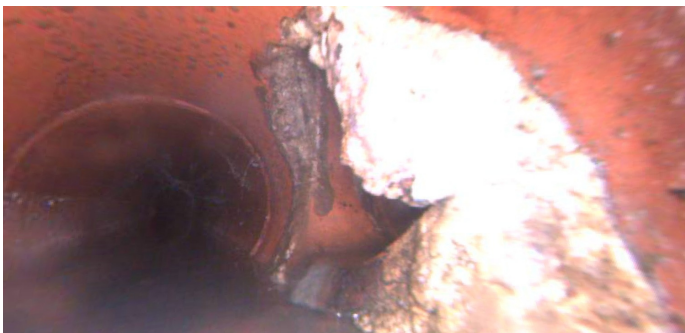
Code: **DAE**  
Description: **Deposits Attached Encrustation**

Distance (ft): **47.4**  
Structural Grade: **0**  
O&M Grade: **2**  
Clock Start/From: **1**  
Clock To: **4**  
1st Value:  
2nd Value:  
Value Percent: **10.000**  
Continuous Index:  
Within 8" of Joint: **NO**  
Remarks:

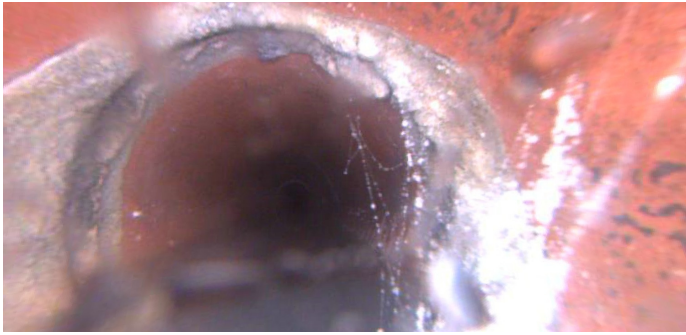
Code: **DAE**  
Description: **Deposits Attached Encrustation**

Distance (ft): **52.9**  
Structural Grade: **0**  
O&M Grade: **2**  
Clock Start/From: **8**  
Clock To: **4**  
1st Value:  
2nd Value:  
Value Percent: **10.000**  
Continuous Index:  
Within 8" of Joint: **YES**  
Remarks:

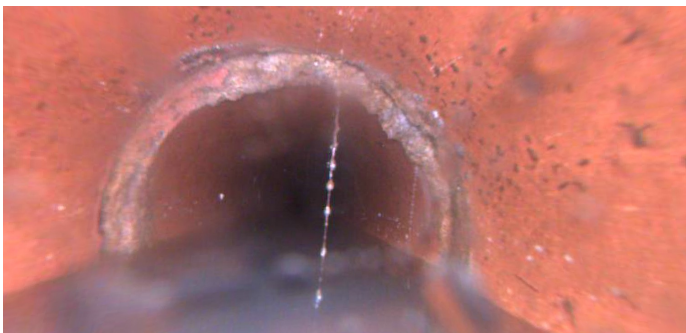
Code: **DAE**  
Description: **Deposits Attached Encrustation**

Distance (ft): **57.8**  
Structural Grade: **0**  
O&M Grade: **2**  
Clock Start/From: **8**  
Clock To: **4**  
1st Value:  
2nd Value:  
Value Percent: **5.000**  
Continuous Index:  
Within 8" of Joint: **YES**  
Remarks:

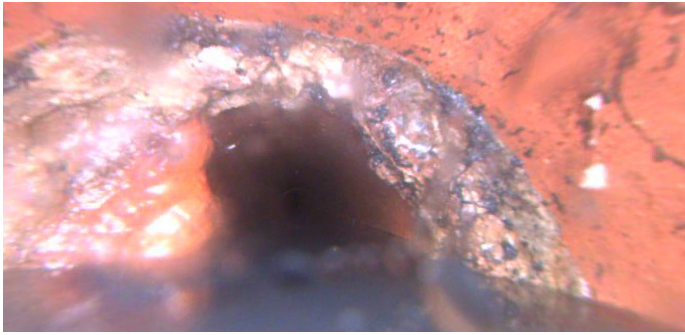
Code: **DAE**  
Description: **Deposits Attached Encrustation**

Distance (ft): **92.7**  
Structural Grade: **0**  
O&M Grade: **5**  
Clock Start/From: **8**  
Clock To: **4**  
1st Value:  
2nd Value:  
Value Percent: **40.000**  
Continuous Index:  
Within 8" of Joint: **YES**  
Remarks:

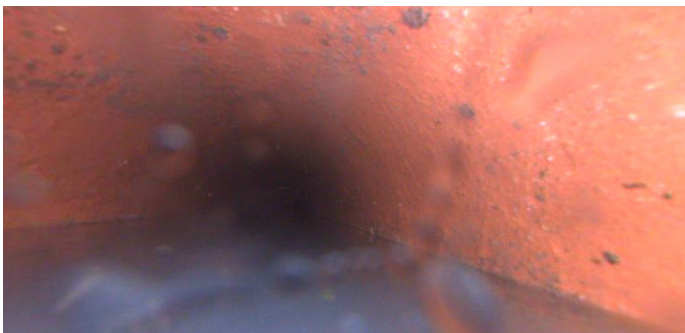
Code: **MSA**  
Description: **Abandoned Survey**

Distance (ft): **93.9**  
Structural Grade: **0**  
O&M Grade: **0**  
Clock Start/From:  
Clock To:  
1st Value:  
2nd Value:  
Value Percent:  
Continuous Index:  
Within 8" of Joint: **NO**  
Remarks: **DAE**
