Profile/Photo Observation Report

Date:	04/14/2018	Weather:		Coding:	PACP 6.0
Pipe Length (ft):	247.2	Owner:	NA	Pre Clean:	No Pre-Cleaning
P.O.#:		Surveyor:	Jen Costello	PSR:	P-505-097-079
Customer:		Clean Date:	01/01/1900	Shape:	C

Street:	FOXCROFT STREET	Flow Control:	Not Controlled
City:	Hobart, IN	Year Renewed:	
Location:	Yard	Tape/Media #:	
Purpose:	Routine Assessment	Dia/Height:	10"
Use:	Sanitary	Material:	VCP
Drain Area:	NA	Lining:	
Category:	NA		
Comment:

Location Details:		Direction of Survey:	Upstream
US MH:	M-505-097	DS MH:	M-505-079
		Total Length Surveyed (ft):	93.9

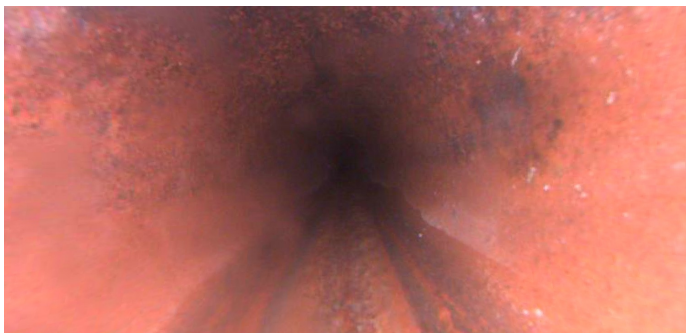
Code: **AMH**
Description: **Manhole**

Distance (ft): **.0**
Structural Grade: **0**
O&M Grade: **0**
Clock Start/From:
Clock To:
1st Value:
2nd Value:
Value Percent:
Continuous Index:
Within 8" of Joint: **NO**
Remarks: **M-505-079**

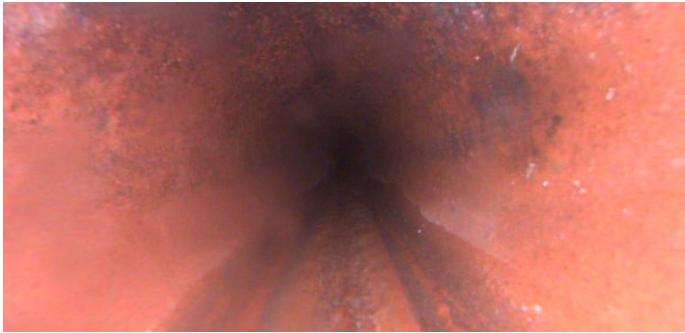
Code:	MWL
Description:	Water Level

Distance (ft):	.0
Structural Grade:	0
O&M Grade:	0
Clock Start/From:	
Clock To:	
1st Value:	
2nd Value:	
Value Percent:	5.000
Continuous Index:	
Within 8" of Joint:	NO
Remarks:

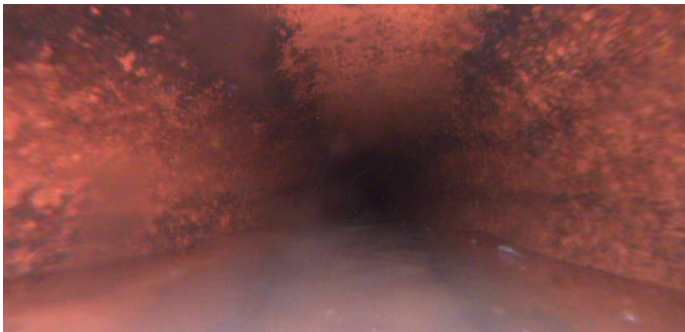
Code:	MWL
Description:	Water Level

Distance (ft):	21.0
Structural Grade:	0
O&M Grade:	0
Clock Start/From:	
Clock To:	
1st Value:	
2nd Value:	
Value Percent:	40.000
Continuous Index:	
Within 8" of Joint:	NO
Remarks:

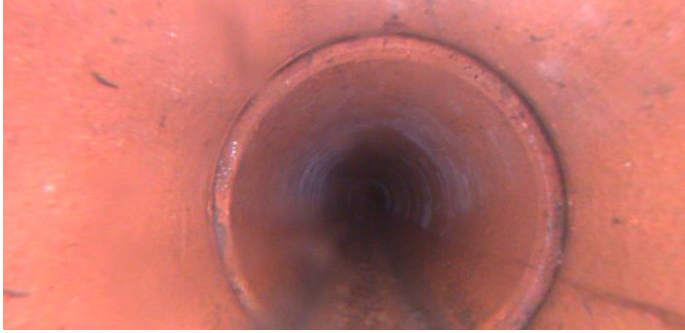
Code: **MWL**
Description: **Water Level**

Distance (ft): **33.9**
Structural Grade: **0**
O&M Grade: **0**
Clock Start/From:
Clock To:
1st Value:
2nd Value:
Value Percent: **5.000**
Continuous Index:
Within 8" of Joint: **NO**
Remarks:

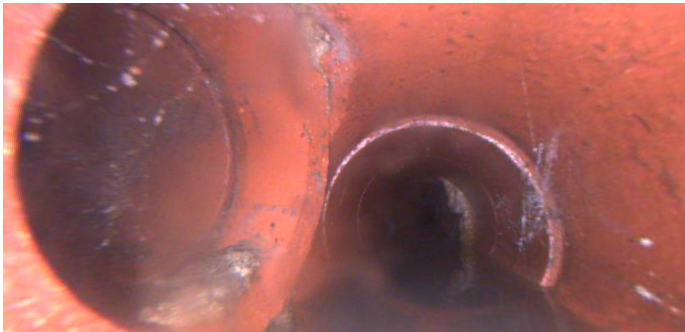
Code: **TBI**
Description: **Tap Break-in Intruding**

Distance (ft): **45.5**
Structural Grade: **0**
O&M Grade: **2**
Clock Start/From: **9**
Clock To:
1st Value: **4.000**
2nd Value: **1.000**
Value Percent:
Continuous Index:
Within 8" of Joint:
Remarks:

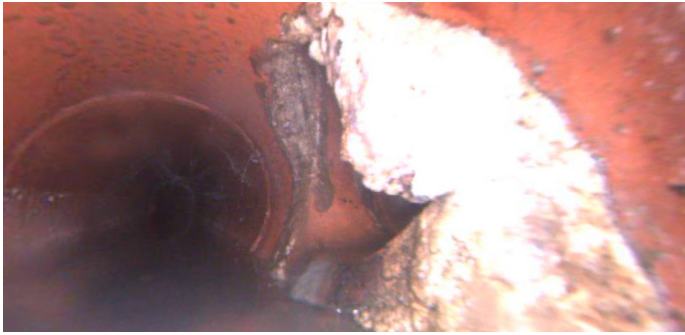
Code: **TFD**
Description: **Tap Factory Defective**

Distance (ft): **47.4**
Structural Grade: **0**
O&M Grade: **2**
Clock Start/From: **3**
Clock To:
1st Value: **4.000**
2nd Value:
Value Percent:
Continuous Index:
Within 8" of Joint:
Remarks: **dae**

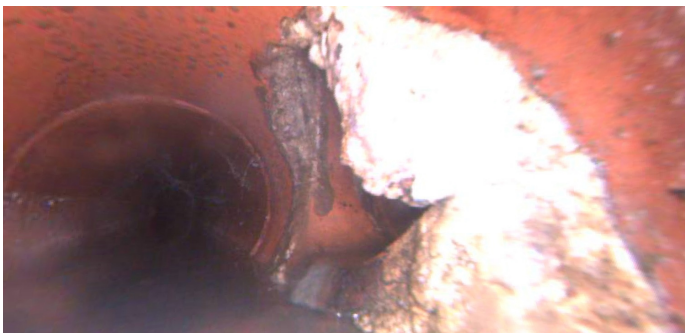
Code: **DAE**
Description: **Deposits Attached Encrustation**

Distance (ft): **47.4**
Structural Grade: **0**
O&M Grade: **2**
Clock Start/From: **1**
Clock To: **4**
1st Value:
2nd Value:
Value Percent: **10.000**
Continuous Index:
Within 8" of Joint: **NO**
Remarks:

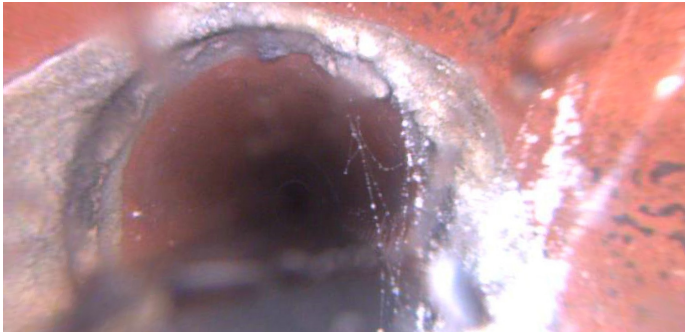
Code: **DAE**
Description: **Deposits Attached Encrustation**

Distance (ft): **52.9**
Structural Grade: **0**
O&M Grade: **2**
Clock Start/From: **8**
Clock To: **4**
1st Value:
2nd Value:
Value Percent: **10.000**
Continuous Index:
Within 8" of Joint: **YES**
Remarks:

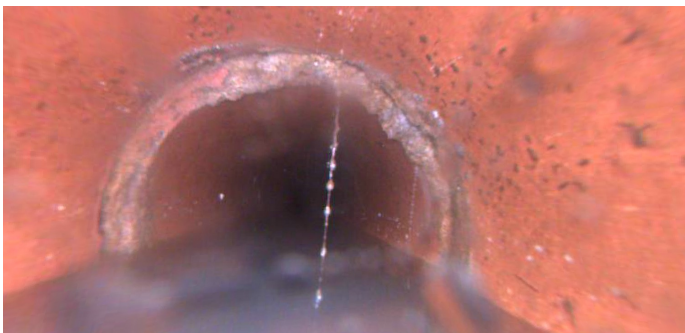
Code: **DAE**
Description: **Deposits Attached Encrustation**

Distance (ft): **57.8**
Structural Grade: **0**
O&M Grade: **2**
Clock Start/From: **8**
Clock To: **4**
1st Value:
2nd Value:
Value Percent: **5.000**
Continuous Index:
Within 8" of Joint: **YES**
Remarks:

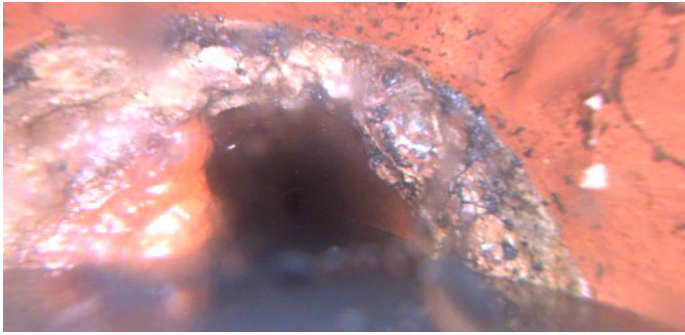
Code: **DAE**
Description: **Deposits Attached Encrustation**

Distance (ft): **92.7**
Structural Grade: **0**
O&M Grade: **5**
Clock Start/From: **8**
Clock To: **4**
1st Value:
2nd Value:
Value Percent: **40.000**
Continuous Index:
Within 8" of Joint: **YES**
Remarks:

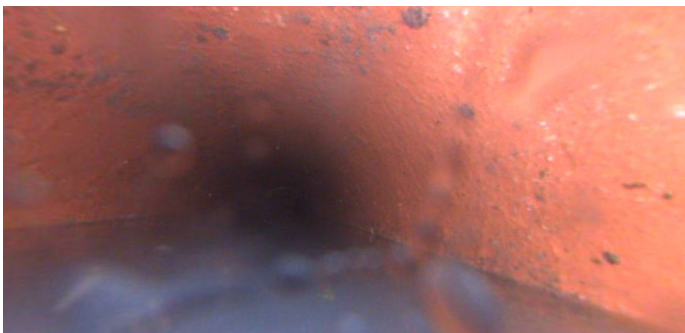
Code: **MSA**
Description: **Abandoned Survey**

Distance (ft): **93.9**
Structural Grade: **0**
O&M Grade: **0**
Clock Start/From:
Clock To:
1st Value:
2nd Value:
Value Percent:
Continuous Index:
Within 8" of Joint: **NO**
Remarks: **DAE**
