Profile/Photo Observation Report

Date:	04/14/2018	Weather:		Coding:	PACP 6.0
Pipe Length (ft):	247.2	Owner:	NA	Pre Clean:	No Pre-Cleaning
P.O.#:		Surveyor:	Jen Costello	PSR:	P-505-097-079
Customer:		Clean Date:	01/01/1900	Shape:	C

Street:	W 4TH PL	Flow Control:	Not Controlled
City:	Hobart, IN	Year Renewed:	
Location:	Yard	Tape/Media #:	
Purpose:	Routine Assessment	Dia/Height:	10"
Use:	Sanitary	Material:	VCP
Drain Area:	NA	Lining:	
Category:	NA		
Comment:

Location Details:		Direction of Survey:	Downstream
US MH:	M-505-097	DS MH:	M-505-079
		Total Length Surveyed (ft):	141.7

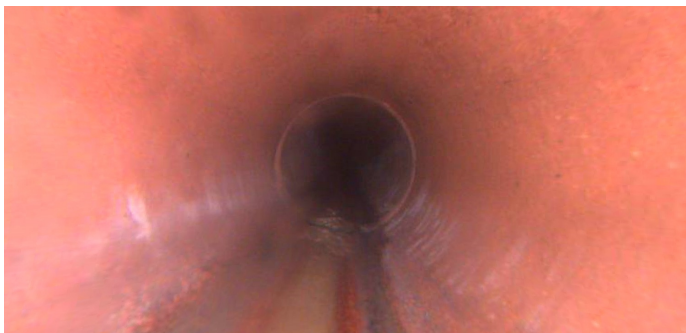
Code: **AMH**
Description: **Manhole**

Distance (ft): **.0**
Structural Grade: **0**
O&M Grade: **0**
Clock Start/From:
Clock To:
1st Value:
2nd Value:
Value Percent:
Continuous Index:
Within 8" of Joint: **NO**
Remarks: **M-505-097**

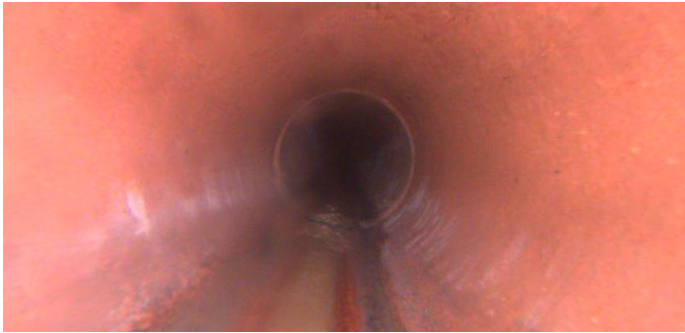
Code:	MWL
Description:	Water Level

Distance (ft):	.0
Structural Grade:	0
O&M Grade:	0
Clock Start/From:	
Clock To:	
1st Value:	
2nd Value:	
Value Percent:	5.000
Continuous Index:	
Within 8" of Joint:	NO
Remarks:

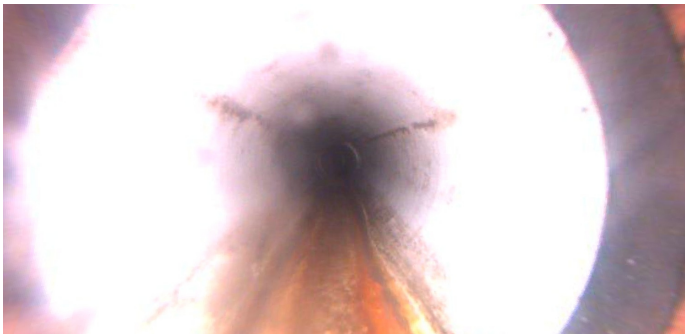
Code:	MMC
Description:	Material Change

Distance (ft):	16.9
Structural Grade:	0
O&M Grade:	0
Clock Start/From:	
Clock To:	
1st Value:	
2nd Value:	
Value Percent:	
Continuous Index:	
Within 8" of Joint:	NO
Remarks:	pvc

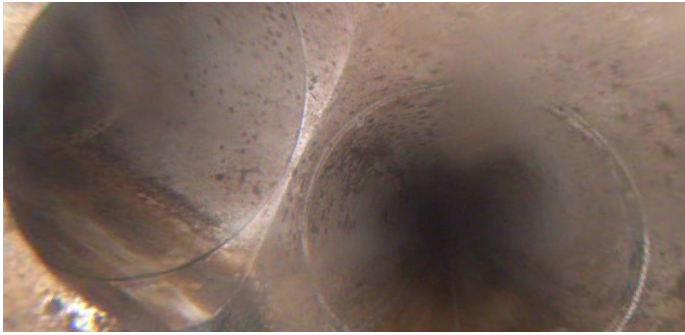
Code: **TFA**
Description: **Tap Factory Active**

Distance (ft): **21.4**
Structural Grade: **0**
O&M Grade: **0**
Clock Start/From: **3**
Clock To:
1st Value: **4.000**
2nd Value:
Value Percent:
Continuous Index:
Within 8" of Joint:
Remarks:

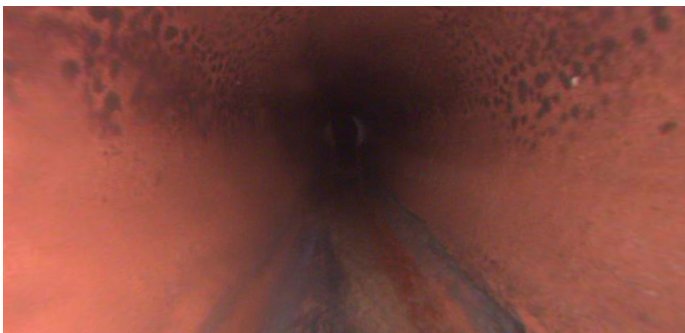
Code: **MMC**
Description: **Material Change**

Distance (ft): **22.4**
Structural Grade: **0**
O&M Grade: **0**
Clock Start/From:
Clock To:
1st Value:
2nd Value:
Value Percent:
Continuous Index:
Within 8" of Joint: **NO**
Remarks: **VCP**

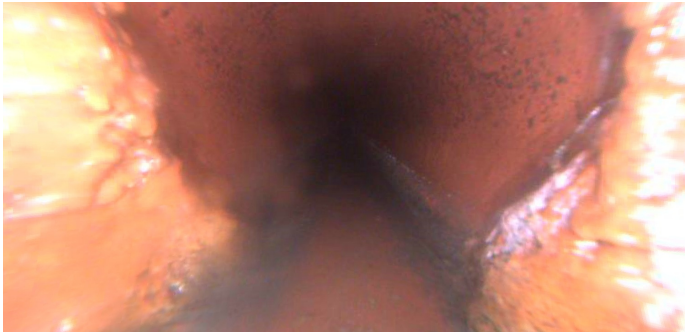
Code: **DAE**
Description: **Deposits Attached Encrustation**

Distance (ft): **27.1**
Structural Grade: **0**
O&M Grade: **2**
Clock Start/From: **8**
Clock To: **4**
1st Value:
2nd Value:
Value Percent: **10.000**
Continuous Index:
Within 8" of Joint: **YES**
Remarks:

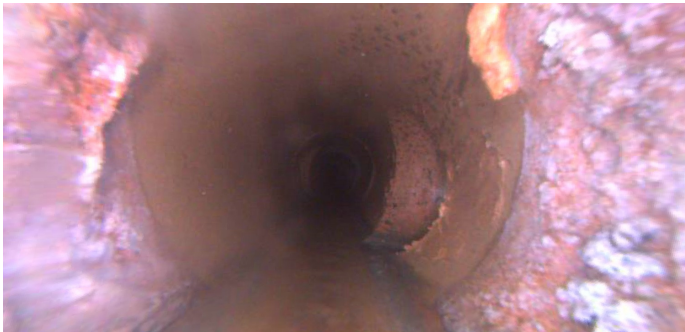
Code: **DAE**
Description: **Deposits Attached Encrustation**

Distance (ft): **37.0**
Structural Grade: **0**
O&M Grade: **2**
Clock Start/From: **8**
Clock To: **4**
1st Value:
2nd Value:
Value Percent: **10.000**
Continuous Index:
Within 8" of Joint: **YES**
Remarks:

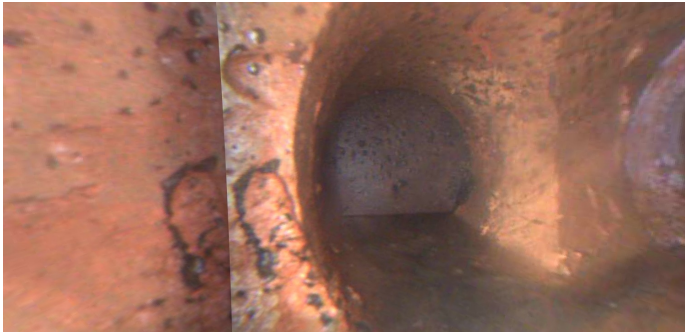
Code: **TFA**
Description: **Tap Factory Active**

Distance (ft): **38.2**
Structural Grade: **0**
O&M Grade: **0**
Clock Start/From: **3**
Clock To:
1st Value: **4.000**
2nd Value:
Value Percent:
Continuous Index:
Within 8" of Joint:
Remarks:

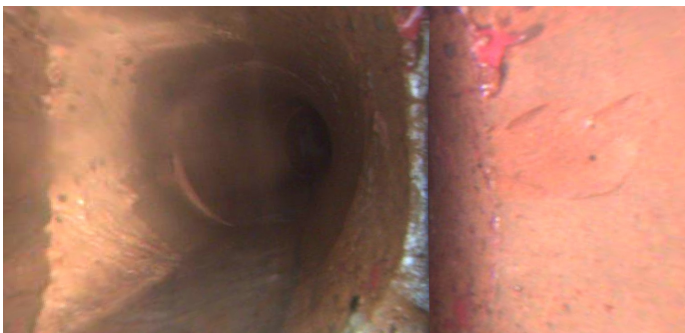
Code: **TFA**
Description: **Tap Factory Active**

Distance (ft): **40.2**
Structural Grade: **0**
O&M Grade: **0**
Clock Start/From: **9**
Clock To:
1st Value: **4.000**
2nd Value:
Value Percent:
Continuous Index:
Within 8" of Joint:
Remarks:

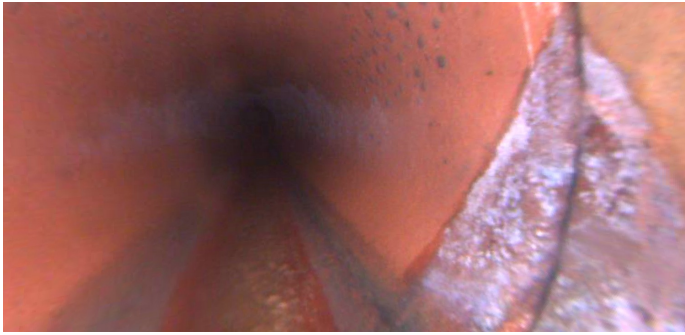
Code: **IS**
Description: **Infil Stain**

Distance (ft): **40.9**
Structural Grade: **0**
O&M Grade: **0**
Clock Start/From: **3**
Clock To: **5**
1st Value:
2nd Value:
Value Percent:
Continuous Index:
Within 8" of Joint: **YES**
Remarks:

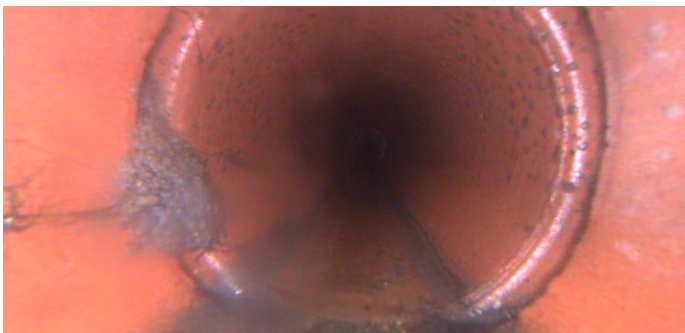
Code: **RMJ**
Description: **Roots Medium Joint**

Distance (ft): **45.8**
Structural Grade: **0**
O&M Grade: **3**
Clock Start/From: **8**
Clock To: **9**
1st Value:
2nd Value:
Value Percent: **5.000**
Continuous Index:
Within 8" of Joint: **YES**
Remarks:

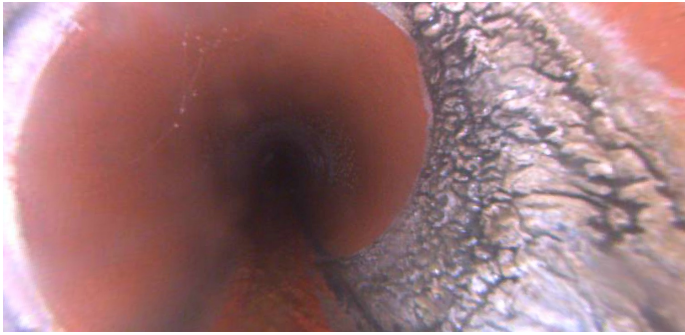
Code: **DAE**
Description: **Deposits Attached Encrustation**

Distance (ft): **50.8**
Structural Grade: **0**
O&M Grade: **2**
Clock Start/From: **8**
Clock To: **4**
1st Value:
2nd Value:
Value Percent: **5.000**
Continuous Index:
Within 8" of Joint: **YES**
Remarks:

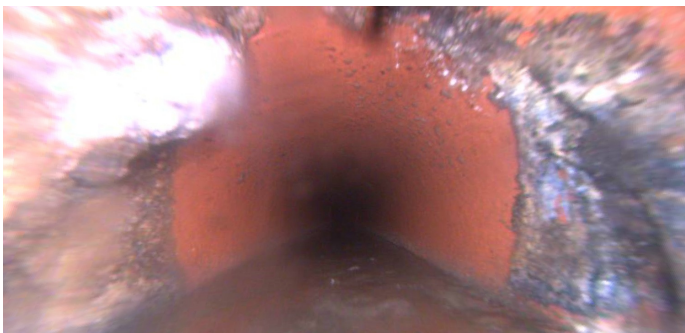
Code: **DAE**
Description: **Deposits Attached Encrustation**

Distance (ft): **55.8**
Structural Grade: **0**
O&M Grade: **2**
Clock Start/From: **8**
Clock To: **4**
1st Value:
2nd Value:
Value Percent: **10.000**
Continuous Index:
Within 8" of Joint: **YES**
Remarks:

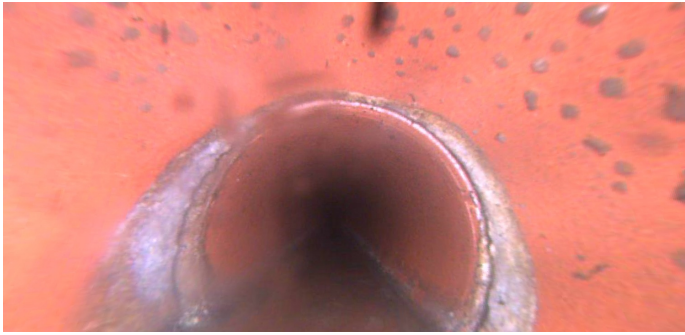
Code: **DAE**
Description: **Deposits Attached Encrustation**

Distance (ft): **70.5**
Structural Grade: **0**
O&M Grade: **2**
Clock Start/From: **8**
Clock To: **4**
1st Value:
2nd Value:
Value Percent: **5.000**
Continuous Index:
Within 8" of Joint: **YES**
Remarks:

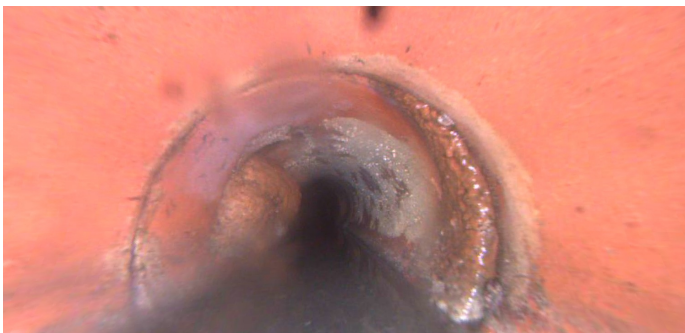
Code: **IW**
Description: **Infil Weeper**

Distance (ft): **140.2**
Structural Grade: **0**
O&M Grade: **2**
Clock Start/From: **1**
Clock To: **4**
1st Value:
2nd Value:
Value Percent:
Continuous Index:
Within 8" of Joint: **YES**
Remarks:

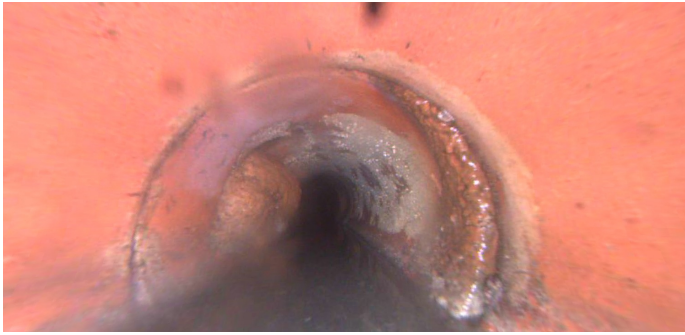
Code: **DAE**
Description: **Deposits Attached Encrustation**

Distance (ft): **140.2**
Structural Grade: **0**
O&M Grade: **2**
Clock Start/From: **1**
Clock To: **4**
1st Value:
2nd Value:
Value Percent: **5.000**
Continuous Index:
Within 8" of Joint: **YES**
Remarks:

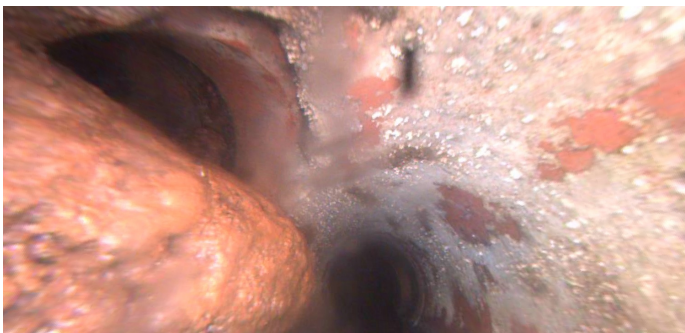
Code: **TBD**
Description: **Tap Break-in Defective**

Distance (ft): **140.9**
Structural Grade: **0**
O&M Grade: **3**
Clock Start/From: **10**
Clock To:
1st Value: **4.000**
2nd Value:
Value Percent:
Continuous Index:
Within 8" of Joint:
Remarks: **DAE**

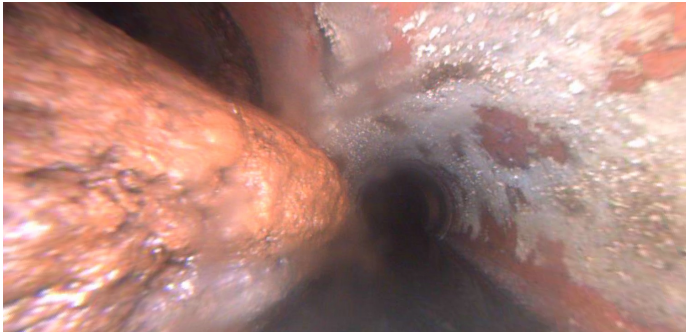
Code: **DAE**
Description: **Deposits Attached Encrustation**

Distance (ft): **140.9**
Structural Grade: **0**
O&M Grade: **2**
Clock Start/From: **8**
Clock To: **9**
1st Value:
2nd Value:
Value Percent: **10.000**
Continuous Index:
Within 8" of Joint: **NO**
Remarks:

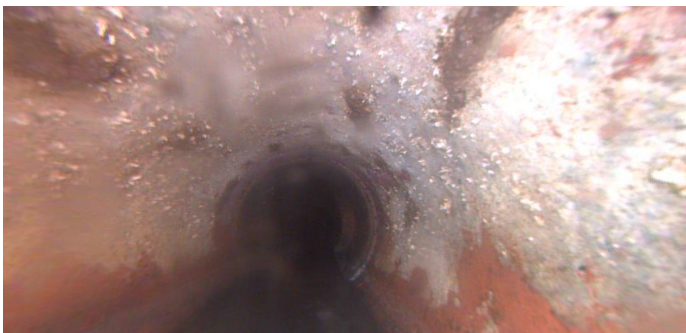
Code: **MSA**
Description: **Abandoned Survey**

Distance (ft): **141.7**
Structural Grade: **0**
O&M Grade: **0**
Clock Start/From:
Clock To:
1st Value:
2nd Value:
Value Percent:
Continuous Index:
Within 8" of Joint: **NO**
Remarks: **DAE**
