Profile/Photo Observation Report

| Street: | W 8TH ST | Flow Control: | Not Controlled |
| City: | Hobart, IN | Year Renewed: | |

| US MH: | M-506-003 | DS MH: | M-506-002 |

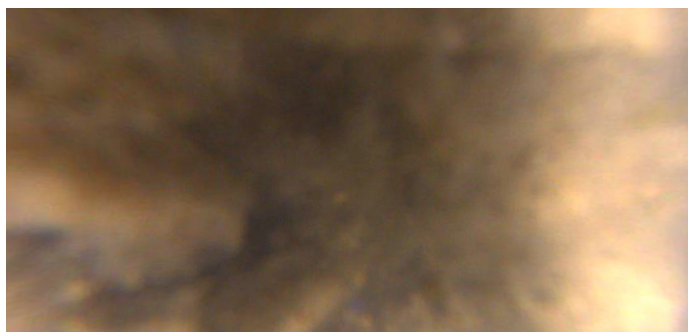
Code: **AMH**
Description: **Manhole**

Distance (ft): **.0**
Structural Grade: **0**
O&M Grade: **0**
Clock Start/From:
Clock To:
1st Value:
2nd Value:
Value Percent:
Continuous Index:
Within 8" of Joint: **NO**
Remarks: **M-506-002**

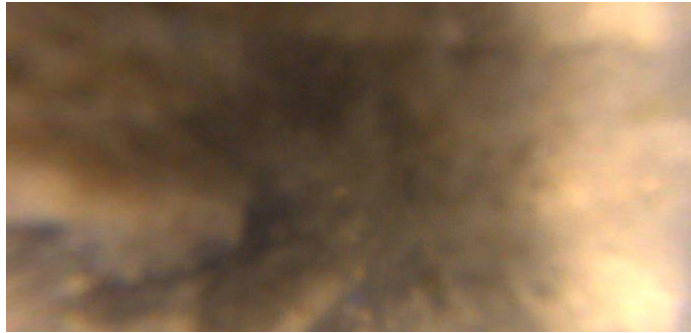
Code: **MWL**
Description: **Water Level**

Distance (ft): **.0**
Structural Grade: **0**
O&M Grade: **0**
Clock Start/From:
Clock To:
1st Value:
2nd Value:
Value Percent: **100.000**
Continuous Index:
Within 8" of Joint: **NO**
Remarks:
