Profile/Photo Observation Report

Date:	02/06/2022	Weather:		Coding:	PACP 7.0
Pipe Length (ft):	296.7	Owner:	City of Hobart	Pre Clean:	Heavy Cleaning
P.O.#:	YES502259	Surveyor:	S. Bucklin	PSR:	P-506-003-002
Customer:	City of Hobart	Clean Date:	02/03/2022	Shape:	C

Street:	South 8th Street	Flow Control:	Not Controlled
City:	Hobart, IN	Year Renewed:	
Location:	Easement/Right of Way	Tape/Media #:	
Purpose:	Routine Assessment	Dia/Height:	12"
Use:	Sanitary Sewage Pipe	Material:	VCP
Drain Area:		Lining:	None
Category:	NA		
Comment:			
Location Details:		Direction of Survey:	Downstream
US MH:	M-506-003	DS MH:	M-506-002
		Total Length Surveyed (ft):	296.7

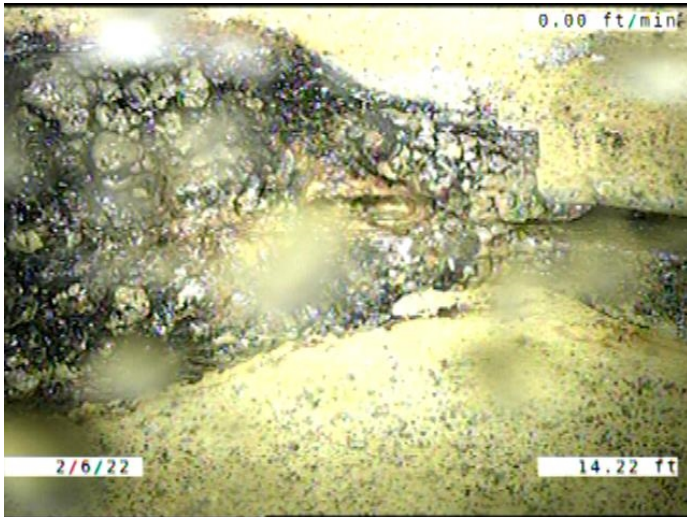
Code: **DAE**
 Description: **Deposits Attached Encrustation**

Distance (ft): **14.2**
 Structural Grade: **0**
 O&M Grade: **2**
 Clock Start/From: **8**
 Clock To: **4**
 1st Value:
 2nd Value:
 Value Percent: **5.000**
 Continuous Index:
 Within 8" of Joint: **YES**
 Remarks:

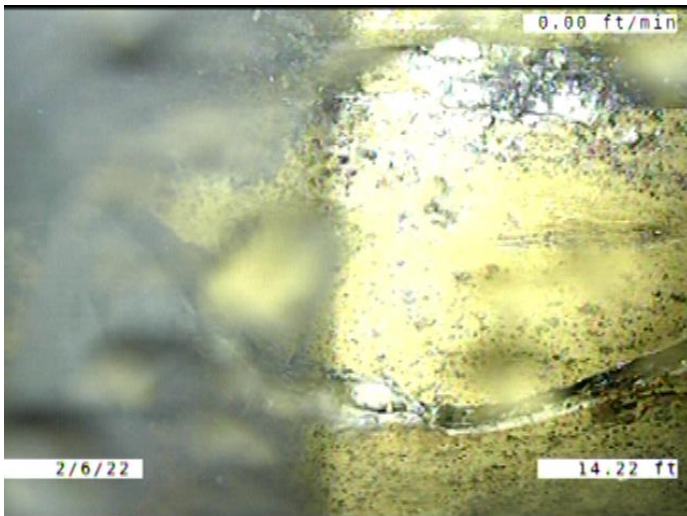
Code: **B**
 Description: **Broken**

Distance (ft): **14.2**
 Structural Grade: **4**
 O&M Grade: **0**
 Clock Start/From: **8**
 Clock To: **10**
 1st Value:
 2nd Value:
 Value Percent:
 Continuous Index:
 Within 8" of Joint: **YES**
 Remarks:

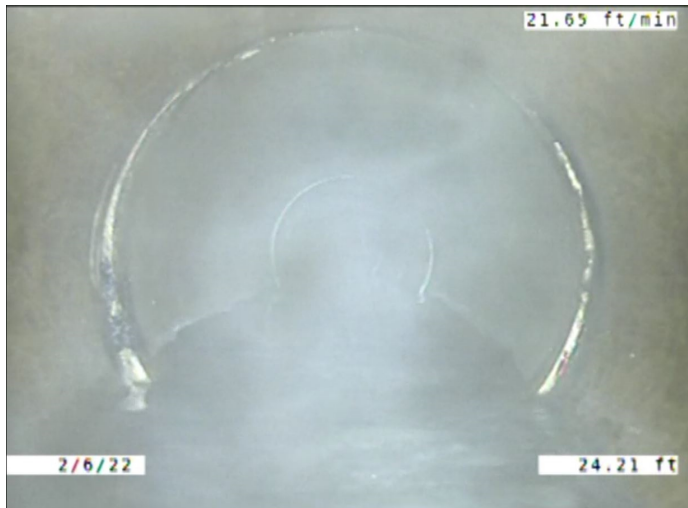
Code: **ISJ**
 Description: **Infiltration Stain Joint**

Distance (ft): **24.2**
 Structural Grade: **0**
 O&M Grade: **1**
 Clock Start/From: **8**
 Clock To: **10**
 1st Value:
 2nd Value:
 Value Percent:
 Continuous Index:
 Within 8" of Joint: **YES**
 Remarks:

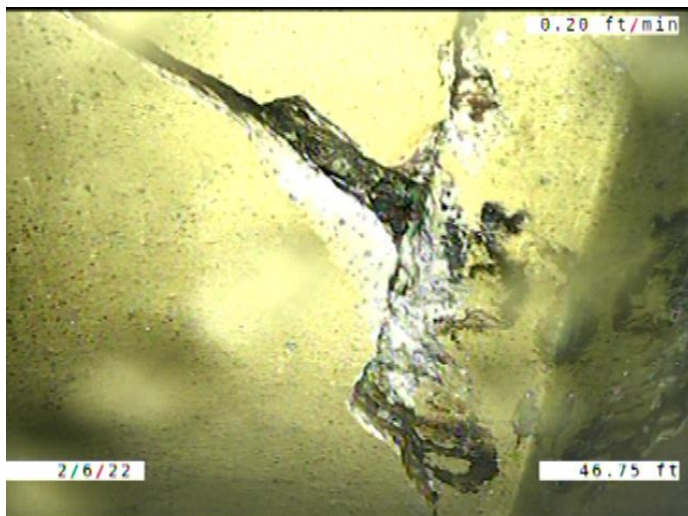
Code: **BSV**
 Description: **Broken Soil Visible**

Distance (ft): **46.1**
 Structural Grade: **5**
 O&M Grade: **0**
 Clock Start/From: **8**
 Clock To: **4**
 1st Value:
 2nd Value:
 Value Percent:
 Continuous Index:
 Within 8" of Joint: **YES**
 Remarks:

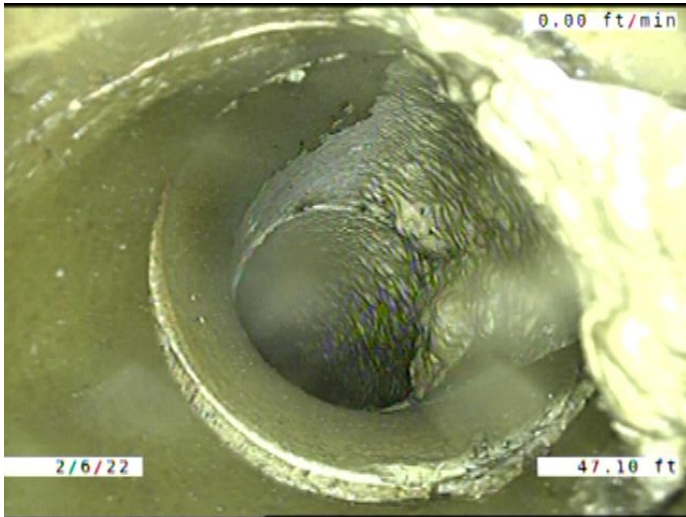
Code:	TFD
Description:	Tap Factory Defective
Distance (ft):	47.1
Structural Grade:	0
O&M Grade:	3
Clock Start/From:	1
Clock To:	
1st Value:	6.000
2nd Value:	
Value Percent:	
Continuous Index:	
Within 8" of Joint:	YES
Remarks:	TAP BROKEN. ENCRUSTATION COMING DOWN THE SERVICE INTO T

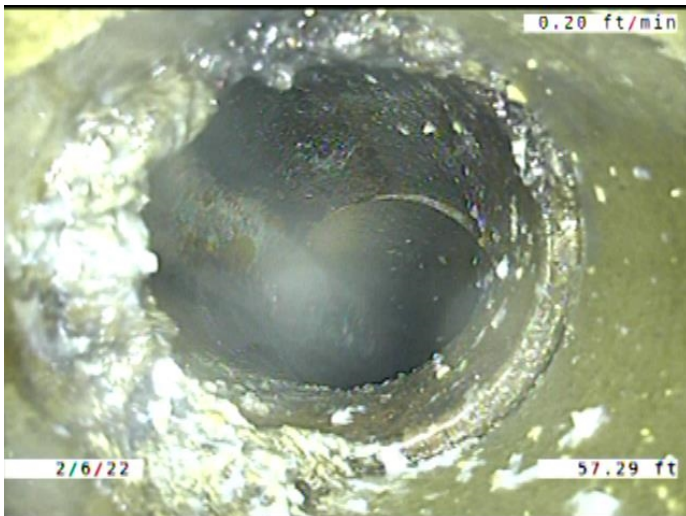
Code:	TF
Description:	Tap Factory
Distance (ft):	57.3
Structural Grade:	0
O&M Grade:	0
Clock Start/From:	11
Clock To:	
1st Value:	6.000
2nd Value:	
Value Percent:	
Continuous Index:	
Within 8" of Joint:	YES
Remarks:	CONSTANTLY RUNNING WATER. ENCRUSTATION COMING FROM THE

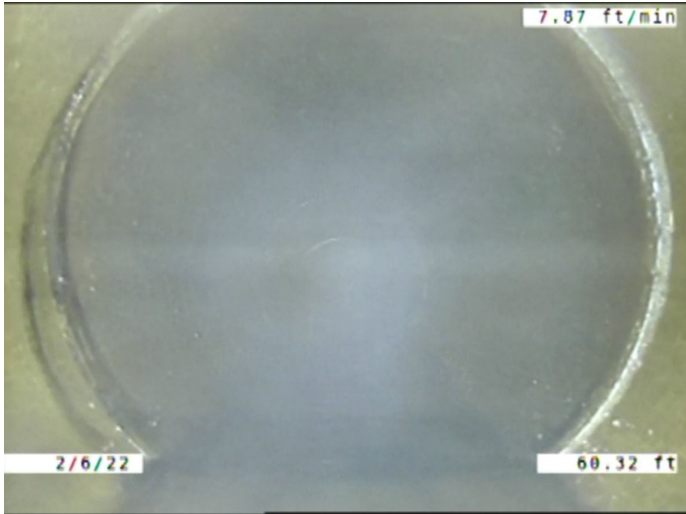
Code: **ISJ**
Description: **Infiltration Stain Joint**

Distance (ft): **60.3**
Structural Grade: **0**
O&M Grade: **1**
Clock Start/From: **8**
Clock To: **10**
1st Value:
2nd Value:
Value Percent:
Continuous Index:
Within 8" of Joint: **YES**
Remarks:

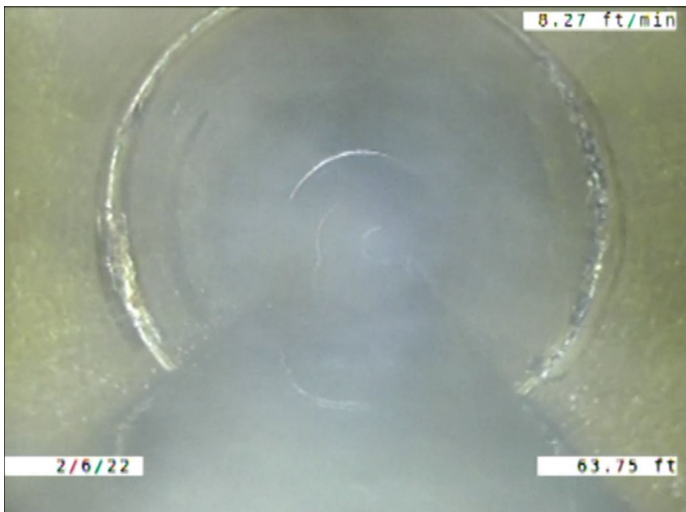
Code: **ISJ**
Description: **Infiltration Stain Joint**

Distance (ft): **63.8**
Structural Grade: **0**
O&M Grade: **1**
Clock Start/From: **8**
Clock To: **4**
1st Value:
2nd Value:
Value Percent:
Continuous Index:
Within 8" of Joint: **YES**
Remarks:

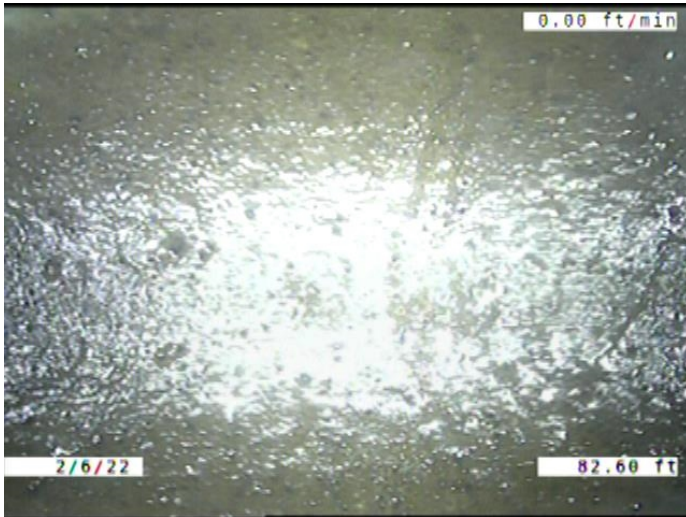
Code:	MCU
Description:	Miscellaneous Camera Underwater
Distance (ft):	82.6
Structural Grade:	0
O&M Grade:	4
Clock Start/From:	
Clock To:	
1st Value:	
2nd Value:	
Value Percent:	
Continuous Index:	
Within 8" of Joint:	NO
Remarks:	Out at 84.8

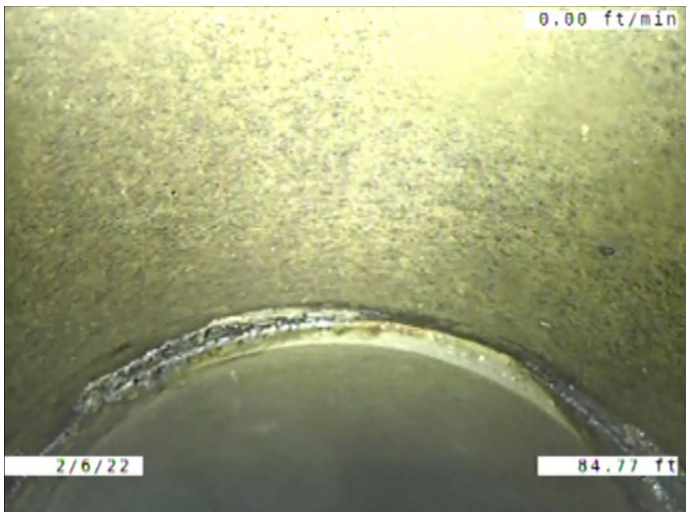
Code:	ISJ
Description:	Infiltration Stain Joint
Distance (ft):	84.8
Structural Grade:	0
O&M Grade:	1
Clock Start/From:	10
Clock To:	2
1st Value:	
2nd Value:	
Value Percent:	
Continuous Index:	
Within 8" of Joint:	YES
Remarks:

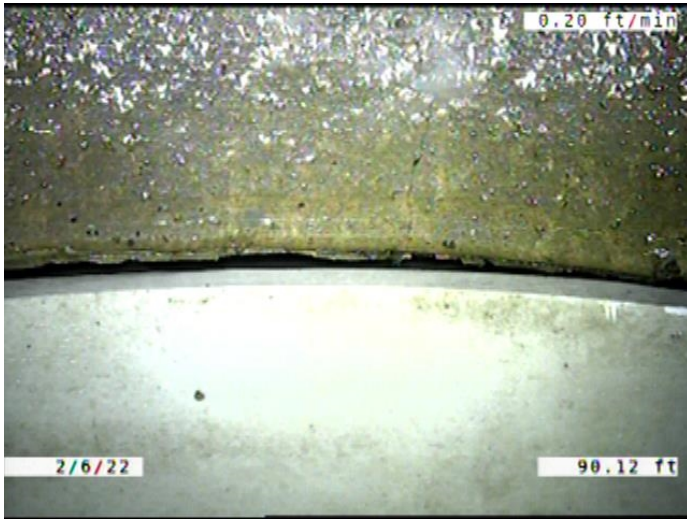
Code: **JOM**
Description: **Joint Offset Medium**

Distance (ft): **90.1**
Structural Grade: **3**
O&M Grade: **0**
Clock Start/From:
Clock To:
1st Value:
2nd Value:
Value Percent:
Continuous Index:
Within 8" of Joint: **NO**
Remarks:

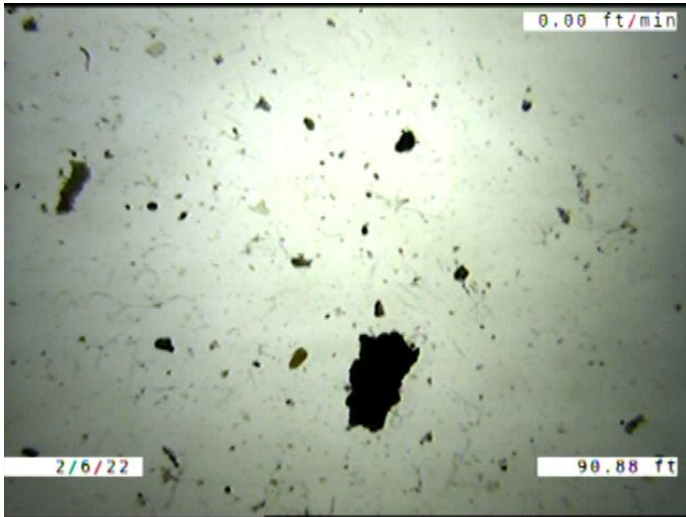
Code:	MCU
Description:	Miscellaneous Camera Underwater
Distance (ft):	90.9
Structural Grade:	0
O&M Grade:	4
Clock Start/From:	
Clock To:	
1st Value:	
2nd Value:	
Value Percent:	
Continuous Index:	
Within 8" of Joint:	NO
Remarks:	Out at 92.3

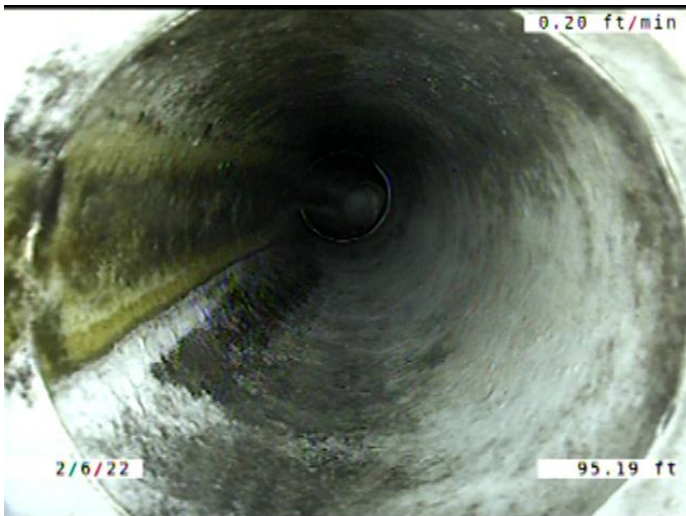
Code:	TF
Description:	Tap Factory
Distance (ft):	95.2
Structural Grade:	0
O&M Grade:	0
Clock Start/From:	11
Clock To:	
1st Value:	6.000
2nd Value:	
Value Percent:	
Continuous Index:	
Within 8" of Joint:	YES
Remarks:	CONSTANTLY RUNNING WATER.

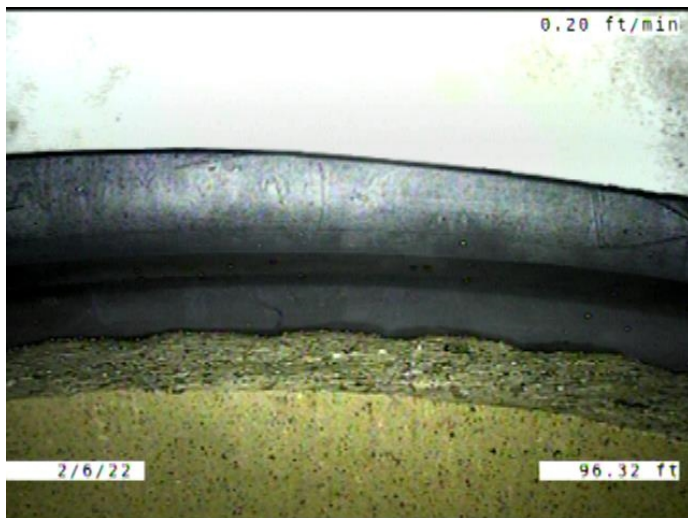
Code: **JOM**
 Description: **Joint Offset Medium**

Distance (ft): **96.3**
 Structural Grade: **3**
 O&M Grade: **0**
 Clock Start/From:
 Clock To:
 1st Value:
 2nd Value:
 Value Percent:
 Continuous Index:
 Within 8" of Joint: **NO**
 Remarks:

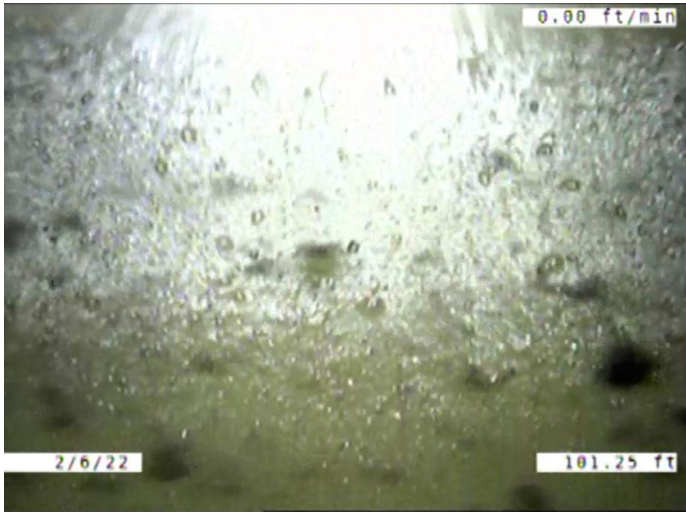
Code:	MCU
Description:	Miscellaneous Camera Underwater
Distance (ft):	101.3
Structural Grade:	0
O&M Grade:	4
Clock Start/From:	
Clock To:	
1st Value:	
2nd Value:	
Value Percent:	
Continuous Index:	
Within 8" of Joint:	NO
Remarks:	Out at 102.6

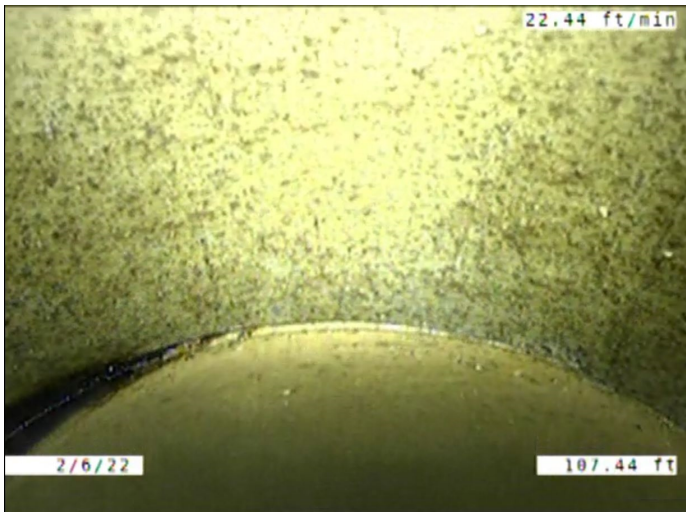
Code:	IWJ
Description:	Infiltration Weeper Joint
Distance (ft):	107.4
Structural Grade:	0
O&M Grade:	2
Clock Start/From:	10
Clock To:	11
1st Value:	
2nd Value:	
Value Percent:	
Continuous Index:	
Within 8" of Joint:	YES
Remarks:

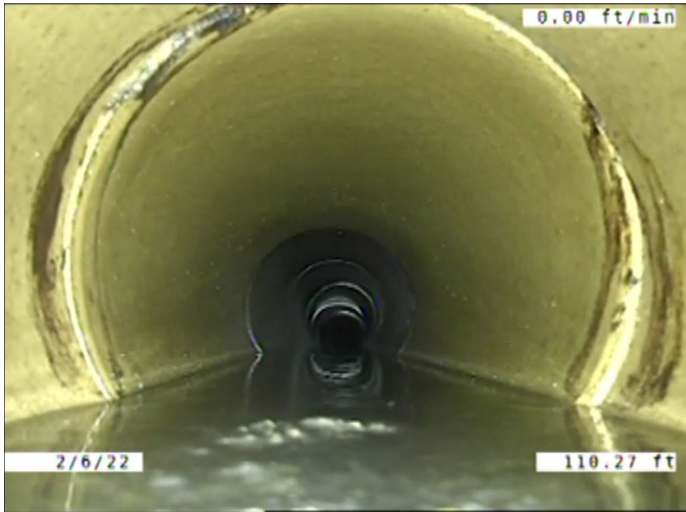
Code: **ISJ**
Description: **Infiltration Stain Joint**

Distance (ft): **110.3**
Structural Grade: **0**
O&M Grade: **1**
Clock Start/From: **2**
Clock To: **4**
1st Value:
2nd Value:
Value Percent:
Continuous Index:
Within 8" of Joint: **YES**
Remarks:

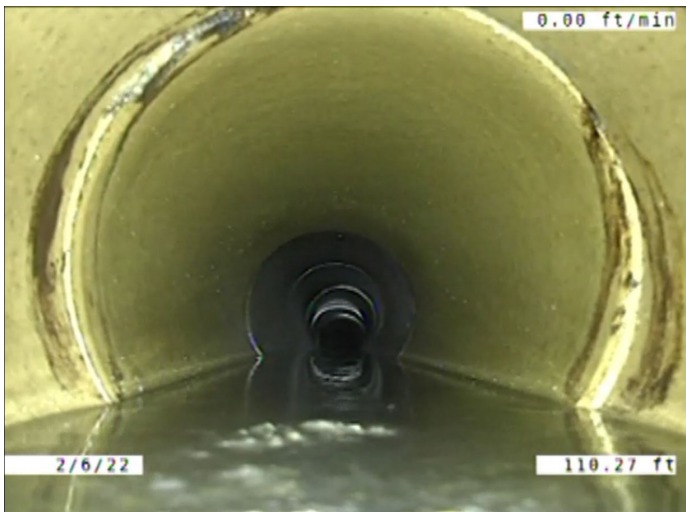
Code: **ISJ**
Description: **Infiltration Stain Joint**

Distance (ft): **110.3**
Structural Grade: **0**
O&M Grade: **1**
Clock Start/From: **8**
Clock To: **11**
1st Value:
2nd Value:
Value Percent:
Continuous Index:
Within 8" of Joint: **YES**
Remarks:

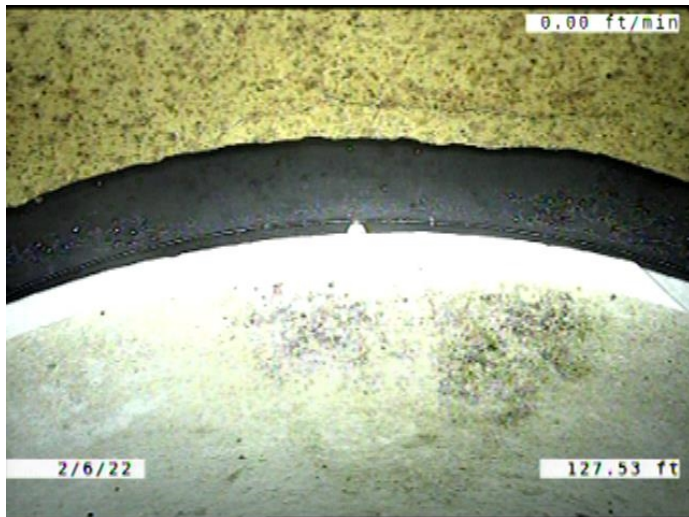
Code: **JOM**
 Description: **Joint Offset Medium**

Distance (ft): **127.5**
 Structural Grade: **3**
 O&M Grade: **0**
 Clock Start/From:
 Clock To:
 1st Value: **1.000**
 2nd Value:
 Value Percent:
 Continuous Index:
 Within 8" of Joint: **NO**
 Remarks:

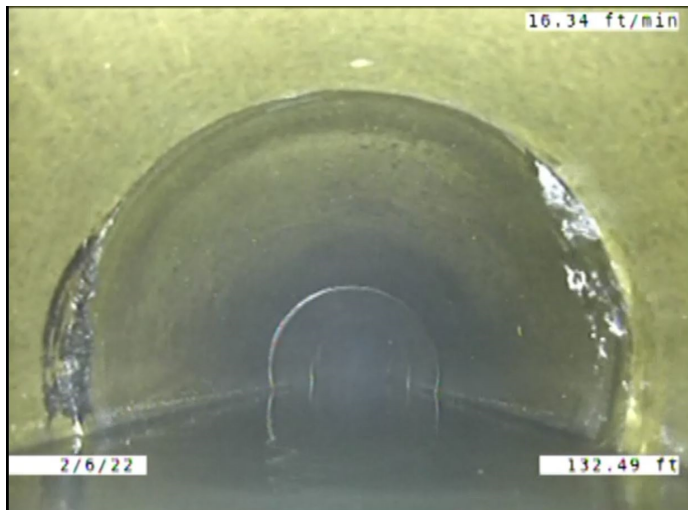
Code: **IW**
 Description: **Infiltration Weeper**

Distance (ft): **132.5**
 Structural Grade: **0**
 O&M Grade: **2**
 Clock Start/From: **8**
 Clock To: **10**
 1st Value:
 2nd Value:
 Value Percent:
 Continuous Index:
 Within 8" of Joint: **YES**
 Remarks:

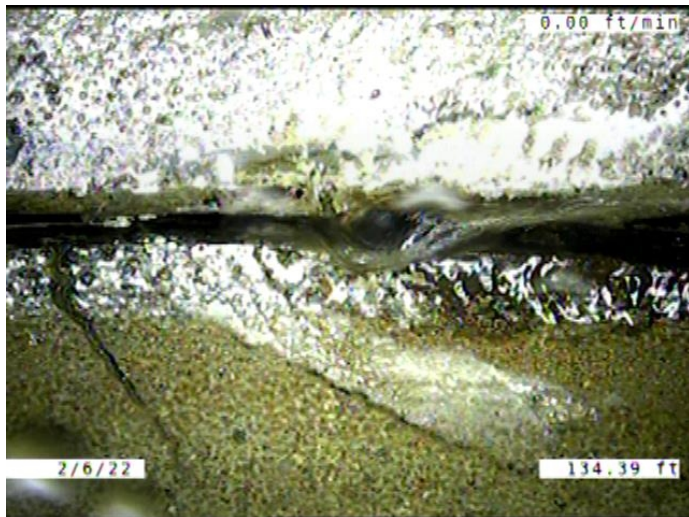
Code: **IGJ**
 Description: **Infiltration Gusher Joint**

Distance (ft): **134.4**
 Structural Grade: **0**
 O&M Grade: **5**
 Clock Start/From: **1**
 Clock To:
 1st Value:
 2nd Value:
 Value Percent:
 Continuous Index:
 Within 8" of Joint: **YES**
 Remarks:

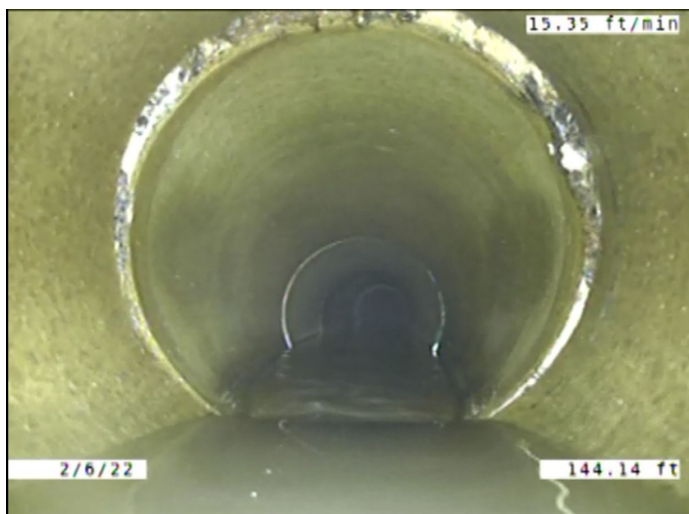
Code: **DAE**
 Description: **Deposits Attached Encrustation**

Distance (ft): **144.1**
 Structural Grade: **0**
 O&M Grade: **2**
 Clock Start/From: **2**
 Clock To:
 1st Value:
 2nd Value:
 Value Percent: **5.000**
 Continuous Index:
 Within 8" of Joint: **YES**
 Remarks:

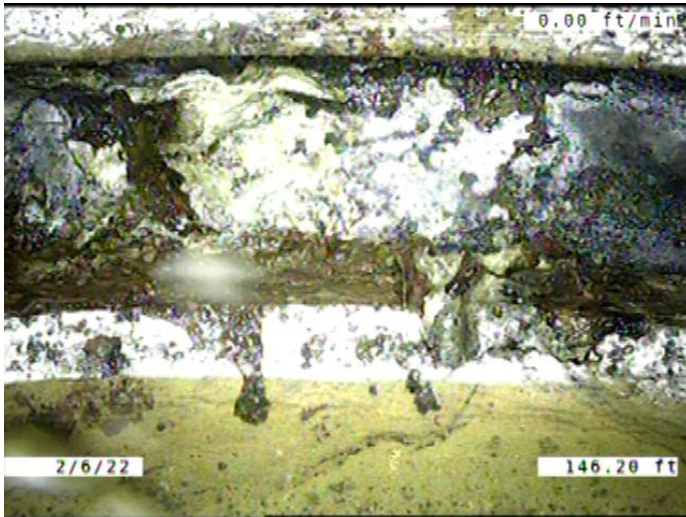
Code: **JAL**
 Description: **Joint Angular Large**

Distance (ft): **146.2**
 Structural Grade: **4**
 O&M Grade: **0**
 Clock Start/From:
 Clock To:
 1st Value:
 2nd Value:
 Value Percent:
 Continuous Index:
 Within 8" of Joint: **NO**
 Remarks:

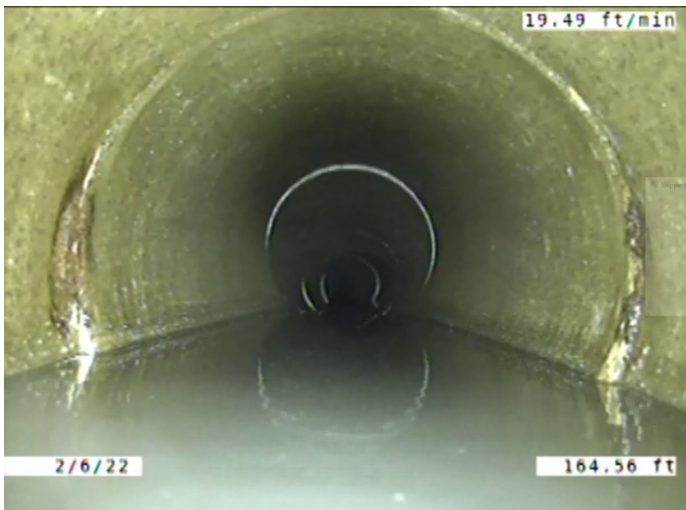
Code: **ISJ**
Description: **Infiltration Stain Joint**

Distance (ft): **164.6**
Structural Grade: **0**
O&M Grade: **1**
Clock Start/From: **9**
Clock To: **10**
1st Value:
2nd Value:
Value Percent:
Continuous Index:
Within 8" of Joint: **YES**
Remarks:

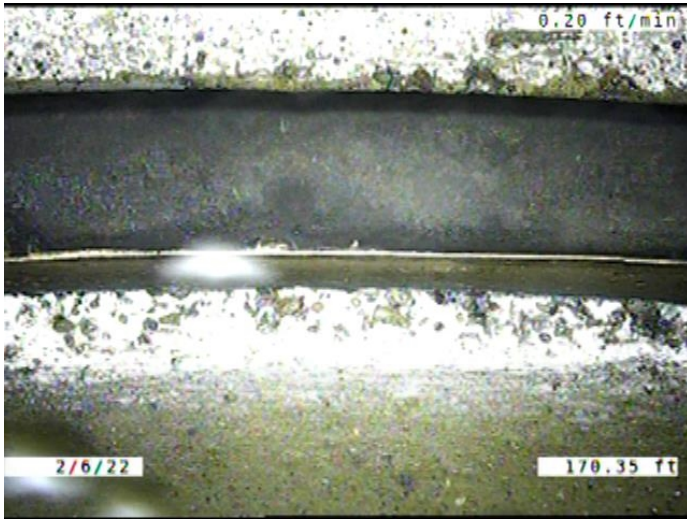
Code: **JAL**
 Description: **Joint Angular Large**

Distance (ft): **170.3**
 Structural Grade: **4**
 O&M Grade: **0**
 Clock Start/From:
 Clock To:
 1st Value:
 2nd Value:
 Value Percent:
 Continuous Index:
 Within 8" of Joint: **NO**
 Remarks:

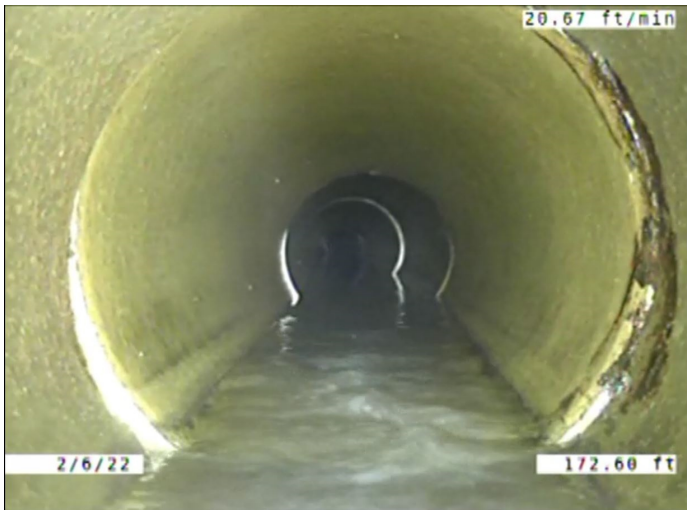
Code: **ISJ**
 Description: **Infiltration Stain Joint**

Distance (ft): **172.6**
 Structural Grade: **0**
 O&M Grade: **1**
 Clock Start/From: **1**
 Clock To: **4**
 1st Value:
 2nd Value:
 Value Percent:
 Continuous Index:
 Within 8" of Joint: **YES**
 Remarks:

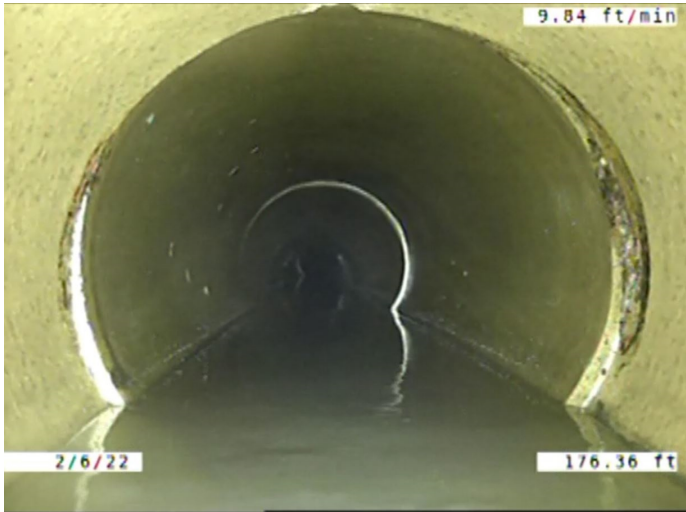
Code: **ISJ**
Description: **Infiltration Stain Joint**

Distance (ft): **176.4**
Structural Grade: **0**
O&M Grade: **1**
Clock Start/From: **2**
Clock To: **4**
1st Value:
2nd Value:
Value Percent:
Continuous Index:
Within 8" of Joint: **YES**
Remarks:

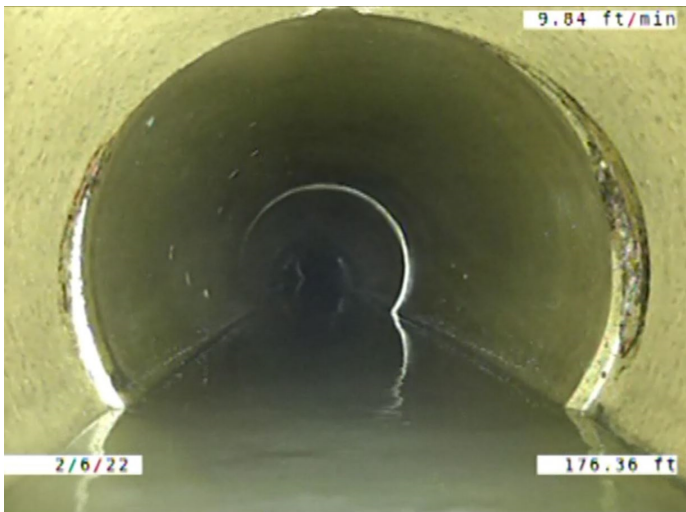
Code: **ISJ**
Description: **Infiltration Stain Joint**

Distance (ft): **176.4**
Structural Grade: **0**
O&M Grade: **1**
Clock Start/From: **9**
Clock To: **10**
1st Value:
2nd Value:
Value Percent:
Continuous Index:
Within 8" of Joint: **YES**
Remarks:

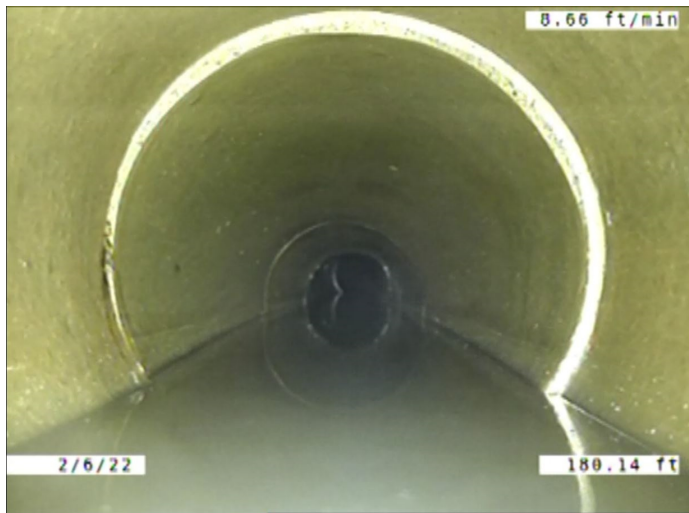
Code: **ISJ**
Description: **Infiltration Stain Joint**

Distance (ft): **180.1**
Structural Grade: **0**
O&M Grade: **1**
Clock Start/From: **8**
Clock To: **9**
1st Value:
2nd Value:
Value Percent:
Continuous Index:
Within 8" of Joint: **YES**
Remarks:

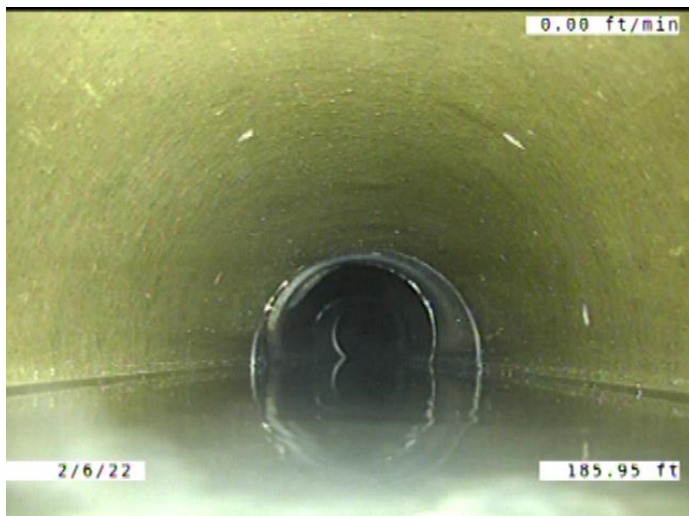
Code: **MWLS**
Description: **Miscellaneous Water Level Sag**

Distance (ft): **185.9**
Structural Grade: **3**
O&M Grade: **0**
Clock Start/From:
Clock To:
1st Value:
2nd Value:
Value Percent: **35.000**
Continuous Index: **S02**
Within 8" of Joint: **NO**
Remarks:

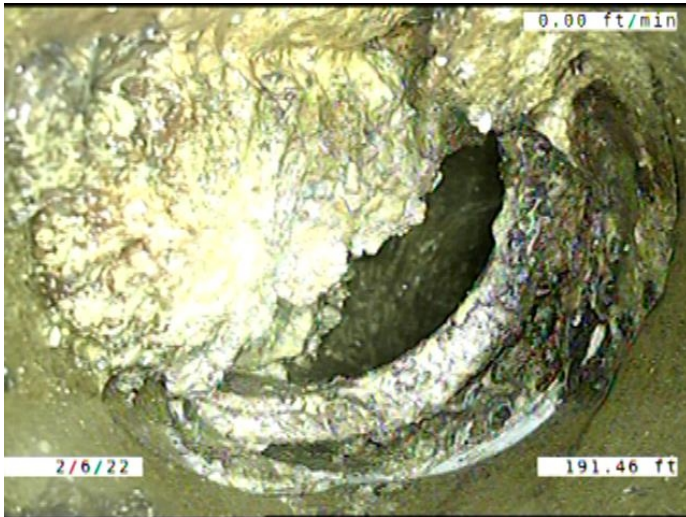
Code:	TFD
Description:	Tap Factory Defective
Distance (ft):	191.5
Structural Grade:	0
O&M Grade:	3
Clock Start/From:	10
Clock To:	
1st Value:	6.000
2nd Value:	
Value Percent:	
Continuous Index:	
Within 8" of Joint:	YES
Remarks:	BROKEN. CONSTANTLY RUNNING WATER. ENCRUSTATION COMING FR

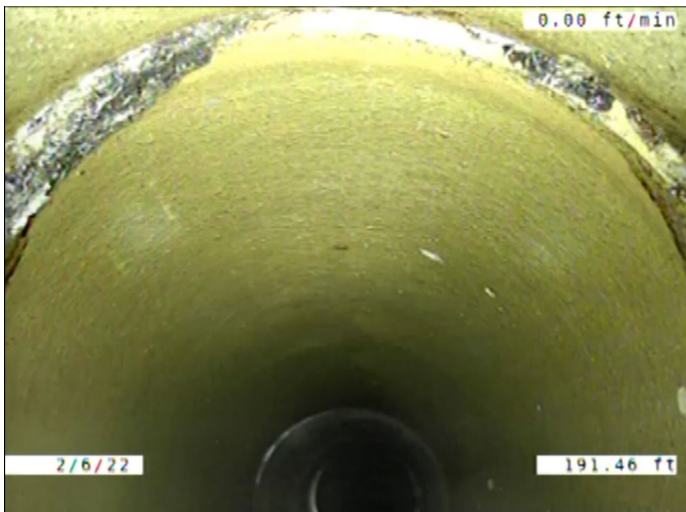
Code:	DAE
Description:	Deposits Attached Encrustation
Distance (ft):	191.5
Structural Grade:	0
O&M Grade:	2
Clock Start/From:	10
Clock To:	11
1st Value:	
2nd Value:	
Value Percent:	5.000
Continuous Index:	
Within 8" of Joint:	YES
Remarks:

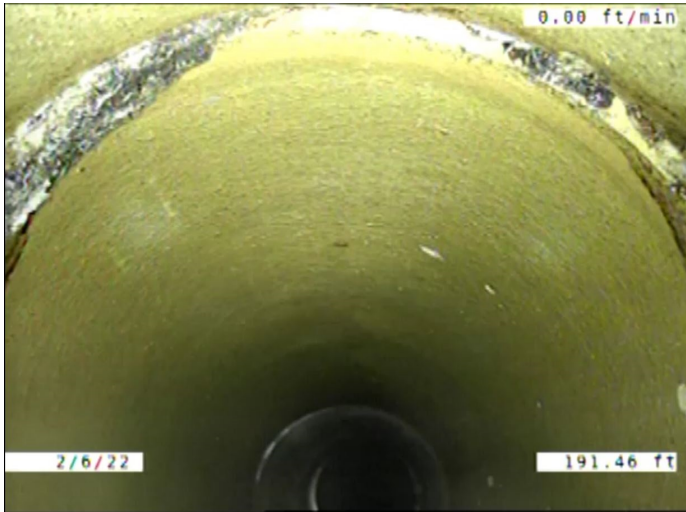
Code: **ISJ**
Description: **Infiltration Stain Joint**

Distance (ft): **191.5**
Structural Grade: **0**
O&M Grade: **1**
Clock Start/From: **1**
Clock To: **2**
1st Value:
2nd Value:
Value Percent:
Continuous Index:
Within 8" of Joint: **YES**
Remarks:

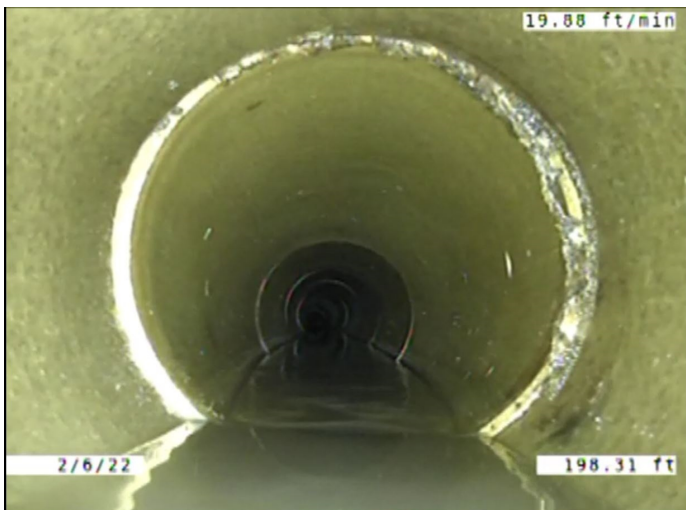
Code: **DAE**
Description: **Deposits Attached Encrustation**

Distance (ft): **198.3**
Structural Grade: **0**
O&M Grade: **2**
Clock Start/From: **12**
Clock To: **4**
1st Value:
2nd Value:
Value Percent: **5.000**
Continuous Index:
Within 8" of Joint: **YES**
Remarks:

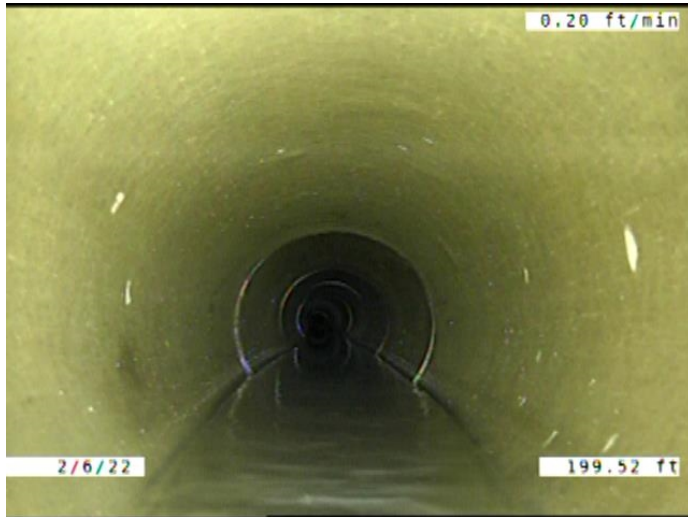
Code: **MWLS**
 Description: **Miscellaneous Water Level Sag**

Distance (ft): **199.5**
 Structural Grade: **3**
 O&M Grade: **0**
 Clock Start/From:
 Clock To:
 1st Value:
 2nd Value:
 Value Percent: **35.000**
 Continuous Index: **F02**
 Within 8" of Joint: **NO**
 Remarks:

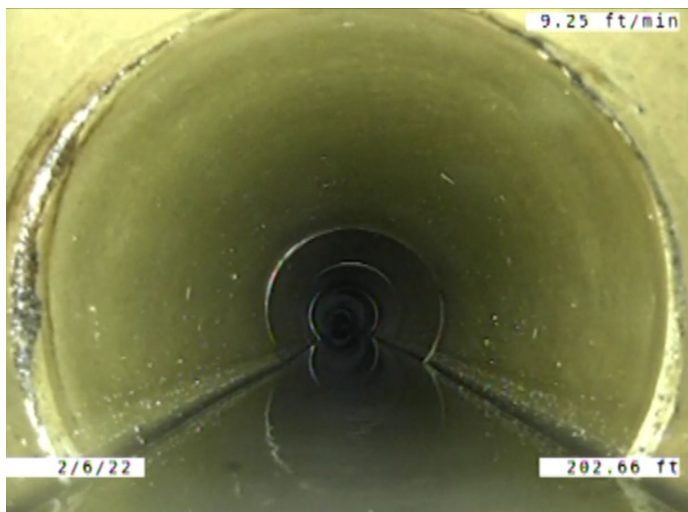
Code: **ISJ**
 Description: **Infiltration Stain Joint**

Distance (ft): **202.7**
 Structural Grade: **0**
 O&M Grade: **1**
 Clock Start/From: **8**
 Clock To: **11**
 1st Value:
 2nd Value:
 Value Percent:
 Continuous Index:
 Within 8" of Joint: **YES**
 Remarks:

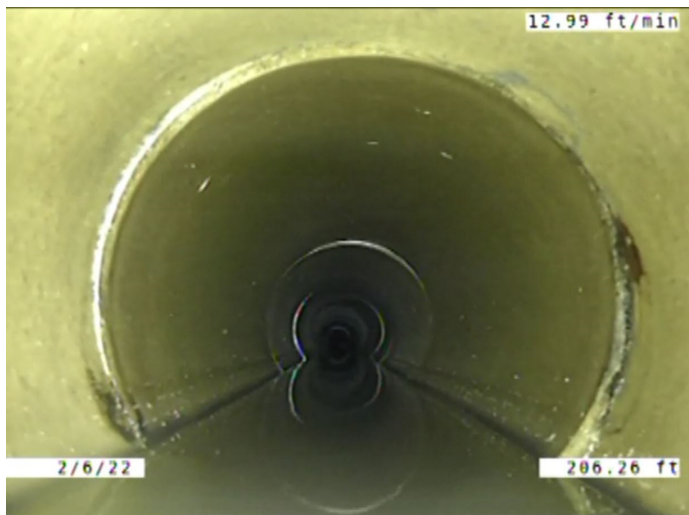
Code: **ISJ**
Description: **Infiltration Stain Joint**

Distance (ft): **206.3**
Structural Grade: **0**
O&M Grade: **1**
Clock Start/From: **2**
Clock To:
1st Value:
2nd Value:
Value Percent:
Continuous Index:
Within 8" of Joint: **YES**
Remarks:

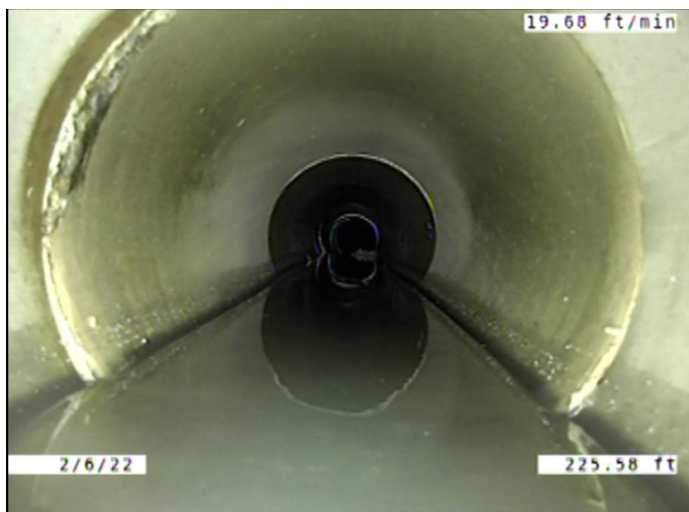
Code: **ISJ**
Description: **Infiltration Stain Joint**

Distance (ft): **225.6**
Structural Grade: **0**
O&M Grade: **1**
Clock Start/From: **9**
Clock To: **11**
1st Value:
2nd Value:
Value Percent:
Continuous Index:
Within 8" of Joint: **YES**
Remarks:

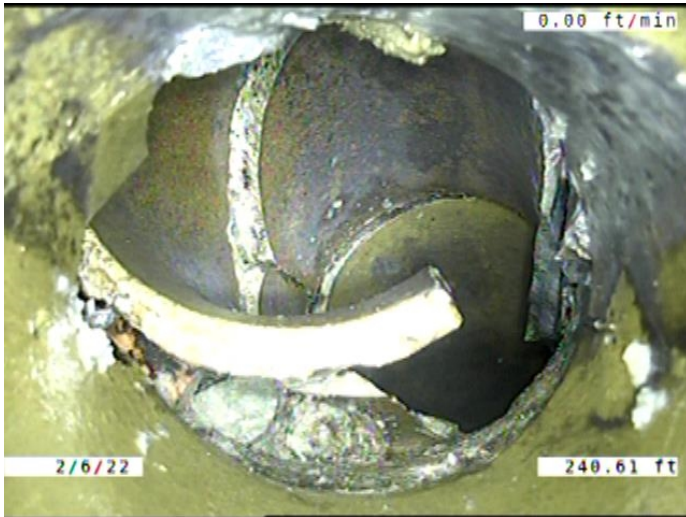
Code: **TFD**
Description: **Tap Factory Defective**

Distance (ft): **240.6**
Structural Grade: **0**
O&M Grade: **3**
Clock Start/From: **12**
Clock To:
1st Value: **6.000**
2nd Value:
Value Percent:
Continuous Index:
Within 8" of Joint: **YES**
Remarks: **BROKEN SOIL VISIBLE. SERVICE LINE
BROKEN AT THE CONNECTION. CON**

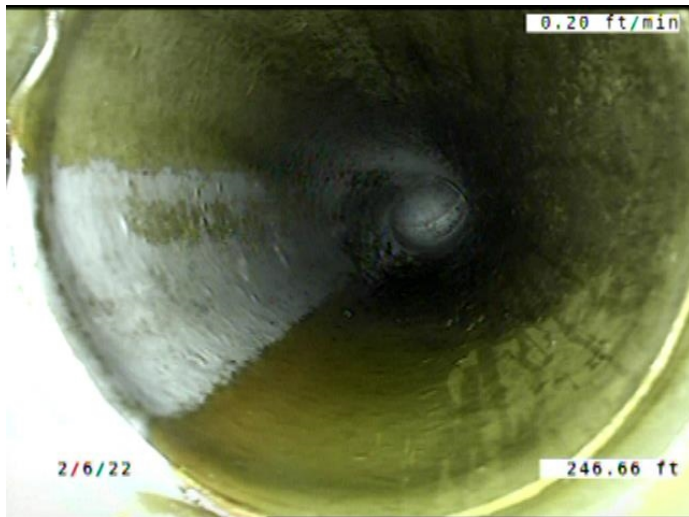
Code: **TF**
 Description: **Tap Factory**

Distance (ft): **246.7**
 Structural Grade: **0**
 O&M Grade: **0**
 Clock Start/From: **11**
 Clock To:
 1st Value: **6.000**
 2nd Value:
 Value Percent:
 Continuous Index:
 Within 8" of Joint: **YES**
 Remarks: **CONSTANTLY RUNNING WATER**

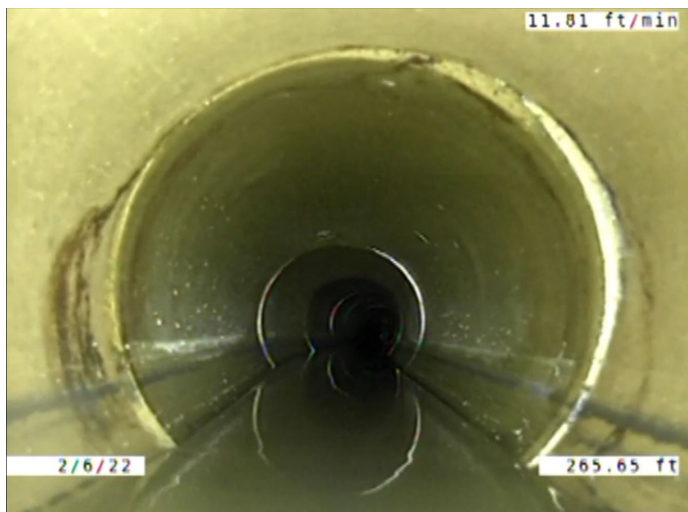
Code: **ISJ**
 Description: **Infiltration Stain Joint**

Distance (ft): **265.7**
 Structural Grade: **0**
 O&M Grade: **1**
 Clock Start/From: **8**
 Clock To: **4**
 1st Value:
 2nd Value:
 Value Percent:
 Continuous Index:
 Within 8" of Joint: **YES**
 Remarks:

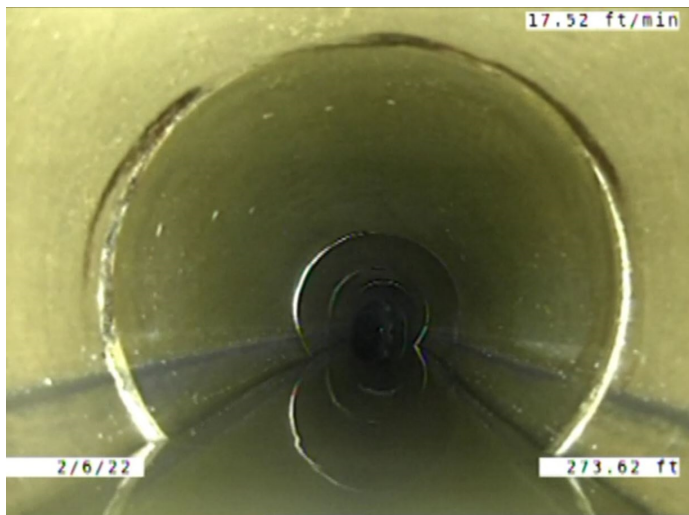
Code: **ISJ**
 Description: **Infiltration Stain Joint**

Distance (ft): **273.6**
 Structural Grade: **0**
 O&M Grade: **1**
 Clock Start/From: **10**
 Clock To: **2**
 1st Value:
 2nd Value:
 Value Percent:
 Continuous Index:
 Within 8" of Joint: **YES**
 Remarks:

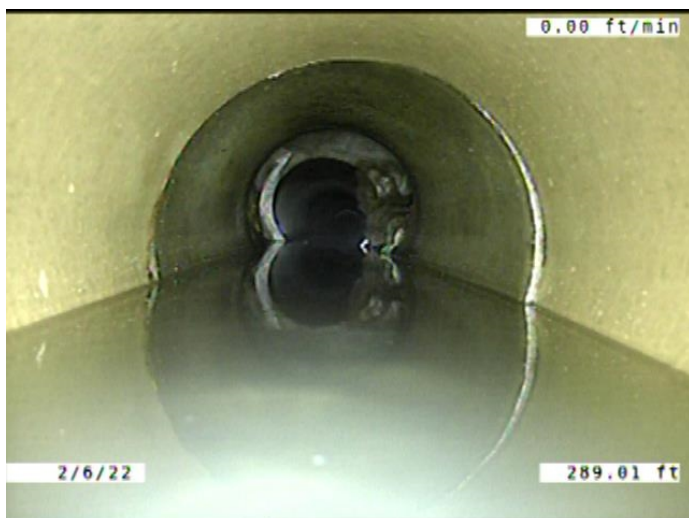
Code: **MWLS**
 Description: **Miscellaneous Water Level Sag**

Distance (ft): **289.0**
 Structural Grade: **2**
 O&M Grade: **0**
 Clock Start/From:
 Clock To:
 1st Value:
 2nd Value:
 Value Percent: **15.000**
 Continuous Index: **S03**
 Within 8" of Joint: **NO**
 Remarks:

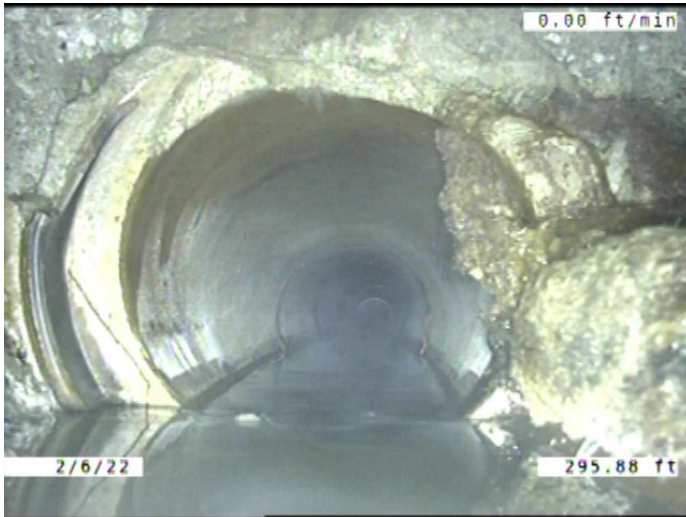
Code: **MWLS**
 Description: **Miscellaneous Water Level Sag**

Distance (ft): **295.9**
 Structural Grade: **2**
 O&M Grade: **0**
 Clock Start/From:
 Clock To:
 1st Value:
 2nd Value:
 Value Percent: **15.000**
 Continuous Index: **F03**
 Within 8" of Joint: **NO**
 Remarks:
