## Profile/Photo Observation Report

Date:	<b>02/05/2022</b>	Weather:		Coding:	<b>PACP 7.0</b>
Pipe Length (ft):	<b>238.0</b>	Owner:	<b>City of Hobart</b>	Pre Clean:	<b>Heavy Cleaning</b>
P.O.#:	<b>YES502259</b>	Surveyor:	<b>S. Bucklin</b>	PSR:	<b>P-506-004-003</b>
Customer:	<b>City of Hobart</b>	Clean Date:	<b>02/03/2022</b>	Shape:	<b>C</b>

Street:	<b>South 8th Street</b>	Flow Control:	<b>Not Controlled</b>
City:	<b>Hobart, IN</b>	Year Renewed:	
Location:	<b>Easement/Right of Way</b>	Tape/Media #:	
Purpose:	<b>Routine Assessment</b>	Dia/Height:	<b>12"</b>
Use:	<b>Sanitary Sewage Pipe</b>	Material:	<b>VCP</b>
Drain Area:		Lining:	<b>None</b>
Category:	<b>NA</b>		
Comment:			
Location Details:		Direction of Survey:	<b>Downstream</b>
US MH:	<b>M-506-004</b>	DS MH:	<b>M-506-003</b>
		Total Length Surveyed (ft):	<b>235.7</b>

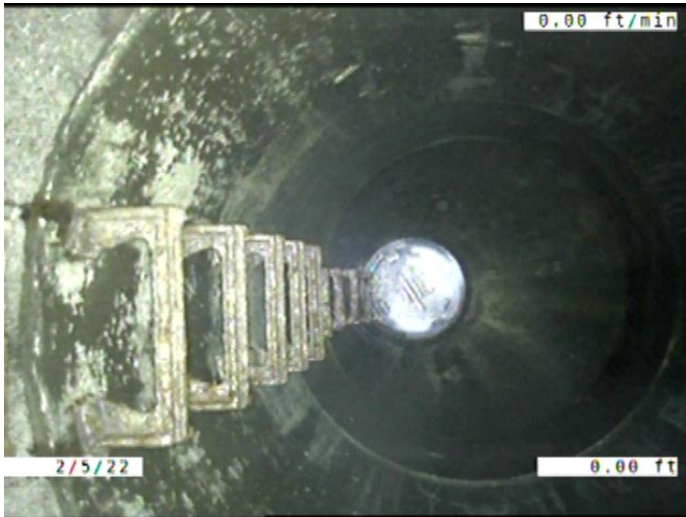
Code: **AMH**  
 Description: **Manhole**

Distance (ft): **.0**  
 Structural Grade: **0**  
 O&M Grade: **0**  
 Clock Start/From:  
 Clock To:  
 1st Value:  
 2nd Value:  
 Value Percent:  
 Continuous Index:  
 Within 8" of Joint: **NO**  
 Remarks: **M-506-004**

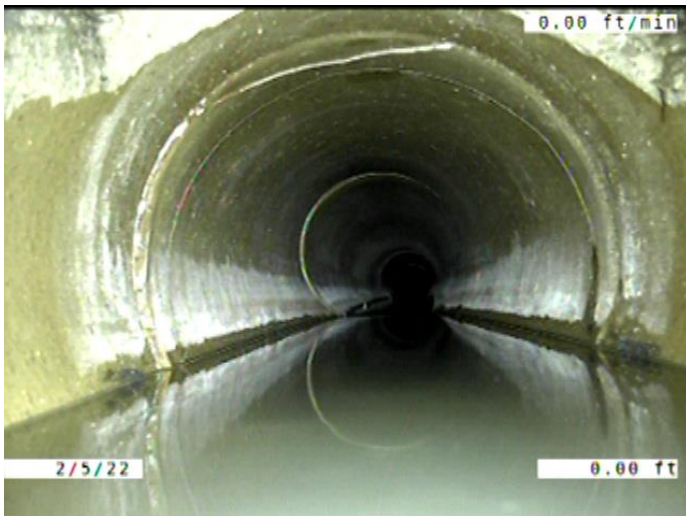
Code: **MWL**  
 Description: **Miscellaneous Water Level**

Distance (ft): **.0**  
 Structural Grade: **0**  
 O&M Grade: **0**  
 Clock Start/From:  
 Clock To:  
 1st Value:  
 2nd Value:  
 Value Percent: **10.000**  
 Continuous Index:  
 Within 8" of Joint: **NO**  
 Remarks:

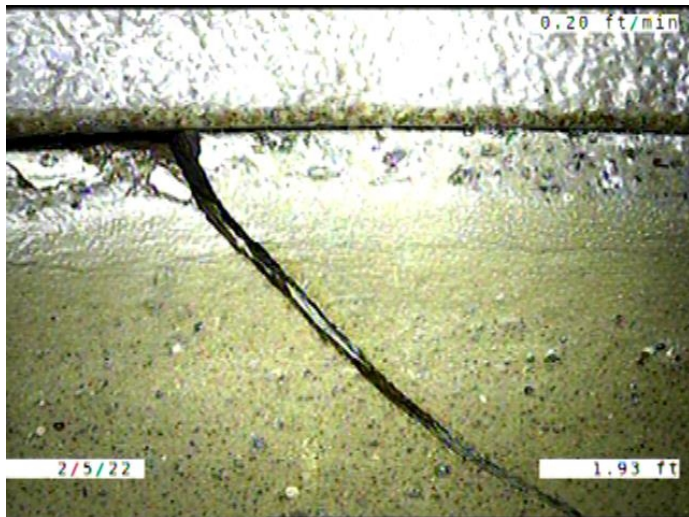
Code: **B**  
 Description: **Broken**

Distance (ft): **1.9**  
 Structural Grade: **4**  
 O&M Grade: **0**  
 Clock Start/From: **7**  
 Clock To: **5**  
 1st Value:  
 2nd Value:  
 Value Percent:  
 Continuous Index:  
 Within 8" of Joint: **YES**  
 Remarks:

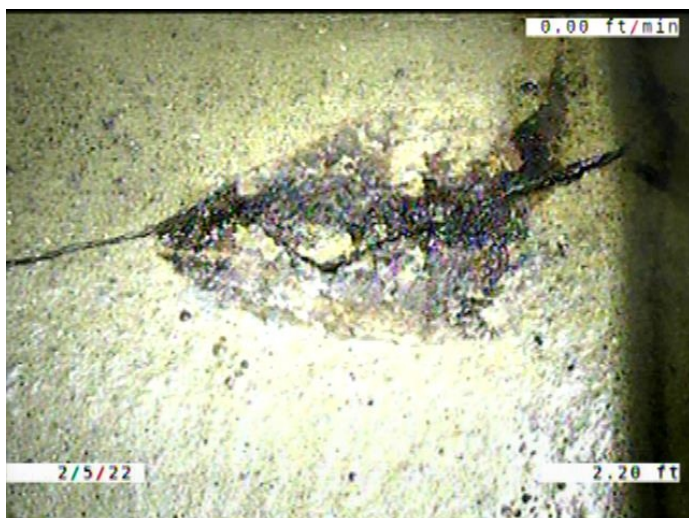
Code: **DAE**  
 Description: **Deposits Attached Encrustation**

Distance (ft): **2.2**  
 Structural Grade: **0**  
 O&M Grade: **2**  
 Clock Start/From: **3**  
 Clock To:  
 1st Value:  
 2nd Value:  
 Value Percent: **5.000**  
 Continuous Index:  
 Within 8" of Joint: **YES**  
 Remarks:

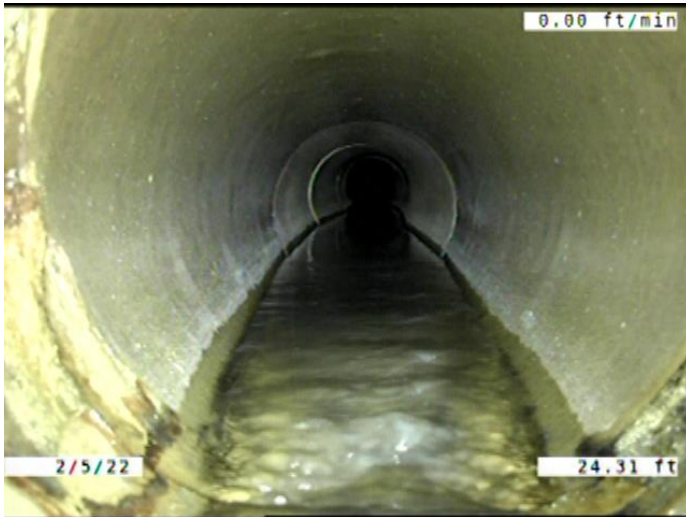
Code: **MWLS**  
 Description: **Miscellaneous Water Level Sag**

Distance (ft): **24.3**  
 Structural Grade: **2**  
 O&M Grade: **0**  
 Clock Start/From:  
 Clock To:  
 1st Value:  
 2nd Value:  
 Value Percent: **10.000**  
 Continuous Index: **S01**  
 Within 8" of Joint: **NO**  
 Remarks:

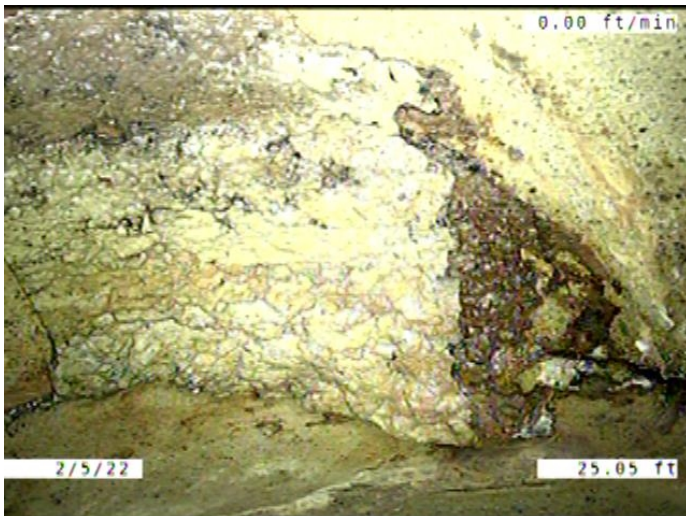
Code: **DAE**  
 Description: **Deposits Attached Encrustation**

Distance (ft): **25.0**  
 Structural Grade: **0**  
 O&M Grade: **2**  
 Clock Start/From: **3**  
 Clock To: **10**  
 1st Value:  
 2nd Value:  
 Value Percent: **5.000**  
 Continuous Index:  
 Within 8" of Joint: **YES**  
 Remarks:

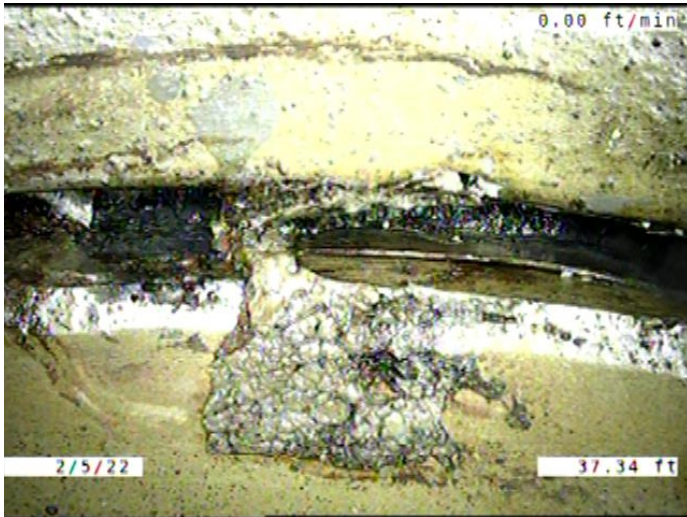
Code: **DAE**  
Description: **Deposits Attached Encrustation**

Distance (ft): **37.3**  
Structural Grade: **0**  
O&M Grade: **2**  
Clock Start/From: **8**  
Clock To: **4**  
1st Value:  
2nd Value:  
Value Percent: **5.000**  
Continuous Index: **S02**  
Within 8" of Joint: **YES**  
Remarks:

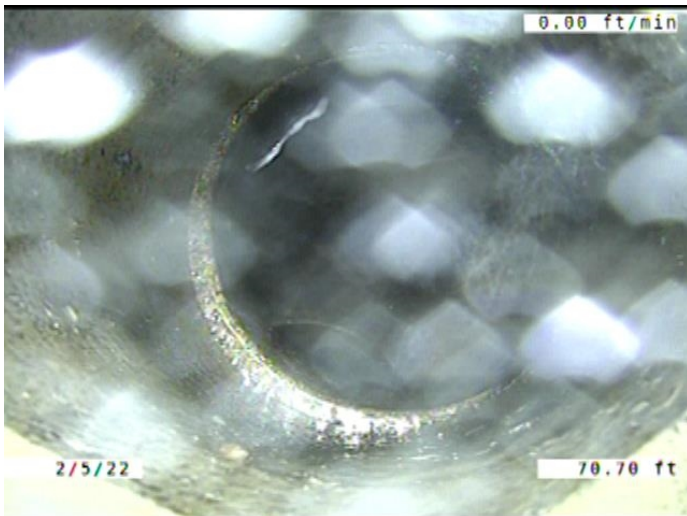
Code: **TF**  
Description: **Tap Factory**

Distance (ft): **70.7**  
Structural Grade: **0**  
O&M Grade: **0**  
Clock Start/From: **1**  
Clock To:  
1st Value: **6.000**  
2nd Value:  
Value Percent:  
Continuous Index:  
Within 8" of Joint: **NO**  
Remarks: **CONSTANTLY RUNNING WATER**

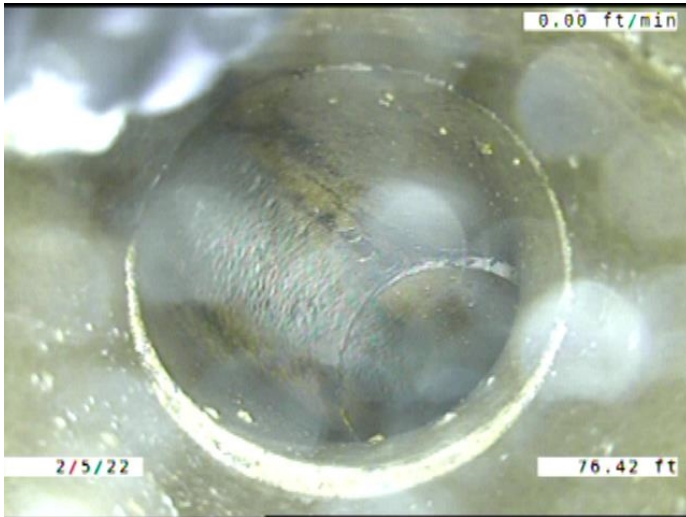
Code: **TF**  
Description: **Tap Factory**

Distance (ft): **76.4**  
Structural Grade: **0**  
O&M Grade: **0**  
Clock Start/From: **11**  
Clock To:  
1st Value: **6.000**  
2nd Value:  
Value Percent:  
Continuous Index:  
Within 8" of Joint: **YES**  
Remarks: **CONSTANTLY RUNNING WATER.**

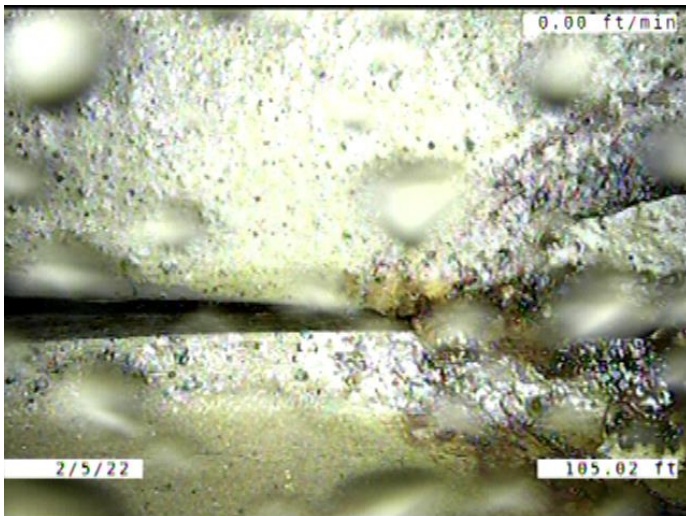
Code: **JOM**  
Description: **Joint Offset Medium**

Distance (ft): **105.0**  
Structural Grade: **3**  
O&M Grade: **0**  
Clock Start/From:  
Clock To:  
1st Value:  
2nd Value:  
Value Percent:  
Continuous Index:  
Within 8" of Joint: **NO**  
Remarks:

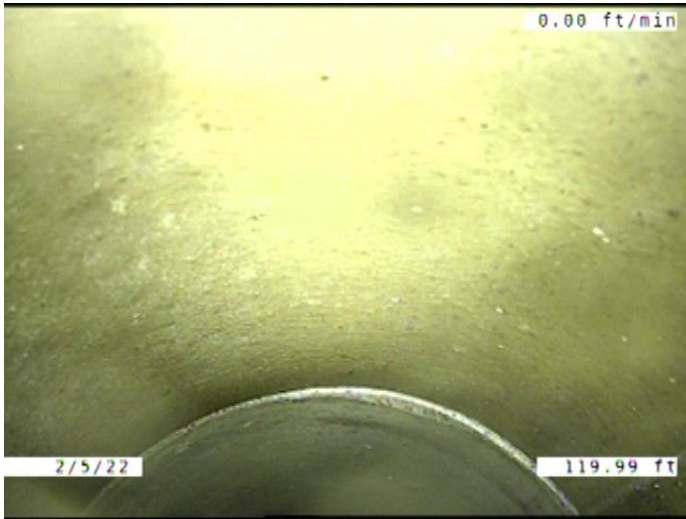
Code: **CS**  
Description: **Crack Spiral**

Distance (ft): **120.0**  
Structural Grade: **2**  
O&M Grade: **0**  
Clock Start/From: **8**  
Clock To: **2**  
1st Value:  
2nd Value:  
Value Percent:  
Continuous Index:  
Within 8" of Joint: **NO**  
Remarks:

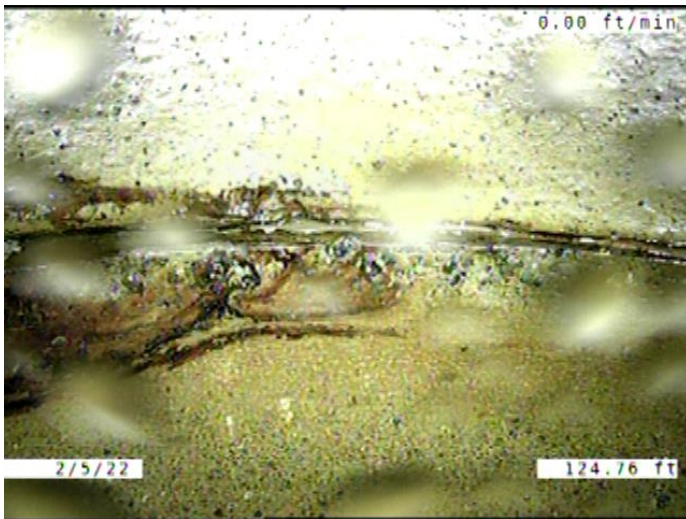
Code: **IDJ**  
Description: **Infiltration Dripper Joint**

Distance (ft): **124.8**  
Structural Grade: **0**  
O&M Grade: **3**  
Clock Start/From: **11**  
Clock To: **12**  
1st Value:  
2nd Value:  
Value Percent:  
Continuous Index:  
Within 8" of Joint: **YES**  
Remarks:

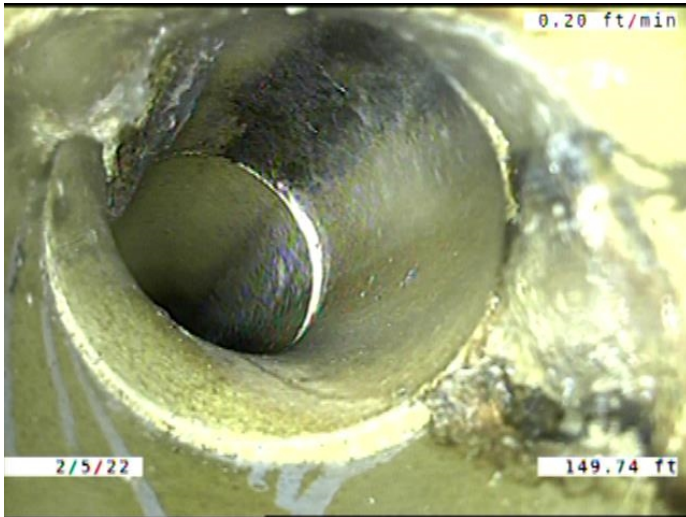
Code: **TF**  
 Description: **Tap Factory**

Distance (ft): **149.7**  
 Structural Grade: **0**  
 O&M Grade: **0**  
 Clock Start/From: **1**  
 Clock To:  
 1st Value: **6.000**  
 2nd Value:  
 Value Percent:  
 Continuous Index:  
 Within 8" of Joint: **YES**  
 Remarks: **CONSTANTLY RUNNING WATER. ENCRUSTATION COMING FROM THE**

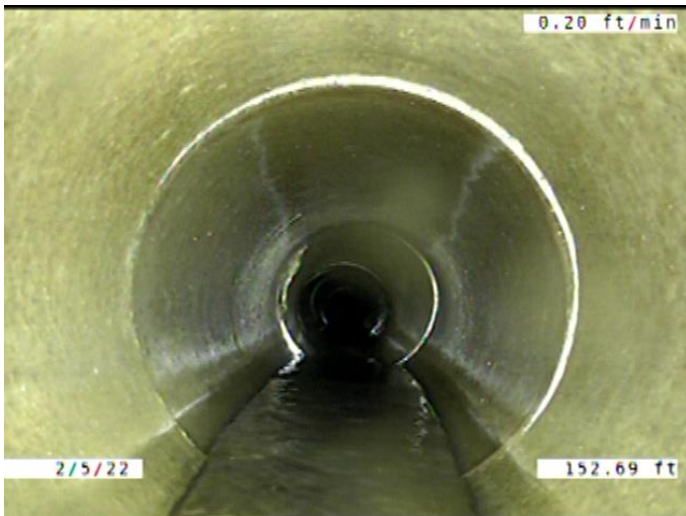
Code: **MWLS**  
 Description: **Miscellaneous Water Level Sag**

Distance (ft): **152.7**  
 Structural Grade: **2**  
 O&M Grade: **0**  
 Clock Start/From:  
 Clock To:  
 1st Value:  
 2nd Value:  
 Value Percent: **10.000**  
 Continuous Index: **F01**  
 Within 8" of Joint: **NO**  
 Remarks:

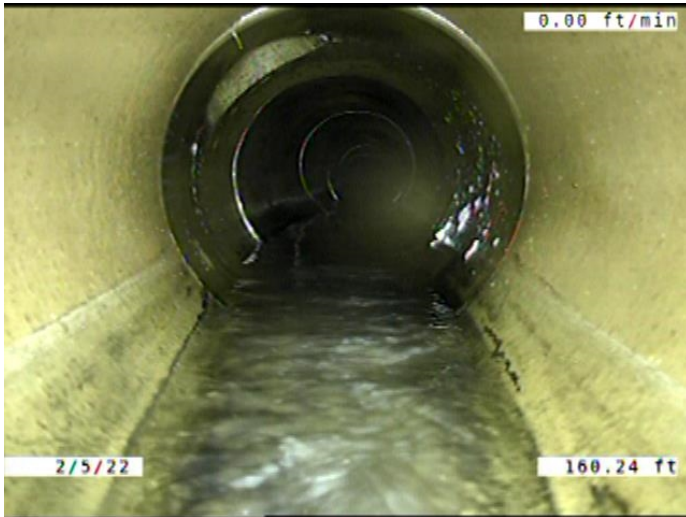
Code: **MWLS**  
Description: **Miscellaneous Water Level Sag**

Distance (ft): **160.2**  
Structural Grade: **2**  
O&M Grade: **0**  
Clock Start/From:  
Clock To:  
1st Value:  
2nd Value:  
Value Percent: **5.000**  
Continuous Index: **S03**  
Within 8" of Joint: **NO**  
Remarks:

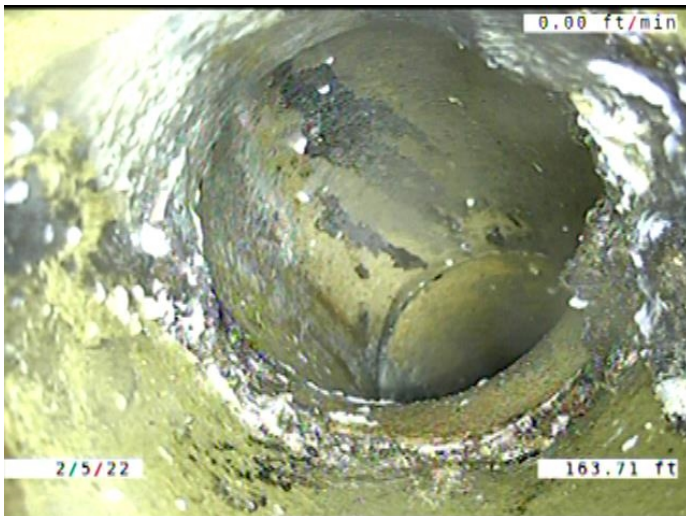
Code: **TF**  
Description: **Tap Factory**

Distance (ft): **163.7**  
Structural Grade: **0**  
O&M Grade: **0**  
Clock Start/From: **11**  
Clock To:  
1st Value: **6.000**  
2nd Value:  
Value Percent:  
Continuous Index:  
Within 8" of Joint: **YES**  
Remarks: **ENCrustation COMING FROM THE SERVICE TO MAIN CONNECTION. CO**

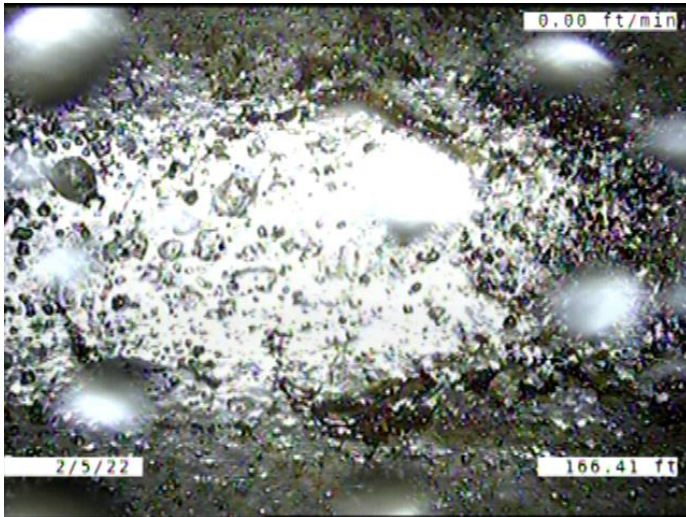
Code: **CL**  
 Description: **Crack Longitudinal**

Distance (ft): **166.4**  
 Structural Grade: **2**  
 O&M Grade: **0**  
 Clock Start/From: **1**  
 Clock To:  
 1st Value:  
 2nd Value:  
 Value Percent:  
 Continuous Index:  
 Within 8" of Joint: **YES**  
 Remarks:

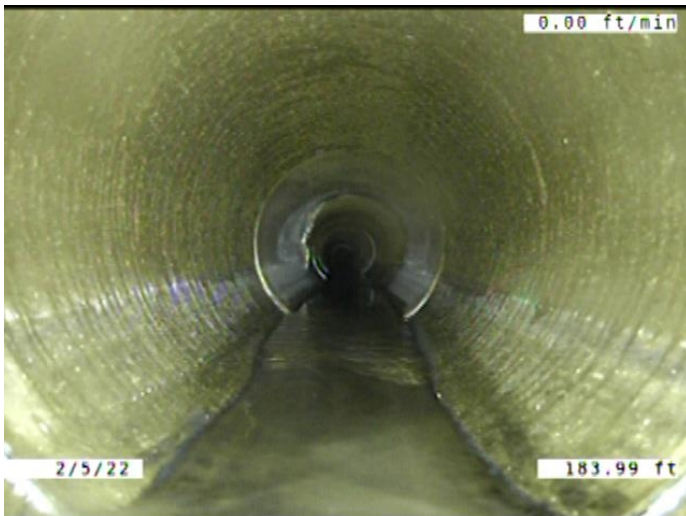
Code: **MWLS**  
 Description: **Miscellaneous Water Level Sag**

Distance (ft): **184.0**  
 Structural Grade: **2**  
 O&M Grade: **0**  
 Clock Start/From:  
 Clock To:  
 1st Value:  
 2nd Value:  
 Value Percent: **5.000**  
 Continuous Index: **F03**  
 Within 8" of Joint: **NO**  
 Remarks:

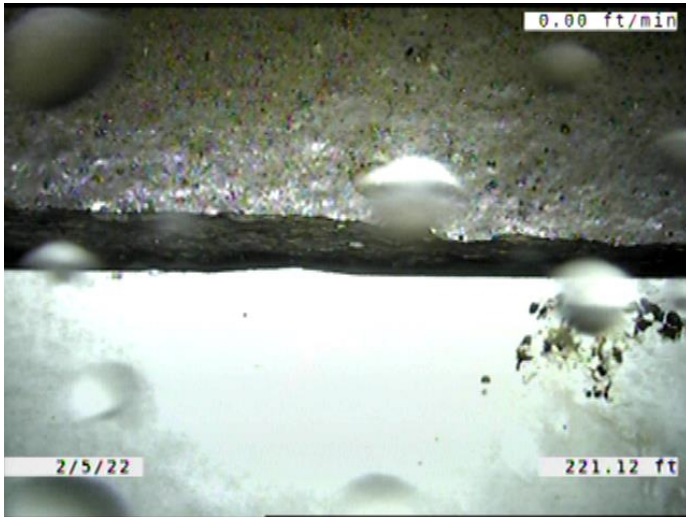
Code: **MMC**  
Description: **Miscellaneous Material Change**

Distance (ft): **221.1**  
Structural Grade: **0**  
O&M Grade: **0**  
Clock Start/From:  
Clock To:  
1st Value:  
2nd Value:  
Value Percent:  
Continuous Index:  
Within 8" of Joint: **NO**  
Remarks: **VCP TO PVC**

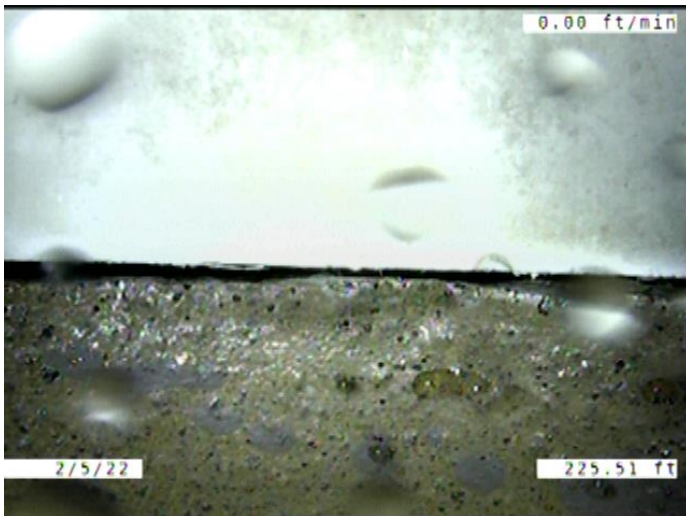
Code: **MMC**  
Description: **Miscellaneous Material Change**

Distance (ft): **225.5**  
Structural Grade: **0**  
O&M Grade: **0**  
Clock Start/From:  
Clock To:  
1st Value:  
2nd Value:  
Value Percent:  
Continuous Index:  
Within 8" of Joint: **NO**  
Remarks: **PVC TO VCP**

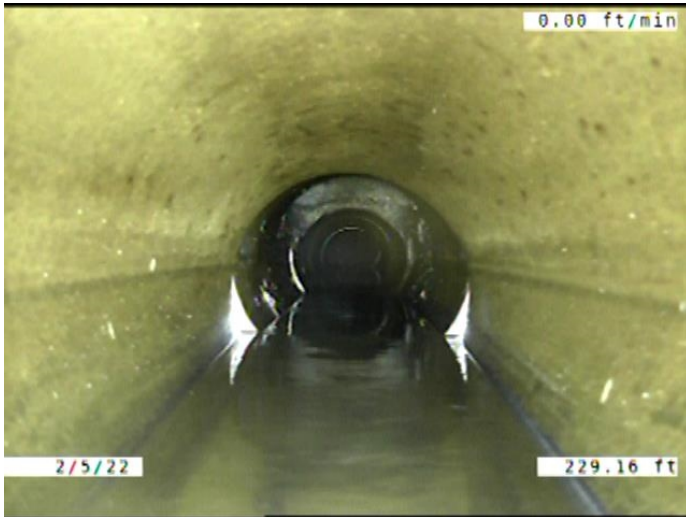
Code: **MWLS**  
Description: **Miscellaneous Water Level Sag**

Distance (ft): **229.2**  
Structural Grade: **2**  
O&M Grade: **0**  
Clock Start/From:  
Clock To:  
1st Value:  
2nd Value:  
Value Percent: **5.000**  
Continuous Index: **S04**  
Within 8" of Joint: **NO**  
Remarks:

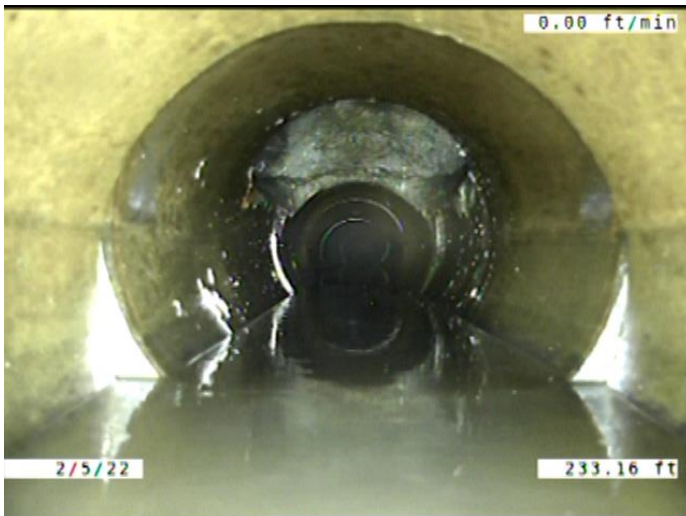
Code: **JOM**  
Description: **Joint Offset Medium**

Distance (ft): **233.2**  
Structural Grade: **3**  
O&M Grade: **0**  
Clock Start/From:  
Clock To:  
1st Value:  
2nd Value:  
Value Percent:  
Continuous Index:  
Within 8" of Joint: **NO**  
Remarks:

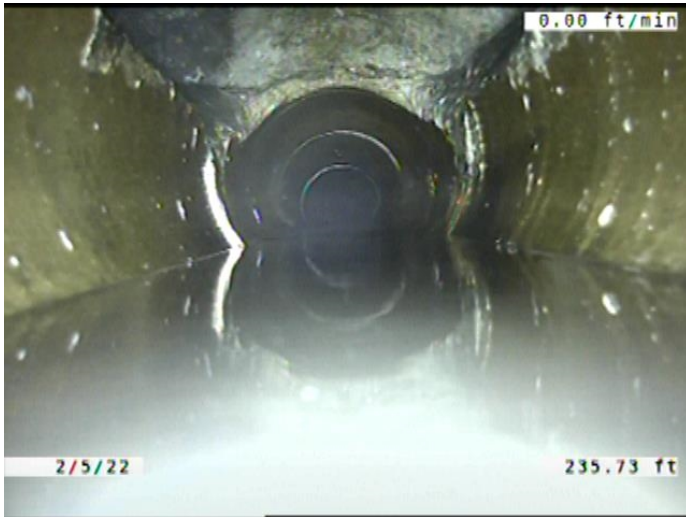
Code: **DAE**  
Description: **Deposits Attached Encrustation**

Distance (ft): **235.7**  
Structural Grade: **0**  
O&M Grade: **2**  
Clock Start/From: **8**  
Clock To: **4**  
1st Value:  
2nd Value:  
Value Percent: **5.000**  
Continuous Index: **F02**  
Within 8" of Joint: **YES**  
Remarks:

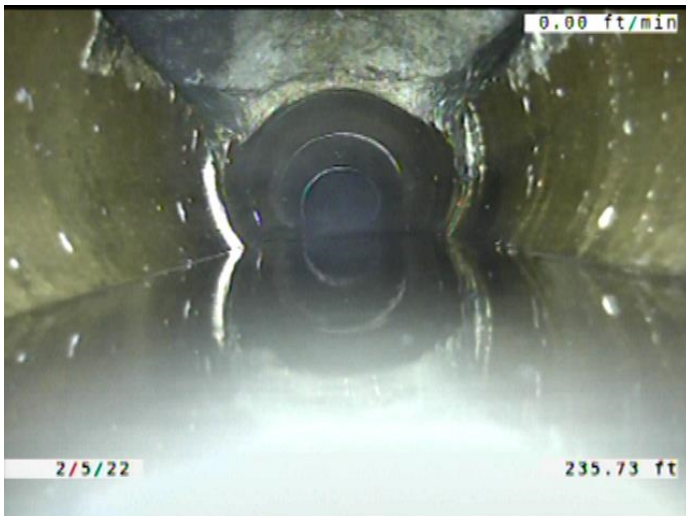
Code: **MWLS**  
Description: **Miscellaneous Water Level Sag**

Distance (ft): **235.7**  
Structural Grade: **2**  
O&M Grade: **0**  
Clock Start/From:  
Clock To:  
1st Value:  
2nd Value:  
Value Percent: **5.000**  
Continuous Index: **F04**  
Within 8" of Joint: **NO**  
Remarks:

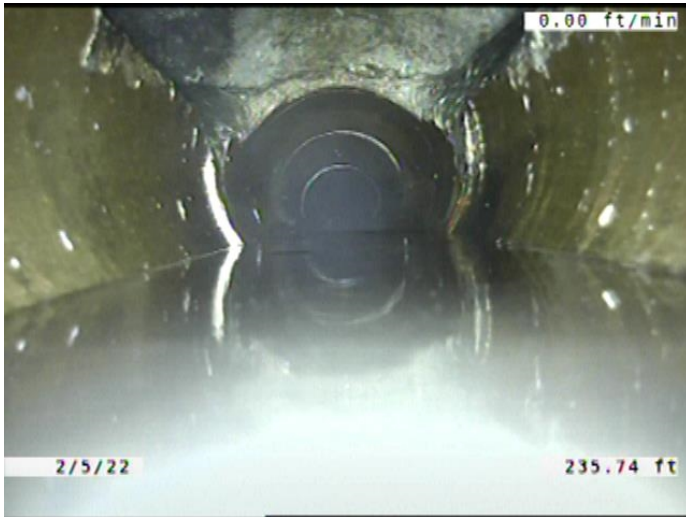
Code:	MSA
Description:	Miscellaneous Survey Abandoned
Distance (ft):	235.7
Structural Grade:	0
O&M Grade:	0
Clock Start/From:	
Clock To:	
1st Value:	
2nd Value:	
Value Percent:	
Continuous Index:	
Within 8" of Joint:	NO
Remarks:	CAMERA CANT MAKEIT PAST OFFSET JOINT
