## Profile/Photo Observation Report

Street:	<b>W 8TH ST</b>	Flow Control:	<b>Not Controlled</b>
City:	<b>Hobart, IN</b>	Year Renewed:	
Location:	<b>Yard</b>	Tape/Media #:	
Purpose:	<b>Routine Assessment</b>	Dia/Height:	<b>12"</b>
Use:	<b>Sanitary</b>	Material:	<b>VCP</b>
Drain Area:	<b>NA</b>	Lining:	
Category:	<b>NA</b>		
Comment:	<b>False MH_F, P_C debris.</b>

Location Details:		Direction of Survey:	<b>Downstream</b>
US MH:	<b>M-506-006</b>	DS MH:	<b>M-506-005</b>
		Total Length Surveyed (ft):	<b>22.9</b>

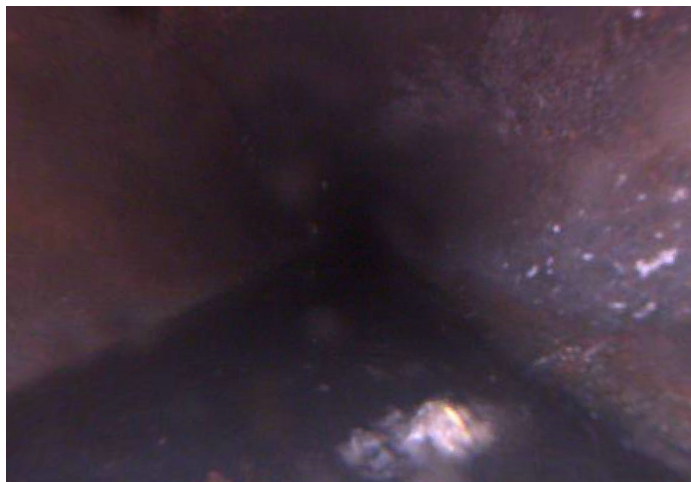
Code: **AMH**  
Description: **Manhole**

Distance (ft): **.0**  
Structural Grade: **0**  
O&M Grade: **0**  
Clock Start/From:  
Clock To:  
1st Value:  
2nd Value:  
Value Percent:  
Continuous Index:  
Within 8" of Joint: **NO**  
Remarks: **M-506-006**

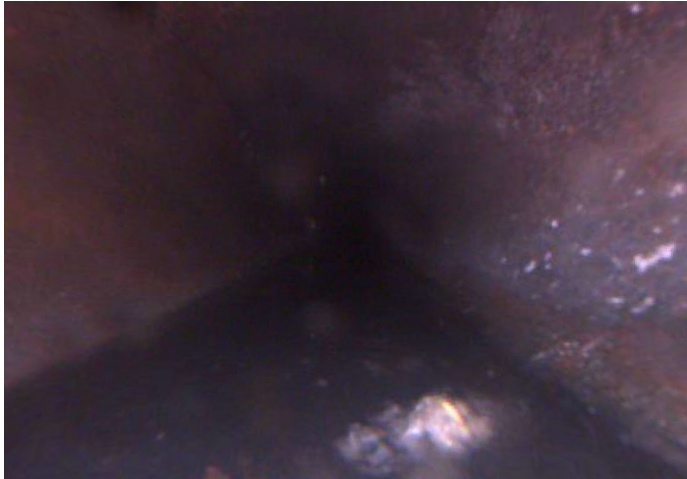
Code:	<b>MWL</b>
Description:	<b>Water Level</b>
Distance (ft):	<b>.0</b>
Structural Grade:	<b>0</b>
O&M Grade:	<b>0</b>
Clock Start/From:	
Clock To:	
1st Value:	
2nd Value:	
Value Percent:	<b>10.000</b>
Continuous Index:	
Within 8" of Joint:	<b>NO</b>
Remarks:

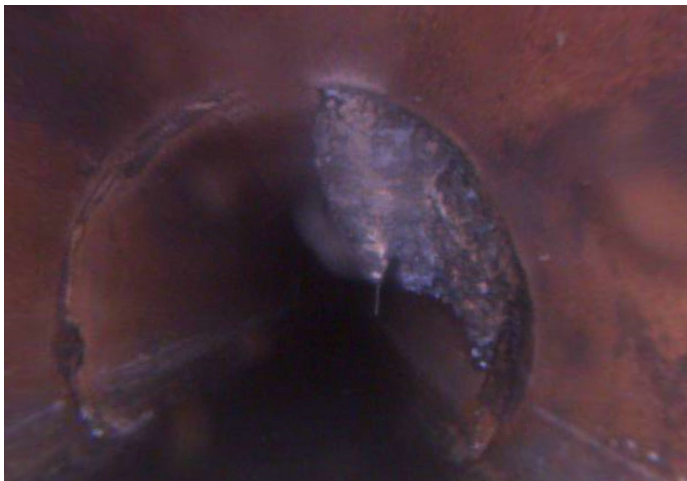
Code:	<b>DAE</b>
Description:	<b>Deposits Attached Encrustation</b>
Distance (ft):	<b>20.1</b>
Structural Grade:	<b>0</b>
O&M Grade:	<b>3</b>
Clock Start/From:	<b>12</b>
Clock To:	<b>3</b>
1st Value:	
2nd Value:	
Value Percent:	<b>15.000</b>
Continuous Index:	
Within 8" of Joint:	<b>YES</b>
Remarks:

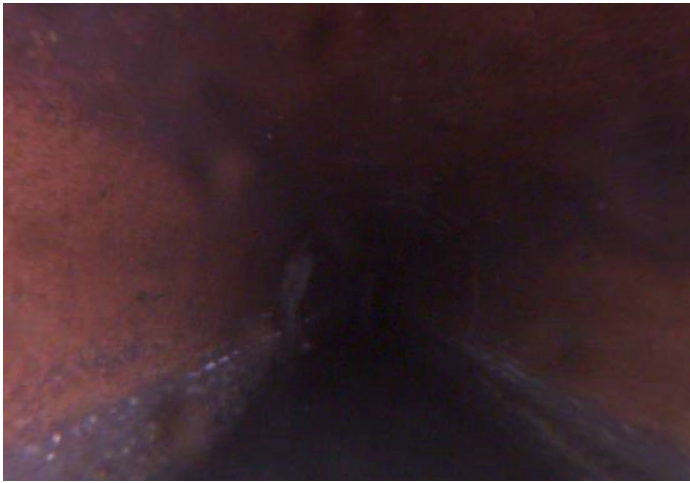
Code:	MSA
Description:	Abandoned Survey
Distance (ft):	22.9
Structural Grade:	0
O&M Grade:	0
Clock Start/From:	
Clock To:	
1st Value:	
2nd Value:	
Value Percent:	
Continuous Index:	
Within 8" of Joint:	NO
Remarks:	Unknown
