Profile/Photo Observation Report

Street:	FOXCROFT STREET	Flow Control:	Not Controlled
City:	Hobart, IN	Year Renewed:	
Location:	Yard	Tape/Media #:	
Purpose:	Routine Assessment	Dia/Height:	12"
Use:	Sanitary	Material:	VCP
Drain Area:	NA	Lining:	
Category:	NA		
Comment:	False MH_F, P_C debris.

Location Details:		Direction of Survey:	Downstream
US MH:	M-506-006	DS MH:	M-506-005
		Total Length Surveyed (ft):	22.9

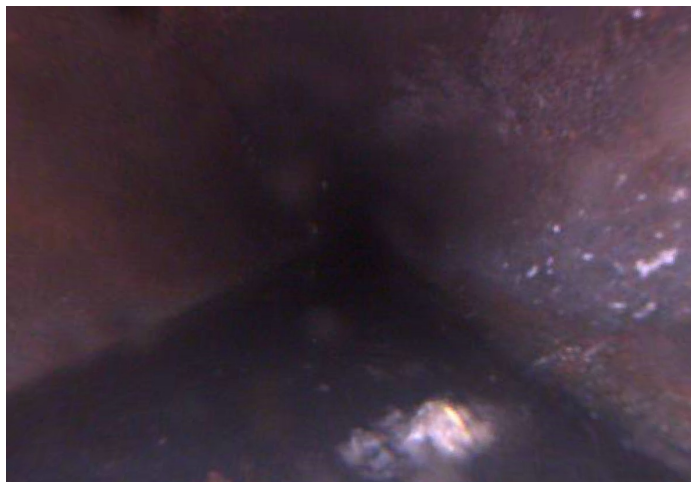
Code: **AMH**
 Description: **Manhole**

Distance (ft): **.0**
 Structural Grade: **0**
 O&M Grade: **0**
 Clock Start/From:
 Clock To:
 1st Value:
 2nd Value:
 Value Percent:
 Continuous Index:
 Within 8" of Joint: **NO**
 Remarks: **M-506-006**

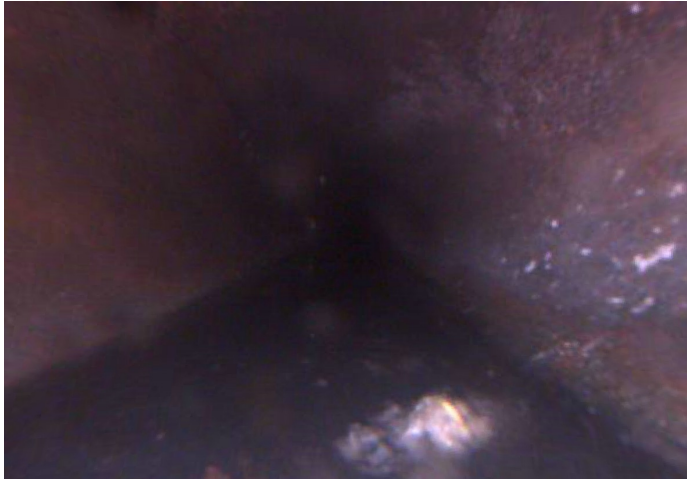
Code:	MWL
Description:	Water Level
Distance (ft):	.0
Structural Grade:	0
O&M Grade:	0
Clock Start/From:	
Clock To:	
1st Value:	
2nd Value:	
Value Percent:	10.000
Continuous Index:	
Within 8" of Joint:	NO
Remarks:

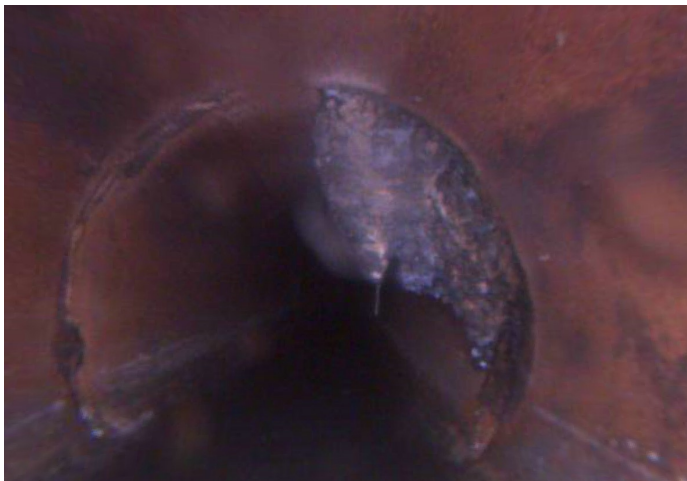
Code:	DAE
Description:	Deposits Attached Encrustation
Distance (ft):	20.1
Structural Grade:	0
O&M Grade:	3
Clock Start/From:	12
Clock To:	3
1st Value:	
2nd Value:	
Value Percent:	15.000
Continuous Index:	
Within 8" of Joint:	YES
Remarks:

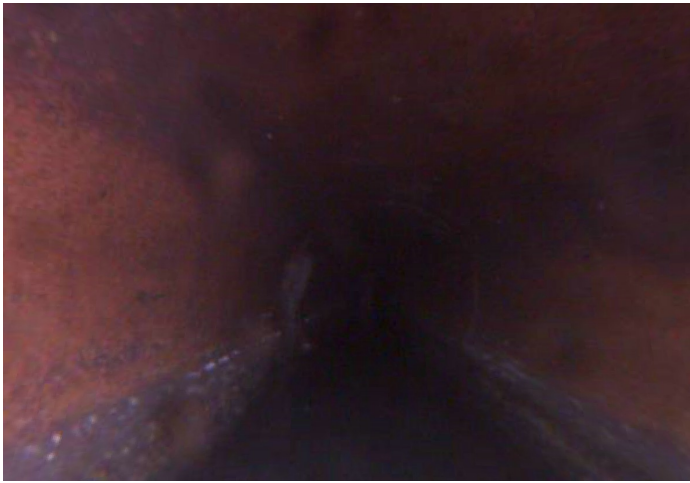
Code:	MSA
Description:	Abandoned Survey
Distance (ft):	22.9
Structural Grade:	0
O&M Grade:	0
Clock Start/From:	
Clock To:	
1st Value:	
2nd Value:	
Value Percent:	
Continuous Index:	
Within 8" of Joint:	NO
Remarks:	Unknown
