Profile/Photo Observation Report

| Street: | W 8TH ST & S COLORADO ST | Flow Control: | Not Controlled |
| City: | Hobart, IN | Year Renewed: | |
| US MH: | M-506-006 | DS MH: | M-506-033 |

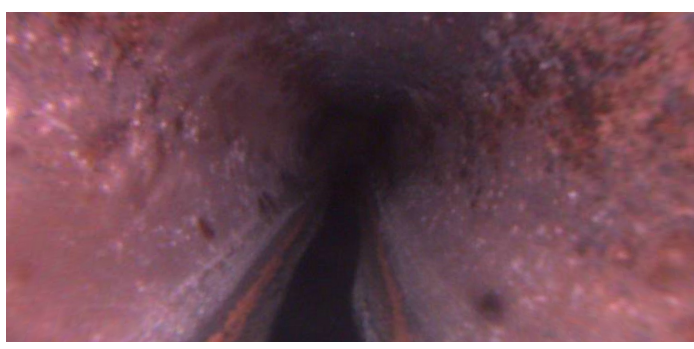
Code: **AMH**
Description: **Manhole**

Distance (ft): **.0**
Structural Grade: **0**
O&M Grade: **0**
Clock Start/From:
Clock To:
1st Value:
2nd Value:
Value Percent:
Continuous Index:
Within 8" of Joint: **NO**
Remarks: **M-506-033**

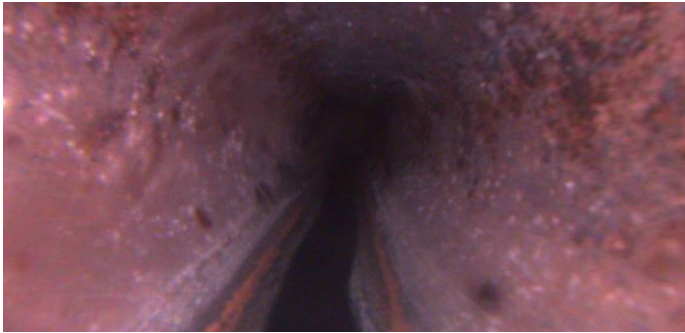
| Code: | MWL |

| Description: | Water Level |

| Distance (ft): | .0 |
| Value Percent: | 5.000 |

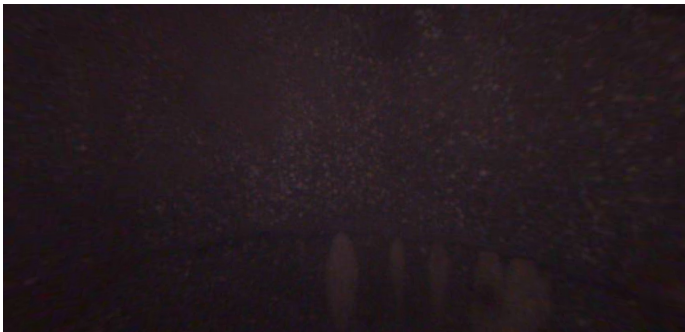
| Code: | AMH |

| Description: | Manhole |

| Distance (ft): | 6.5 |
| Remarks: | M-506-006 |
