## Profile/Photo Observation Report

Street:	<b>FOXCROFT STREET</b>	Flow Control:	<b>Not Controlled</b>
City:	<b>Hobart, IN</b>	Year Renewed:	
Location:	<b>Yard</b>	Tape/Media #:	
Purpose:	<b>Routine Assessment</b>	Dia/Height:	<b>10"</b>
Use:	<b>Sanitary</b>	Material:	<b>VCP</b>
Drain Area:	<b>NA</b>	Lining:	
Category:	<b>NA</b>		
Comment:	<b>Flow direction is marked wrong.</b>		
Location Details:		Direction of Survey:	<b>Upstream</b>
US MH:	<b>M-506-006</b>	DS MH:	<b>M-506-033</b>
		Total Length Surveyed (ft):	<b>6.5</b>

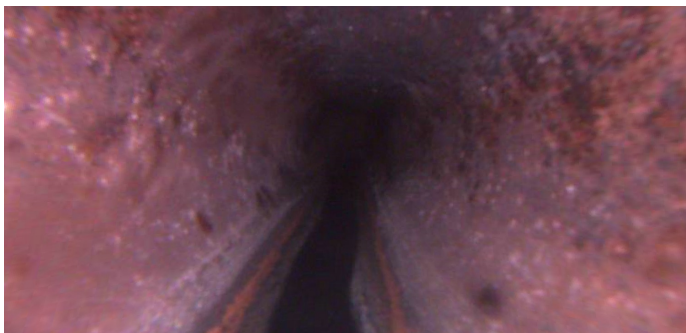
Code: **AMH**  
Description: **Manhole**

Distance (ft): **.0**  
Structural Grade: **0**  
O&M Grade: **0**  
Clock Start/From:  
Clock To:  
1st Value:  
2nd Value:  
Value Percent:  
Continuous Index:  
Within 8" of Joint: **NO**  
Remarks: **M-506-033**

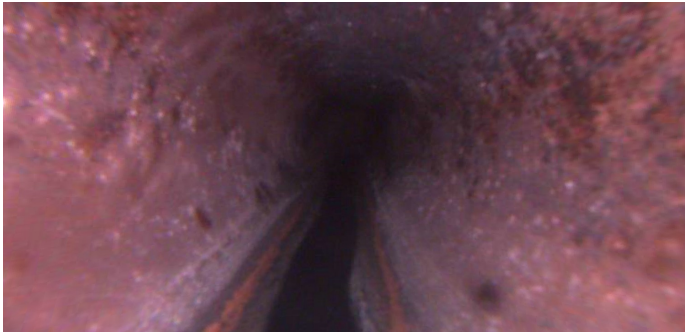
Code:	<b>MWL</b>
Description:	<b>Water Level</b>

Distance (ft):	<b>.0</b>
Structural Grade:	<b>0</b>
O&M Grade:	<b>0</b>
Clock Start/From:	
Clock To:	
1st Value:	
2nd Value:	
Value Percent:	<b>5.000</b>
Continuous Index:	
Within 8" of Joint:	<b>NO</b>
Remarks:
