Profile/Photo Observation Report

Date:	04/06/2018	Weather:		Coding:	PACP 6.0
Pipe Length (ft):	212.4	Owner:	NA	Pre Clean:	No Pre-Cleaning
P.O.#:		Surveyor:	Mark Ruby	PSR:	P-506-009-008
Customer:		Clean Date:	01/01/1900	Shape:	C

Street:	CARDINAL CT	Flow Control:	Not Controlled
City:	Hobart, IN	Year Renewed:	
Location:	Yard	Tape/Media #:	
Purpose:	Routine Assessment	Dia/Height:	10"
Use:	Sanitary	Material:	VCP
Drain Area:	NA	Lining:	
Category:	NA		
Comment:	Flow direction is wrong.		
Location Details:		Direction of Survey:	Upstream
US MH:	M-506-008	DS MH:	M-506-009
		Total Length Surveyed (ft):	105.8

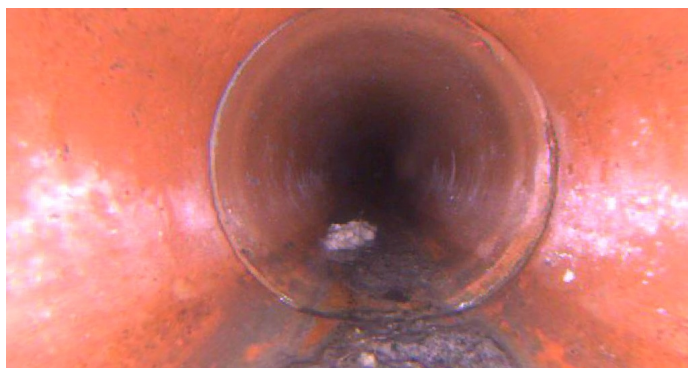
Code: **AMH**
Description: **Manhole**

Distance (ft): **.0**
Structural Grade: **0**
O&M Grade: **0**
Clock Start/From:
Clock To:
1st Value:
2nd Value:
Value Percent:
Continuous Index:
Within 8" of Joint: **NO**
Remarks: **M-506-009**

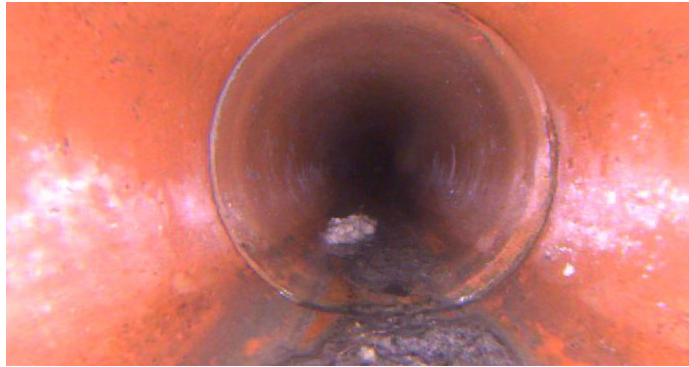
Code: **MWL**
Description: **Water Level**

Distance (ft): **.0**
Structural Grade: **0**
O&M Grade: **0**
Clock Start/From:
Clock To:
1st Value:
2nd Value:
Value Percent: **10.000**
Continuous Index:
Within 8" of Joint: **NO**
Remarks:

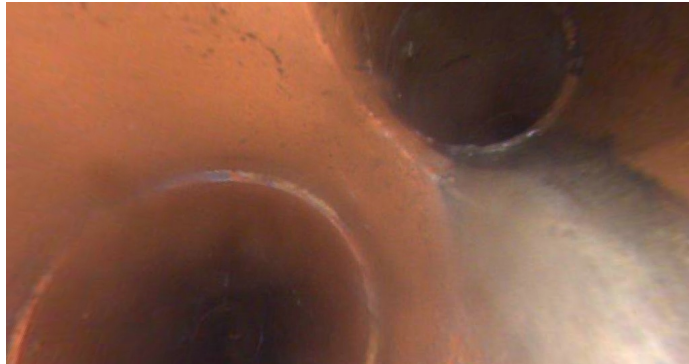
Code: **TF**
Description: **Tap Factory**

Distance (ft): **26.6**
Structural Grade: **0**
O&M Grade: **0**
Clock Start/From: **10**
Clock To:
1st Value: **4.000**
2nd Value:
Value Percent:
Continuous Index:
Within 8" of Joint:
Remarks:

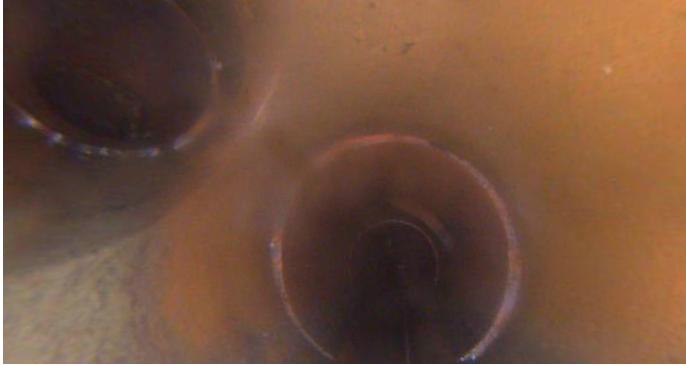
Code: **TF**
Description: **Tap Factory**

Distance (ft): **28.7**
Structural Grade: **0**
O&M Grade: **0**
Clock Start/From: **2**
Clock To:
1st Value: **4.000**
2nd Value:
Value Percent:
Continuous Index:
Within 8" of Joint:
Remarks:

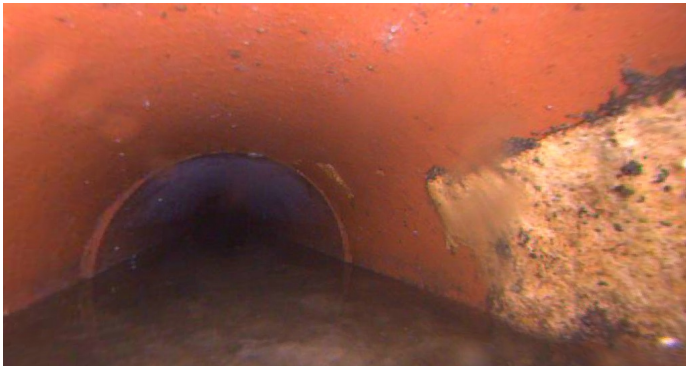
Code: **CL**
Description: **Crack Longitudinal**

Distance (ft): **60.4**
Structural Grade: **2**
O&M Grade: **0**
Clock Start/From: **3**
Clock To:
1st Value:
2nd Value:
Value Percent:
Continuous Index:
Within 8" of Joint:
Remarks:

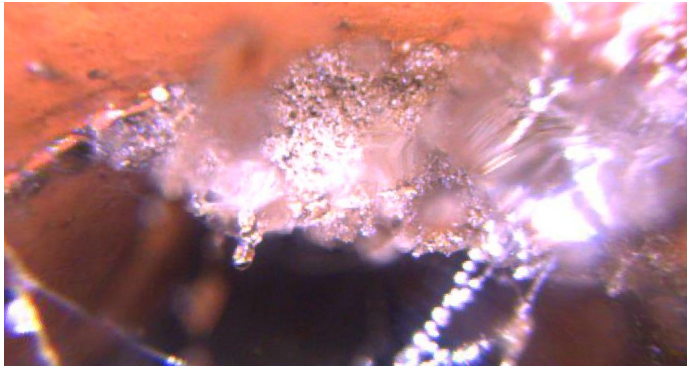
Code: **RMJ**
Description: **Roots Medium Joint**

Distance (ft): **105.3**
Structural Grade: **0**
O&M Grade: **3**
Clock Start/From: **11**
Clock To: **4**
1st Value:
2nd Value:
Value Percent: **10.000**
Continuous Index:
Within 8" of Joint: **YES**
Remarks:

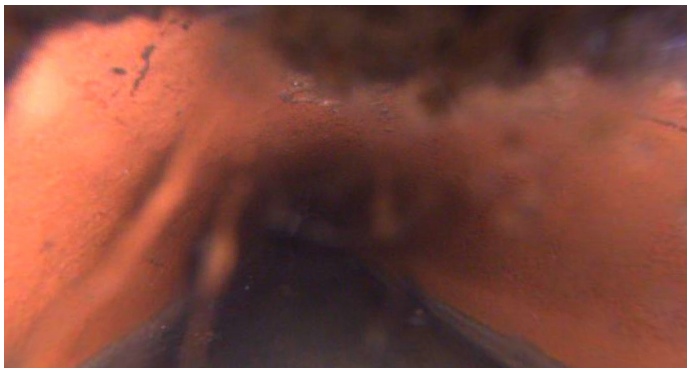
Code: **MSA**
Description: **Abandoned Survey**

Distance (ft): **105.8**
Structural Grade: **0**
O&M Grade: **0**
Clock Start/From:
Clock To:
1st Value:
2nd Value:
Value Percent:
Continuous Index:
Within 8" of Joint: **NO**
Remarks: **Roots**
