Profile/Photo Observation Report

Date:	04/06/2018	Weather:		Coding:	PACP 6.0
Pipe Length (ft):	212.4	Owner:	NA	Pre Clean:	No Pre-Cleaning
P.O.#:		Surveyor:	Mark Ruby	PSR:	P-506-009-008
Customer:		Clean Date:	01/01/1900	Shape:	C

Street:	FOXCROFT STREET	Flow Control:	Not Controlled
City:	Hobart, IN	Year Renewed:	
Location:	Yard	Tape/Media #:	
Purpose:	Routine Assessment	Dia/Height:	10"
Use:	Sanitary	Material:	VCP
Drain Area:	NA	Lining:	
Category:	NA		
Comment:	Flow direction is wrong.		
Location Details:		Direction of Survey:	Upstream
US MH:	M-506-008	DS MH:	M-506-009
		Total Length Surveyed (ft):	105.8

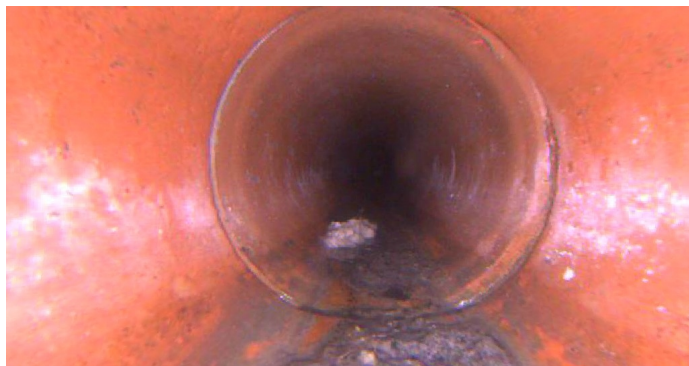
Code: **AMH**
Description: **Manhole**

Distance (ft): **.0**
Structural Grade: **0**
O&M Grade: **0**
Clock Start/From:
Clock To:
1st Value:
2nd Value:
Value Percent:
Continuous Index:
Within 8" of Joint: **NO**
Remarks: **M-506-009**

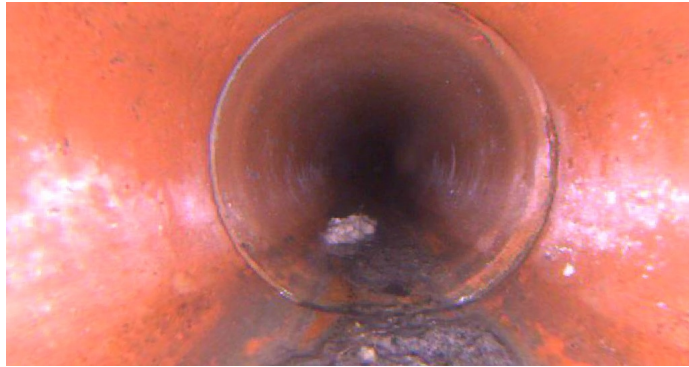
Code: **MWL**
Description: **Water Level**

Distance (ft): **.0**
Structural Grade: **0**
O&M Grade: **0**
Clock Start/From:
Clock To:
1st Value:
2nd Value:
Value Percent: **10.000**
Continuous Index:
Within 8" of Joint: **NO**
Remarks:

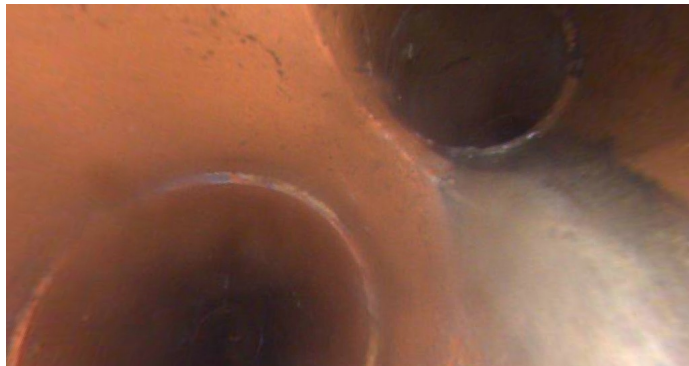
Code: **TF**
Description: **Tap Factory**

Distance (ft): **26.6**
Structural Grade: **0**
O&M Grade: **0**
Clock Start/From: **10**
Clock To:
1st Value: **4.000**
2nd Value:
Value Percent:
Continuous Index:
Within 8" of Joint:
Remarks:

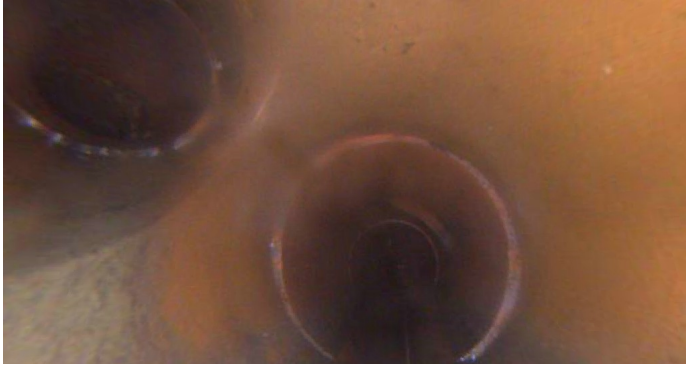
Code: **TF**
Description: **Tap Factory**

Distance (ft): **28.7**
Structural Grade: **0**
O&M Grade: **0**
Clock Start/From: **2**
Clock To:
1st Value: **4.000**
2nd Value:
Value Percent:
Continuous Index:
Within 8" of Joint:
Remarks:

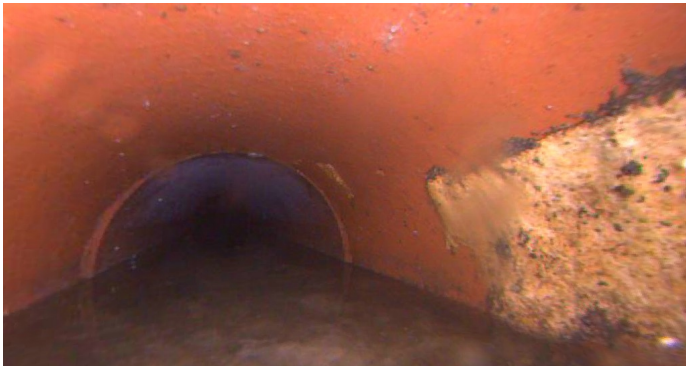
Code: **CL**
Description: **Crack Longitudinal**

Distance (ft): **60.4**
Structural Grade: **2**
O&M Grade: **0**
Clock Start/From: **3**
Clock To:
1st Value:
2nd Value:
Value Percent:
Continuous Index:
Within 8" of Joint:
Remarks:

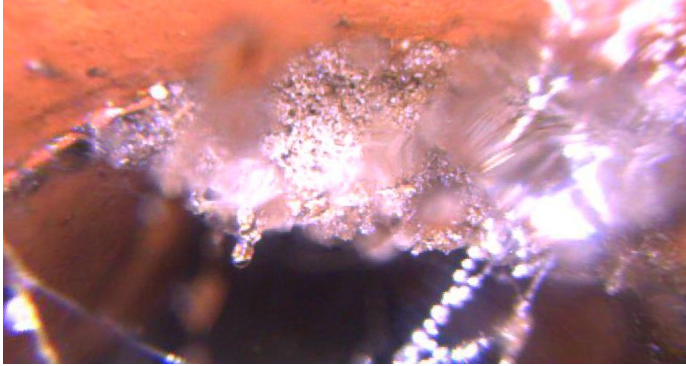
Code: **RMJ**
Description: **Roots Medium Joint**

Distance (ft): **105.3**
Structural Grade: **0**
O&M Grade: **3**
Clock Start/From: **11**
Clock To: **4**
1st Value:
2nd Value:
Value Percent: **10.000**
Continuous Index:
Within 8" of Joint: **YES**
Remarks:

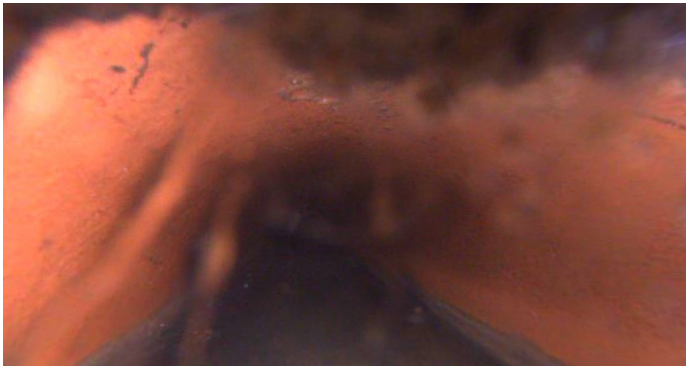
Code: **MSA**
Description: **Abandoned Survey**

Distance (ft): **105.8**
Structural Grade: **0**
O&M Grade: **0**
Clock Start/From:
Clock To:
1st Value:
2nd Value:
Value Percent:
Continuous Index:
Within 8" of Joint: **NO**
Remarks: **Roots**
