Profile/Photo Observation Report

Date:	01/19/2022	Weather:		Coding:	PACP 7.0
Pipe Length (ft):	212.2	Owner:	City of Hobart	Pre Clean:	Heavy Cleaning
P.O.#:	YES502259	Surveyor:	S. Bucklin	PSR:	P-506-009-008
Customer:	City of Hobart	Clean Date:	01/18/2022	Shape:	C

Street:	Cardinal Court	Flow Control:	Not Controlled
City:	Hobart, IN	Year Renewed:	
Location:	Local rural streets with light traffic, t	Tape/Media #:	
Purpose:	Routine Assessment	Dia/Height:	10"
Use:	Sanitary Sewage Pipe	Material:	VCP
Drain Area:		Lining:	None
Category:	NA		
Comment:			
Location Details:		Direction of Survey:	Downstream
US MH:	M-506-008	DS MH:	M-506-009
		Total Length Surveyed (ft):	212.2

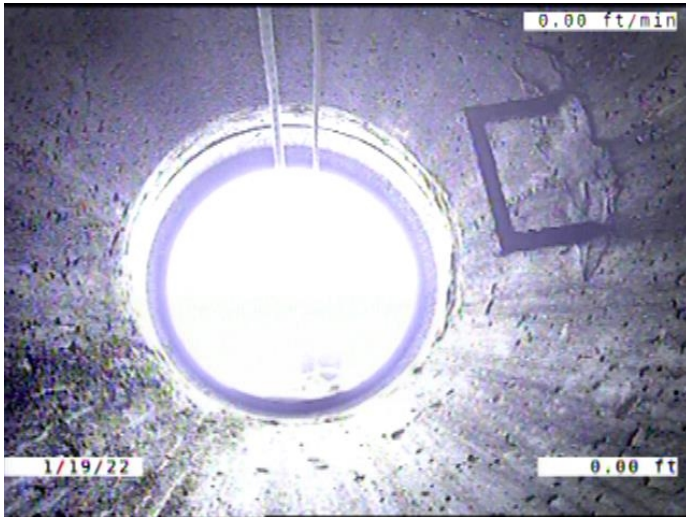
Code: **AMH**
 Description: **Manhole**

Distance (ft): **.0**
 Structural Grade: **0**
 O&M Grade: **0**
 Clock Start/From:
 Clock To:
 1st Value:
 2nd Value:
 Value Percent:
 Continuous Index:
 Within 8" of Joint: **NO**
 Remarks: **M-506-008**

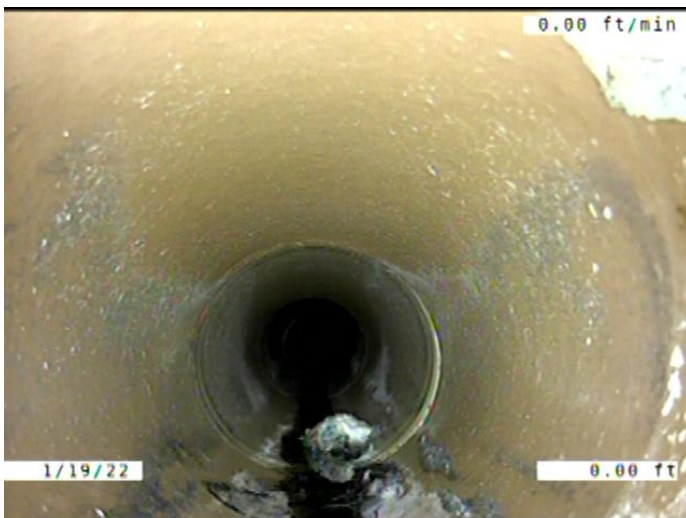
Code: **MWL**
 Description: **Miscellaneous Water Level**

Distance (ft): **.0**
 Structural Grade: **0**
 O&M Grade: **0**
 Clock Start/From:
 Clock To:
 1st Value:
 2nd Value:
 Value Percent: **5.000**
 Continuous Index:
 Within 8" of Joint: **NO**
 Remarks:

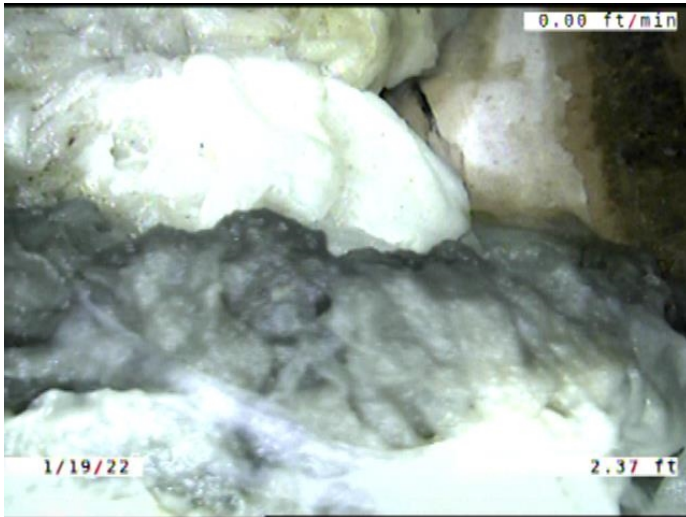
Code: **DAR**
 Description: **Deposits Attached Ragging**

Distance (ft): **2.4**
 Structural Grade: **0**
 O&M Grade: **2**
 Clock Start/From: **5**
 Clock To: **6**
 1st Value:
 2nd Value:
 Value Percent: **5.000**
 Continuous Index:
 Within 8" of Joint: **YES**
 Remarks:

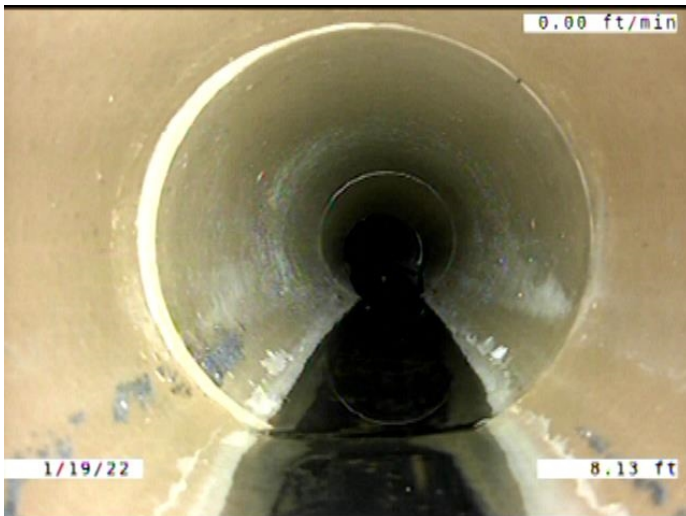
Code: **MWLS**
 Description: **Miscellaneous Water Level Sag**

Distance (ft): **8.1**
 Structural Grade: **2**
 O&M Grade: **0**
 Clock Start/From:
 Clock To:
 1st Value:
 2nd Value:
 Value Percent: **5.000**
 Continuous Index: **S01**
 Within 8" of Joint: **NO**
 Remarks:

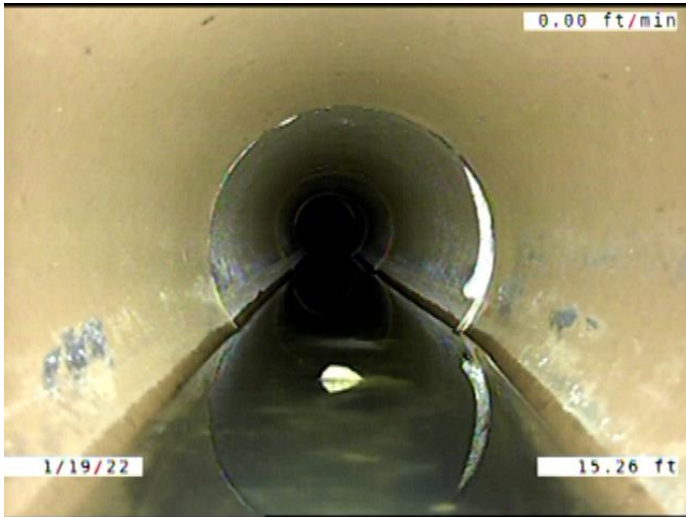
Code: **DSF**
 Description: **Deposits Settled Fine**

Distance (ft): **15.3**
 Structural Grade: **0**
 O&M Grade: **2**
 Clock Start/From: **5**
 Clock To: **7**
 1st Value:
 2nd Value:
 Value Percent: **5.000**
 Continuous Index: **S02**
 Within 8" of Joint: **YES**
 Remarks:

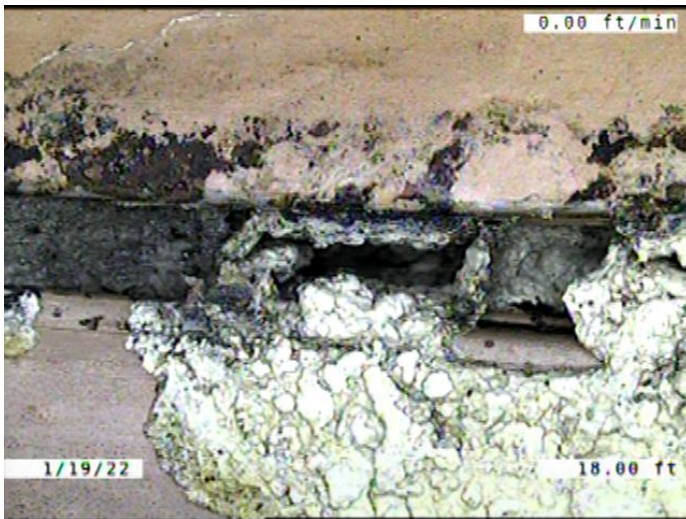
Code: **DAE**
 Description: **Deposits Attached Encrustation**

Distance (ft): **18.0**
 Structural Grade: **0**
 O&M Grade: **2**
 Clock Start/From: **8**
 Clock To: **4**
 1st Value:
 2nd Value:
 Value Percent: **5.000**
 Continuous Index:
 Within 8" of Joint: **YES**
 Remarks:

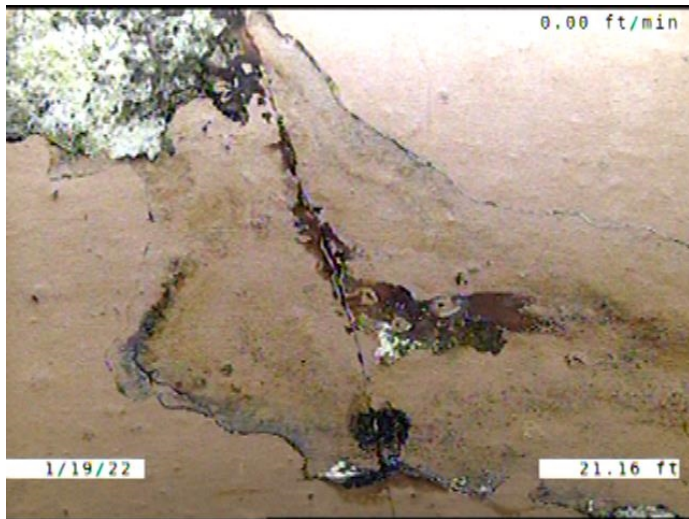
Code: **CS**
 Description: **Crack Spiral**

Distance (ft): **21.2**
 Structural Grade: **2**
 O&M Grade: **0**
 Clock Start/From: **12**
 Clock To: **1**
 1st Value:
 2nd Value:
 Value Percent:
 Continuous Index:
 Within 8" of Joint: **YES**
 Remarks:

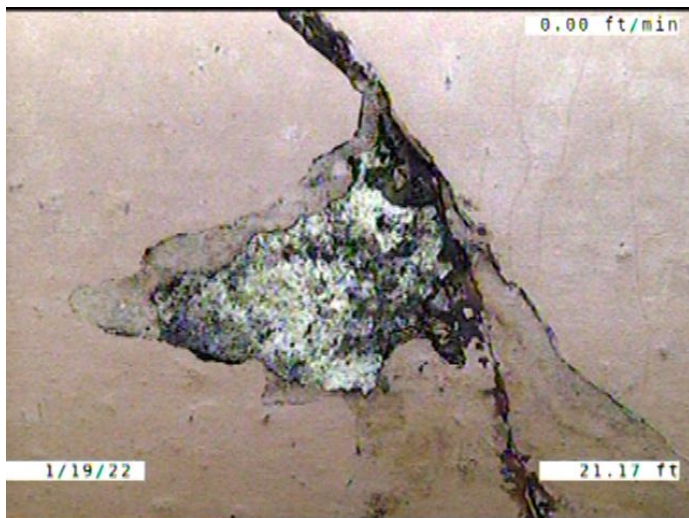
Code: **DAE**
 Description: **Deposits Attached Encrustation**

Distance (ft): **21.2**
 Structural Grade: **0**
 O&M Grade: **2**
 Clock Start/From: **11**
 Clock To: **3**
 1st Value:
 2nd Value:
 Value Percent: **5.000**
 Continuous Index:
 Within 8" of Joint: **YES**
 Remarks:

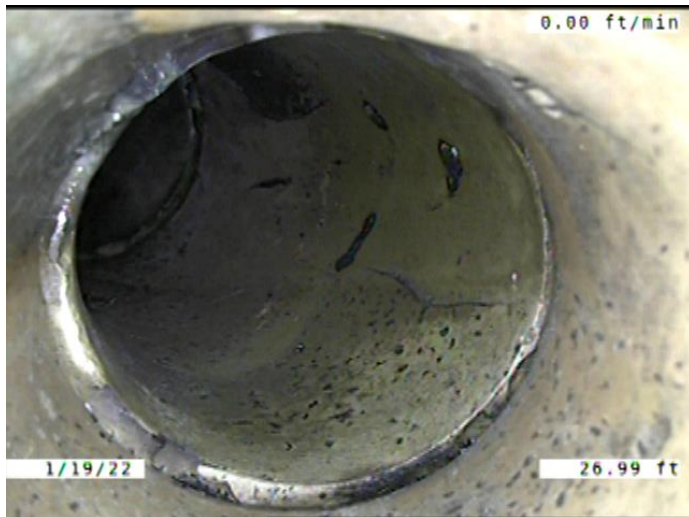
Code: **TF**
Description: **Tap Factory**

Distance (ft): **27.0**
Structural Grade: **0**
O&M Grade: **0**
Clock Start/From: **11**
Clock To:
1st Value: **4.000**
2nd Value:
Value Percent:
Continuous Index:
Within 8" of Joint: **YES**
Remarks: **CONSTANTLY RUNNING WATER.**

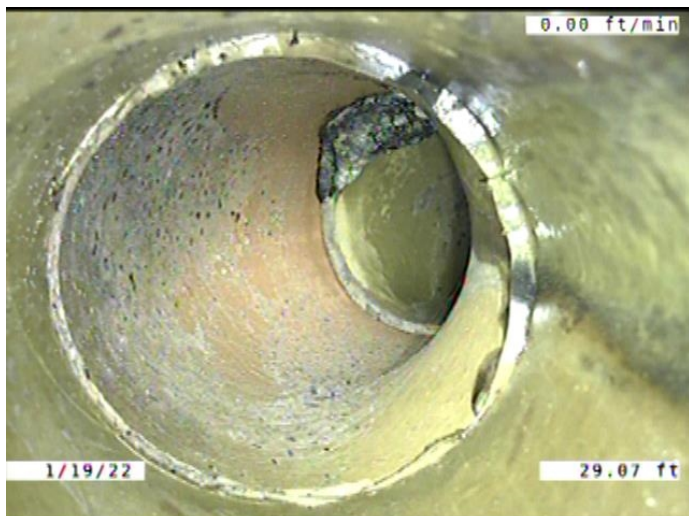
Code: **TF**
Description: **Tap Factory**

Distance (ft): **29.1**
Structural Grade: **0**
O&M Grade: **0**
Clock Start/From: **2**
Clock To:
1st Value: **4.000**
2nd Value:
Value Percent:
Continuous Index:
Within 8" of Joint: **YES**
Remarks: **CONSTANTLY RUNNING WATER.**

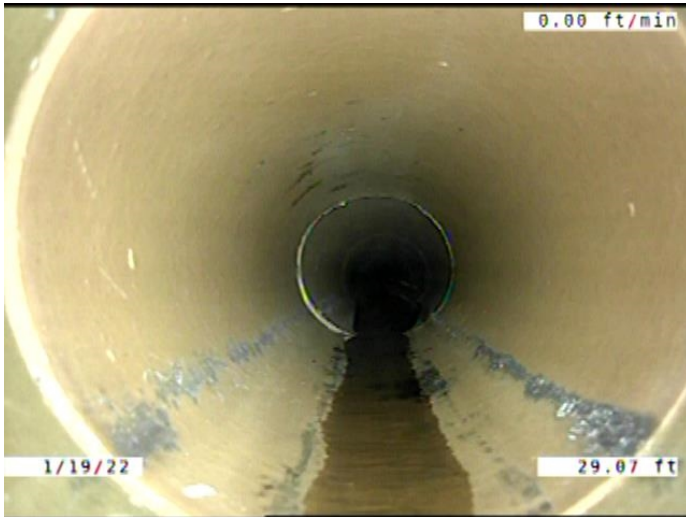
Code: **MWLS**
Description: **Miscellaneous Water Level Sag**

Distance (ft): **29.1**
Structural Grade: **2**
O&M Grade: **0**
Clock Start/From:
Clock To:
1st Value:
2nd Value:
Value Percent: **5.000**
Continuous Index: **F01**
Within 8" of Joint: **NO**
Remarks:

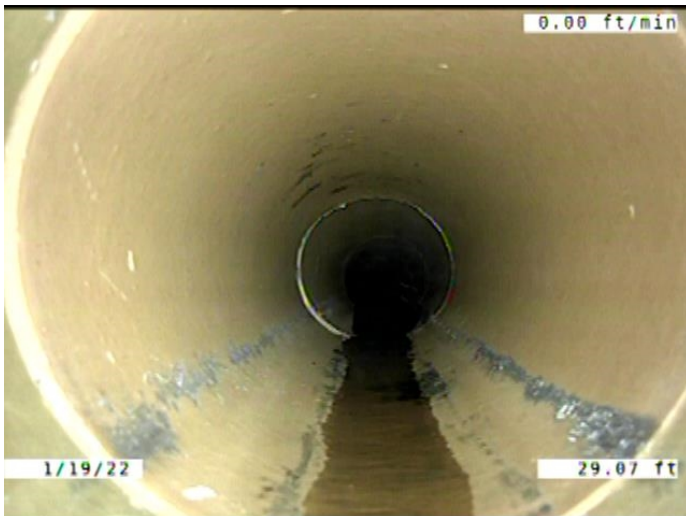
Code: **DSF**
Description: **Deposits Settled Fine**

Distance (ft): **29.1**
Structural Grade: **0**
O&M Grade: **2**
Clock Start/From: **5**
Clock To: **7**
1st Value:
2nd Value:
Value Percent: **5.000**
Continuous Index: **F02**
Within 8" of Joint: **YES**
Remarks:

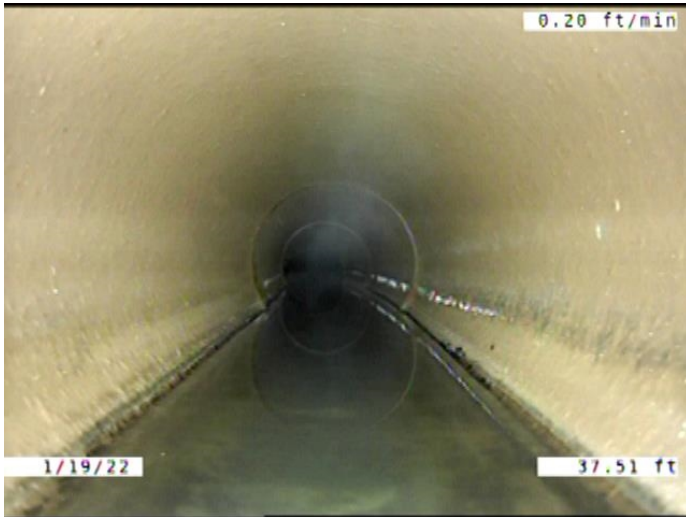
Code: **DSF**
 Description: **Deposits Settled Fine**

Distance (ft): **37.5**
 Structural Grade: **0**
 O&M Grade: **2**
 Clock Start/From: **5**
 Clock To: **7**
 1st Value:
 2nd Value:
 Value Percent: **5.000**
 Continuous Index: **S03**
 Within 8" of Joint: **YES**
 Remarks:

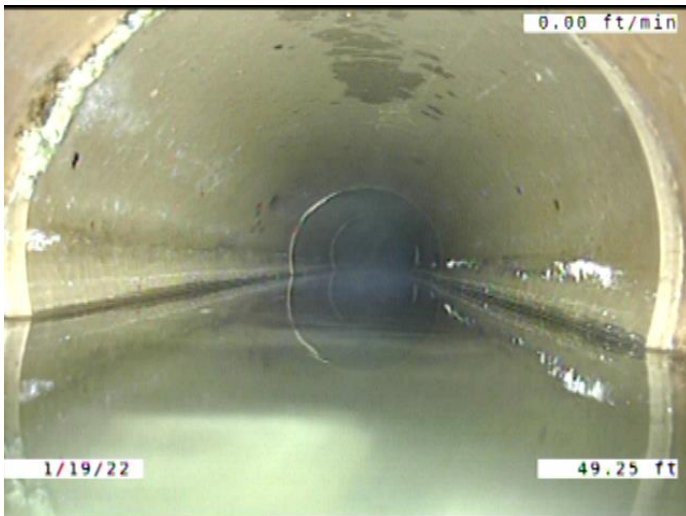
Code: **MWL**
 Description: **Miscellaneous Water Level**

Distance (ft): **49.2**
 Structural Grade: **0**
 O&M Grade: **0**
 Clock Start/From:
 Clock To:
 1st Value:
 2nd Value:
 Value Percent: **15.000**
 Continuous Index:
 Within 8" of Joint: **NO**
 Remarks:

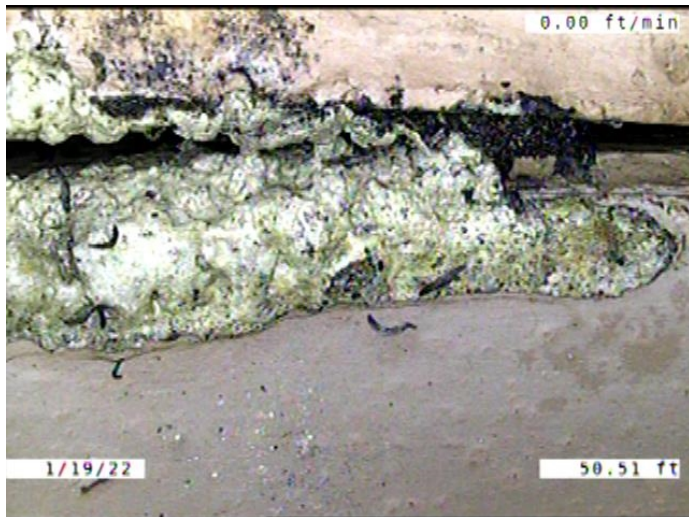
Code: **DAE**
 Description: **Deposits Attached Encrustation**

Distance (ft): **50.5**
 Structural Grade: **0**
 O&M Grade: **2**
 Clock Start/From: **9**
 Clock To: **11**
 1st Value:
 2nd Value:
 Value Percent: **5.000**
 Continuous Index:
 Within 8" of Joint: **YES**
 Remarks:

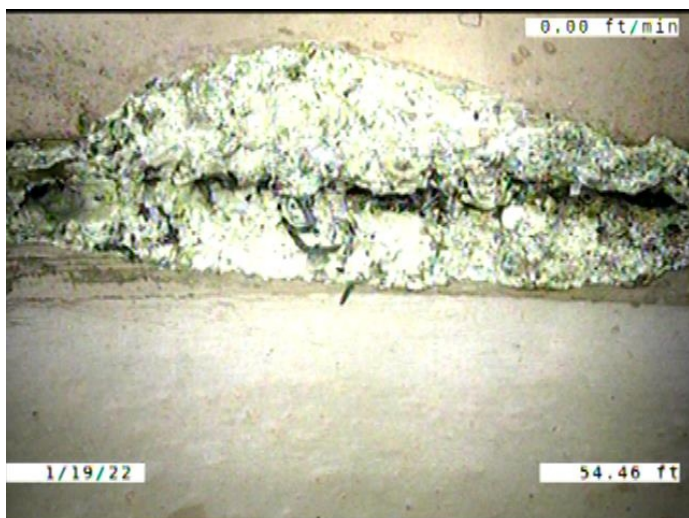
Code: **DAE**
 Description: **Deposits Attached Encrustation**

Distance (ft): **54.5**
 Structural Grade: **0**
 O&M Grade: **2**
 Clock Start/From: **9**
 Clock To: **11**
 1st Value:
 2nd Value:
 Value Percent: **5.000**
 Continuous Index:
 Within 8" of Joint: **YES**
 Remarks:

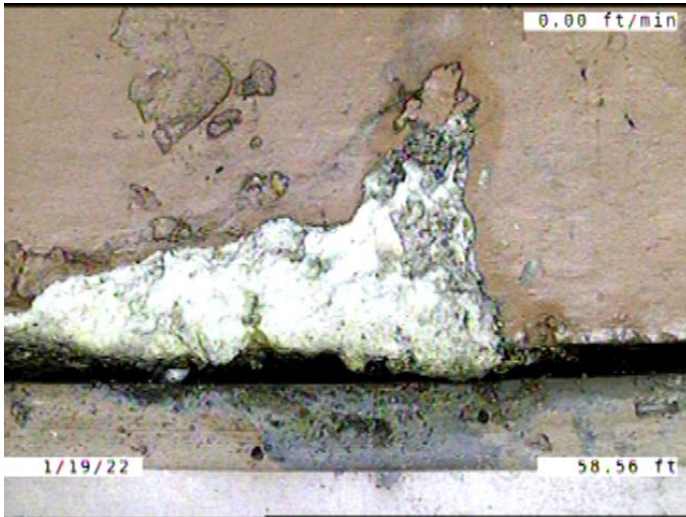
Code: **DAE**
Description: **Deposits Attached Encrustation**

Distance (ft): **58.5**
Structural Grade: **0**
O&M Grade: **2**
Clock Start/From: **1**
Clock To: **3**
1st Value:
2nd Value:
Value Percent: **5.000**
Continuous Index:
Within 8" of Joint: **YES**
Remarks:

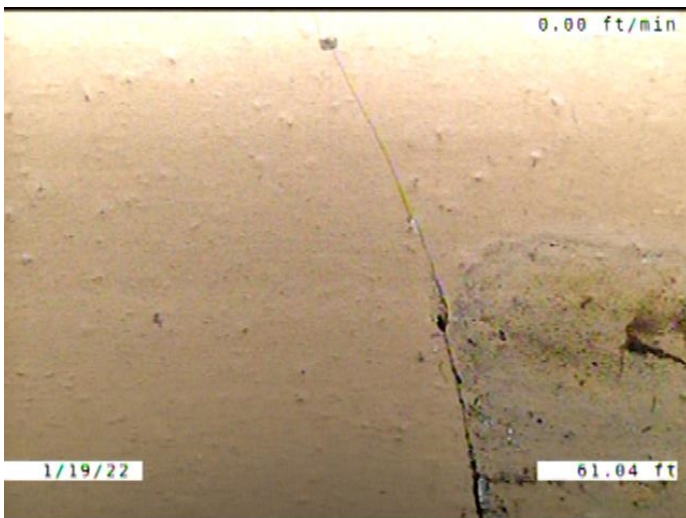
Code: **CS**
Description: **Crack Spiral**

Distance (ft): **61.0**
Structural Grade: **2**
O&M Grade: **0**
Clock Start/From: **12**
Clock To: **1**
1st Value:
2nd Value:
Value Percent:
Continuous Index:
Within 8" of Joint: **YES**
Remarks:

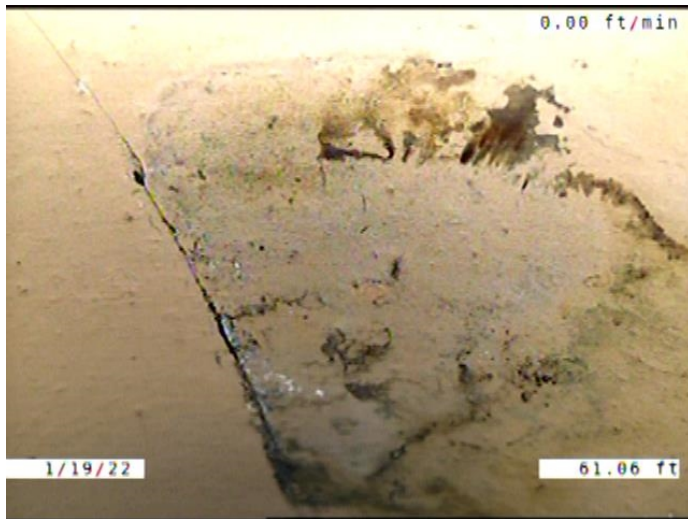
Code: **ISB**
 Description: **Infiltration Stain Barrel**

Distance (ft): **61.1**
 Structural Grade: **0**
 O&M Grade: **1**
 Clock Start/From: **1**
 Clock To: **3**
 1st Value:
 2nd Value:
 Value Percent:
 Continuous Index:
 Within 8" of Joint: **NO**
 Remarks:

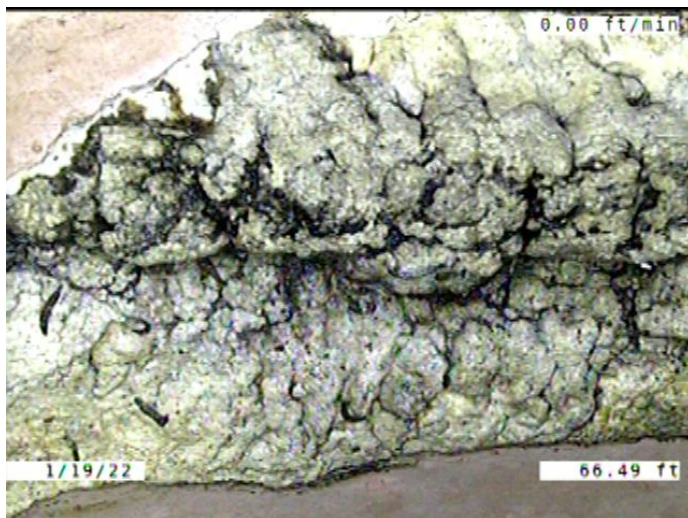
Code: **DAE**
 Description: **Deposits Attached Encrustation**

Distance (ft): **66.5**
 Structural Grade: **0**
 O&M Grade: **2**
 Clock Start/From: **8**
 Clock To: **4**
 1st Value:
 2nd Value:
 Value Percent: **5.000**
 Continuous Index: **S04**
 Within 8" of Joint: **YES**
 Remarks:

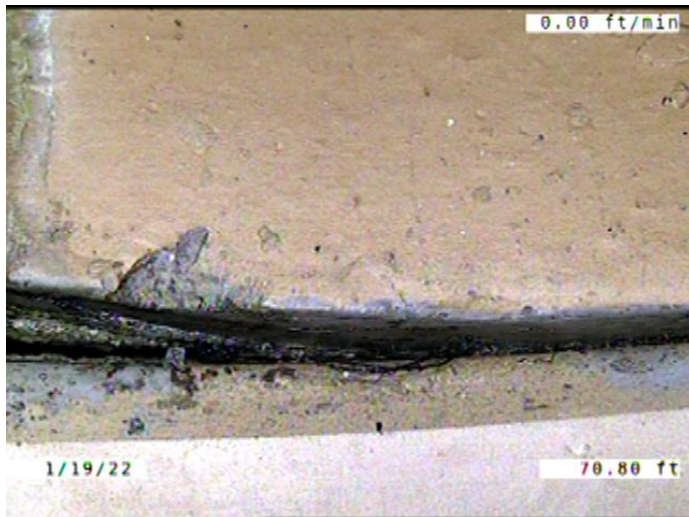
Code: **RFJ**
 Description: **Roots Fine Joint**

Distance (ft): **70.8**
 Structural Grade: **0**
 O&M Grade: **1**
 Clock Start/From: **10**
 Clock To:
 1st Value:
 2nd Value:
 Value Percent:
 Continuous Index:
 Within 8" of Joint: **YES**
 Remarks:

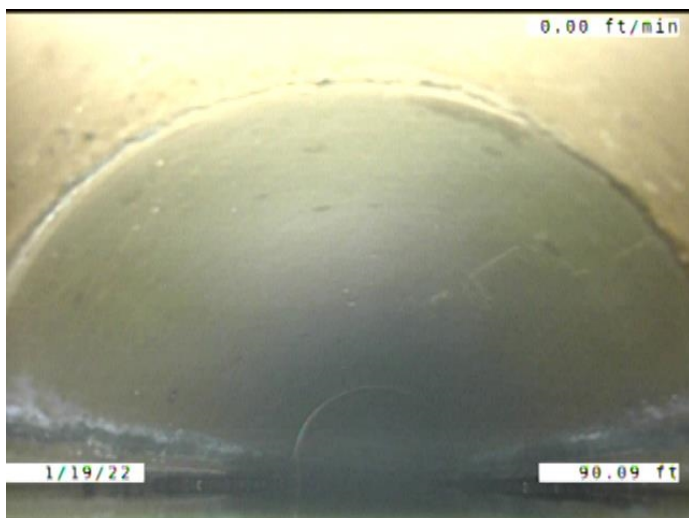
Code: **MWL**
 Description: **Miscellaneous Water Level**

Distance (ft): **90.1**
 Structural Grade: **0**
 O&M Grade: **0**
 Clock Start/From:
 Clock To:
 1st Value:
 2nd Value:
 Value Percent: **25.000**
 Continuous Index:
 Within 8" of Joint: **NO**
 Remarks:

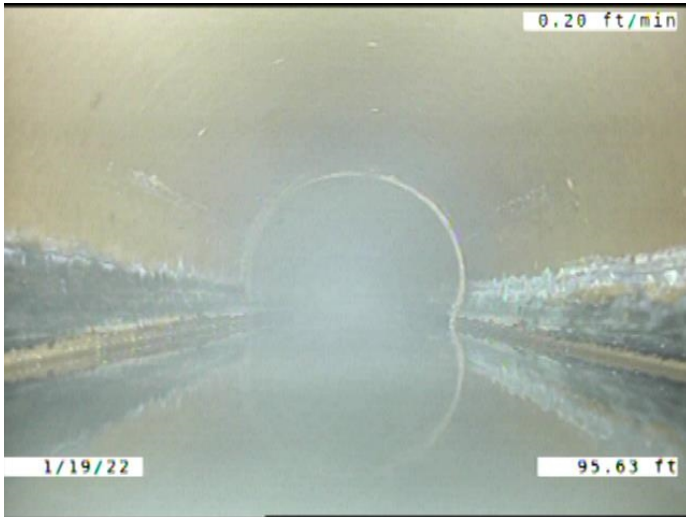
Code: **MWL**
 Description: **Miscellaneous Water Level**

Distance (ft): **95.6**
 Structural Grade: **0**
 O&M Grade: **0**
 Clock Start/From:
 Clock To:
 1st Value:
 2nd Value:
 Value Percent: **15.000**
 Continuous Index:
 Within 8" of Joint: **NO**
 Remarks:

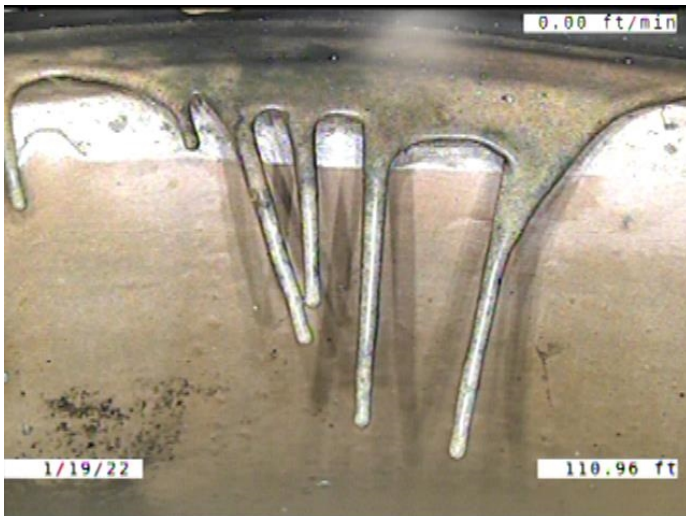
Code: **ISSRH**
 Description: **Intruding Sealing Material Sealing Ring Hanging**

Distance (ft): **111.0**
 Structural Grade: **0**
 O&M Grade: **2**
 Clock Start/From: **9**
 Clock To: **12**
 1st Value:
 2nd Value:
 Value Percent: **5.000**
 Continuous Index:
 Within 8" of Joint: **NO**
 Remarks:

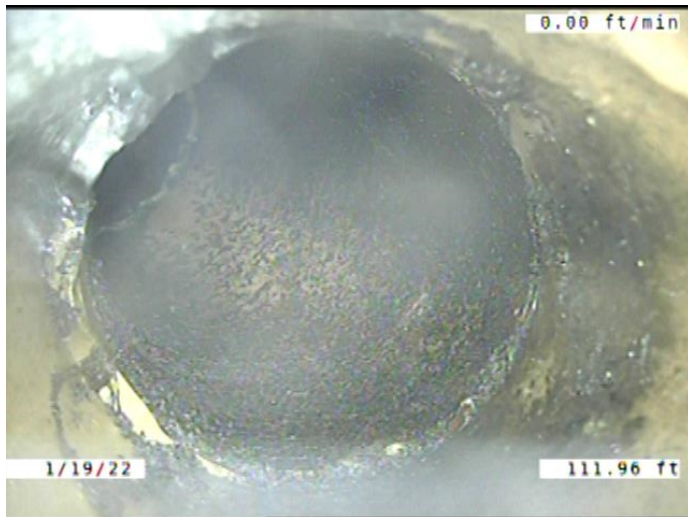
Code: **TFA**
Description: **Tap Factory Activity**

Distance (ft): **112.0**
Structural Grade: **0**
O&M Grade: **0**
Clock Start/From: **11**
Clock To:
1st Value: **4.000**
2nd Value:
Value Percent:
Continuous Index:
Within 8" of Joint: **YES**
Remarks: **CONSTANTLY RUNNING WATER.**

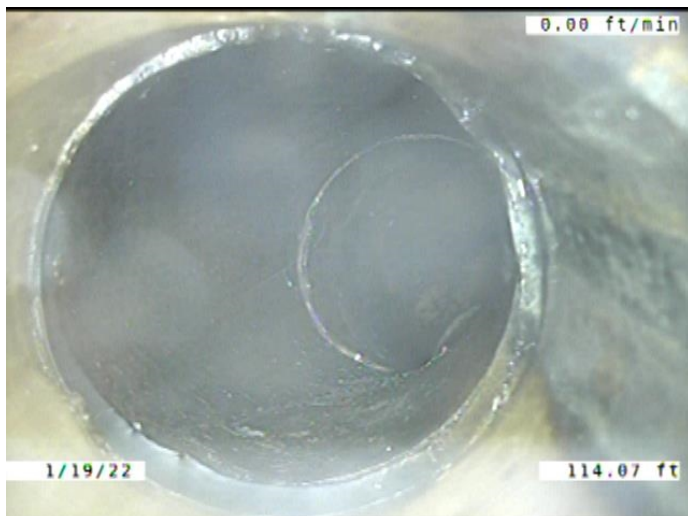
Code: **TF**
Description: **Tap Factory**

Distance (ft): **114.1**
Structural Grade: **0**
O&M Grade: **0**
Clock Start/From: **2**
Clock To:
1st Value: **4.000**
2nd Value:
Value Percent:
Continuous Index:
Within 8" of Joint: **YES**
Remarks:

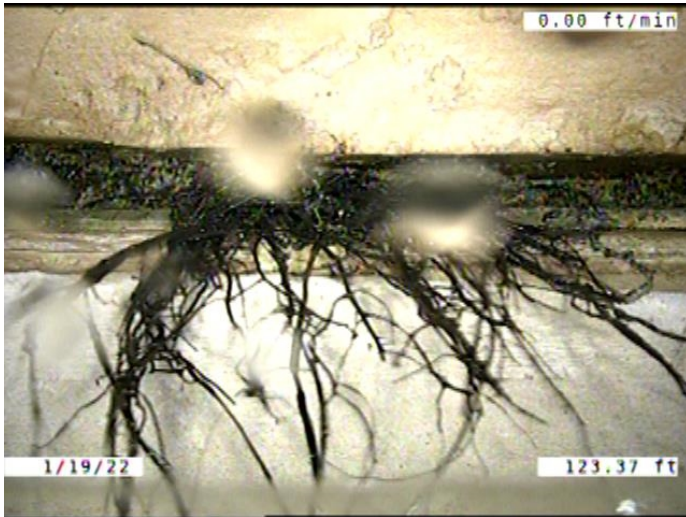
Code: **RFJ**
 Description: **Roots Fine Joint**

Distance (ft): **123.4**
 Structural Grade: **0**
 O&M Grade: **1**
 Clock Start/From: **11**
 Clock To: **1**
 1st Value:
 2nd Value:
 Value Percent:
 Continuous Index:
 Within 8" of Joint: **YES**
 Remarks:

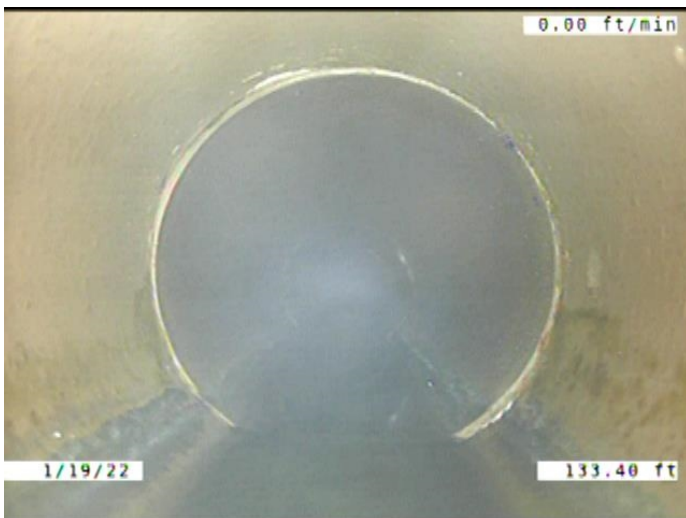
Code: **MWL**
 Description: **Miscellaneous Water Level**

Distance (ft): **133.4**
 Structural Grade: **0**
 O&M Grade: **0**
 Clock Start/From:
 Clock To:
 1st Value:
 2nd Value:
 Value Percent: **5.000**
 Continuous Index:
 Within 8" of Joint: **NO**
 Remarks:

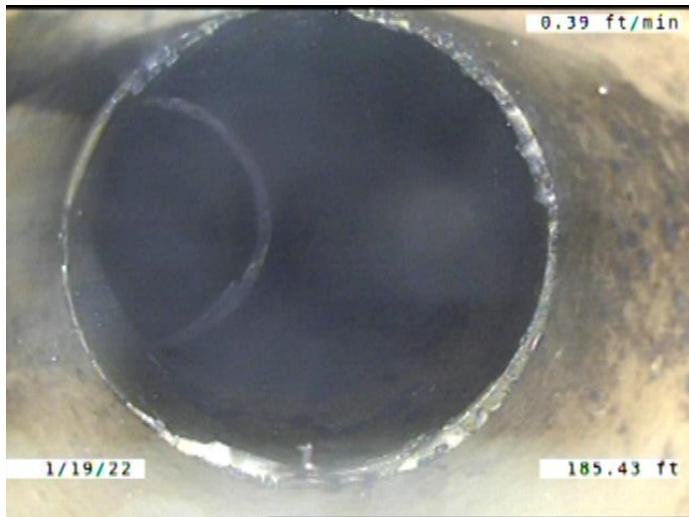
Code: **TF**
Description: **Tap Factory**

Distance (ft): **185.4**
Structural Grade: **0**
O&M Grade: **0**
Clock Start/From: **10**
Clock To:
1st Value: **4.000**
2nd Value:
Value Percent:
Continuous Index:
Within 8" of Joint: **YES**
Remarks:

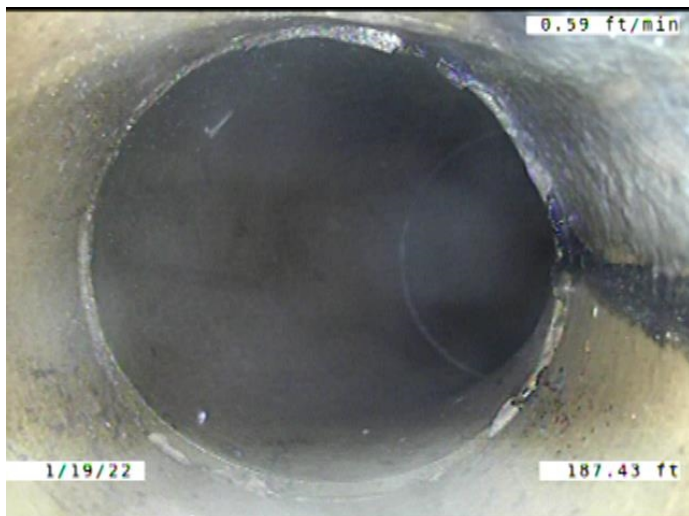
Code: **TF**
Description: **Tap Factory**

Distance (ft): **187.4**
Structural Grade: **0**
O&M Grade: **0**
Clock Start/From: **2**
Clock To:
1st Value: **4.000**
2nd Value:
Value Percent:
Continuous Index:
Within 8" of Joint: **YES**
Remarks:

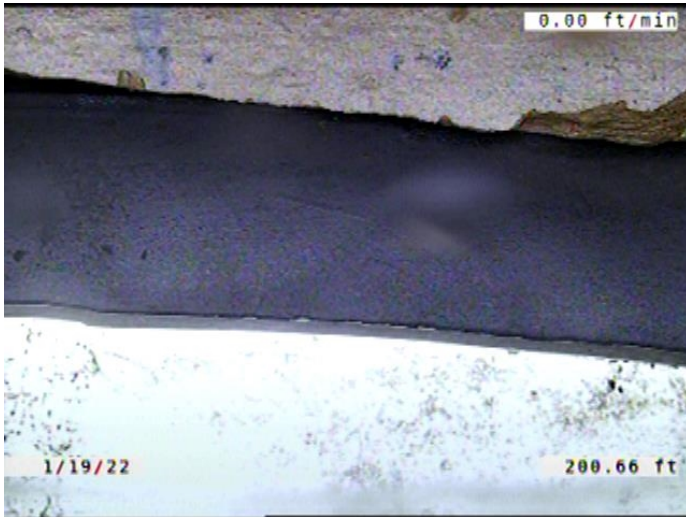
Code: **MMC**
 Description: **Miscellaneous Material Change**

Distance (ft): **200.7**
 Structural Grade: **0**
 O&M Grade: **0**
 Clock Start/From:
 Clock To:
 1st Value:
 2nd Value:
 Value Percent:
 Continuous Index:
 Within 8" of Joint: **NO**
 Remarks: **VCP TO PVC**

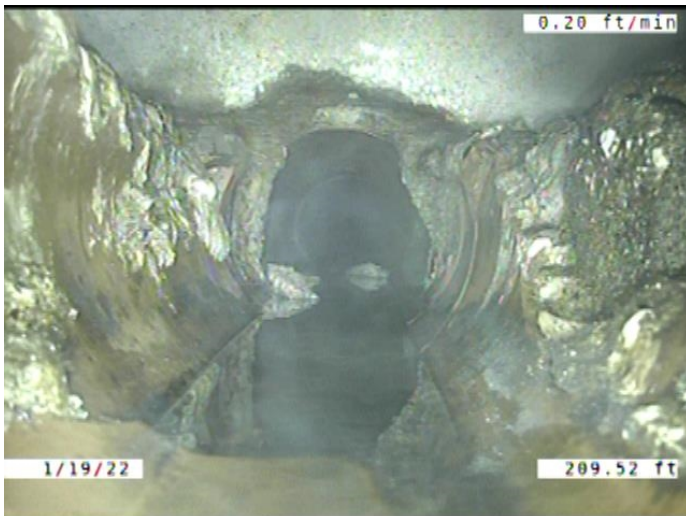
Code: **DSF**
 Description: **Deposits Settled Fine**

Distance (ft): **209.5**
 Structural Grade: **0**
 O&M Grade: **2**
 Clock Start/From: **5**
 Clock To: **7**
 1st Value:
 2nd Value:
 Value Percent: **5.000**
 Continuous Index: **F03**
 Within 8" of Joint: **YES**
 Remarks:

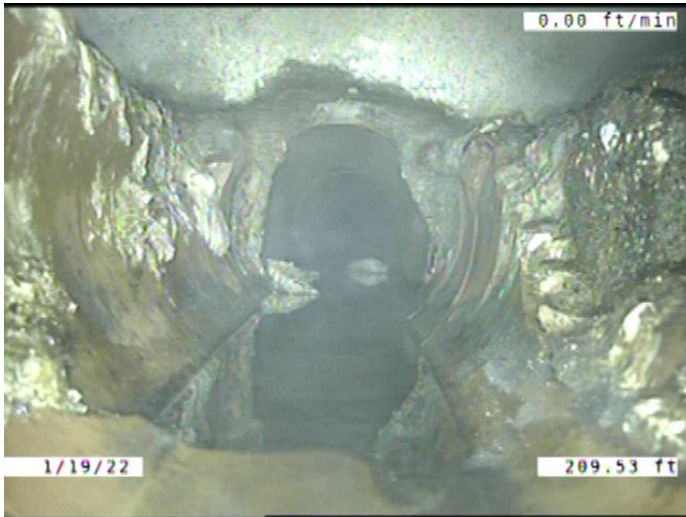
Code: **DAE**
 Description: **Deposits Attached Encrustation**

Distance (ft): **209.5**
 Structural Grade: **0**
 O&M Grade: **2**
 Clock Start/From: **8**
 Clock To: **4**
 1st Value:
 2nd Value:
 Value Percent: **5.000**
 Continuous Index: **F04**
 Within 8" of Joint: **YES**
 Remarks:

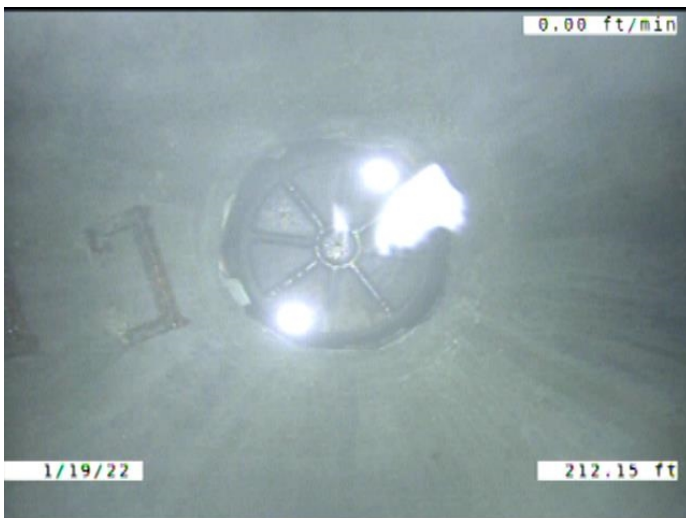
Code: **AMH**
 Description: **Manhole**

Distance (ft): **212.2**
 Structural Grade: **0**
 O&M Grade: **0**
 Clock Start/From:
 Clock To:
 1st Value:
 2nd Value:
 Value Percent:
 Continuous Index:
 Within 8" of Joint: **NO**
 Remarks: **M-506-009**
