## Profile/Photo Observation Report

Street:	<b>S COLORADO ST &amp; W 7TH PL</b>	Flow Control:	<b>Not Controlled</b>
City:	<b>Hobart, IN</b>	Year Renewed:	
Location:	<b>Yard</b>	Tape/Media #:	
Purpose:	<b>Routine Assessment</b>	Dia/Height:	<b>10"</b>
Use:	<b>Sanitary</b>	Material:	<b>VCP</b>
Drain Area:	<b>NA</b>	Lining:	
Category:	<b>NA</b>		
Comment:

Location Details:		Direction of Survey:	<b>Upstream</b>
US MH:	<b>M-506-010</b>	DS MH:	<b>M-506-011</b>
		Total Length Surveyed (ft):	<b>3.1</b>

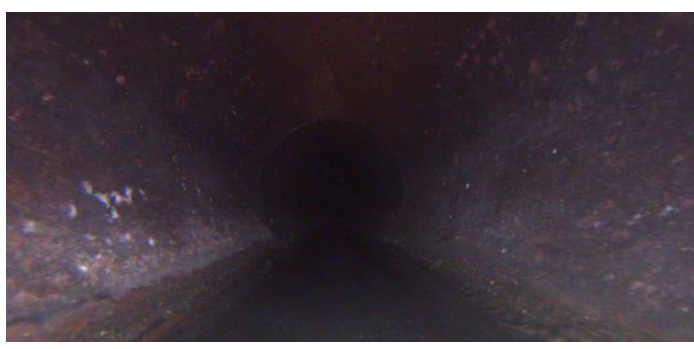
Code: **AMH**  
Description: **Manhole**

Distance (ft): **.0**  
Structural Grade: **0**  
O&M Grade: **0**  
Clock Start/From:  
Clock To:  
1st Value:  
2nd Value:  
Value Percent:  
Continuous Index:  
Within 8" of Joint: **NO**  
Remarks: **M-506-011**

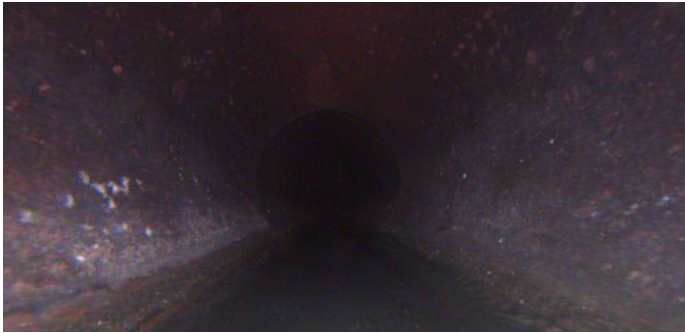
Code:	<b>MWL</b>
Description:	<b>Water Level</b>

Distance (ft):	<b>.0</b>
Structural Grade:	<b>0</b>
O&M Grade:	<b>0</b>
Clock Start/From:	
Clock To:	
1st Value:	
2nd Value:	
Value Percent:	<b>10.000</b>
Continuous Index:	
Within 8" of Joint:	<b>NO</b>
Remarks:

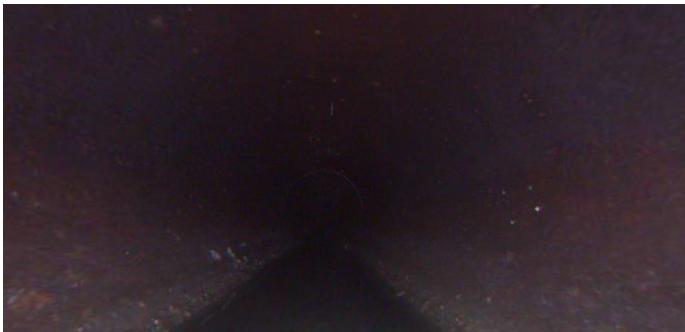
Code:	<b>MSA</b>
Description:	<b>Abandoned Survey</b>

Distance (ft):	<b>3.1</b>
Structural Grade:	<b>0</b>
O&M Grade:	<b>0</b>
Clock Start/From:	
Clock To:	
1st Value:	
2nd Value:	
Value Percent:	
Continuous Index:	
Within 8" of Joint:	<b>NO</b>
Remarks:	<b>unknown</b>
